**REPUBLIC OF CYPRUS
MARINE ACCIDENT AND INCIDENT
INVESTIGATION COMMITTEE**

Investigation Report No: 56E/2016

Very Serious Marine Casualty

**Death of a crew member of the M/V “VASTERBOTTEN” on
14/04/2016 while plying the Baltic Sea**

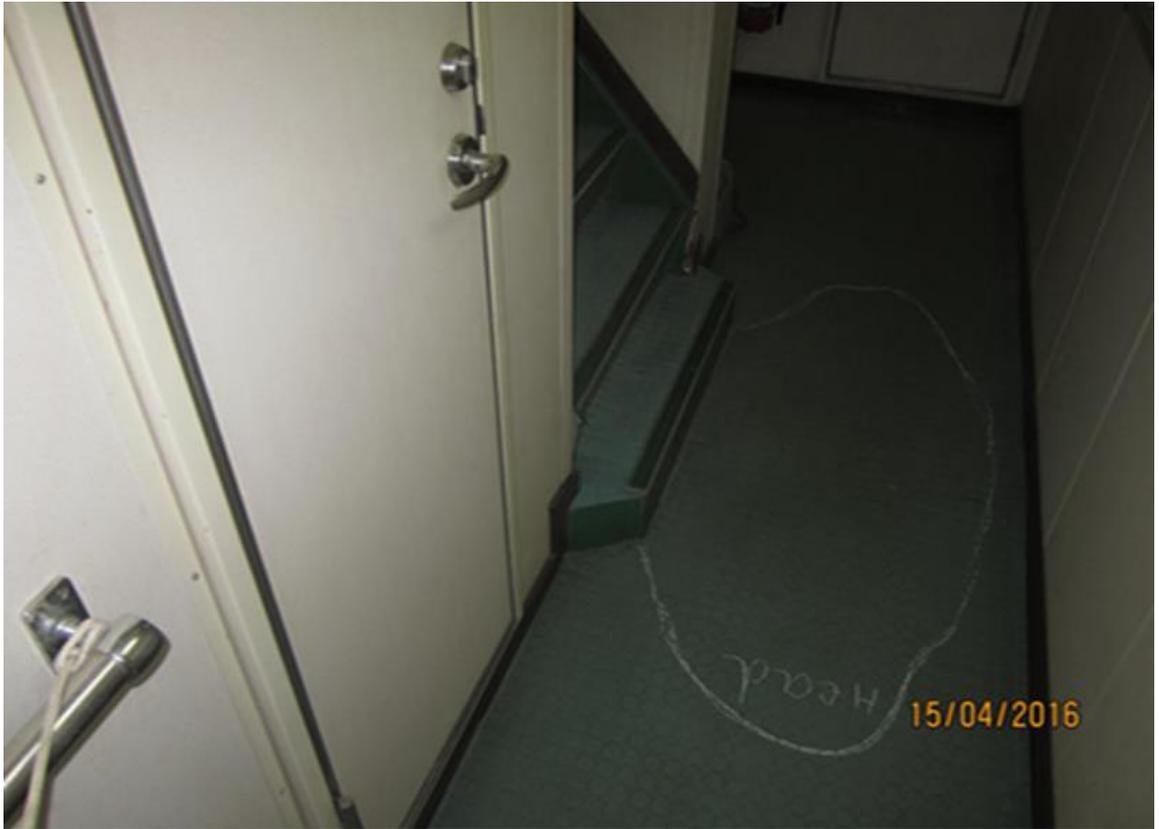
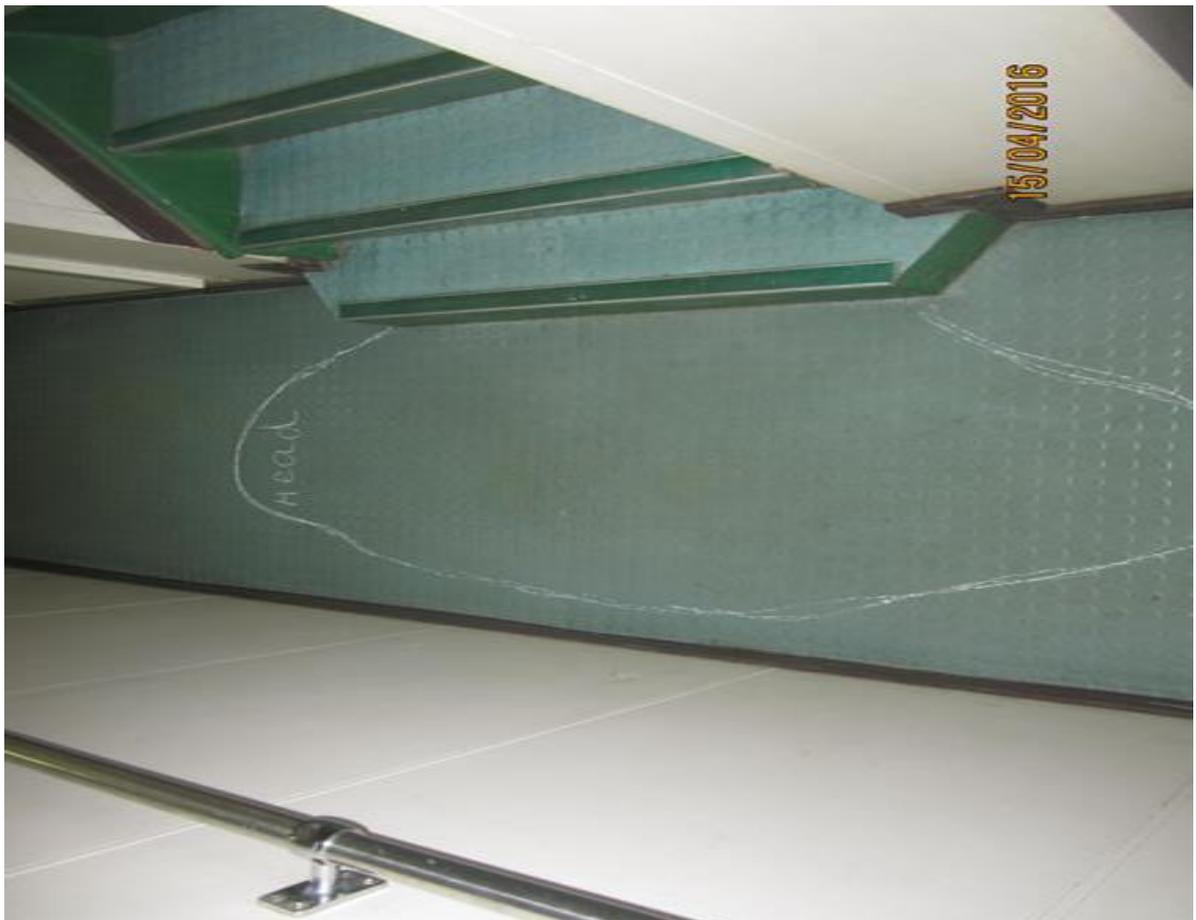
8. At approximately 23:45 hrs the C/E was found by the Ordinary Seaman (OS), unconscious. He was lying on the floor of the accommodation’s main deck alleyway, below a ladder and close to the Engine Room’s (ER) internal door.

Figure 2: The accommodation's main deck internal alleyway where the C/E was lying -The position of the head is noted

Fall of the seafarer onto the back of the head which caused extensive cranial injuries.

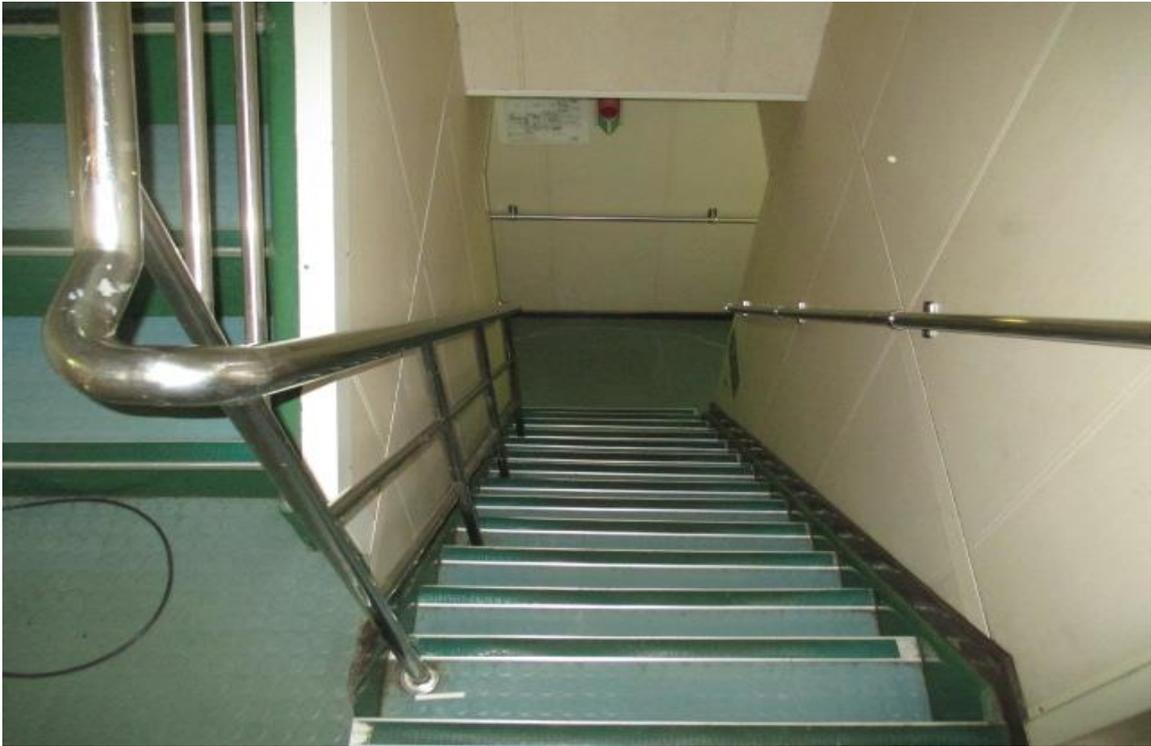
Figure 3: The accommodation's internal ladder from where it is assumed that the C/E fell

There were no any sudden movements of the vessel which could had caused the C/E slipping and falling from the accommodation's internal stairs. The condition of the stairs and the alleyway below, was not wet nor slippery. They were dry.

Injuries to the head may have been caused, by a fall down from the internal accommodation ladder, involving a head impact.

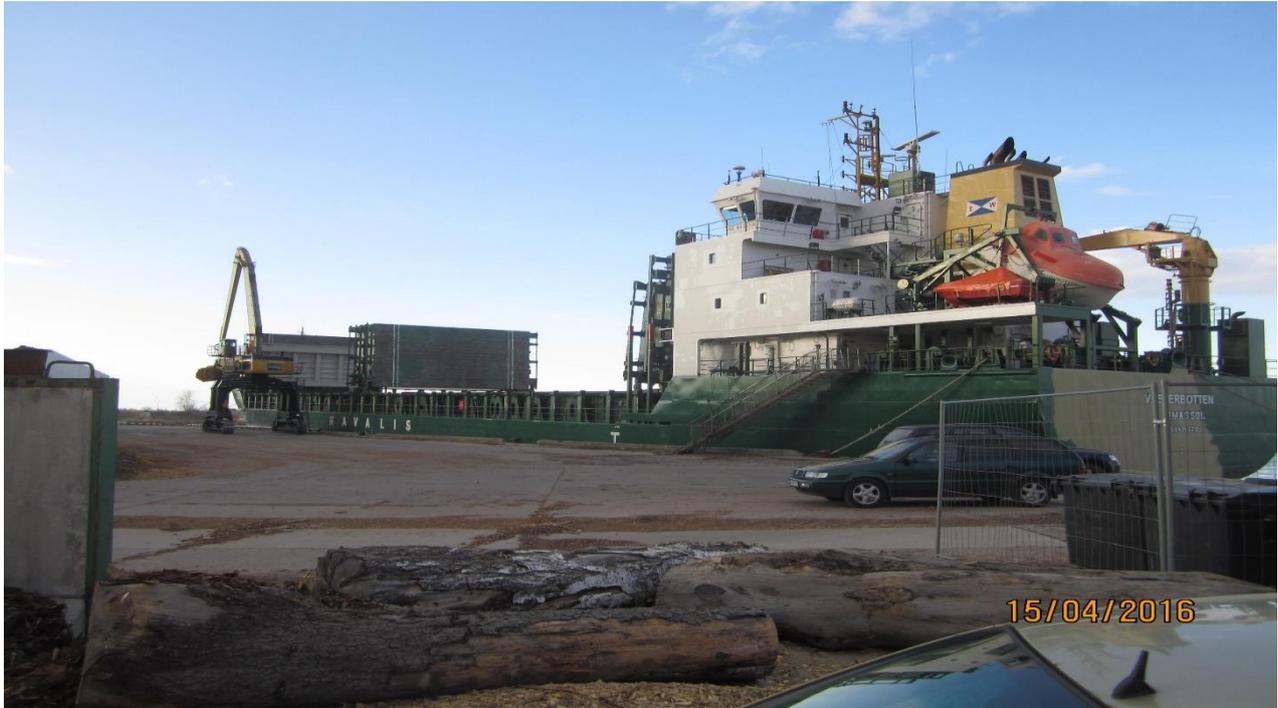
Figure 4: M/V “Vasterbotten” in the port of Mersrags-Latvia, the day after the incident - Alcohol tests to all crew members indicated BAC 0.00 except one who had BAC 0.90

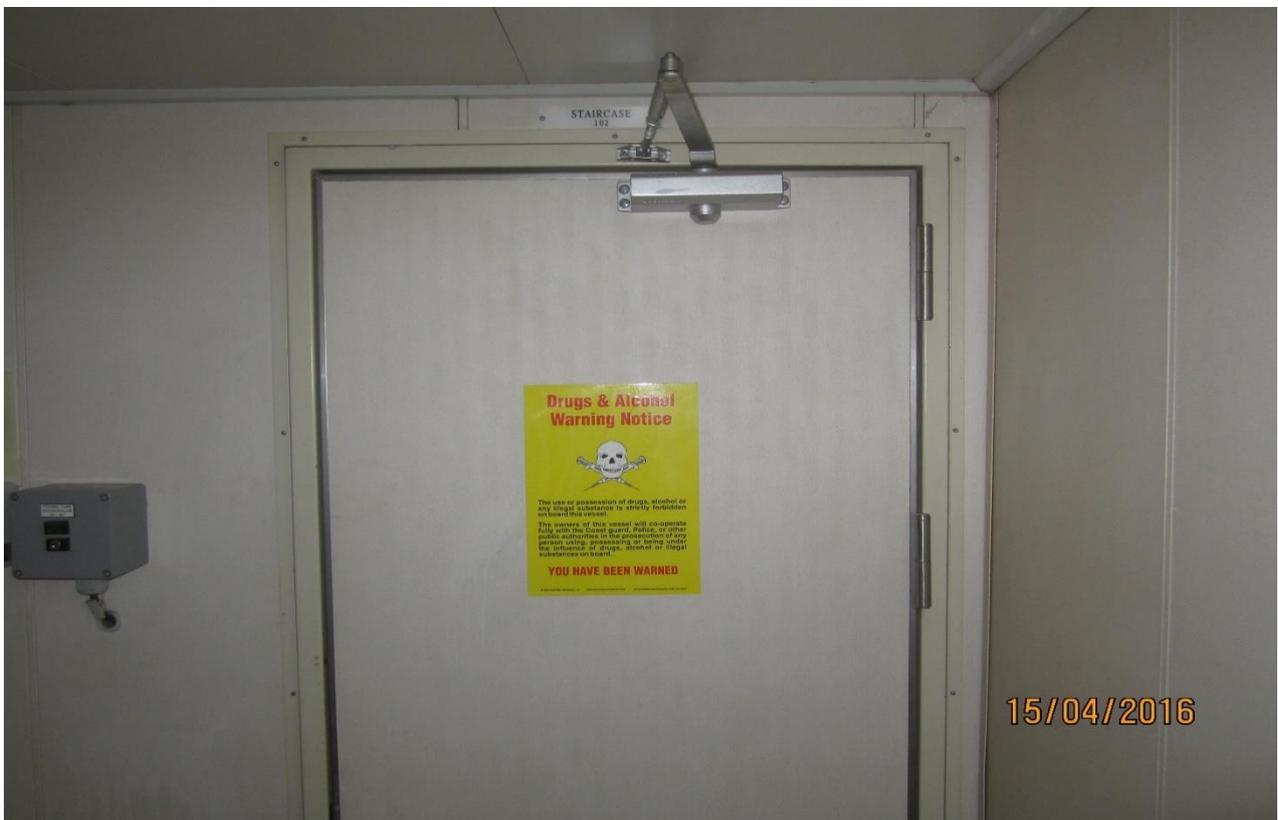
Figure 5: Drug and Alcohol warning notice posted

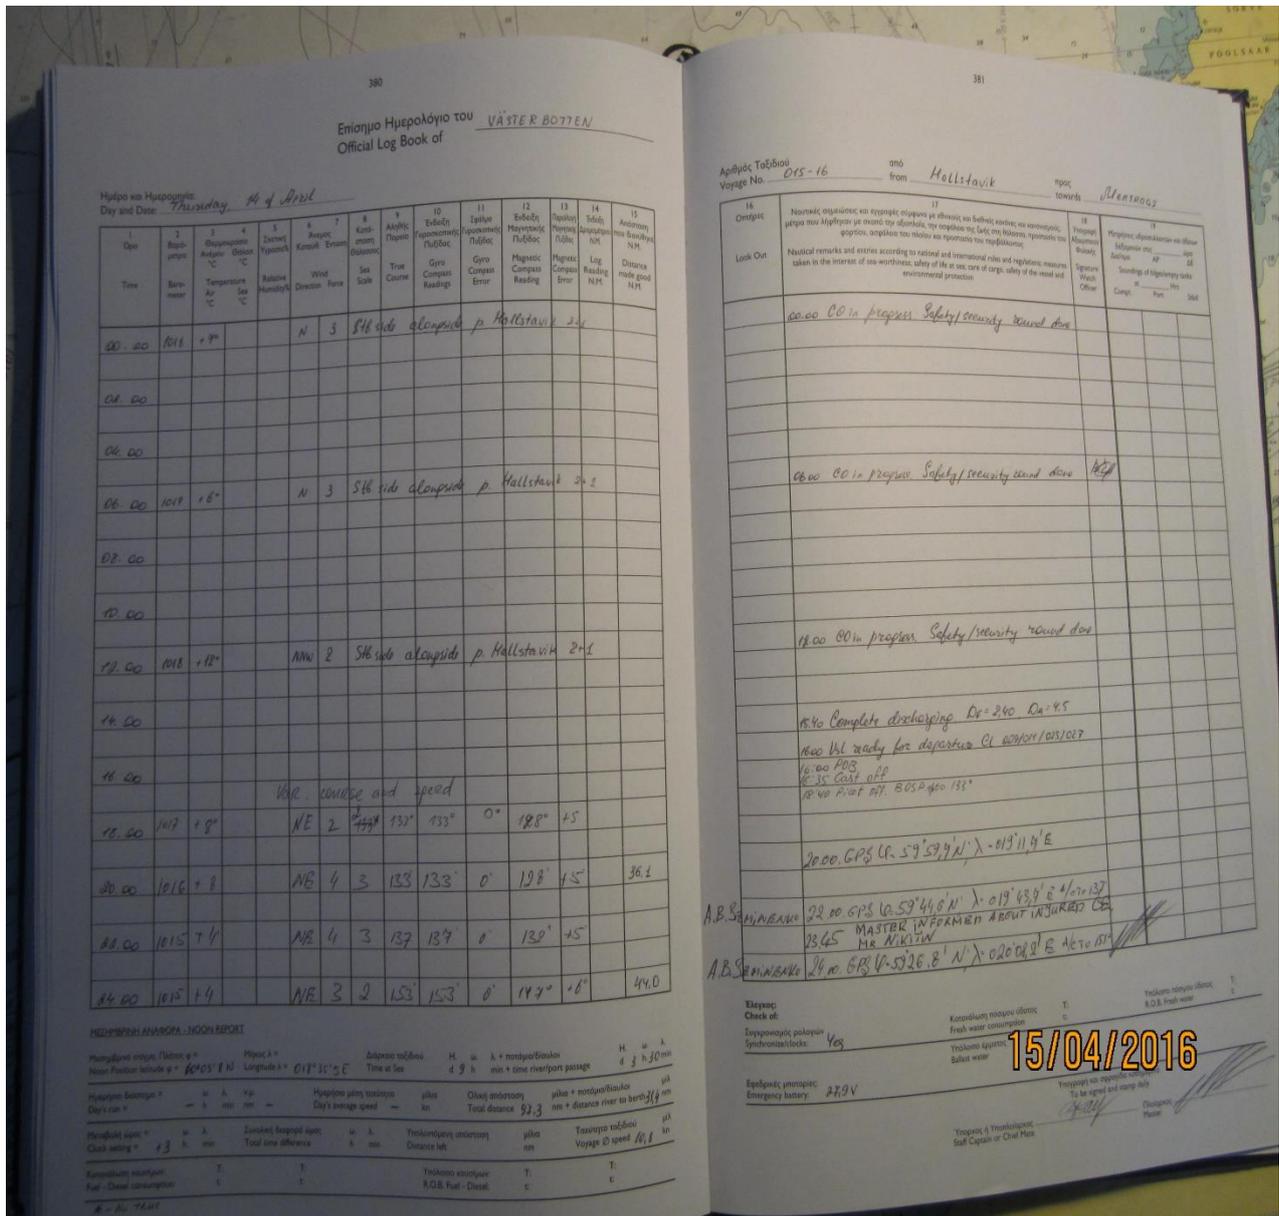
Figure 9: Photo Deck Log-Book extract 14/04/2016 taken by the Investigator the next day 15/04/2016, when the ship berthed in Messregs. (There is no alcotest record).

Therefore, it is concluded that the MC's Procedure on Drug and Alcohol Abuse was not implemented in the day of the accident.

2. The MC to take measures to ensure that the Deck Log-Book is completed in accordance with the “Matters to be Recorded” and “Instructions for Recording Information in the Official Log-Book”, printed in the first pages of the Official Log-Book of the Republic of Cyprus. Particularly, to stress the requirement that entries must be made by the end of each watch as provided by item 17 of the above-mentioned instructions.
