**FINAL REPORT Nr.4-02/4-11-(4/2012)**

**OF THE AIRCRAFT SERIOUS INCIDENT**

**LOSS OF SEPARATION DURING FINAL APPROACH BETWEEN THE AIRCRAFT  
LIBERTY AEROSPACE XL-2, REGISTRATION YL-EON and WizzAir AIRCRAFT  
AIRBUS A-320, REGISTRATION HA-LPI, FLIGHT WZZ7BU, ON JULY 08, 2011**

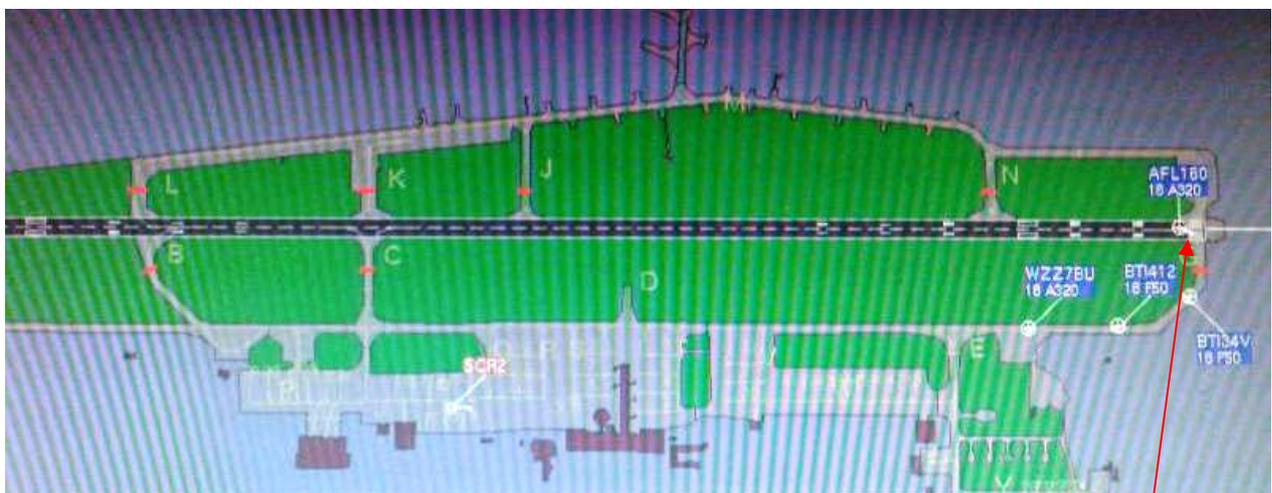
Picture 3

**There was following traffic situation for Riga Tower Controller (Picture 3) at 10:23:**

On departure were 4 (four) aircraft A320 (AFL160), F50 (BTI3FV) F50 (BTI412) and A320 (WZZ7BU).

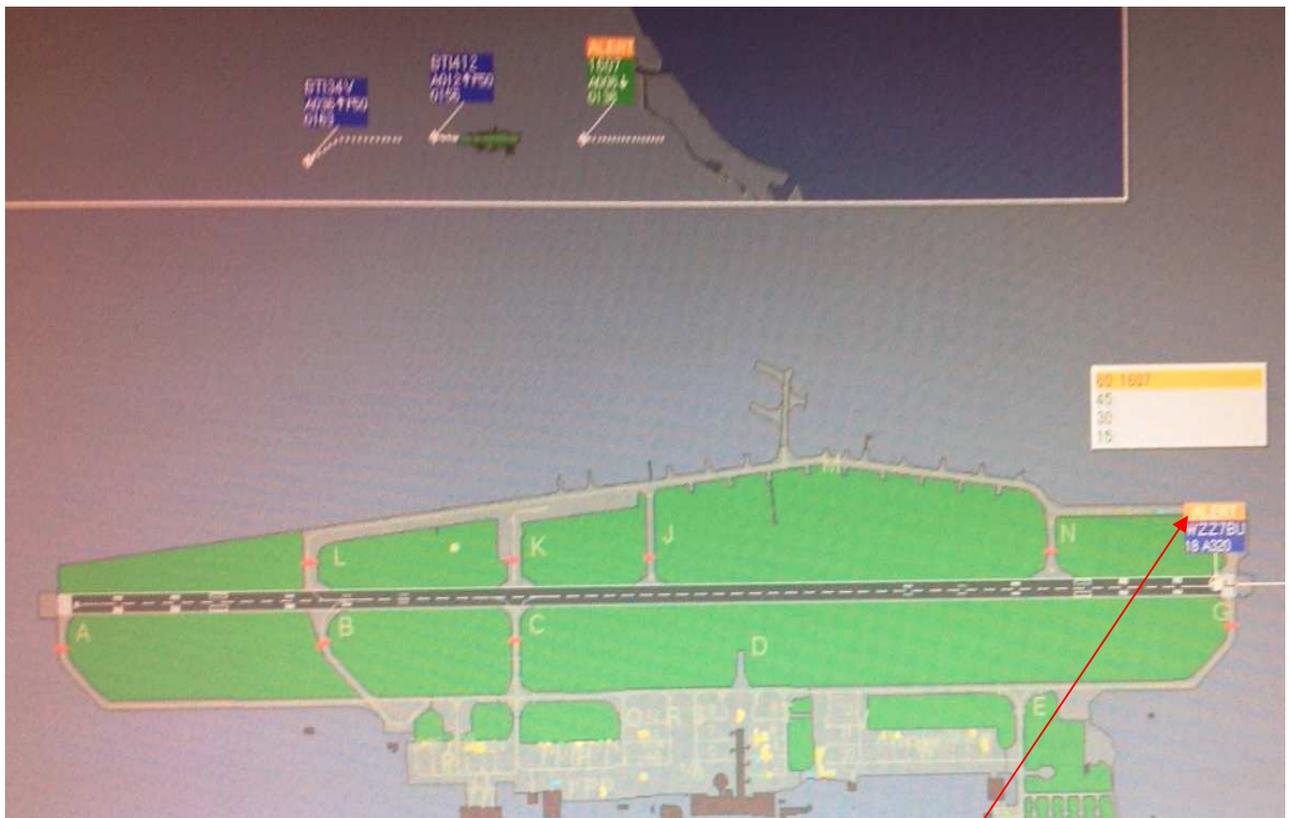
Picture 4

At **10:27:11** A-SMGCS "**ALERT**" distance less then 2NM between traffic. (Picture 4)

A-SMGCS "ALERT"

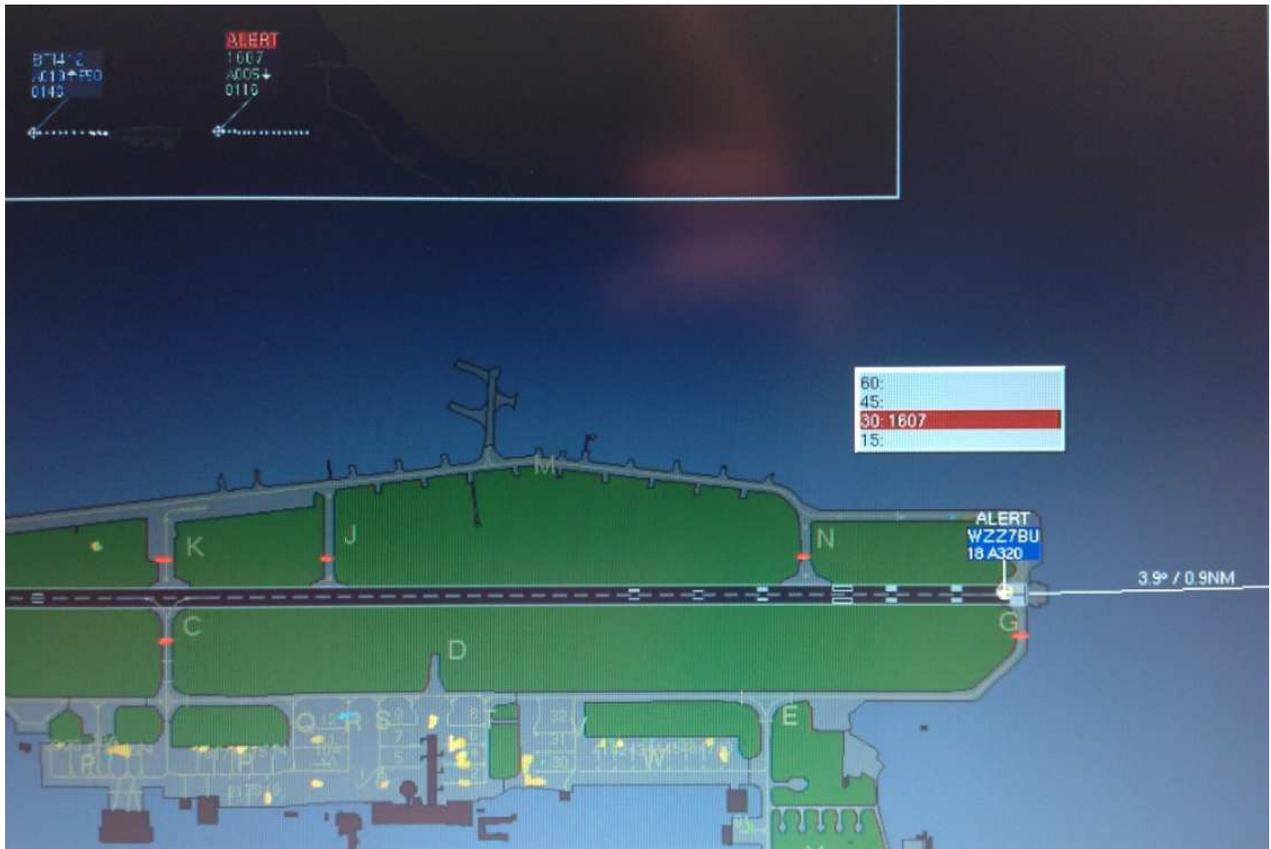
Picture 5

At **10:27:39** A-SMGCS "ALERT" distance less then 1NM between traffic.
