**FINAL REPORT Nr.4-02/5-10/-2/2012**

**OF THE AIRCRAFT SERIOUS INCIDENT**

**CABIN DE-PRESSURIZATION of BOMBARDIER DHC-8-400 AIRCRAFT,  
REGISTRATION YL-BAF ON DECEMBER 5, 2010**

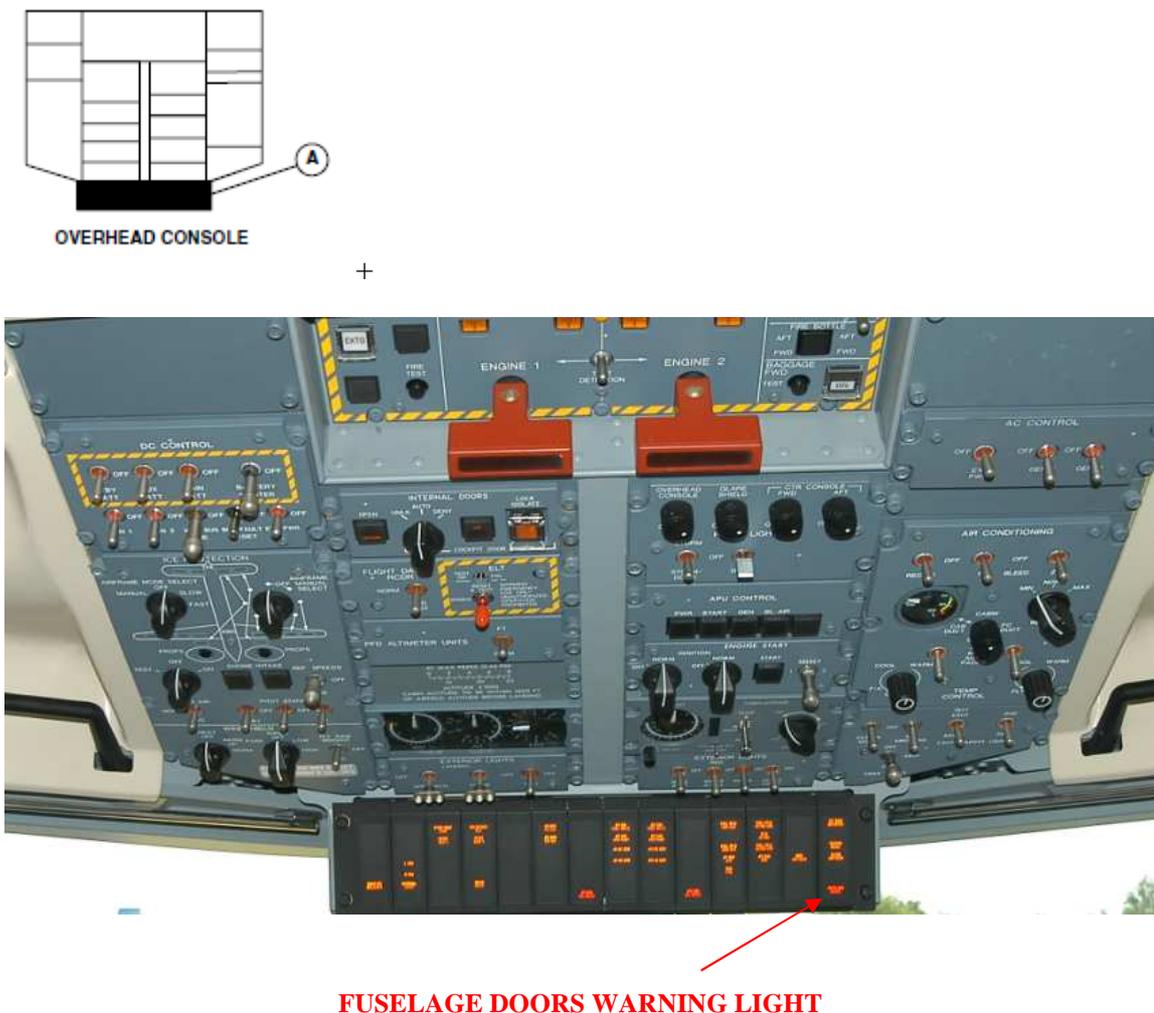
Picture 2, CAUTION AND WARNING PANEL

After closing PAX door before flight BT603, door indication “FUSELAGE DOORS” (1) on CAUTION AND WARNING PANEL (CWP) still lit on indicating that door not closed.

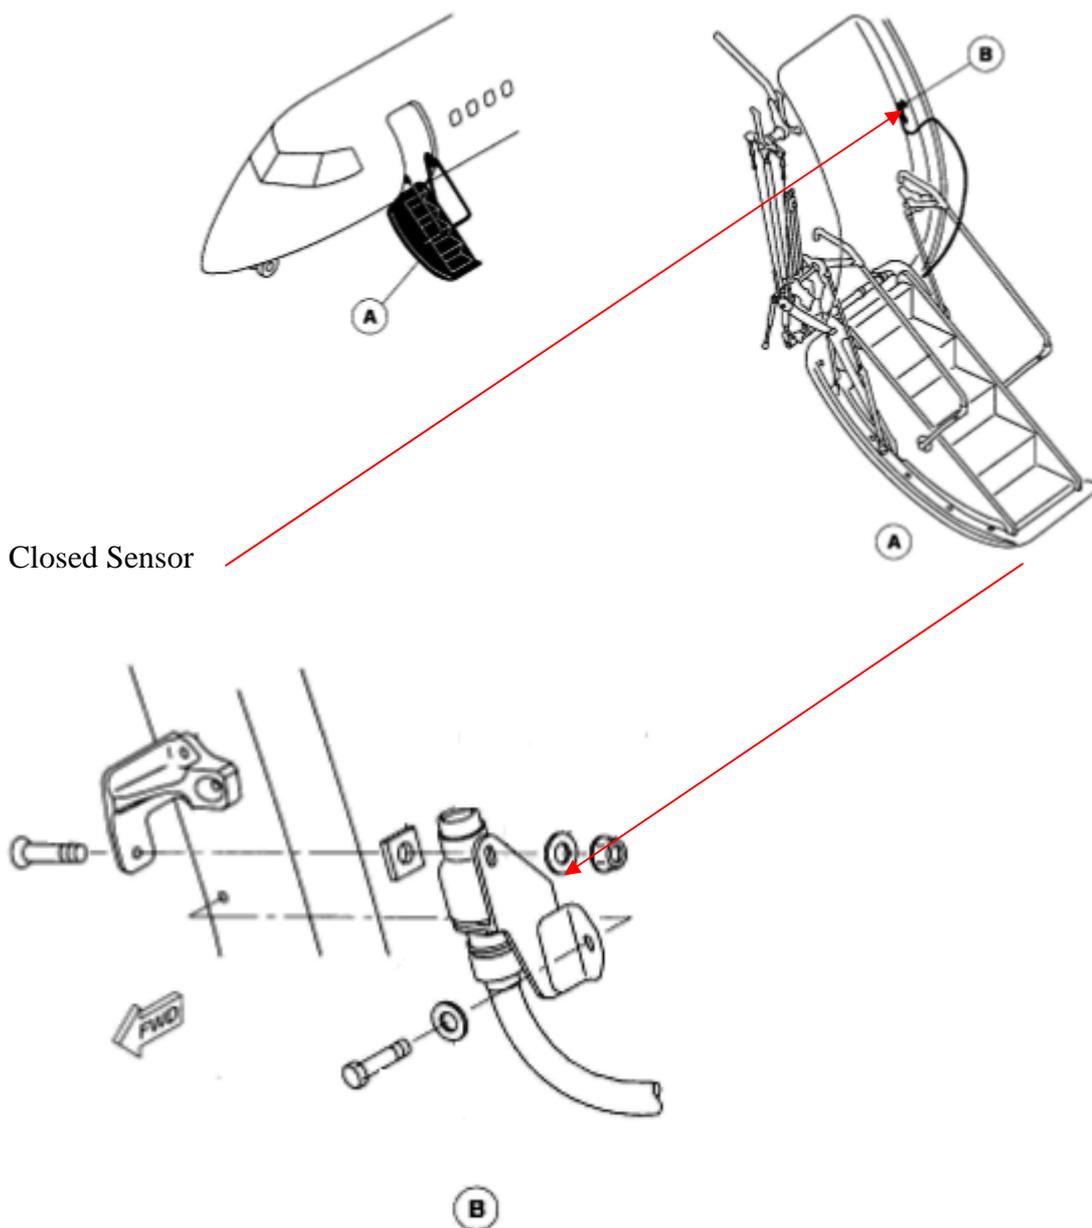
Picture 14, FWD Passenger door sensors location

Two proximity sensors monitor the forward passenger door. *One sensor is located at the top aft side of the door*, to make sure that the door is closed and fully down. *The other sensor, located on the fuselage structure adjacent to the pressurization valve*, monitors the lift link position to make sure that the door mechanism is fully overcentre and in safety.

The factors that resulted this incident are location of aircraft passenger doors proximity sensors, which is open for unfavourable environment - atmospheric precipitation, ice and snow contamination of sensors during weather conditions with low temperatures.

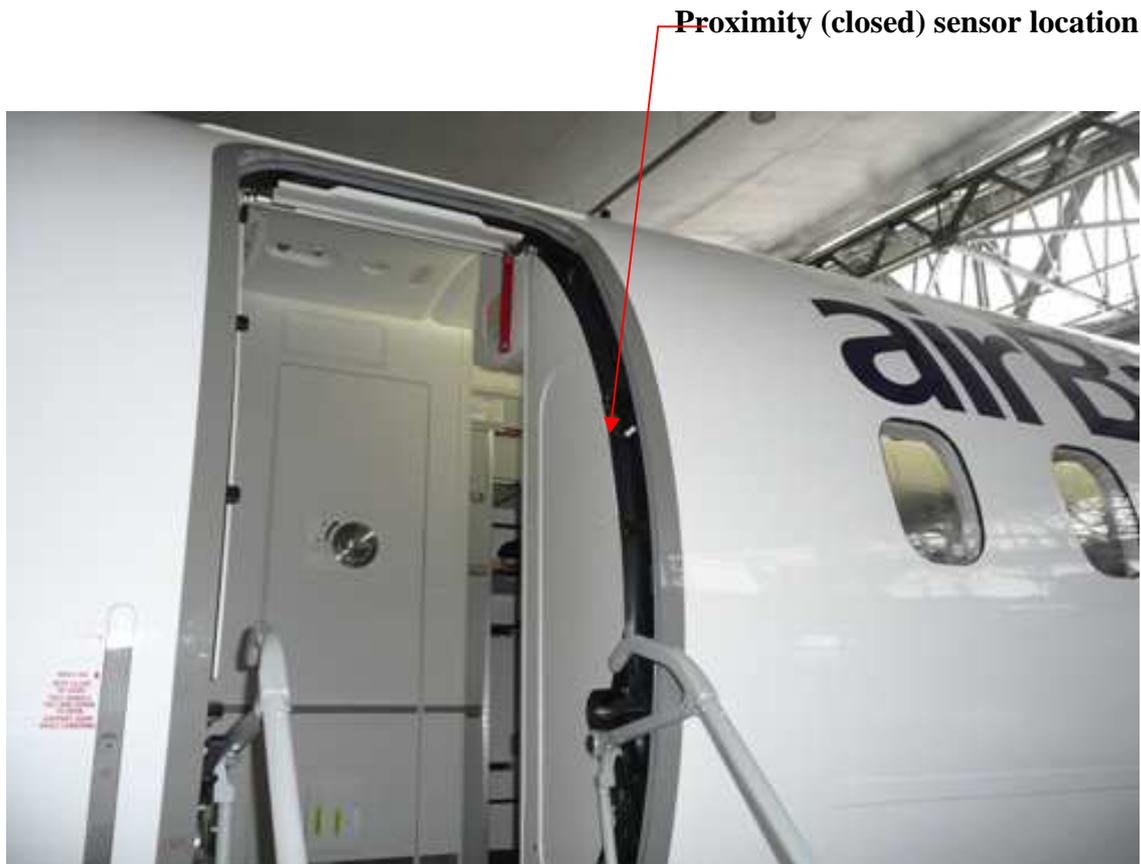
Picture 16, Proximity (closed) sensor location

On December 05, before flight BT-603 from EVRA, when indication “FUSELAGE DOORS” (passenger) was warning when door was closed, it was checked that the door actually was in the closed and locked position- the internal handle was fully down and the external handle was fully up. Pressuarization system was in “MANUAL MODE”. Because “FUSELAGE DOORS” warning light signal stays continuously, that means the inductance did not increase, which generates signal by the sensors proximity to the target. There was an open circuit with no

output at least from one door's sensor and consequently warning system did not send door's sensor output signal to the PSEU and the "FUSELAGE DOORS" warning light flashes.
