**FINAL REPORT Nr.1/2010
OF THE AIRCRAFT SERIOUS INCIDENT**

**INFRINGEMENT OF SEPARATION STANDARDS BETWEEN THE AIRBALTIC
AIRCRAFT BOEING 733, REGISTRATION YL-BBJ, FLIGHT BTI16C AND JAPAN
AIRLINES AIRCRAFT BOEING 777, REGISTRATION JA-733J, FLIGHT JAL 407
IN THE VICINITY OF THE POINT RUTEK ON AUGUST 31, 2009**

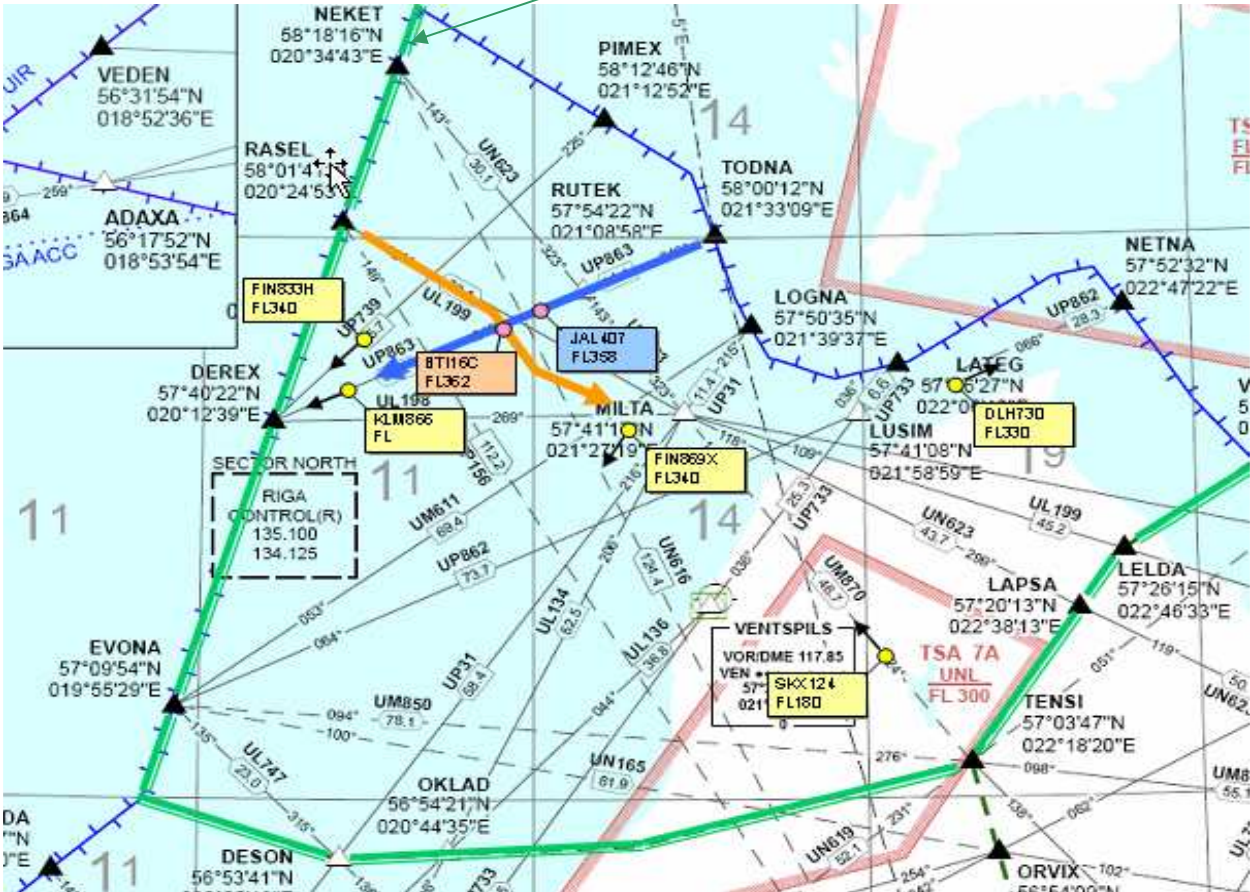
Picture 3 Traffic situation on August 31, 2009 at 14:09:40 UTC

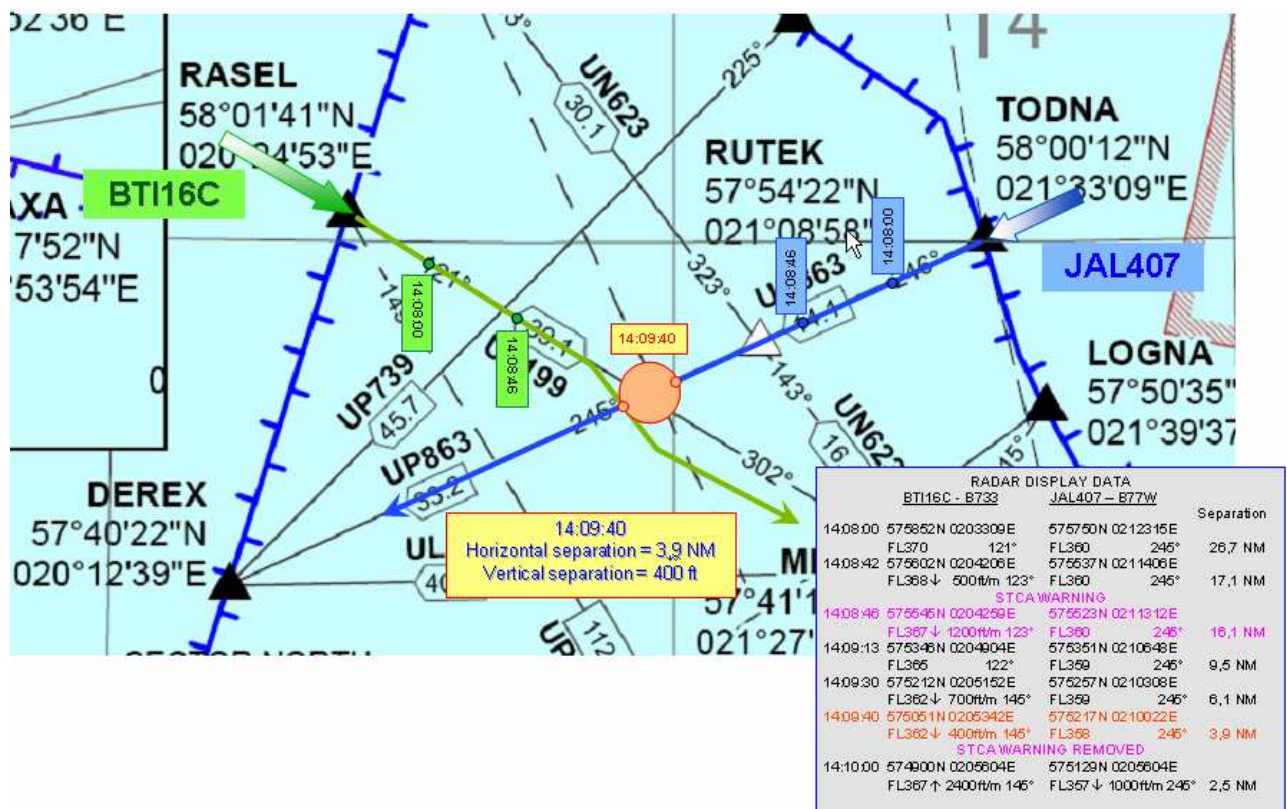
Picture 3 BTI16C & JAL 407 conflict situation

At **14.09.40** BTI16C descending crossed FL362 with descending rate 400 ft/m, heading 145 degrees when JAL 407 was at FL 358. At that moment infringement of separation standards occurred and at **14.09.42** the crew of JAL 407 declared TCAS activation: „Riga Control, Japan Air 407 "TCAS descend"". Respectively BTI16C started TCAS RA "Climb" maneuver. The crew of BTI16C did not inform controller ATC1 of TCAS commands.

Note: The minimum distances between the aircraft were: **3.9 NM lateral and 400 FT vertical.**
