FINAL REPORT Nr.4/2009
OF THE AIRCRAFT SERIOUS INCIDENT

**INFRINGEMENT OF SEPARATION STANDARDS DURING GOING AROUND
BETWEEN THE AIRBALTIC AIRCRAFT BOEING 737, YL-BBX, FLIGHT BTI3G2
AND DEPARTING AIRCRAFT SMARTLYNX AIRBUS A-320, YL-LCD, FLIGHT
ART531 IN THE TERMINAL CONTROL AREA OF RIGA INTERNATIONAL
AIRPORT ON FEBRUARY 13, 2009**

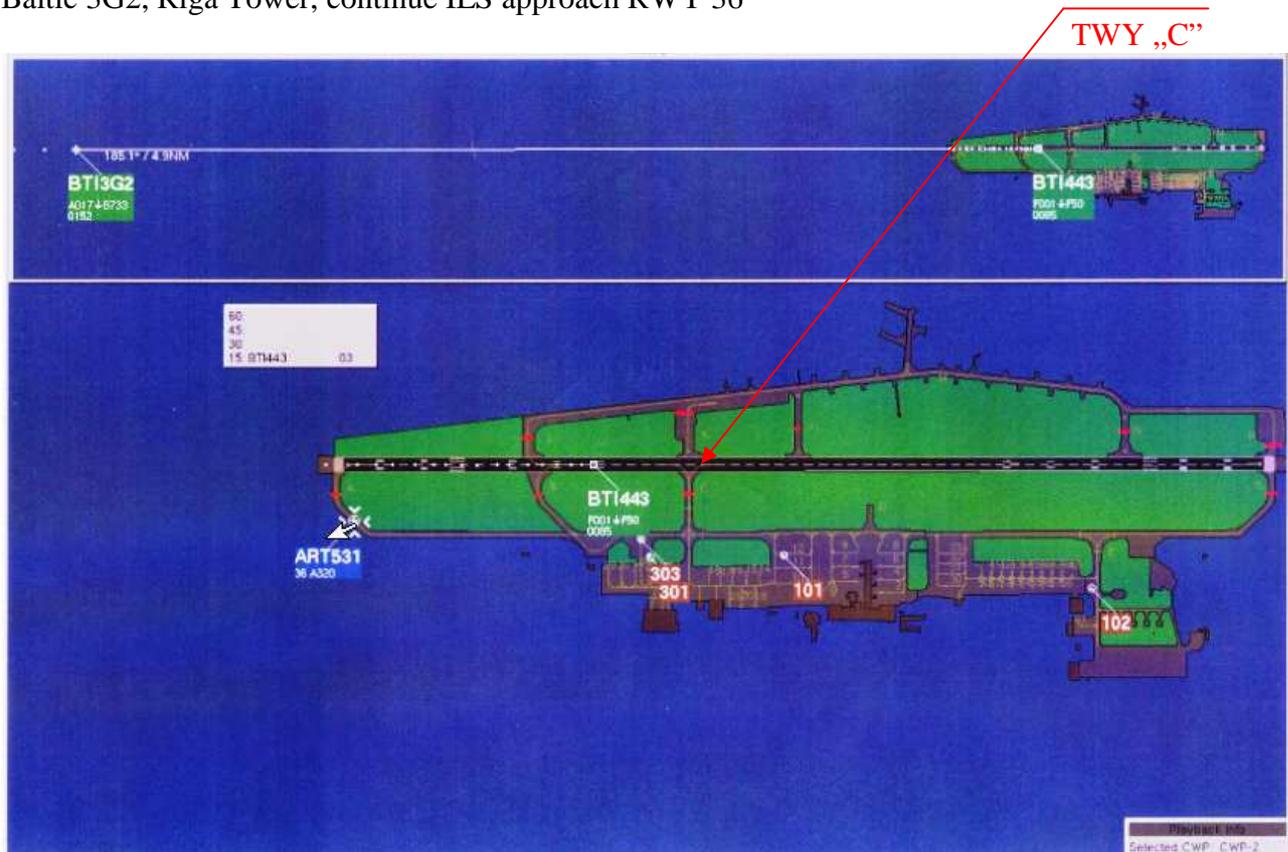
Picture 1 Radar map- Situation plan after BTI443 landing

At **08.48.46** controller cleared BTI443 to land. At the same time SMARTLYNX ART531 contacted controller and reported approaching holding point RWY 36. Controller instructed ART531: “SmartLynx 531, Riga Tower, hold short of RWY 36 ” (Picture 1)

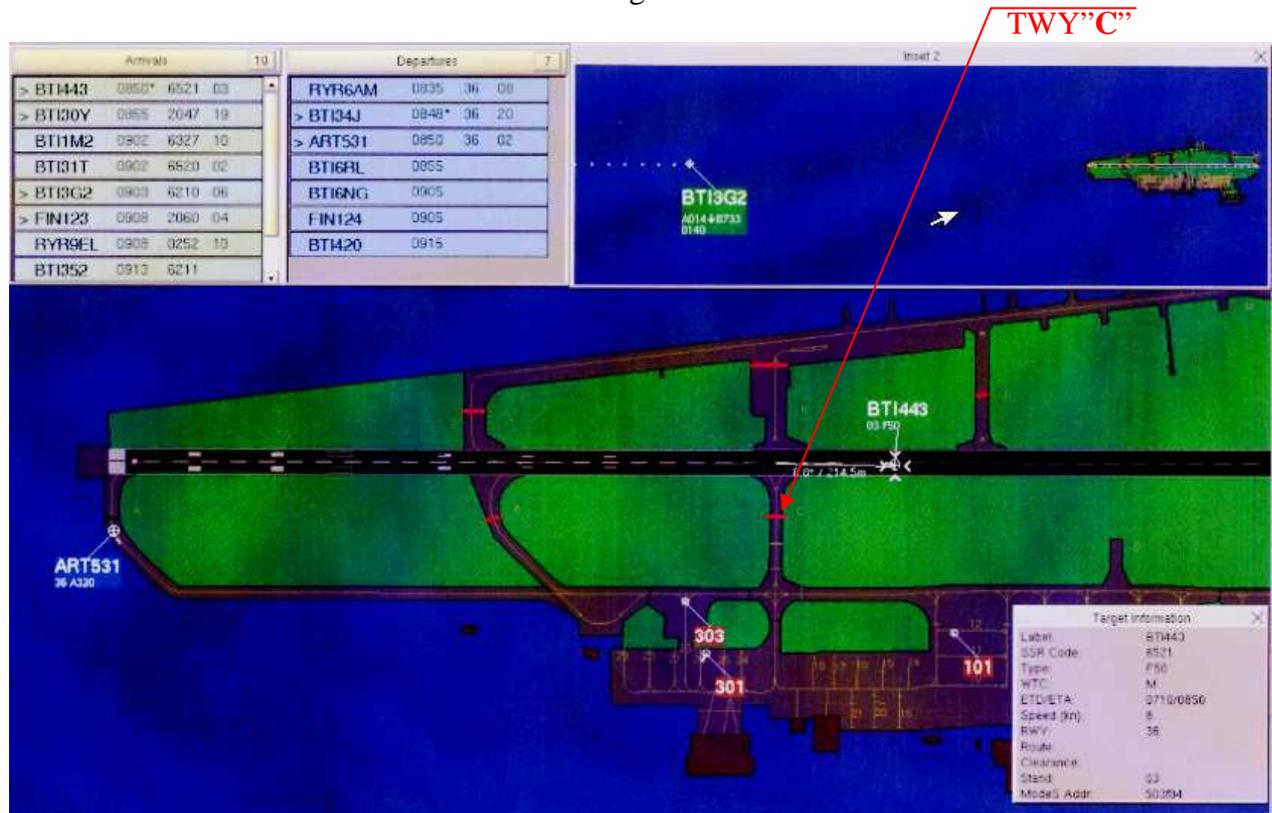
Picture 3 Radar map- BTI443 overrun TWY “C”

At **08.50.40** BTI443 has landed and overran TWY C, because crew answered controller: “118,8 via C, Baltic 443, we have to go back track very quickly to 5 second...(unreadable)” and for that reason BTI443 took longer time on the RWY. Controller answered: “Affirmative, back-track approved.”

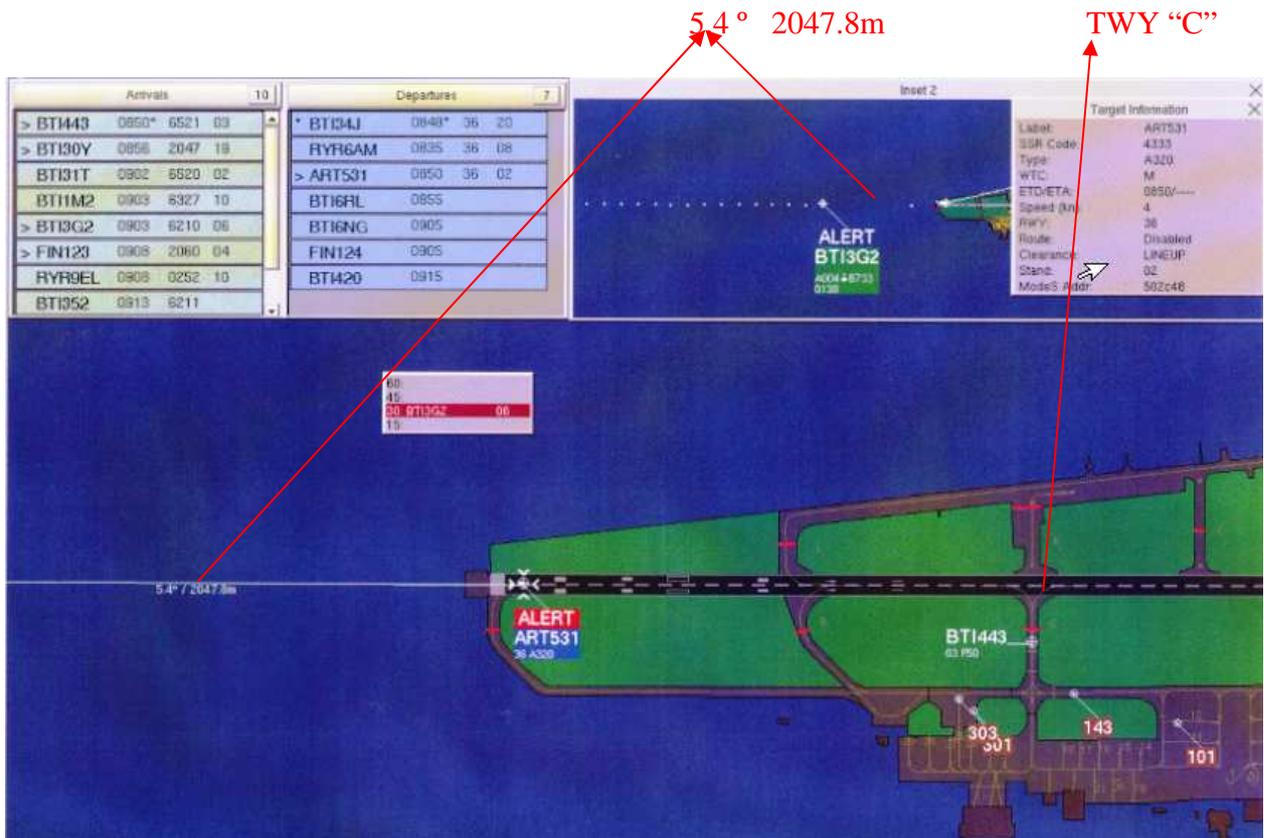
Picture 4 Radar map- SMARTLYNX ART531 Clearance “Lineup, A-SMGCS “ALERT””

At **08.50.40** controller cleared SMARTLYNX ART531: “Smart Lynx 531 line up RWY 36 and wait” (Picture 4) as well as instructed BTI443 to vacate to the right via TWY “C” and told the crew to contact Ground on 118,8.” (Picture 2)

At **08.51.47** BTI443 has vacated RWY36 and declared to controller: “Air Baltic 443 is clear.” (see Picture 4).

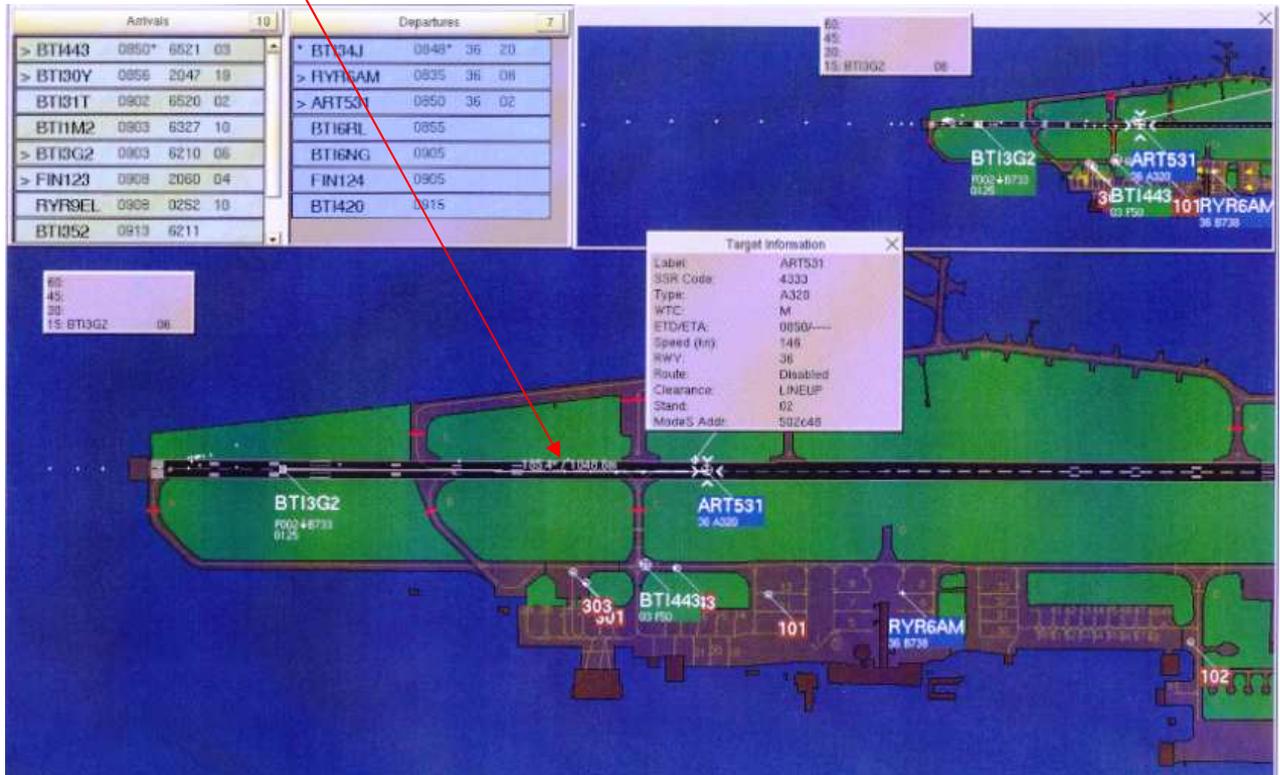
Picture 5 Radar map- ART531 on the RWY 36

185.4 °; 1048.8m

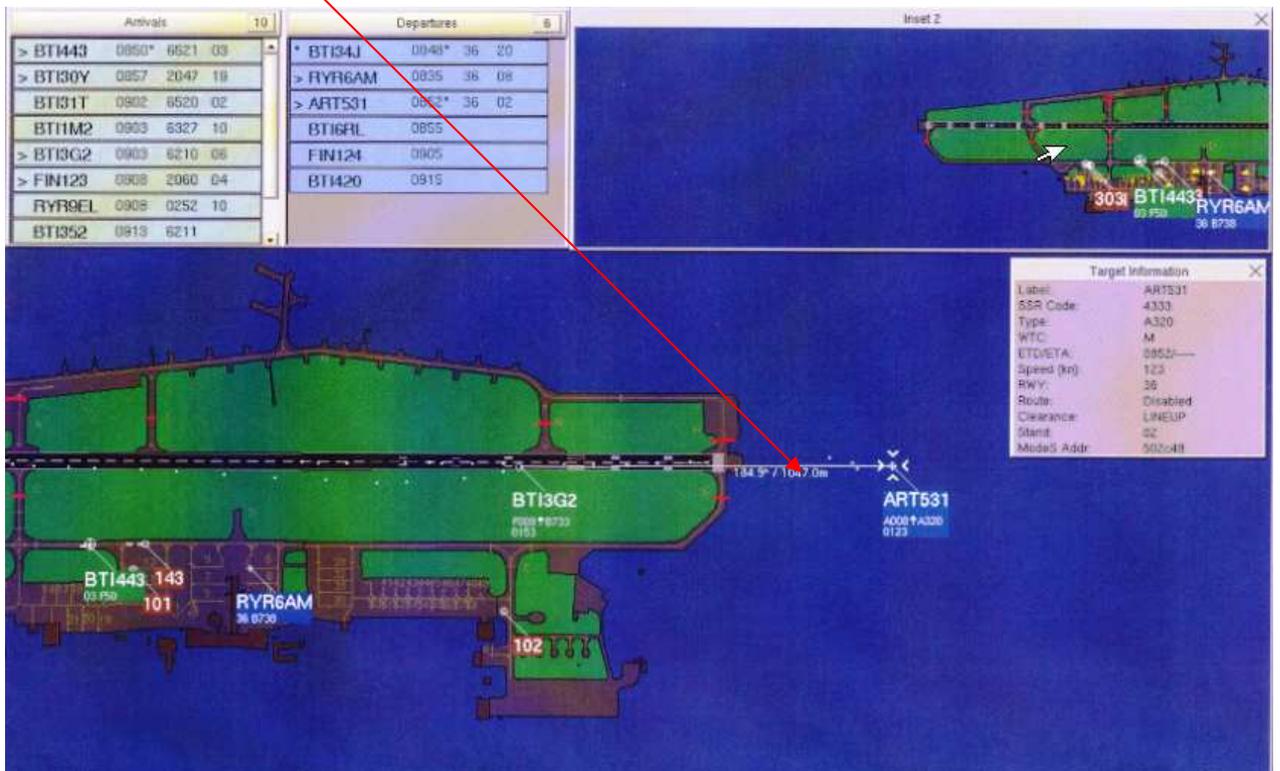
Picture 6. Radar map - The minimal distance at altitude 1100 Ft was 1047 meters (0.565NM)

184.9 °; 1047.0m

After a while at **08.53.24** controller issued clearance for BTI3G2: “3G2 stop climb altitude 500 feet”. Because at that moment BTI3G2 has passed altitude 1100 Ft the crew answered at **08.53.29**: “We are at 1200...” and controller cleared BTI3G2: “3G2 stop climbing at your altitude”, called approach controller and informed him that BTI3G2 has flown at altitude 1500Ft, heading 270 °.

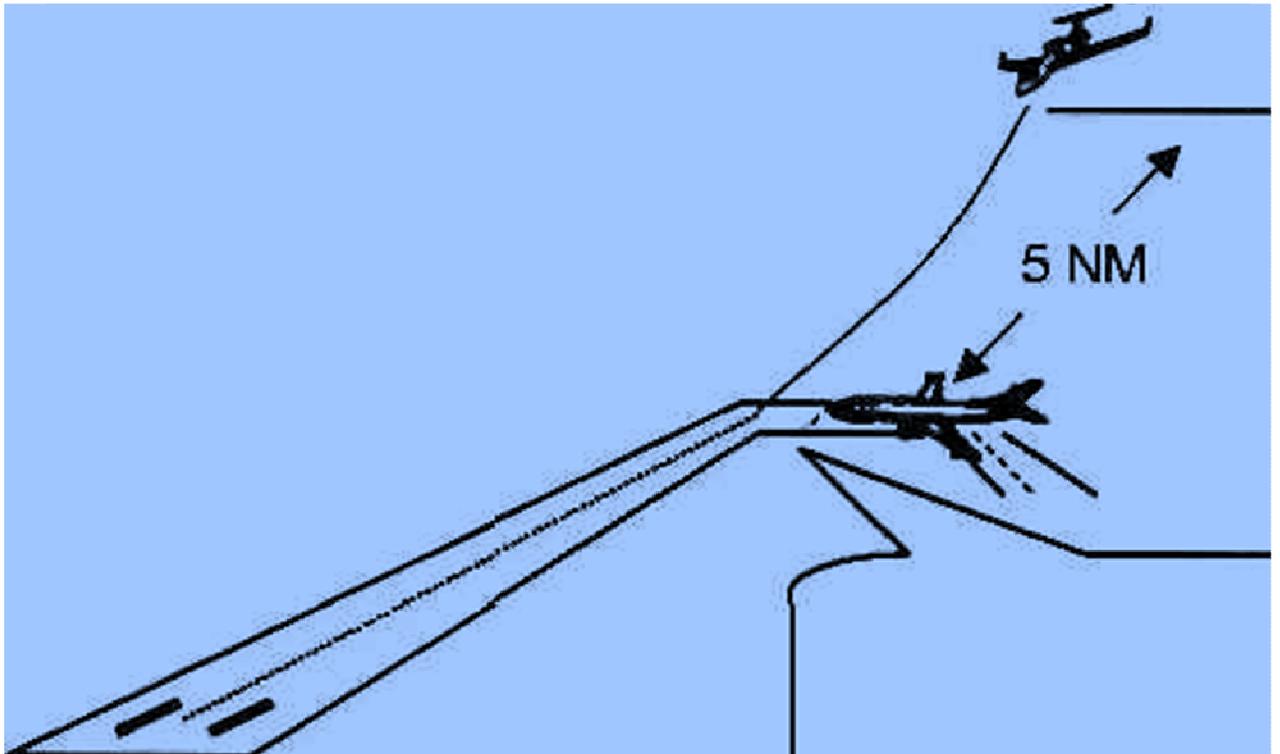
Picture 11. Ready for immediate departure from holding point position

Based on a review of available radar and radio communication information, it is likely that the Tower controller anticipated that departing aircraft ART531 has had time for take-off before approaching BTI3G2 would be come nearer when separation potentially will be lost.

According to *Operational Manual D1-GSV/TWR-01/2* take off clearance based on the position of the arriving aircraft making an instrument approach may be issued when departing aircraft is at the **runway-holding position** of the runway-in-use and ready for immediate take-off, and the arriving aircraft, is not less than 5 NM final.

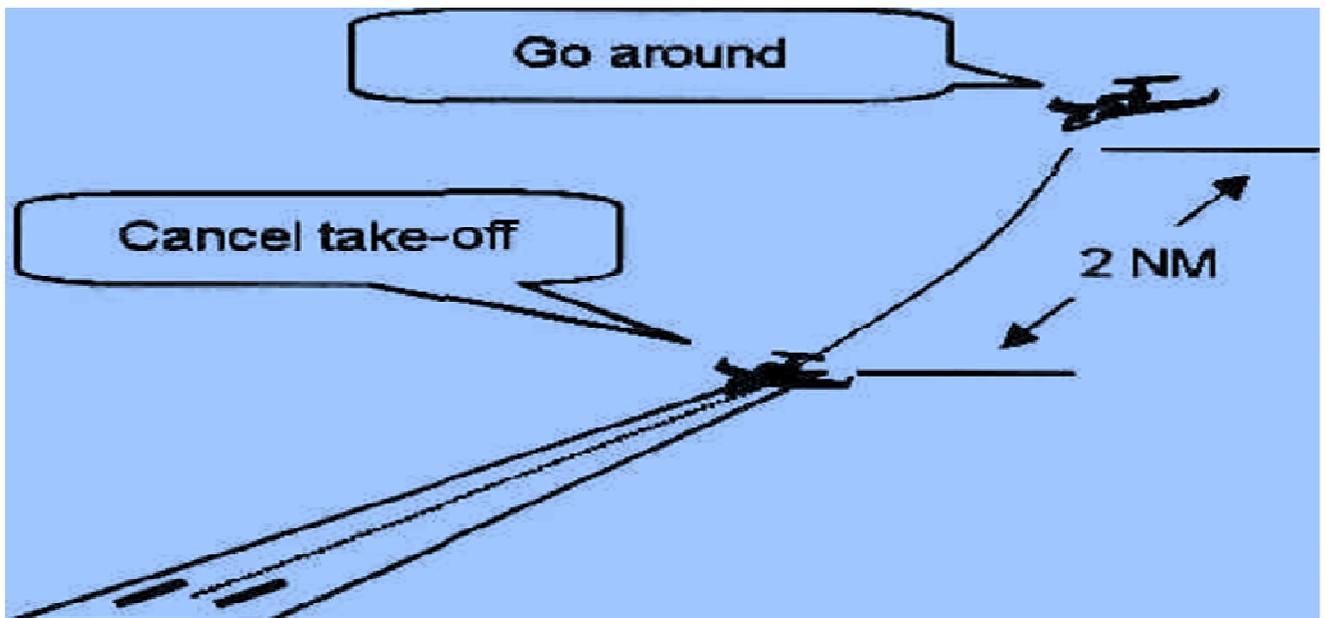
Picture 12

If the departing aircraft is cleared for immediate take-off but has not started rolling, and approaching aircraft is on 2 NM final:

- the Tower controller **shall cancel take-off clearance for departing aircraft** and;
- **instruct the arriving aircraft to go around.**(see Picture 12)
