# **FINAL REPORT Nr. 3/2009 OF THE SERIOUS INCIDENT**

**TO BOEING 737-500 AIRCRAFT, REGISTRATION YL-BBE  
OF S/C “AIR BALTIC CORPORATION” FLIGHT BT-662  
ON DECEMBER 31, 2008 AT DUBLIN**

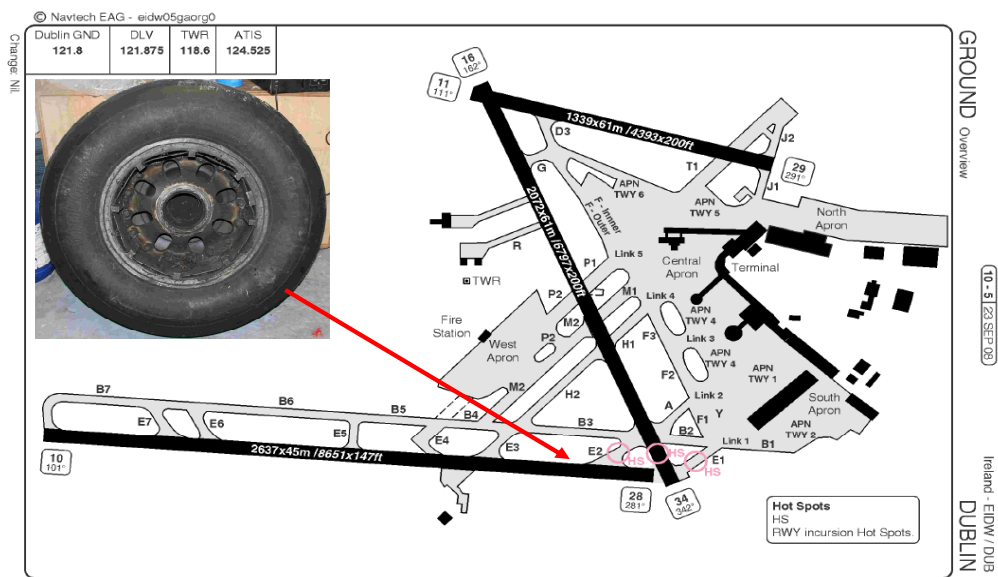
# RH Outer wheel in Dublin

CC was briefed and passengers informed according “Air Baltic” emergency procedures. Emergency landing was declared and performed successfully as planned with flaps 40 degrees on left main wheel on minimum speed 107 knots extremely soft (1.08G) at Riga Airport. No remarks from passengers and good cooperation with ATC. After landing runway has been vacated and passengers disembarked by standard procedure from external stairs. Right hand landing gear outer main wheel No. 4 was missing. It was found in Dublin airport near Runway 10 and Taxiway E2.

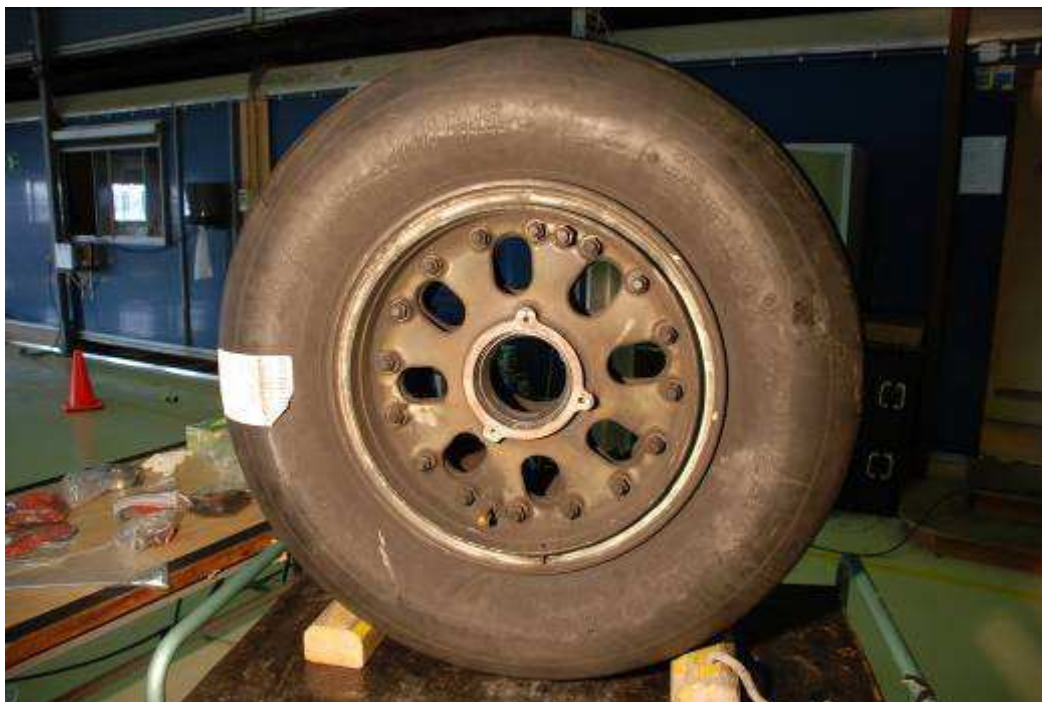
The wheel assembly showed signs of overheating and fire. Damage due to fire was found at the hub and bearing areas. The outboard sidewall surface of the tire was burned over an area of approximately two inches around the circumference.

**Figure 7. Wheel assembly outboard side overview**

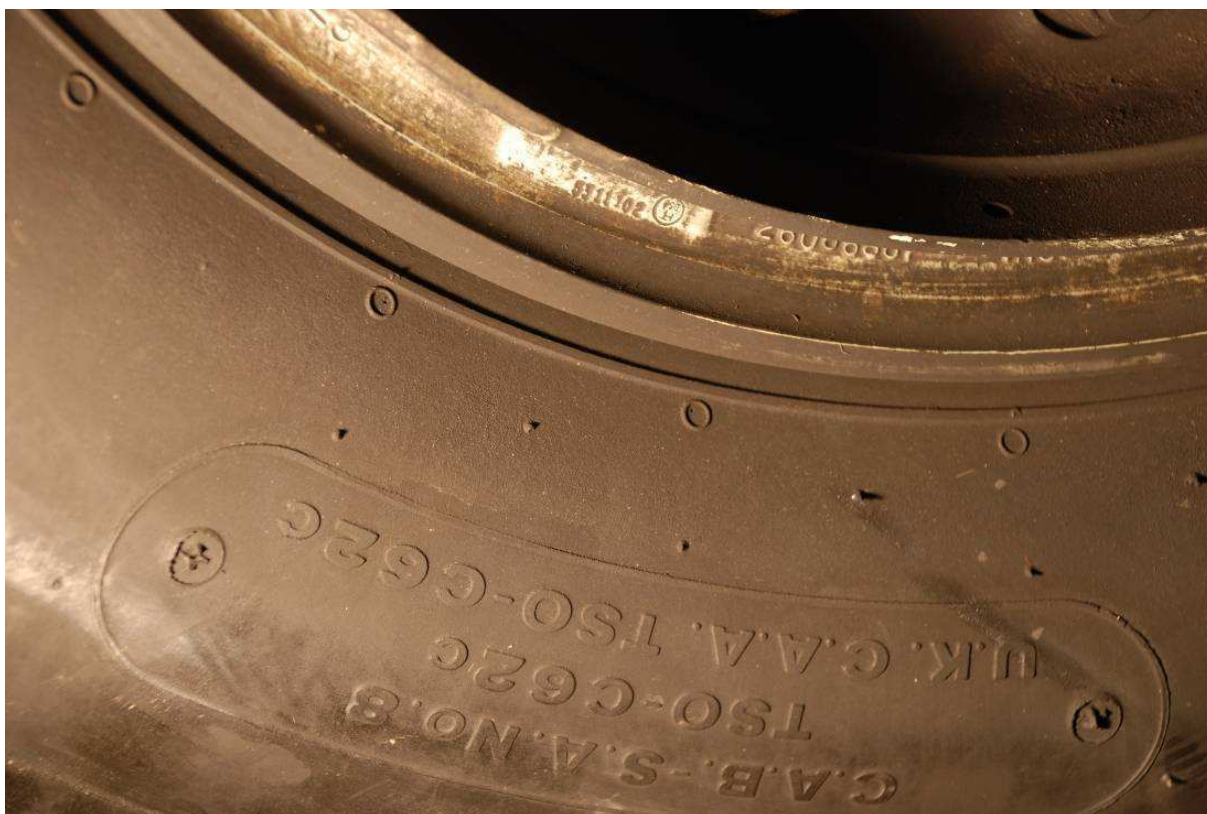
**Figure 8. Tire sidewall surface, evidence of fire**

Evidence of fire was found on the inboard wheel hub and the outboard side wall of the tire. This indicates that a fire existed at the inboard wheel hub and that the flames were drawn through the openings between the spokes to the outboard part of the wheel assembly.

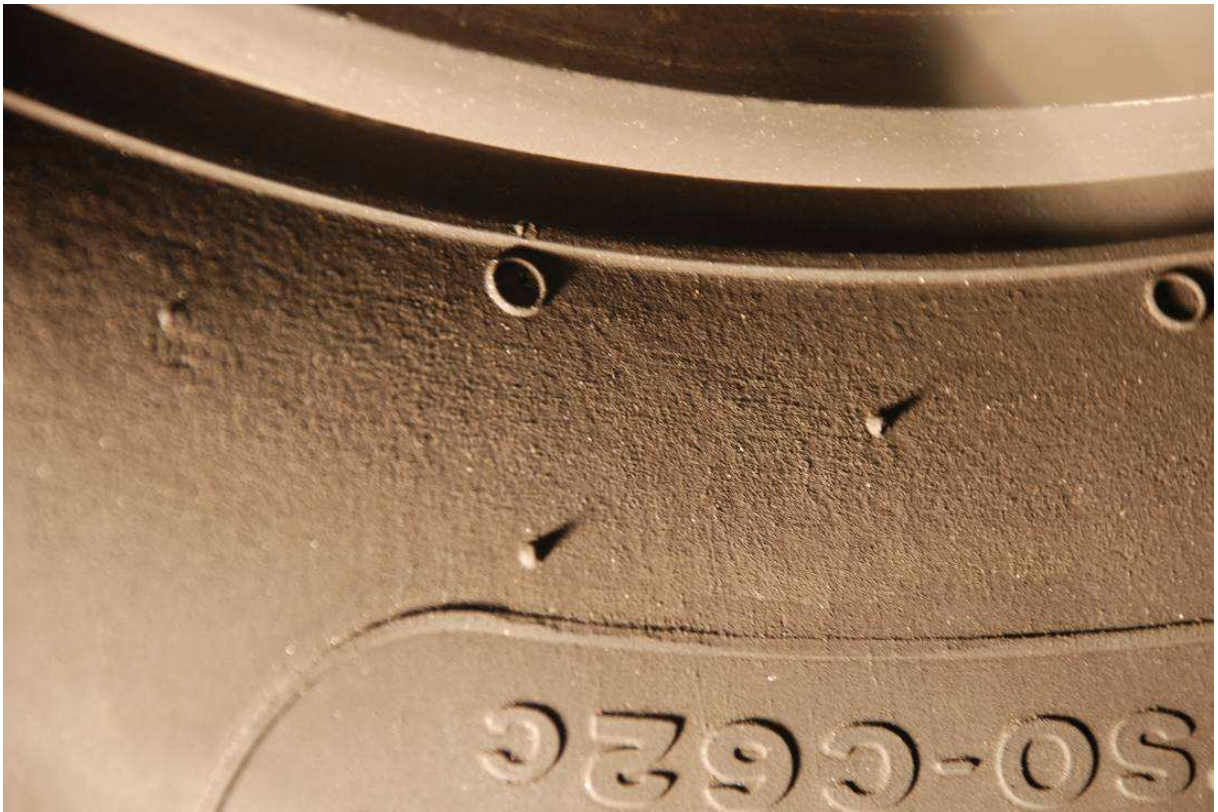
**Figure 9. Tire sidewall surface evidence of fire, detail**

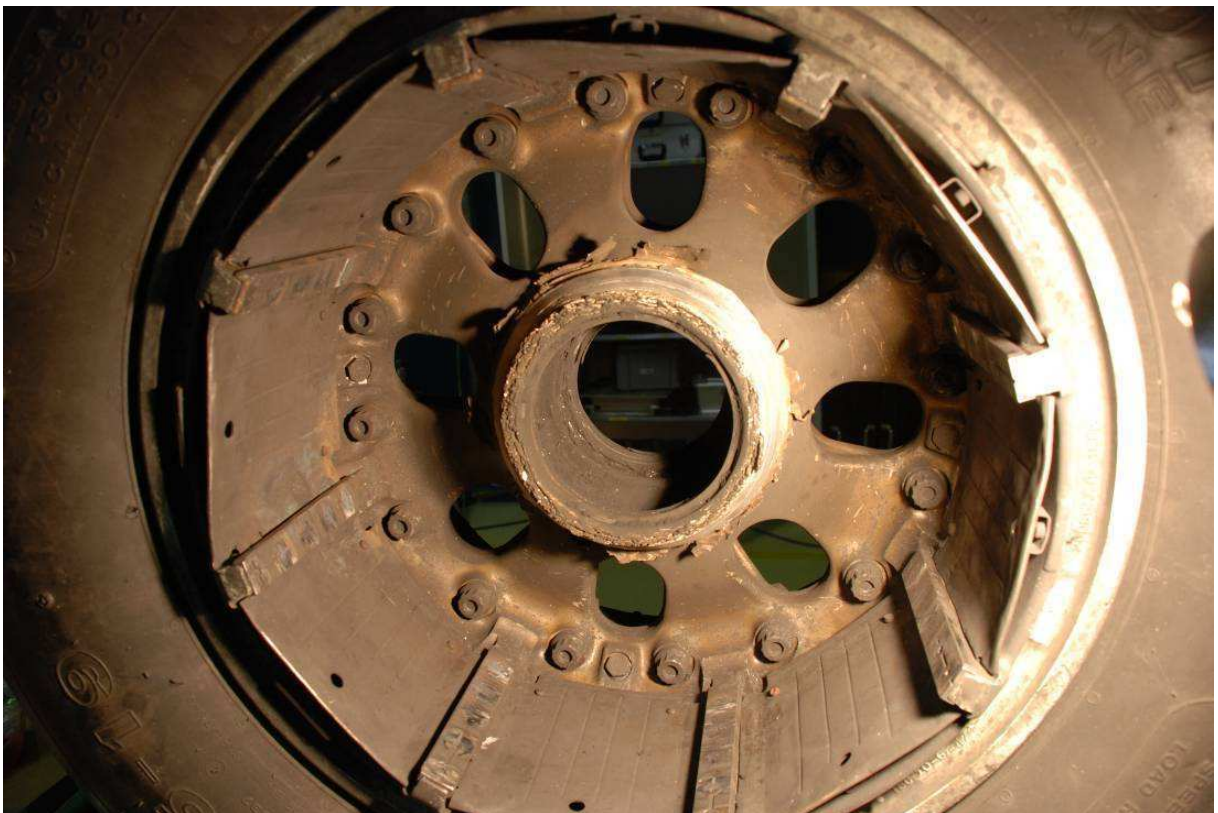
The wheel assembly showed signs of overheating and fire. There was no mechanical damage to the spokes. All wheel bolts and nuts were found installed. The thermal plugs installed were not activated. Damage due to fire was found at the hub and bearing areas. The outboard sidewall surface of the tire was burned over an area of approximately two inches around the circumference. The inboard sidewall of the tire contained three small cuts,

**Figure 10. Wheel assembly inboard side overview**

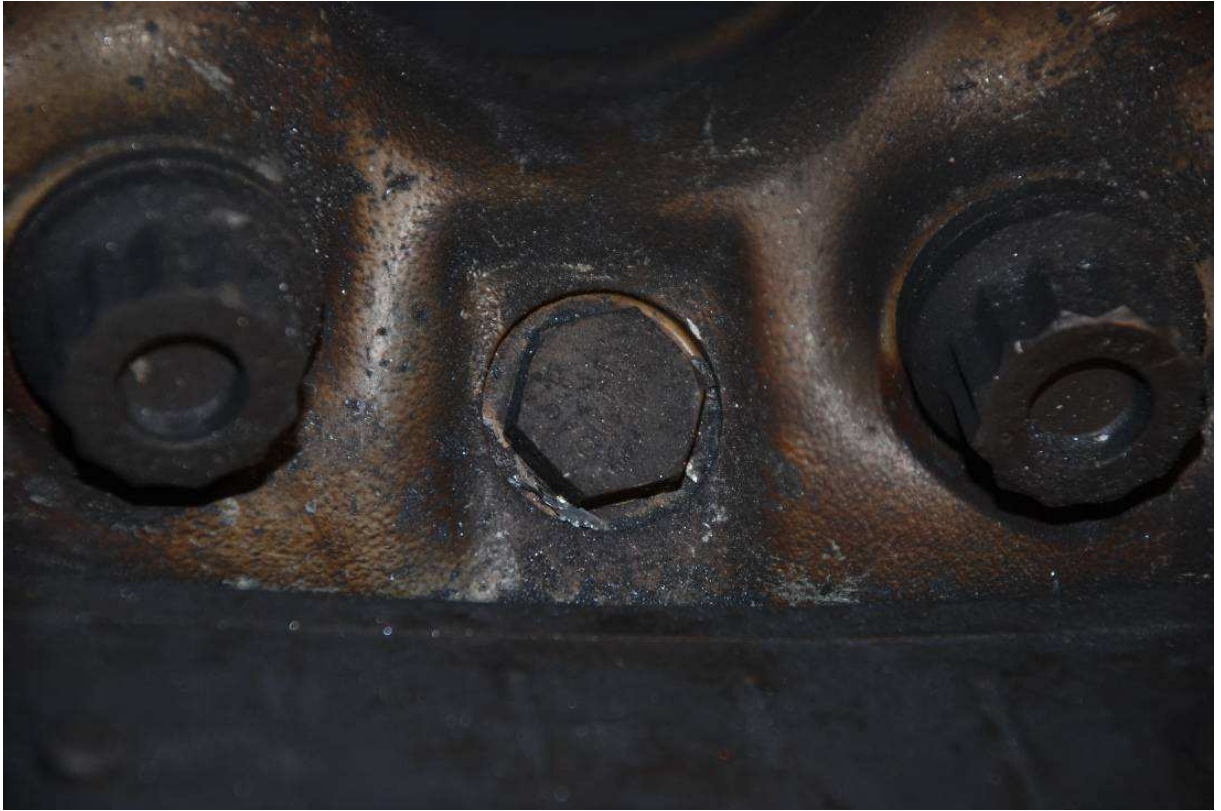
**Figure 11. Thermal fuse screw**

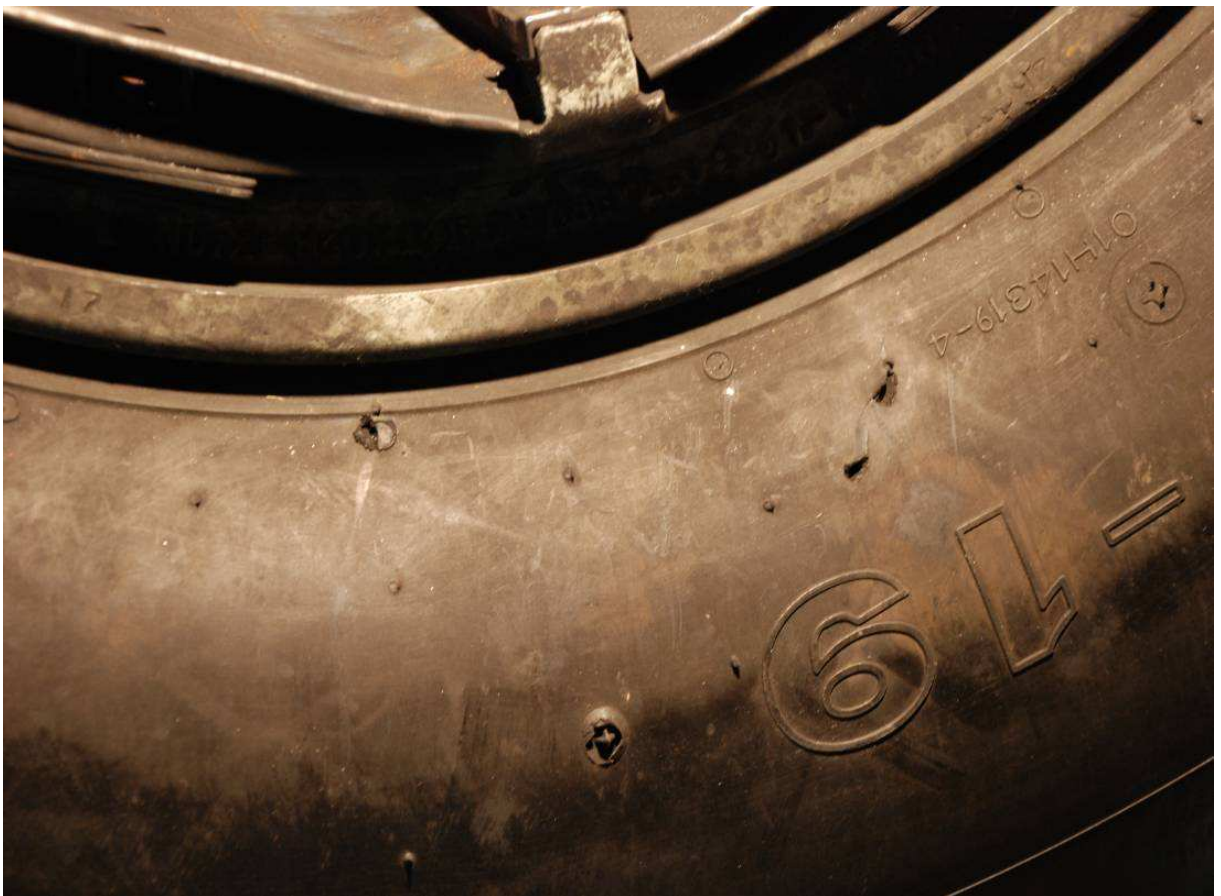
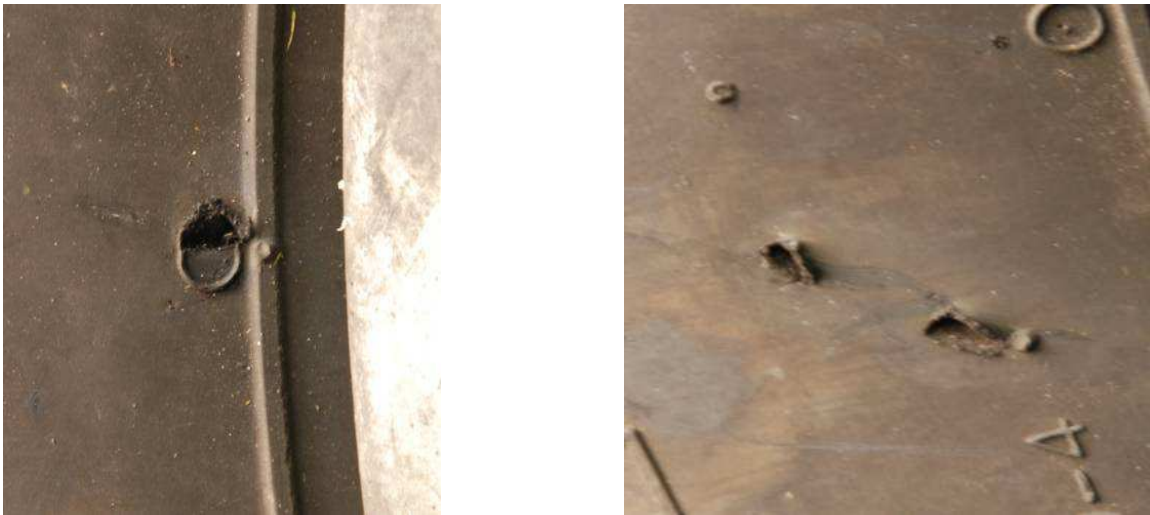
probably caused BYR impact after separation of the wheel assembly. The tire tread was in good condition except for one skid mark of approximately 3.5 x 6 inch.

**Figure 12. Cuts in tire sidewall**

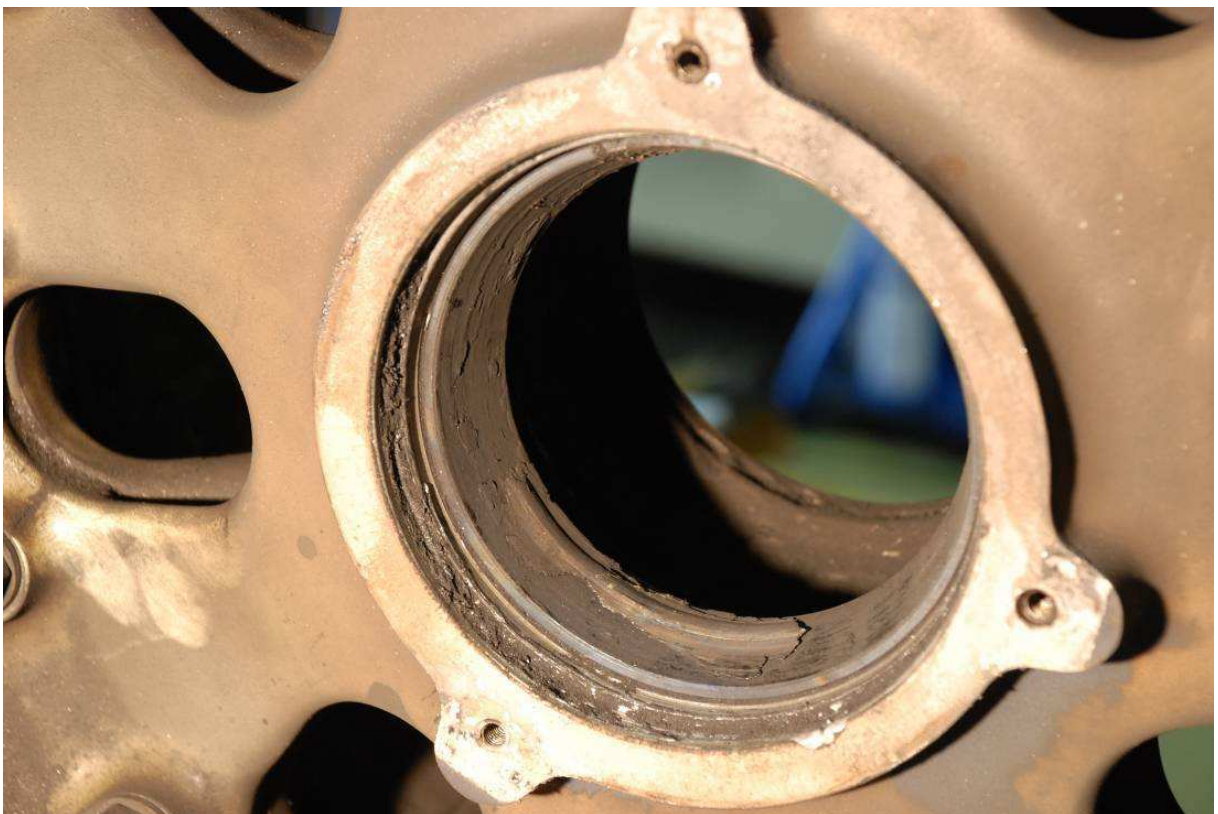
The outer wheel half showed heat damage to the bearing cup. The surface of the bearing cup was partially covered with molten and transferred material.

**Figure 13. Hub with bearing cup of outboard wheel half**

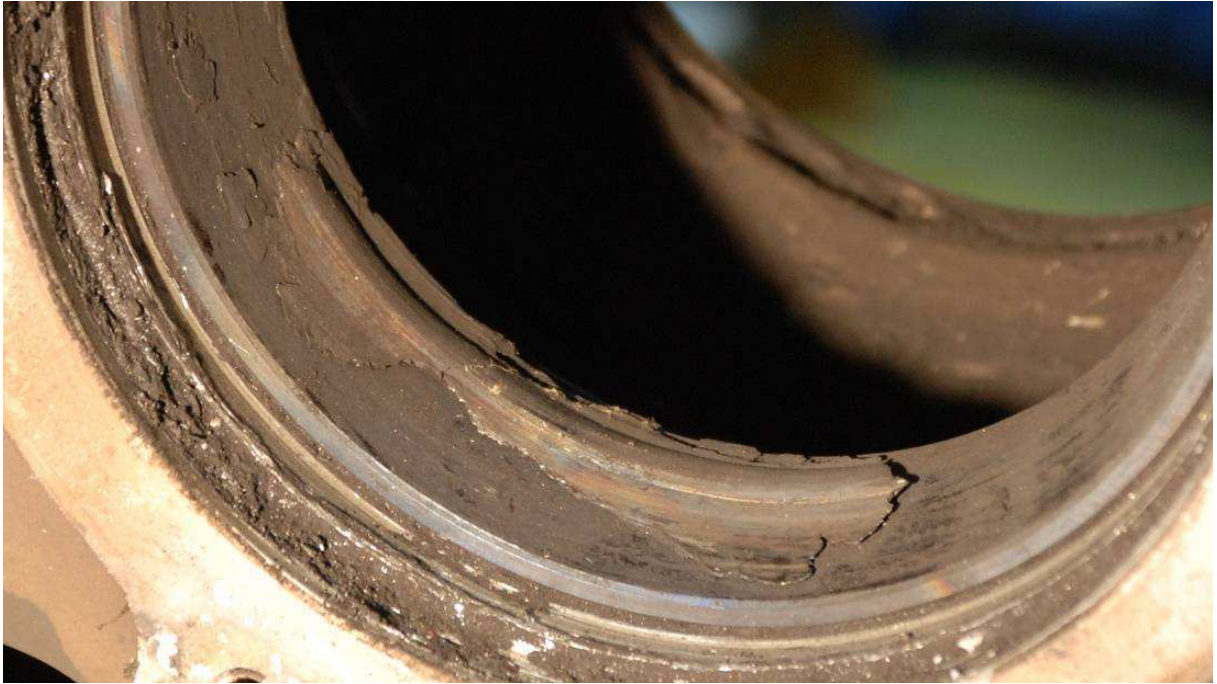
**Figure 14. Hub with bearing cup of outboard wheel half, detail**

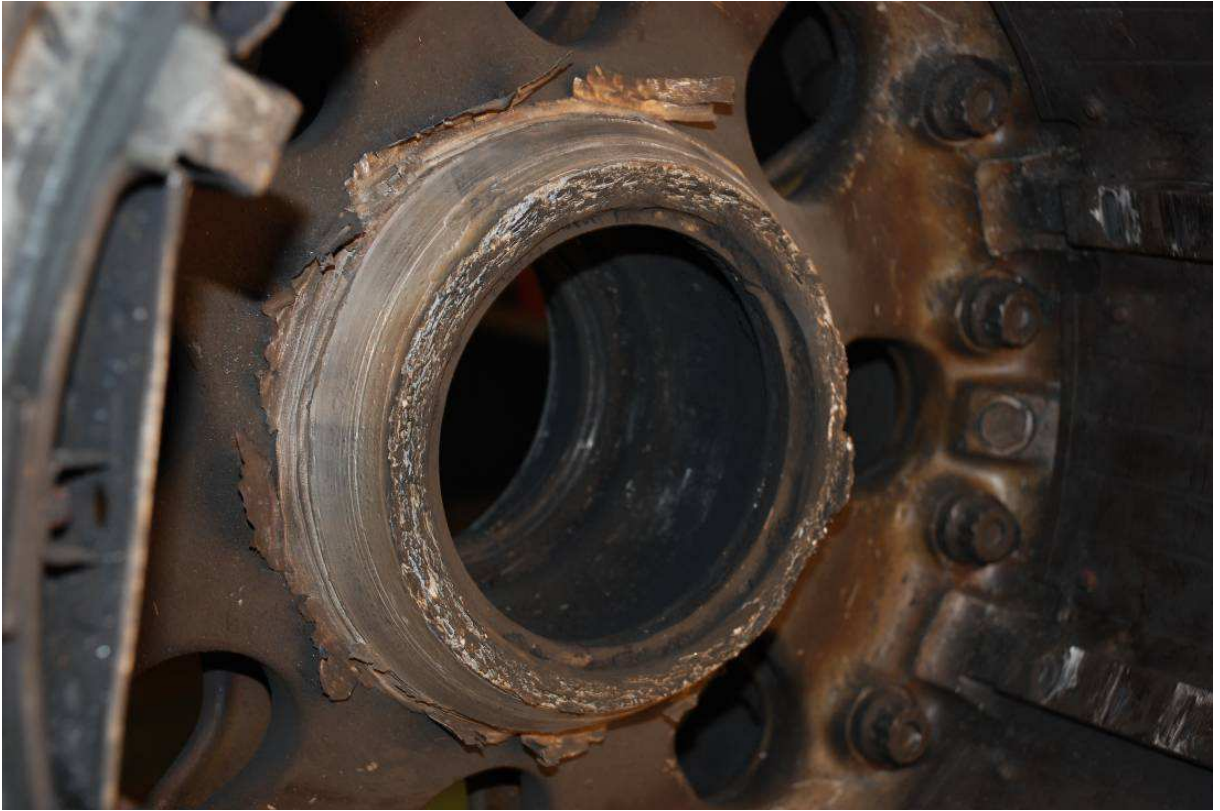
The inboard wheel half showed severe damage caused BYR abrasion and fire. The part of the hub where the bearing cup is installed had been worn down to the position where the grease dam was installed. The inner bore with the bearing cup was completely worn out, the remaining part of the hub was damaged BYR fire. The outside circumference of the hub was covered with transferred material, formed to a conical shape. The transferred material contained steel remains of the bearing cup as well as aluminum from the hub itself. Cracks, particularly in the inner wheel half, are a fairly common initiation for wheel- and bearing failure. However, the visual inspection did not reveal evidence of cracking (pre-existing or as a failure mechanism). The channel type rotor drive keys showed mechanical damage on top due to impact and chafing as a result from contacting the brake rotor disks after bearing failure. The heat shield was dented near the rotor drive keys.

**Figure 15. Hub of inboard wheel half**

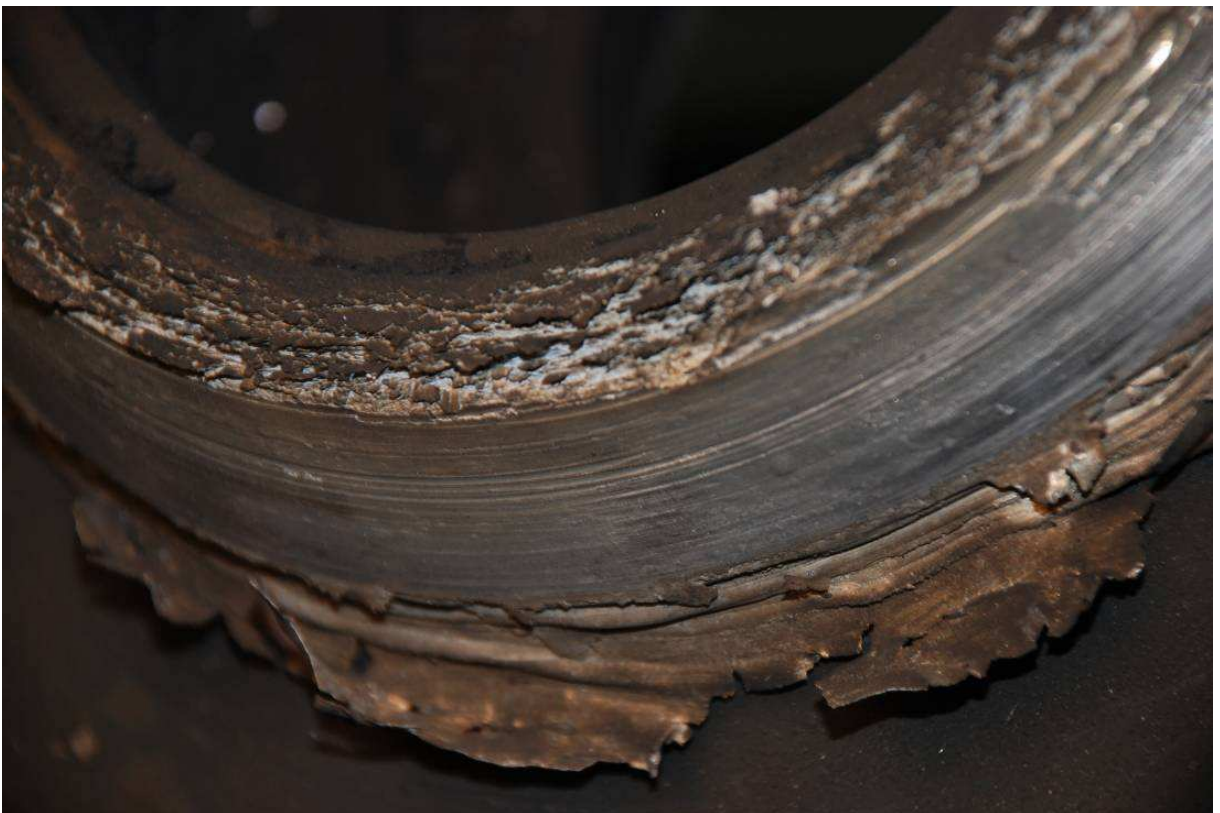
**Figure 16. Hub of inboard wheel half, detail**

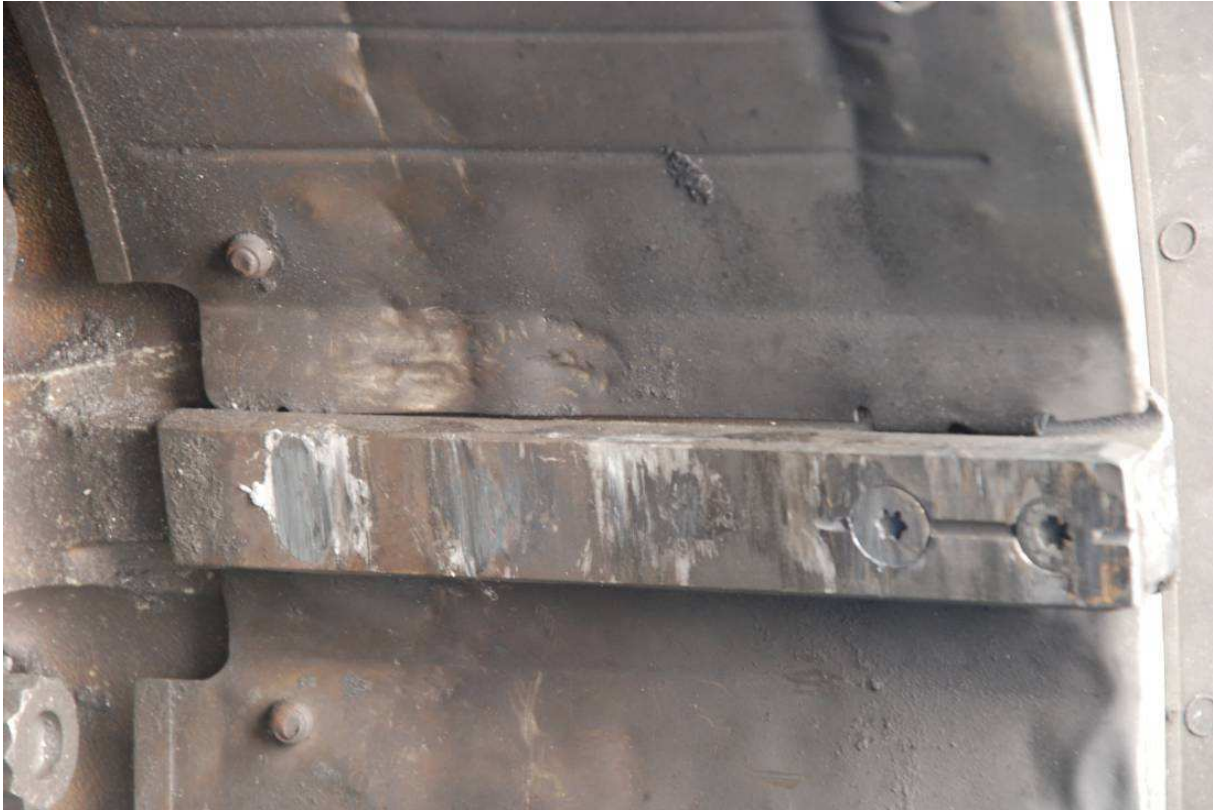
**Figure 17. Damage to heat shield and rotor drive keys**

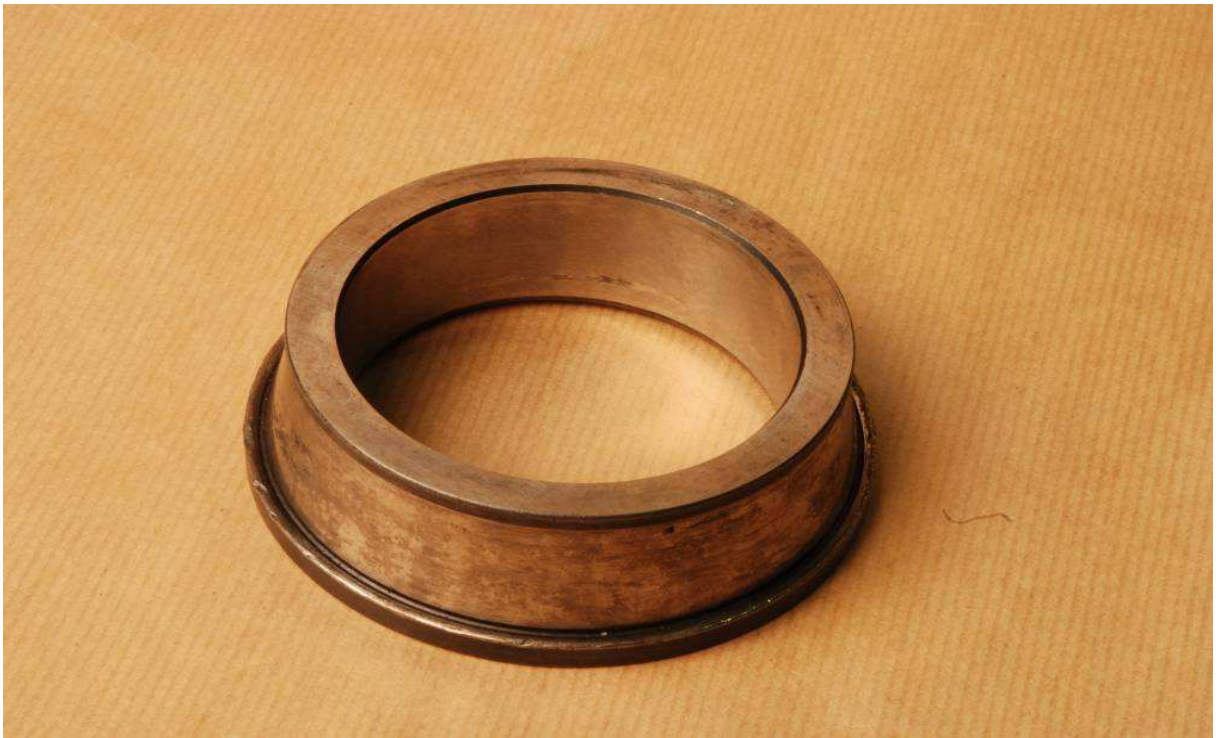
The inboard wheel bearing assembly had disintegrated. The inner race appeared to be in a relatively good condition without signs of overheating. It was labeled Timken nr. 596, which is the correct indication for this bearing. The cage was covered with soot, extensively deformed, and contained three damaged rollers.

**Figure 18. Inboard bearing inner race**

Despite the damage found to the inboard bearing assembly and the damage found on the inboard wheel hub, the inner race and the cage with remaining three rollers were found in a relatively good condition. This is an indication that the inner bearing was intact at wheel separation, and was not instrumental in the failure of the assembly.

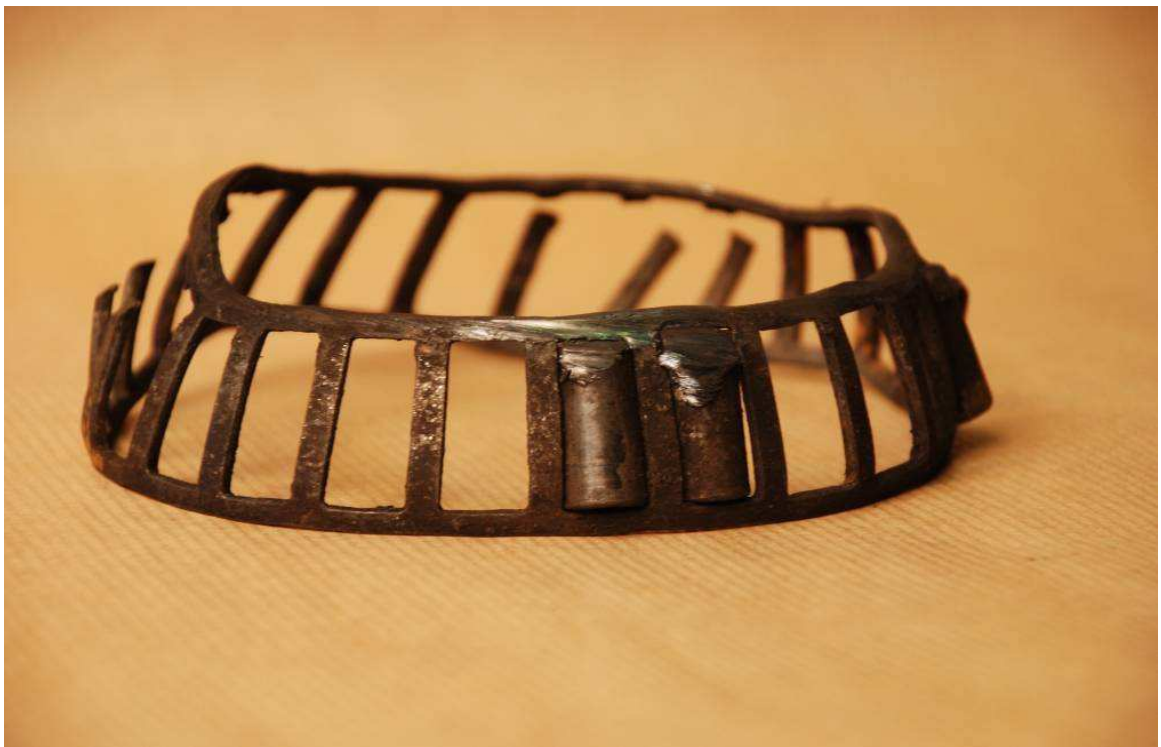
**Figure 19. Inboard bearing cage with rollers**

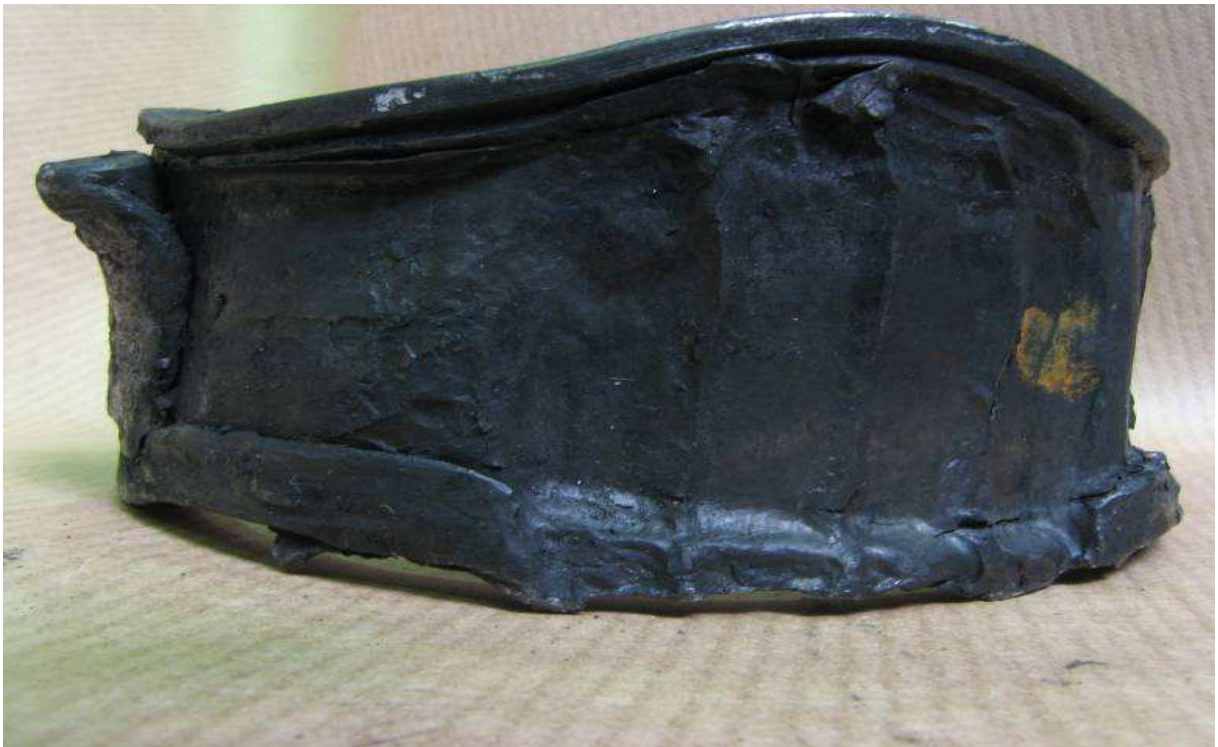
The outboard wheel bearing assembly had disintegrated; the inner race was deformed while exposed to excessive heat, which promoted plastic deformation. Two crushed rollers

were found stuck on the inner race. On the outer circumference of the inner race there were deep impressions caused BYR the bearing rollers, evidence of the high temperature present during deformation. The cage was ruptured; only the inner ring of the cage remained. No bearing identification number could be found.

**Figure 20. Outboard bearing inner race**

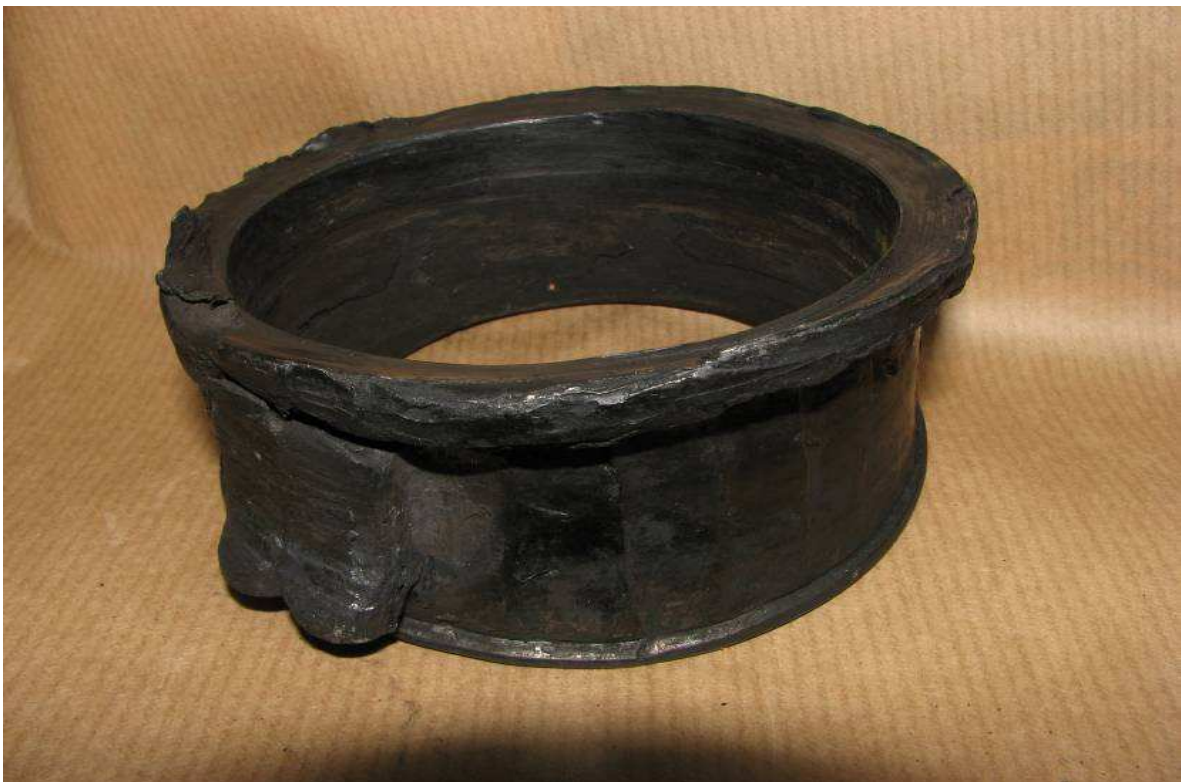
**Figure 21. Outboard bearing inner race (2)**

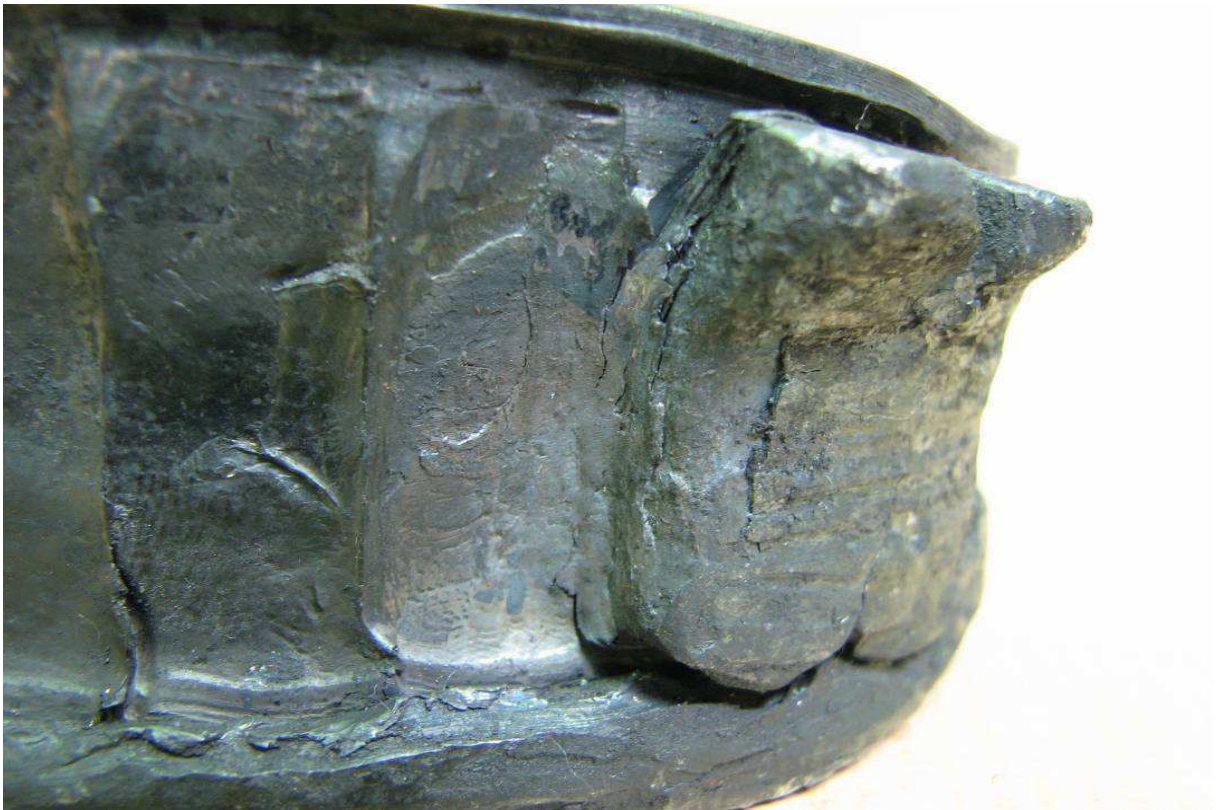
**Figure 22. Outboard bearing inner race, crushed rollers (3)**

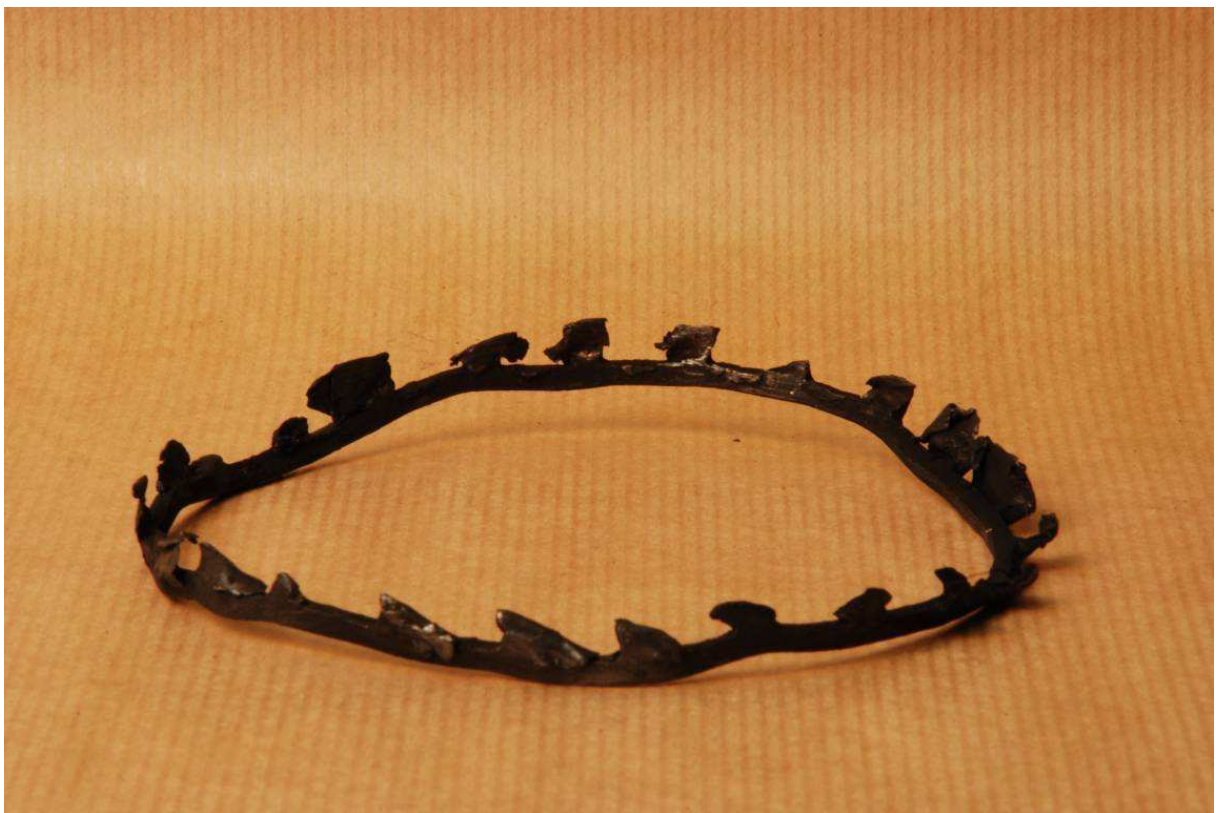
**Figure 23. Outboard bearing cage**

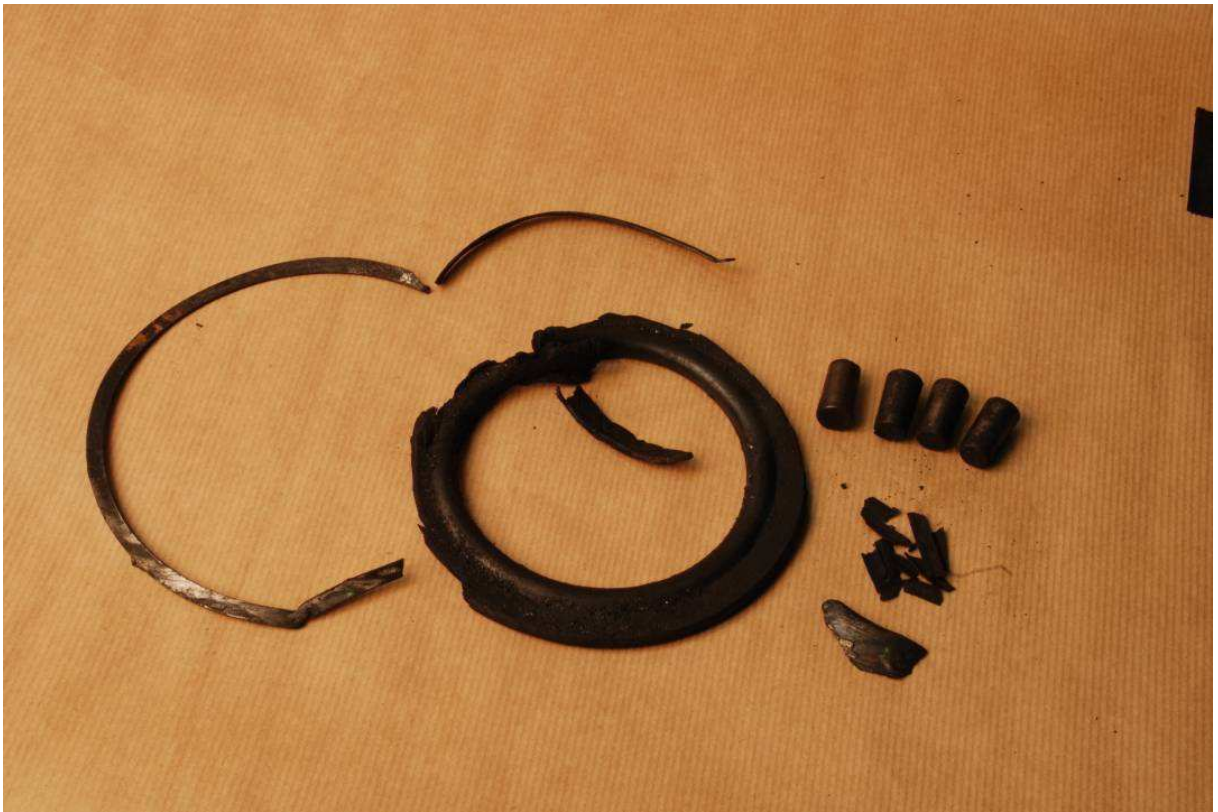
**Figure 24. Bearing rollers, grease seal and clip ring**

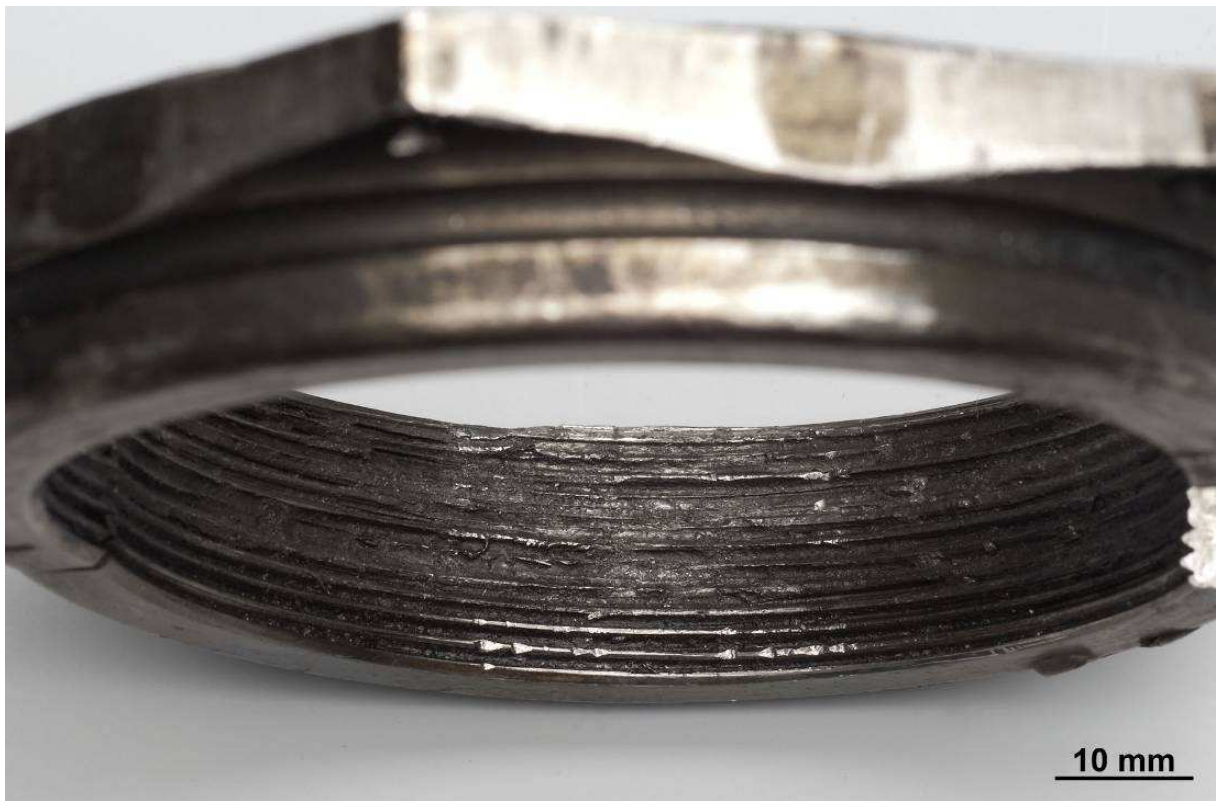
The axle nut showed discoloration due to high temperature and was deformed. The internal thread of the nut was damaged as well as a part of the outside circumference.

**Figure 25. Axle nut**

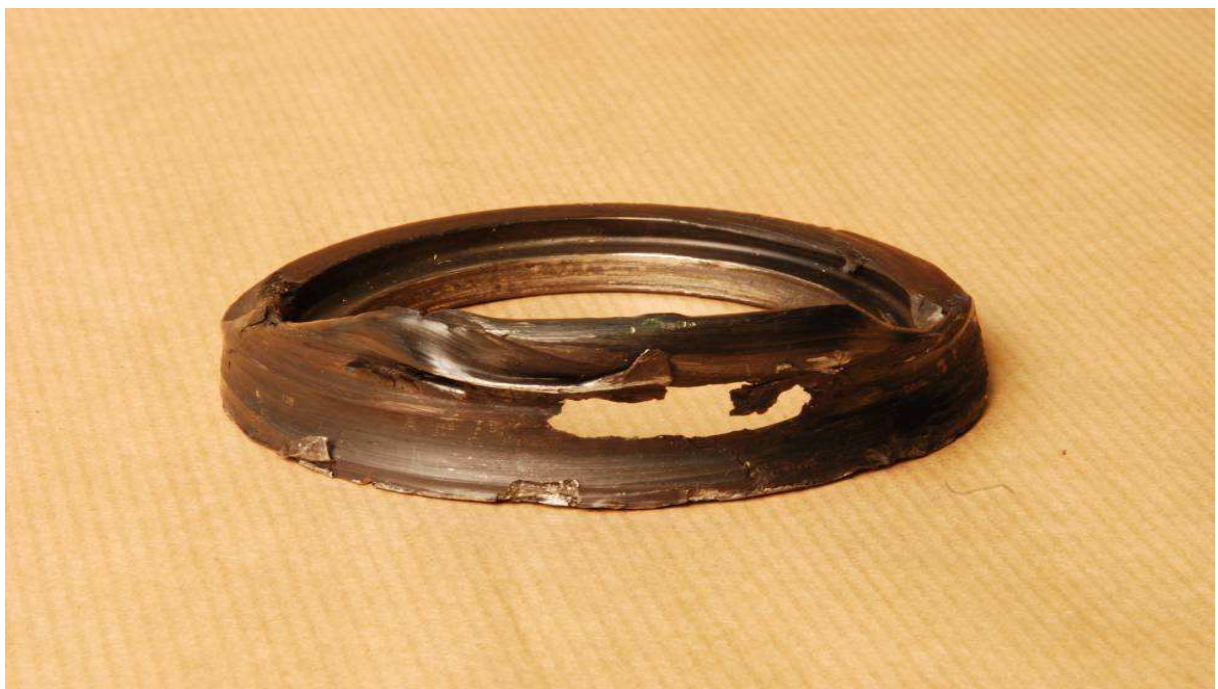
The retaining ring was deformed and extensively damaged. The locking key on the inside bore of the ring had sheared off. A small part of the key was still present on the ring. Discoloration and deformation indicated that the ring had been exposed to high temperatures.

**Figure 26. Retaining ring (1)**

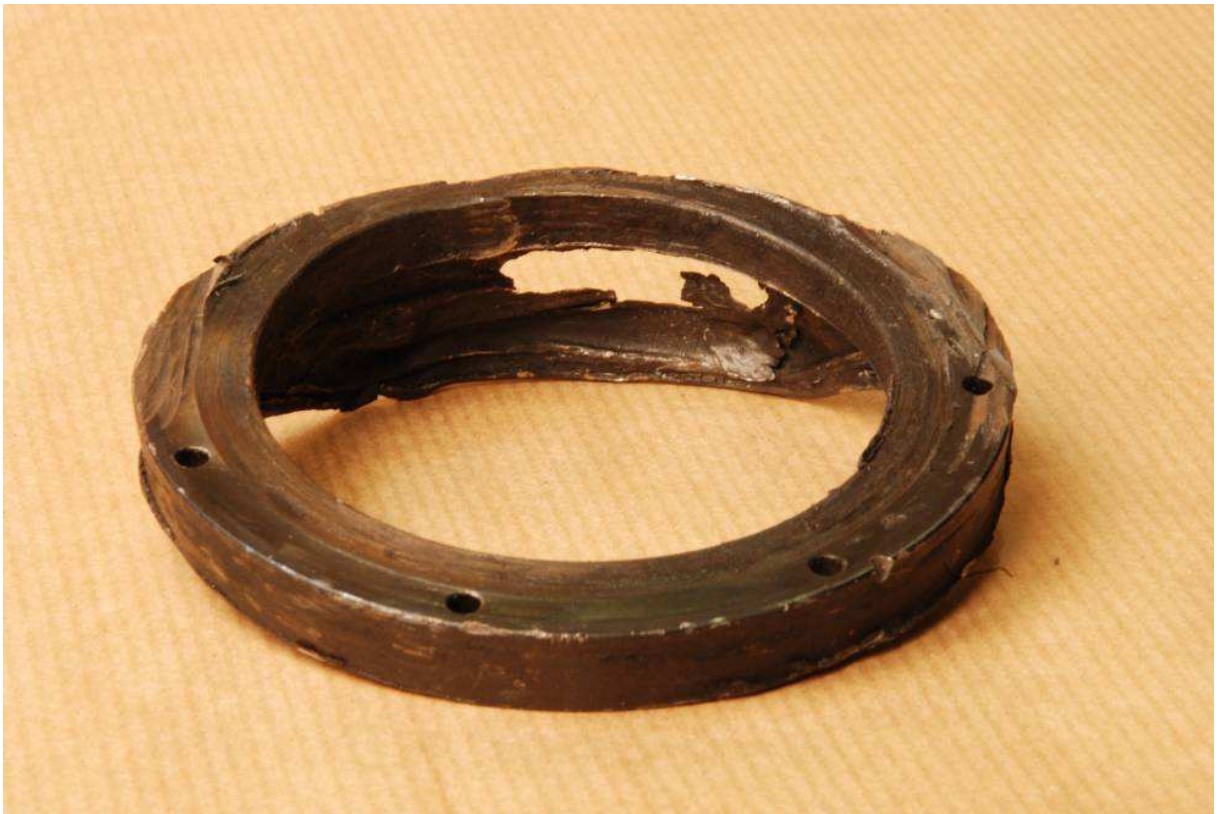
**Figure 27. Retaining ring (2)**
