# **FINAL REPORT Nr. 3/2009 OF THE SERIOUS INCIDENT**

**TO BOEING 737-500 AIRCRAFT, REGISTRATION YL-BBE  
OF S/C “AIR BALTIC CORPORATION” FLIGHT BT-662  
ON DECEMBER 31, 2008 AT DUBLIN**

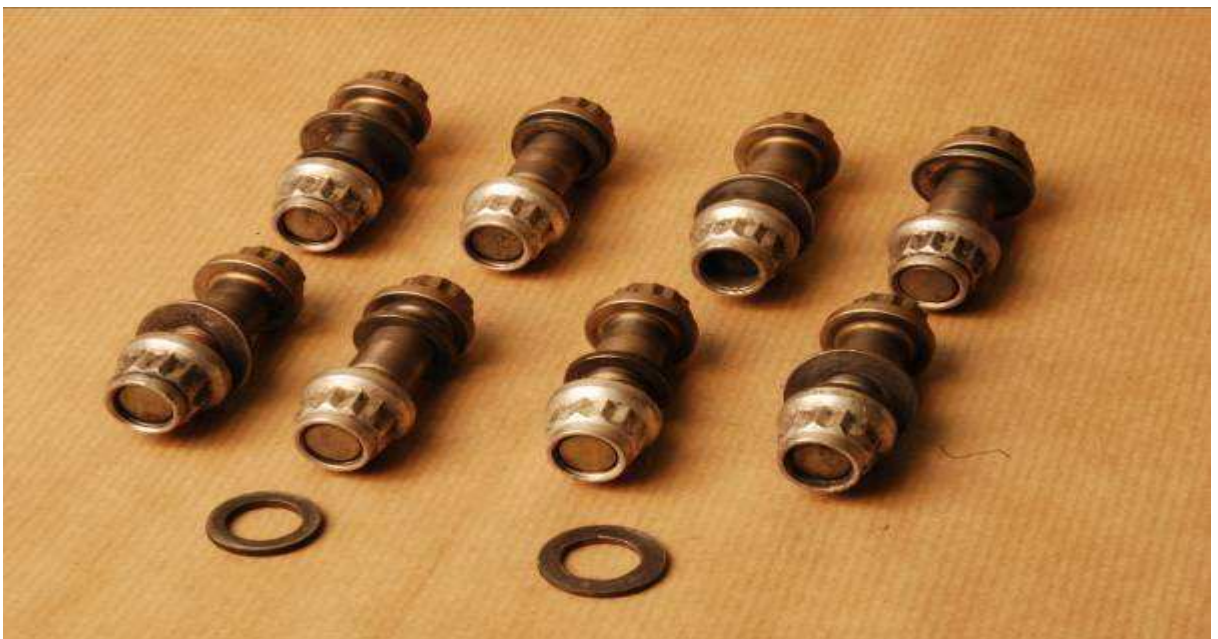
No anomalies were found on the bolts of the number four brake assembly during visual examination. The anti skid transducer was damaged due to impact (off the aircraft) and overheating.

**Figure 28. Brake assembly bolts**

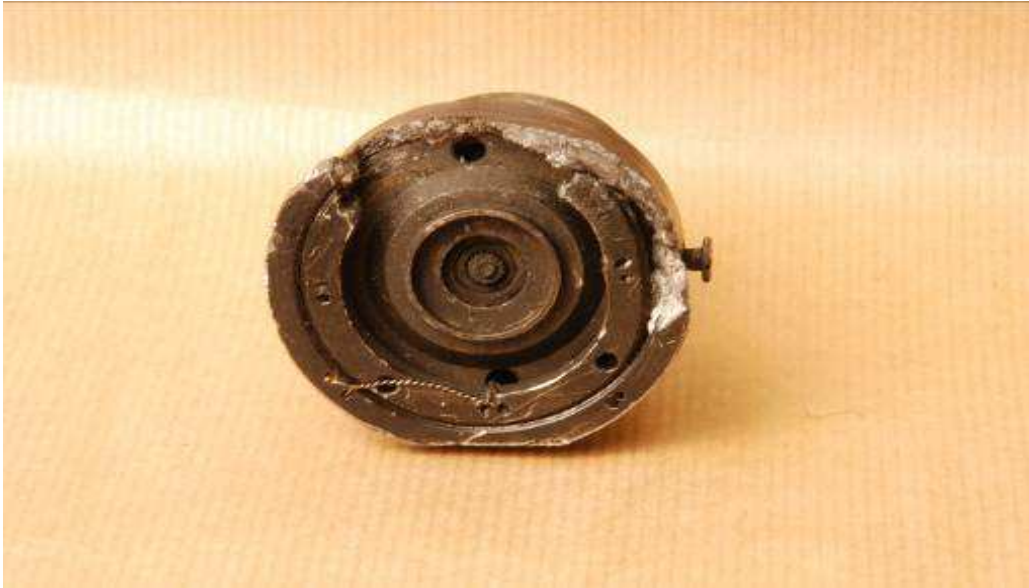
**Figure 29. Antiskid transducer (1)**

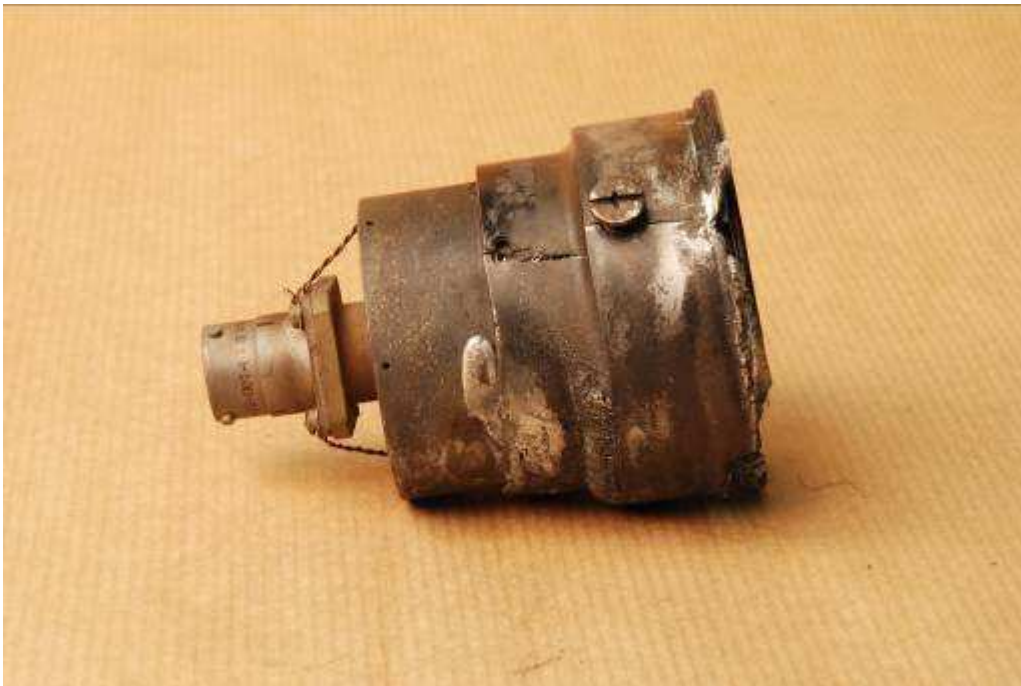
**Figure 30. Anti skid transducer (2)**

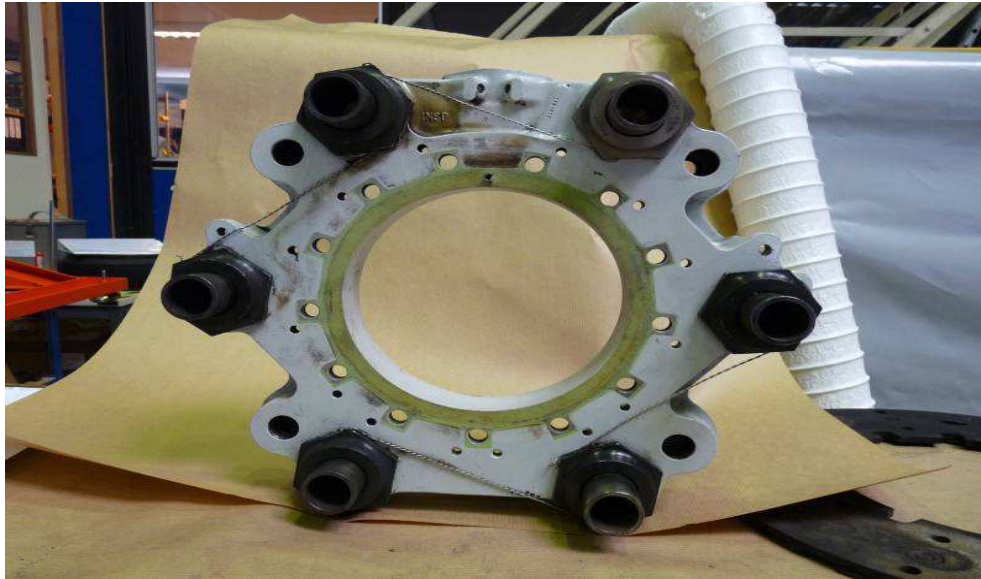
The piston housing had been cleaned before it was shipped to NLR-ATSI. However traces of soot were still visible on this part of the brake assembly. These traces were present on the aft half of the piston housing in relation to the direction of flight.

**Figure 31. Piston Housing**

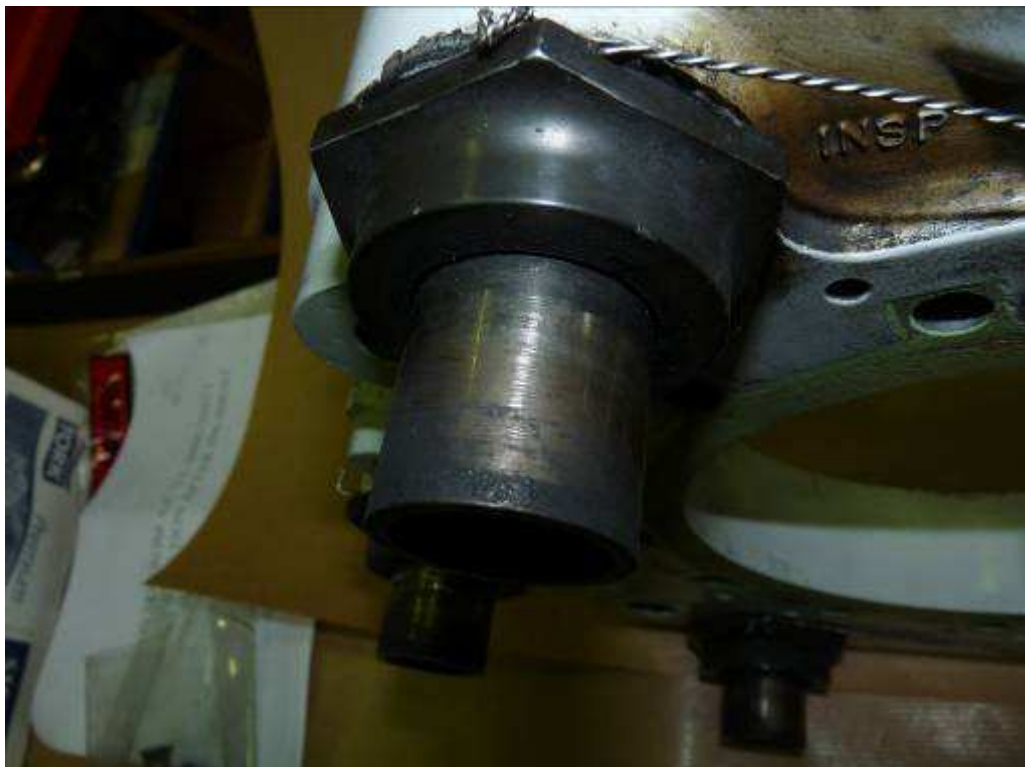
**Figure 32. Piston with fire damage**

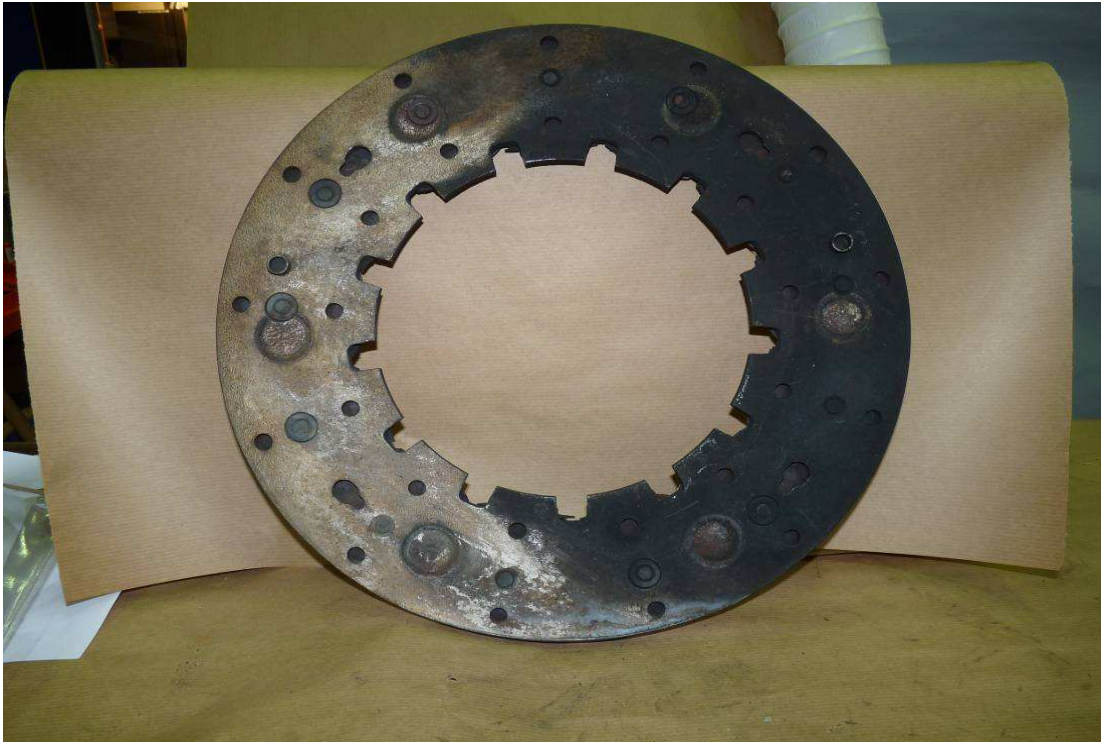
One half of the surface of the pressure plate was damaged BYR fire. This area of damage is consistent with the area found on the piston housing. Rotational damage to the lower area circumference was found.

**Figure 33. Pressure plate fire damage**

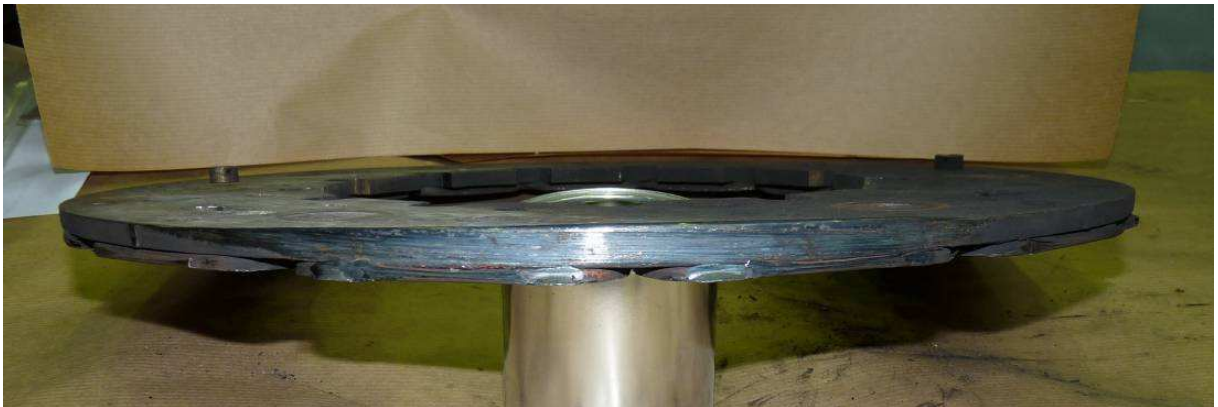
**Figure 34. Pressure plate rotational damage**

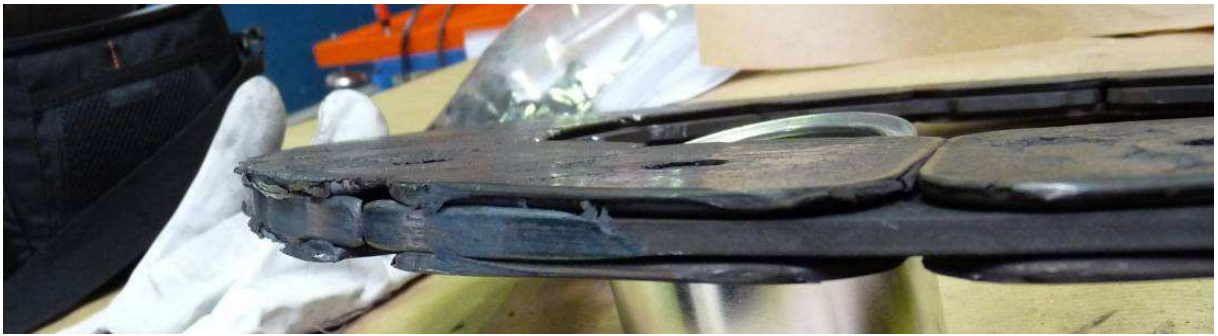
The stator disks were damaged on the lower segment of the outer circumference. This damage is consistent with the damage found on the rotor drive keys indicating that the wheel assembly was supported BYR the brake assembly. The lower linings were crumbled and lining material had crept in a downward direction.

**Figure 35. Damage to the lower segment of stator disk**

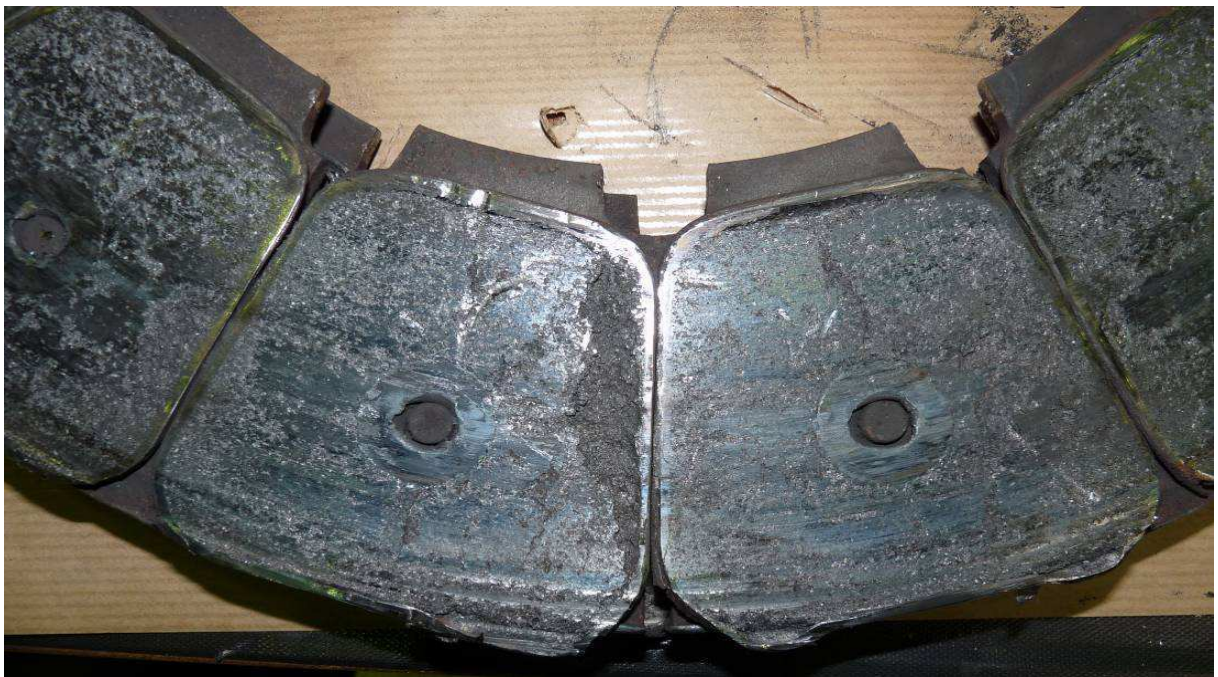
**Figure 36. Brake lining crumbling and creep**

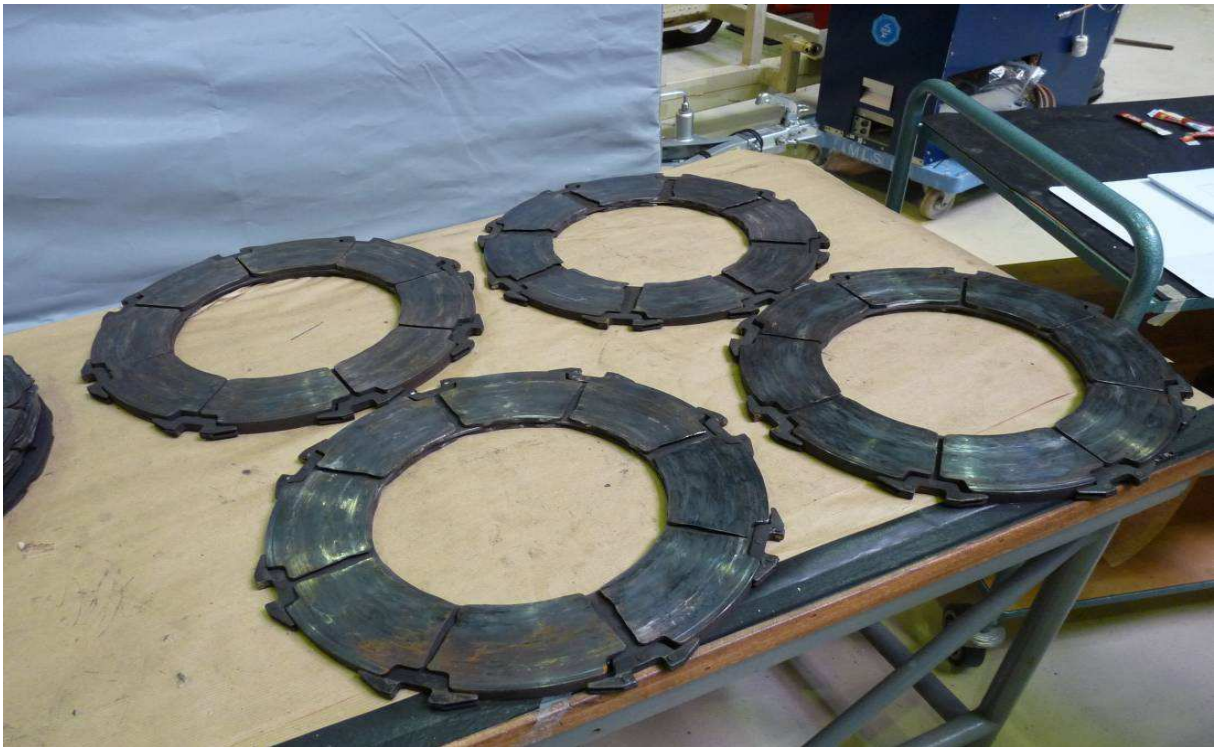
The surfaces of the rotor disks showed signs of normal wear. The inner disk circumferences were mechanically damaged due to contact with the torque tube of the brake assembly, indicating that the wheel assembly has been supported BYR the brake assembly. One disk contained a stuck rotor segment.

**Figure 37. Rotor disks overview**

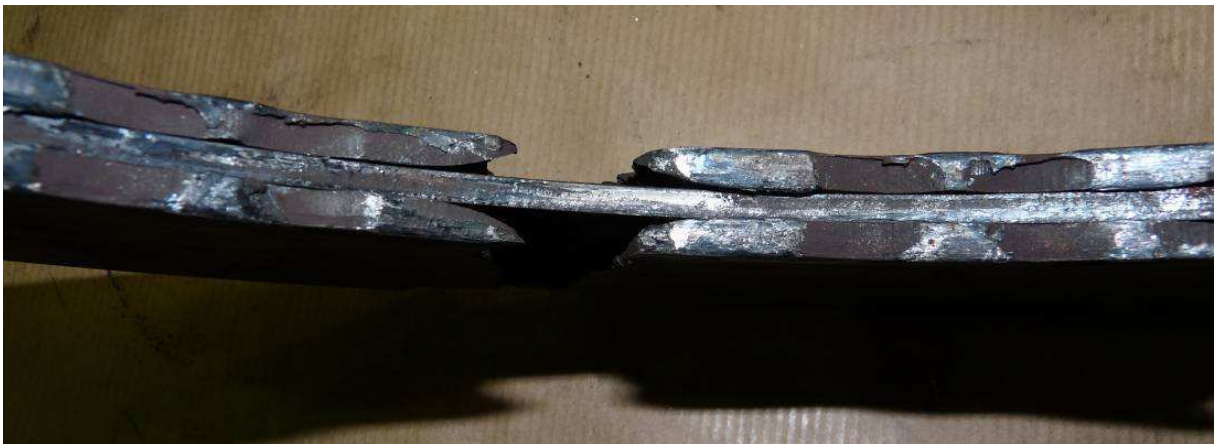
**Figure 38. Damage to inner circumference of rotor disk**

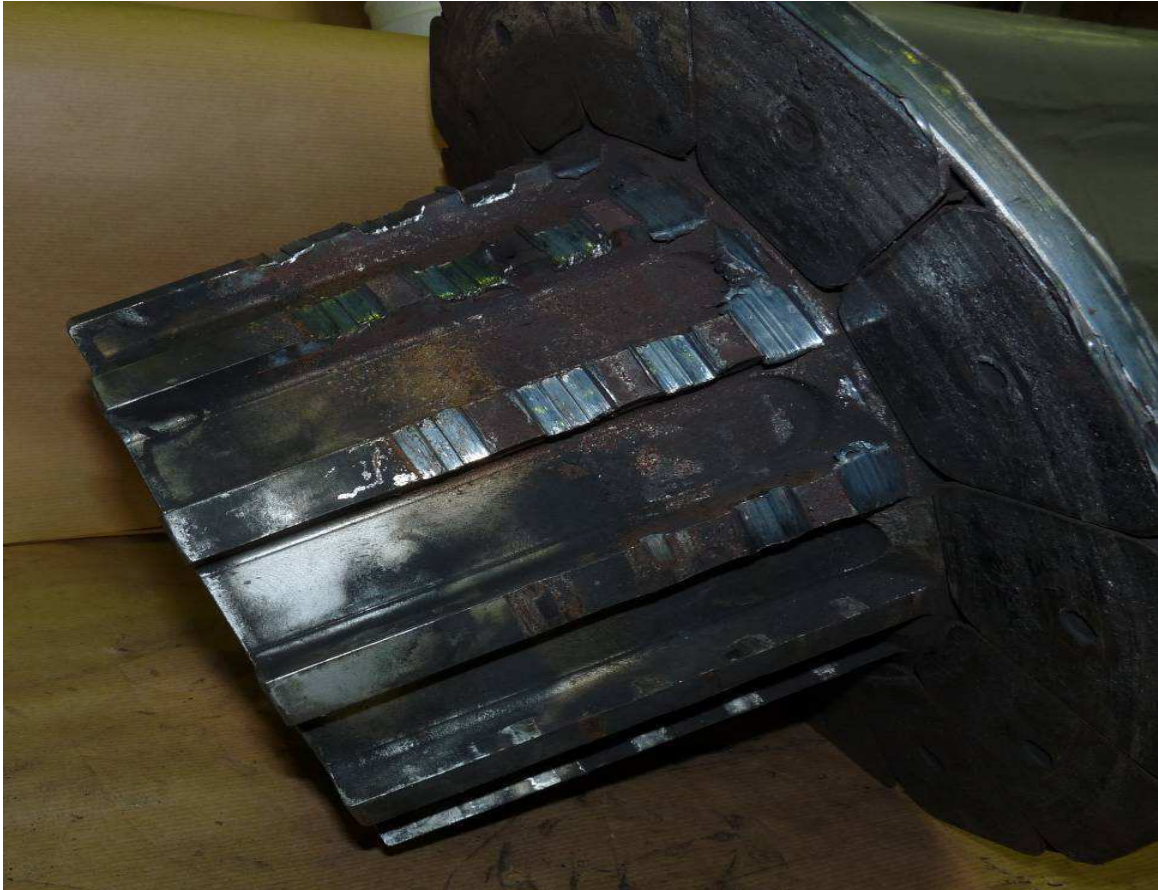
The torque tube assembly was damaged in a number of locations. Discoloration and soot indicates that this assembly was exposed to fire. Mechanical and rotational damage was found on the lower splines. The indentations were consistent with the shape of, and damage found on, the rotor disks. The indentations found on one track of rotor disk differed from the others. This difference was caused BYR a stuck rotor segment on the affected disk. The lower segment of the outer circumference of the backing plate was found damaged due to interaction with the rotor drive keys on the inboard wheel half. A small part of the top segment of the outboard inner bore of the torque tube contained transferred material from the inner wheel half and inboard bearing. This damage and the shape of the inner bore was consistent with the damage found on the hub of the inboard wheel half.

**Figure 39. Torque tube assembly spline damage**

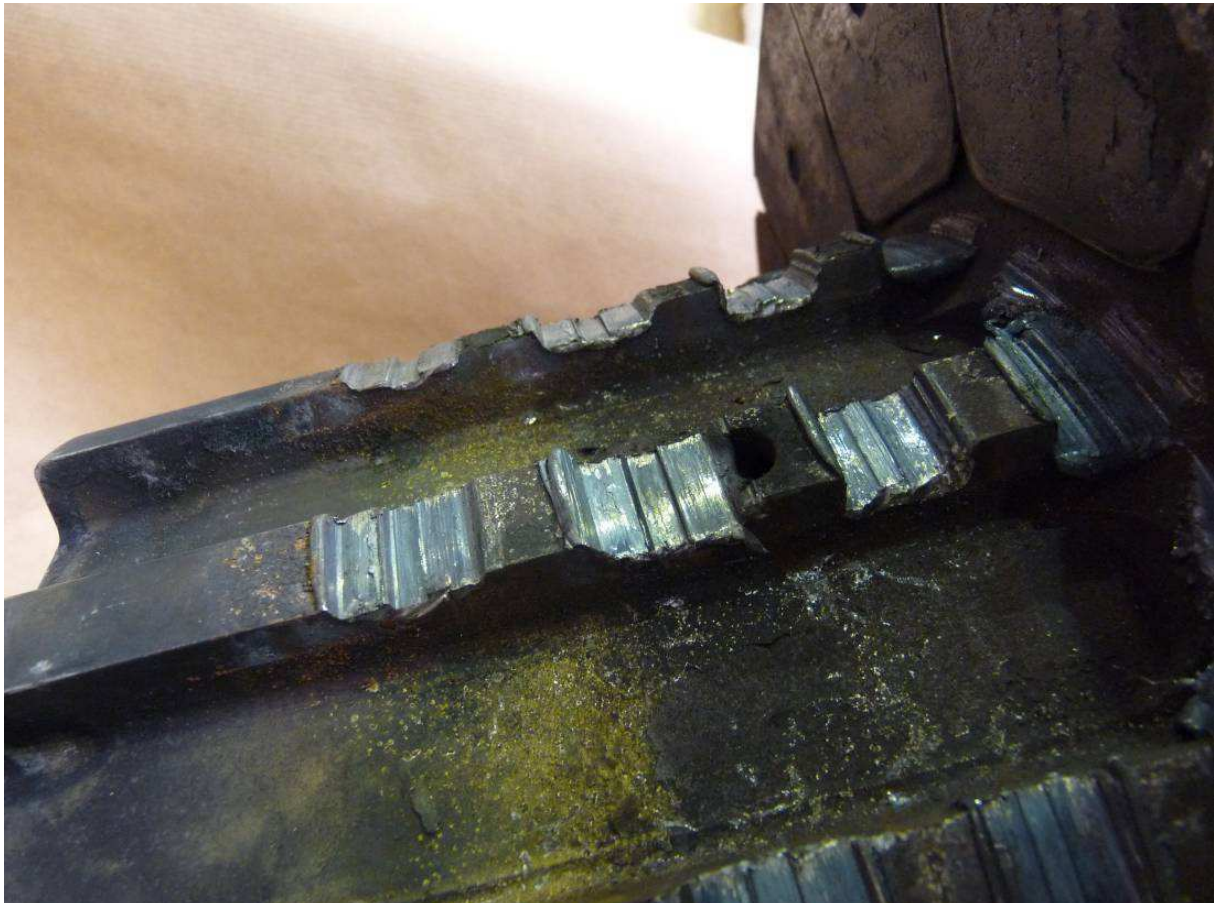
**Figure 40. Difference in indentation caused BYR stuck rotor segment**

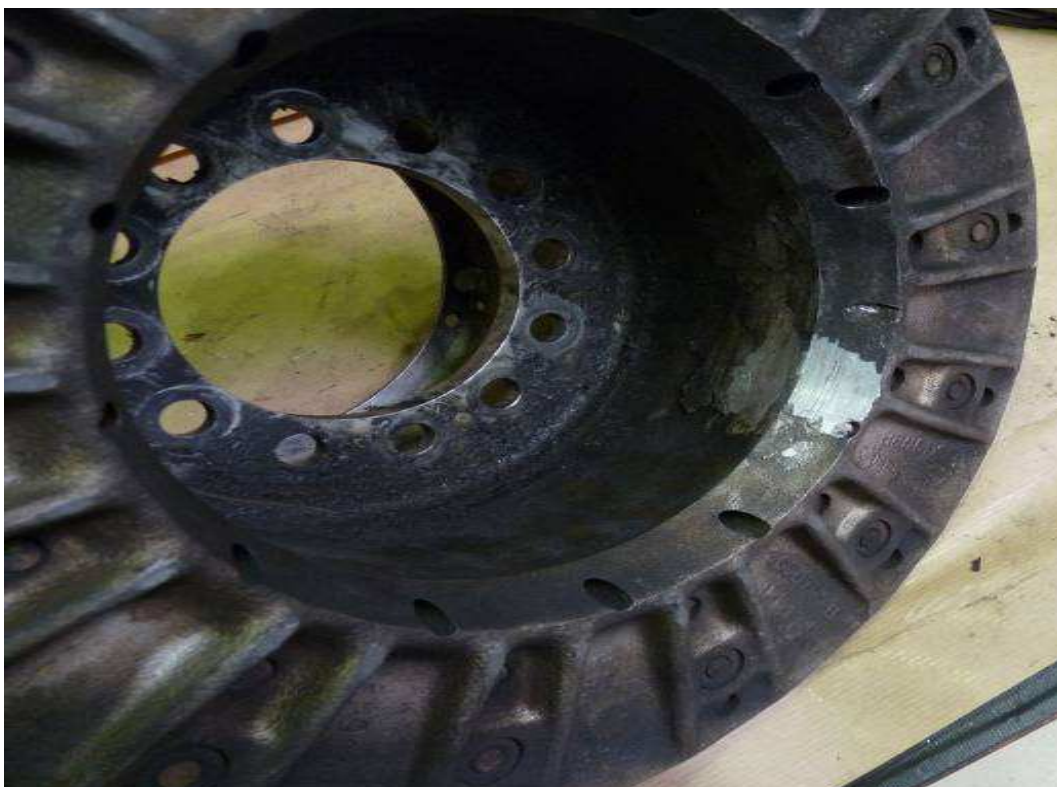
**Figure 41. Torque tube outboard side**

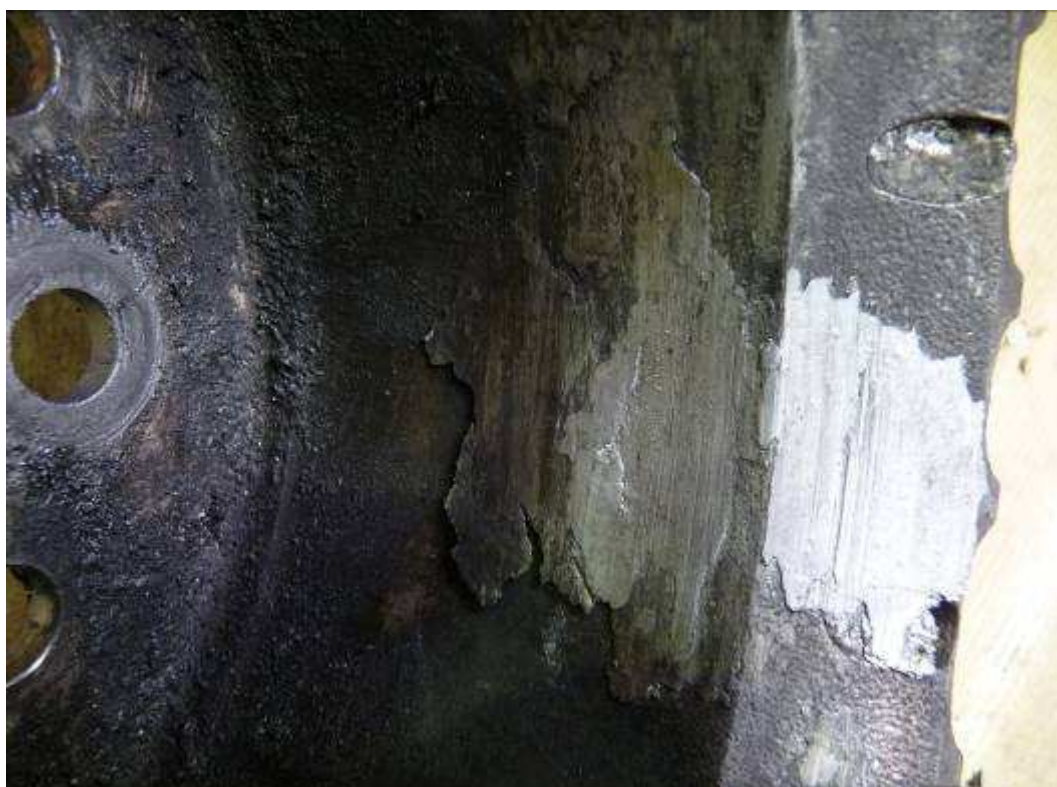
**Figure 42. Transferred material**

The conical shape of the transferred material found on the outside circumference of the inboard wheel hub indicates that there has been extensive friction contact between the wheel assembly and the brake unit due to lateral movement of the wheel assembly.

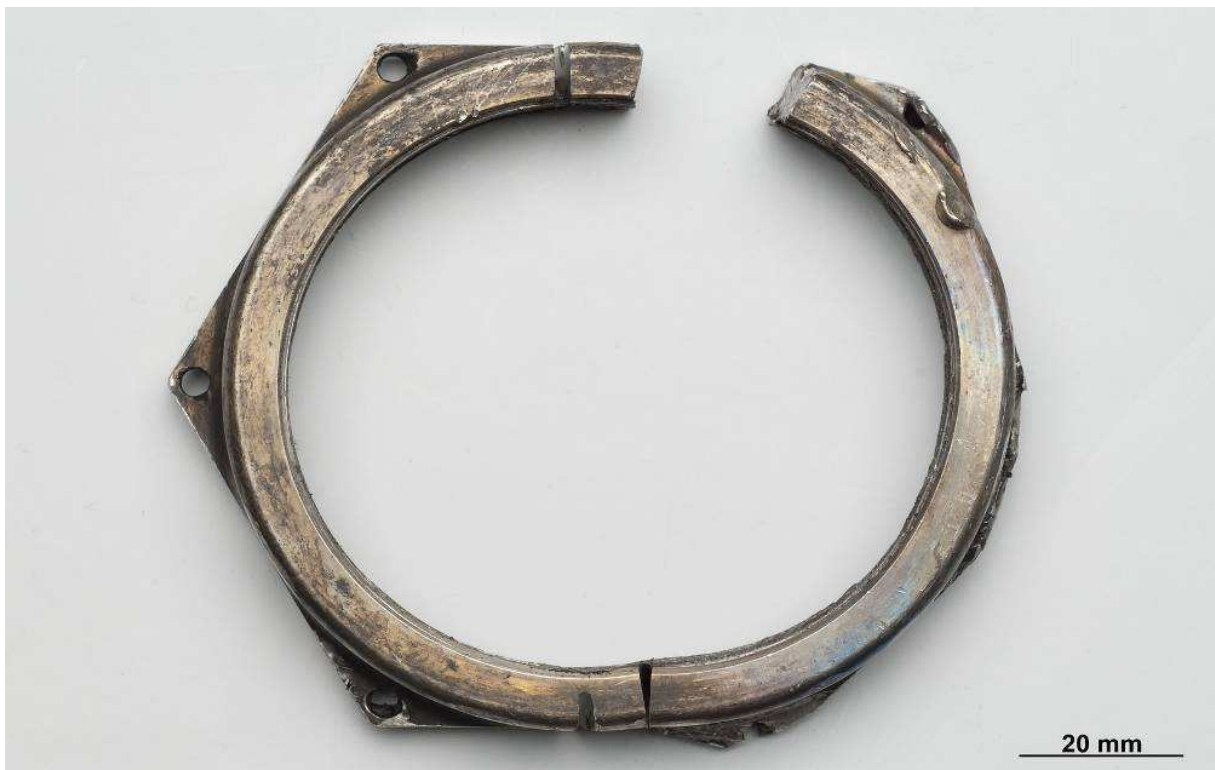
The axle nut was subjected to metallurgical examination. Objective of this examination was to determine if maintenance was a factor in the possible bearing failure; effectively if an over-torque condition occurred during installation. Three cross sections were made in order to determine a shear direction of the internal thread. Examination of the axle nut cross sections did not lead to unambiguous evidence that the internal thread had sheared in one direction, meaning that there was no obvious indication for over-torque.

**Figure 43. Cross sections on axle nut**

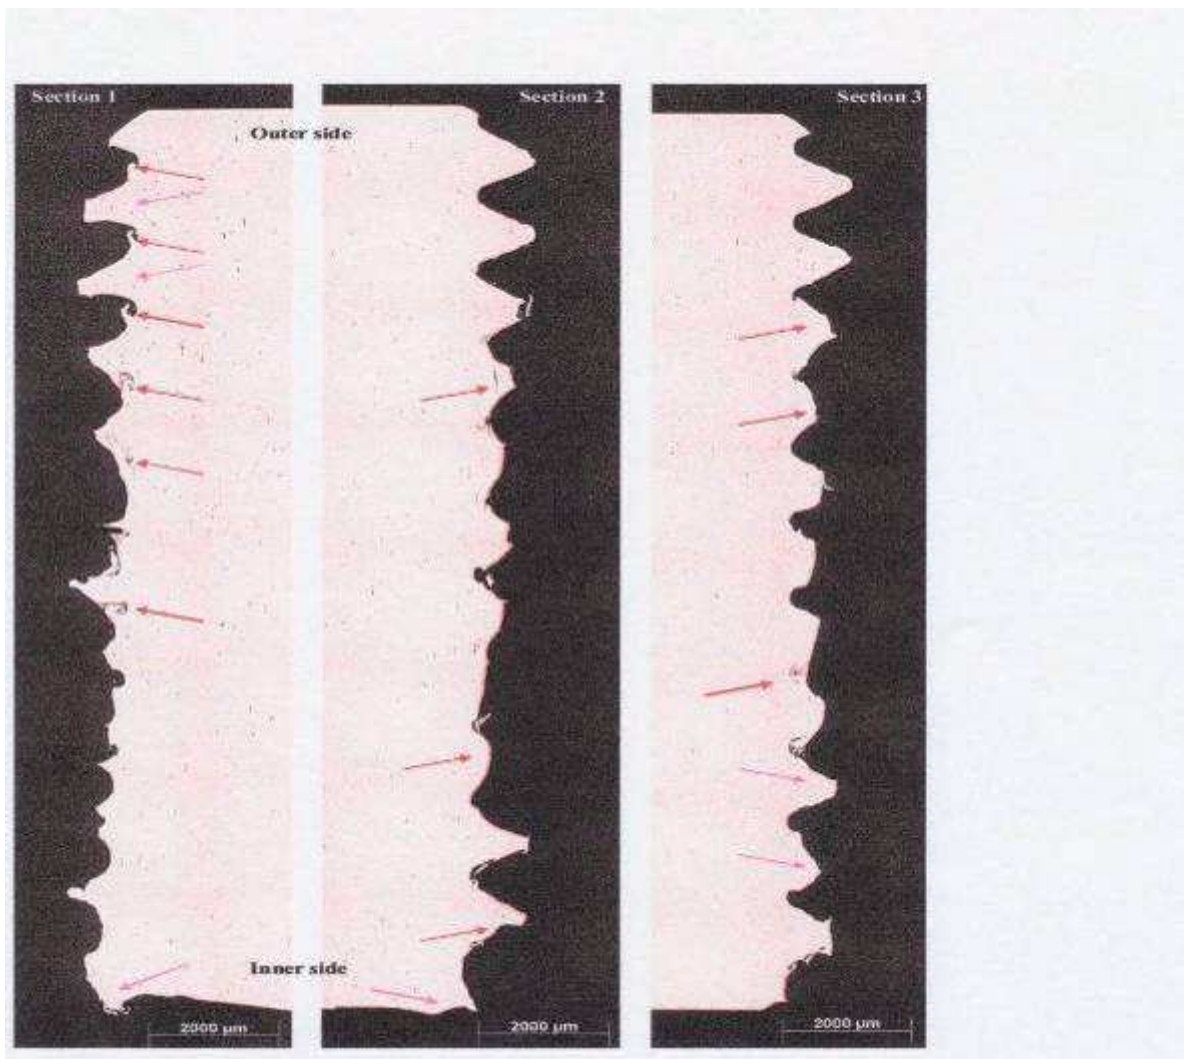
**Figure 44. Shear direction indicators in the three cross sections**
