FINAL REPORT No. 4-02/3-20(1-21)

ON AVIATION SERIOUS INCIDENT INVOLVING AIRCRAFT TECNAM P2008 JC OF ERIVA LTD., REGISTRATION No. YL-EVA AT AERODROME ĀDAŽI ON 1 SEPTEMBER 2020

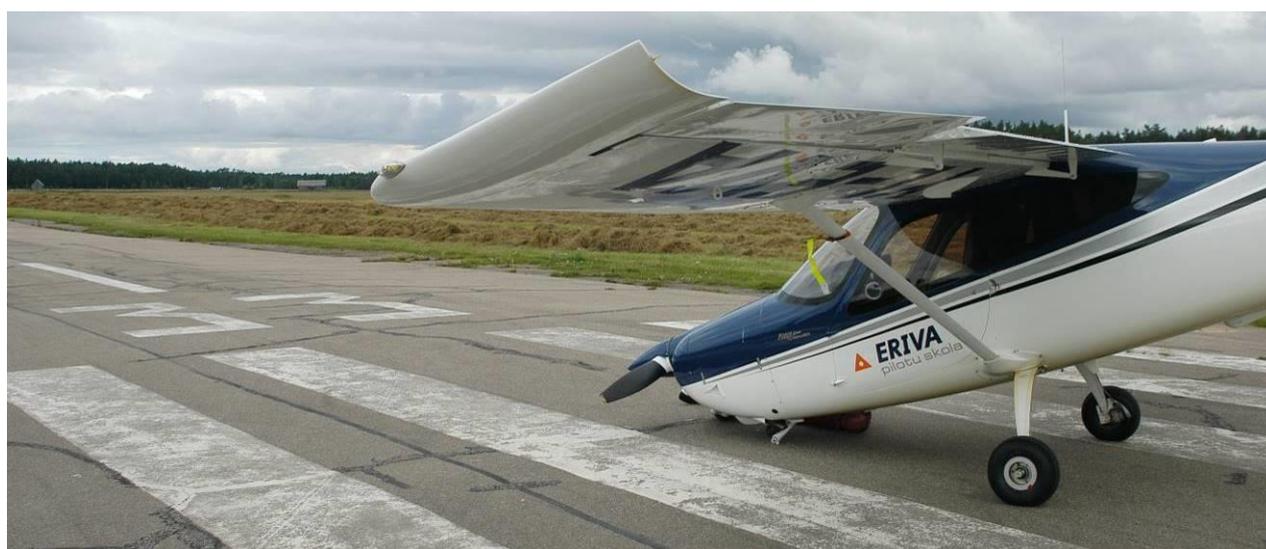
On 1 September 2020 an aviation serious incident involving aircraft Tecnam P2008 JC, registration No. YL-EVA, occurred at aerodrome Ādaži. Upon making a 180 degree left turn at the start of runway 33, nose landing gear leg attachment of the aircraft broke off. During the incident the aircraft sustained insignificant damages, the pilot and the passenger did not sustain injuries in the aviation serious incident.

Figure 1. Aircraft at the site of incident

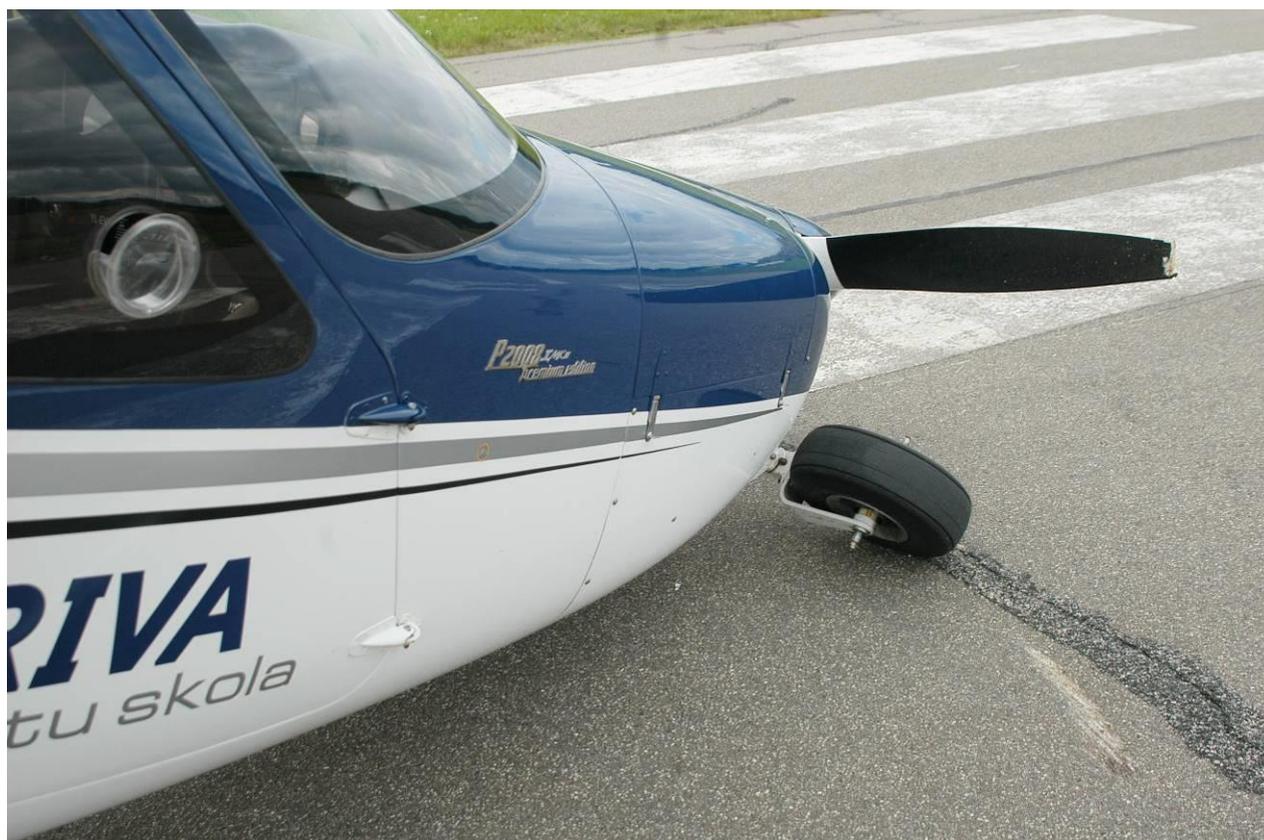
Figure 2. Damage to the nose landing gear

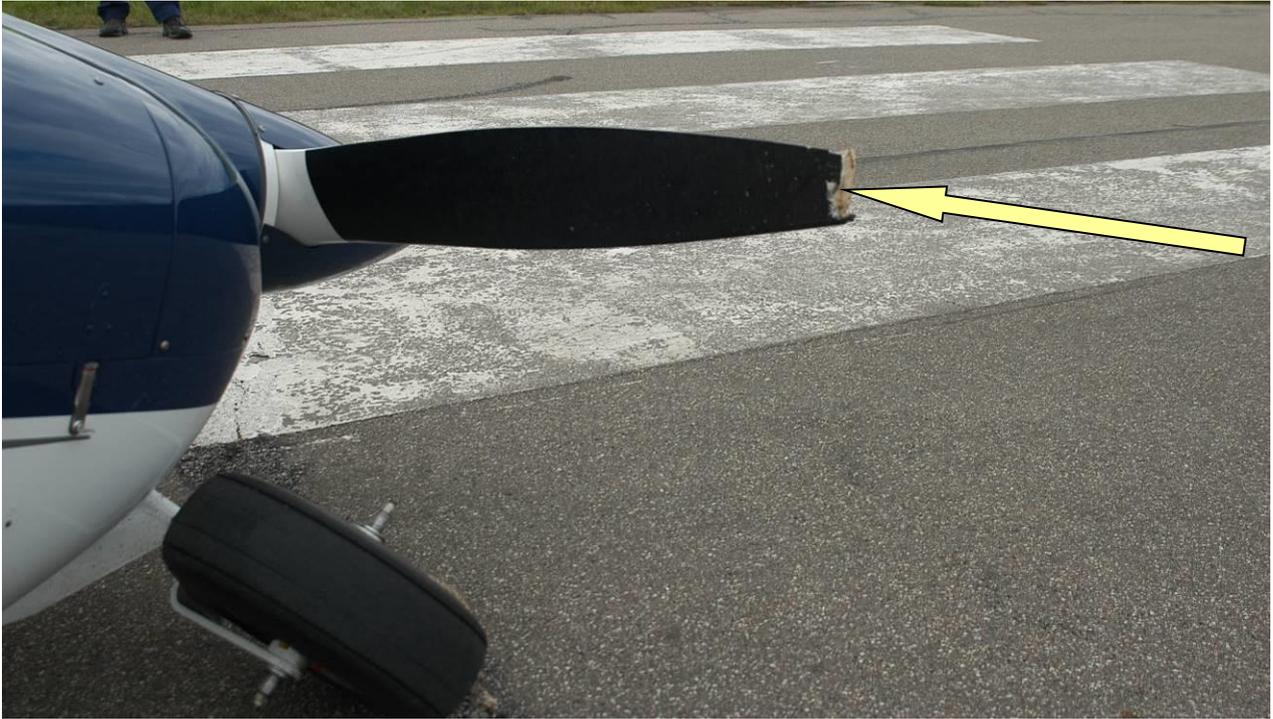
- propeller blades of the aircraft have been damaged;

Figure 3. Damage to the propeller

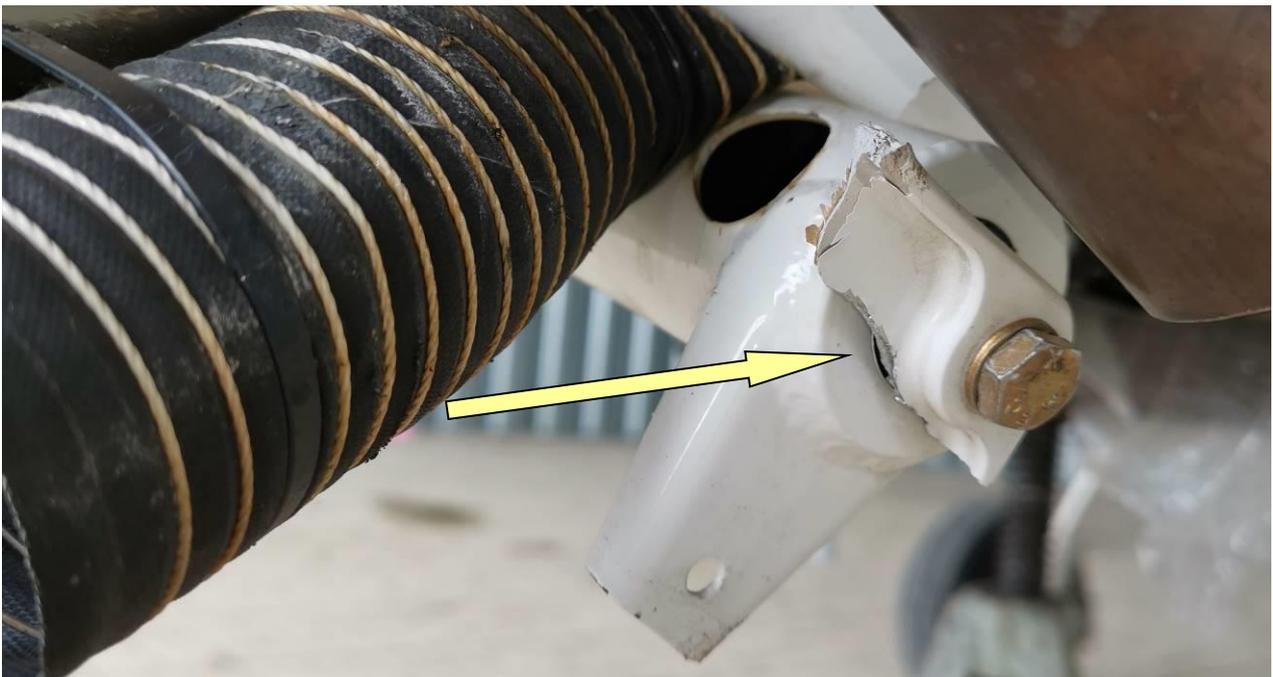
- the left-hand angle flange of the nose landing gear leg attachment has been broken off;

Figure 4. Breaking point of the left-side angle flange of the nose landing gear leg

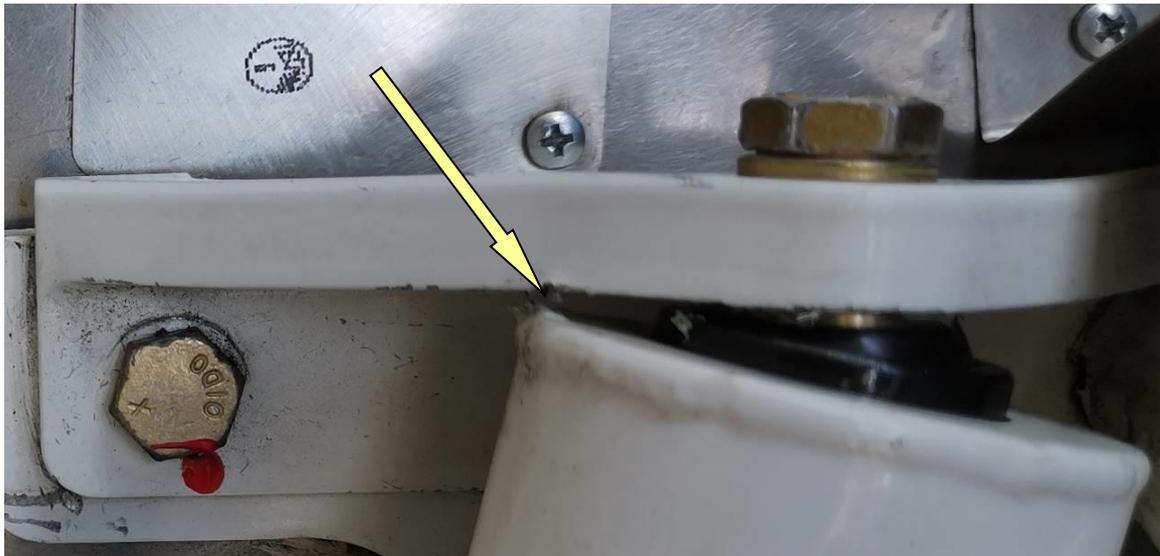
- the right-hand angle flange of the nose landing gear leg attachment has been deformed due to the incident;

Figure 5. Right-hand angle flange

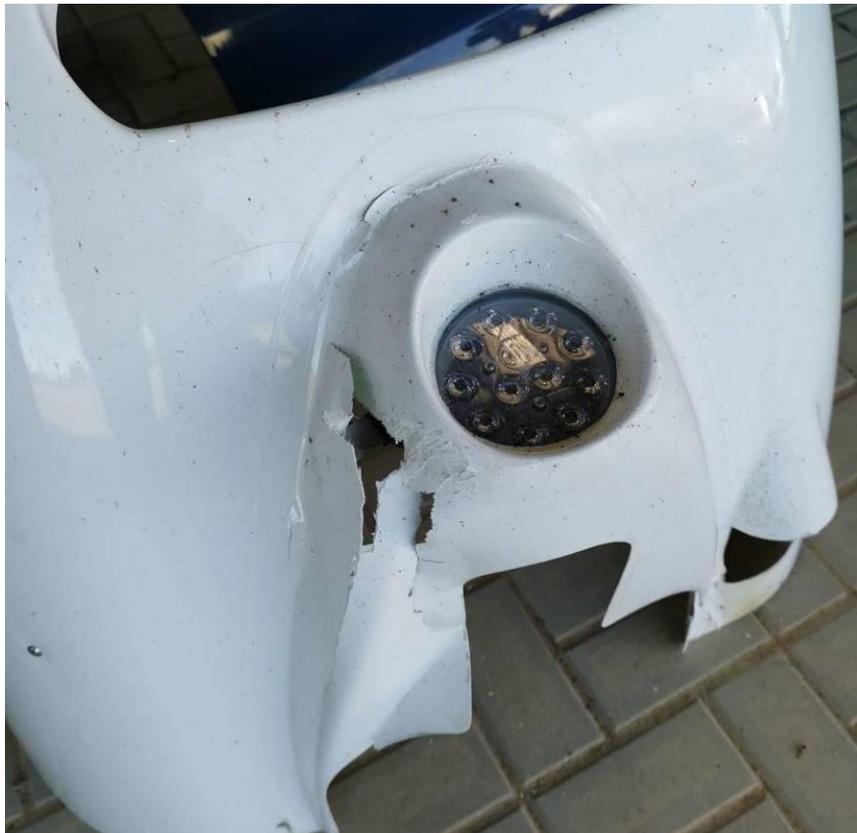
- the lower engine cowling has been damaged;

Figure 6. Damages to the lower part of fuselage of the aircraft

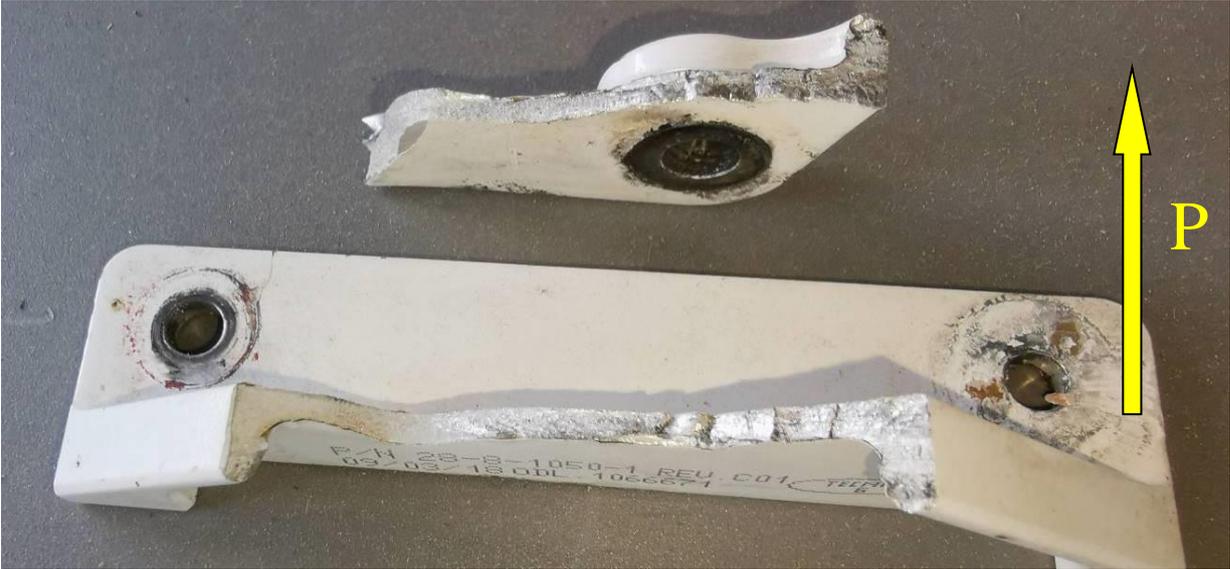
Upon landing, the parts of the nose landing gear leg structure of the aircraft are subjected to dynamic load. The angle flanges are being subjected to load via the horizontal longitudinal axis of the landing gear, thus causing bending stress P therein (Figure 11).

Figure 11. Both fractured parts of the left-hand flange and the action direction of force P

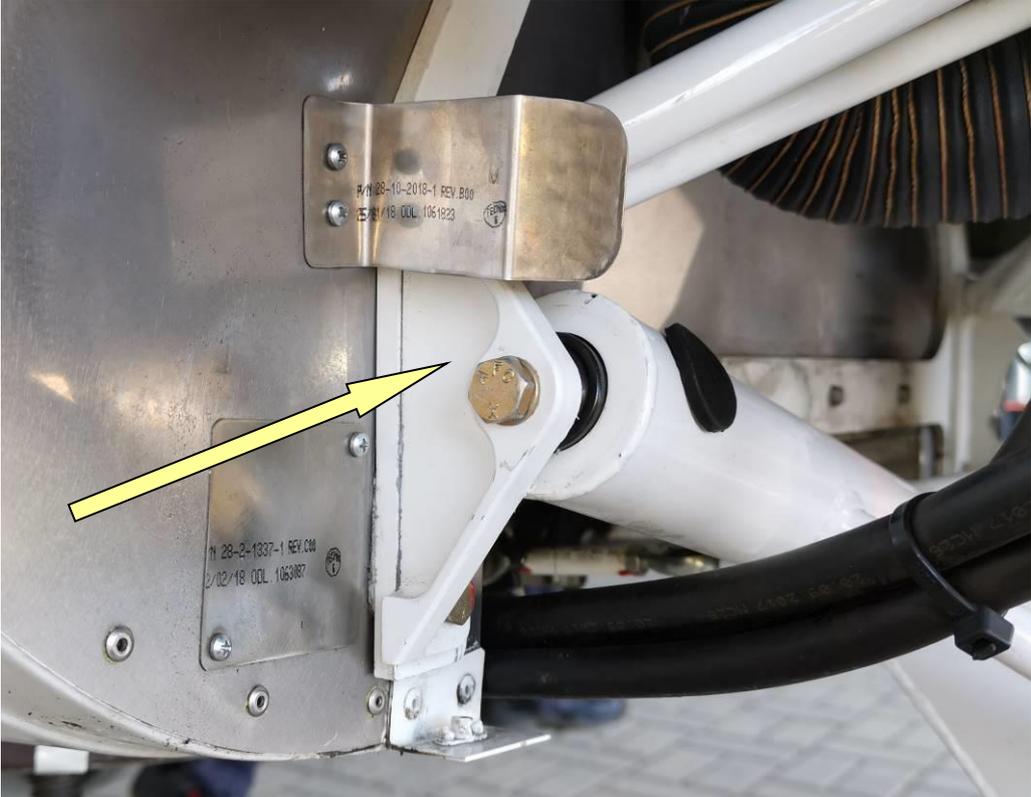
The fracture has formed in the left-hand angle flange. After fracturing thereof, the horizontal longitudinal axis became loose and the nose landing gear leg remained fixed only in the right-hand angle flange (Figure 12).

Figure 12. Right-hand angle flange of the longitudinal axis attachment

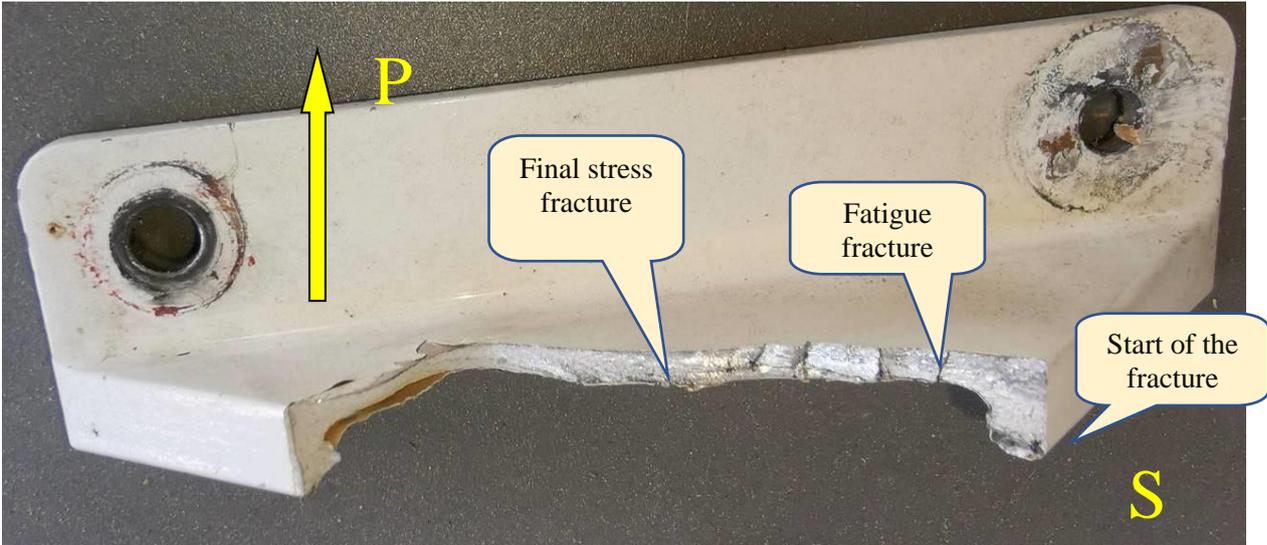
Upon performing analysis of the fracture, it was concluded that the starting point **S** of the fracture was located in a place where maximum bending stress operates. During operation, it does not exceed the designed load of the part.

Small damages to the surface layer with a little admixture of the part to the material or a defect in the structure of the material of the part are visible in the starting point of the fracture (Figure 13). During service of the aircraft the surface layer of the fracture evened out, became smooth and shiny. Notches of 3-6 mm in length are visible further along the fracture when the fracture stopped, however, at the event of the subsequent shock (hard landing) its further development resumed.

Figure 13. Image of the surface of the fracture

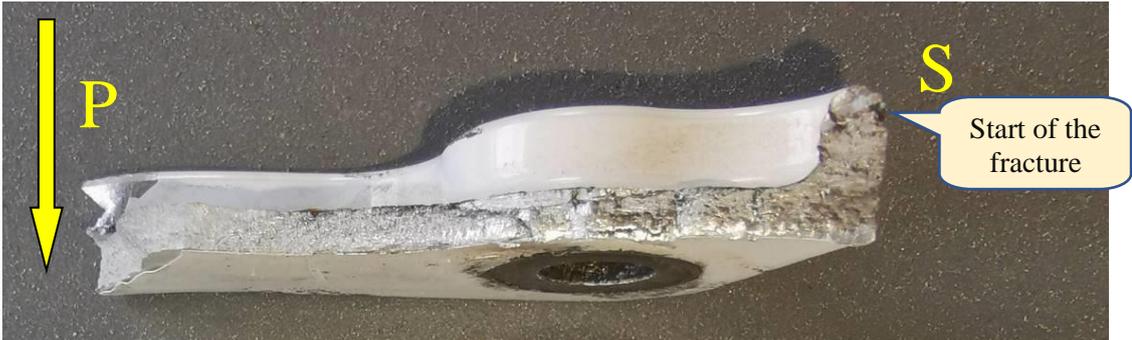
In this stage of development of the fracture (fatigue), the fracture is under low-cycle load, the structure of the landing gear leg keeps operating. Similar surface of the fracture is also visible in the part that has broken off (Figure 14).

Figure 14. Image of the fracture surface of the part that has broken off

When the fatigue fracture developed to the point that the remaining intact cross-section of the flange was not able to withstand the stress caused by the operational load, then the left-hand flange failure occurred. The final fracture is fine-grained, fragile, without plastic deformation.

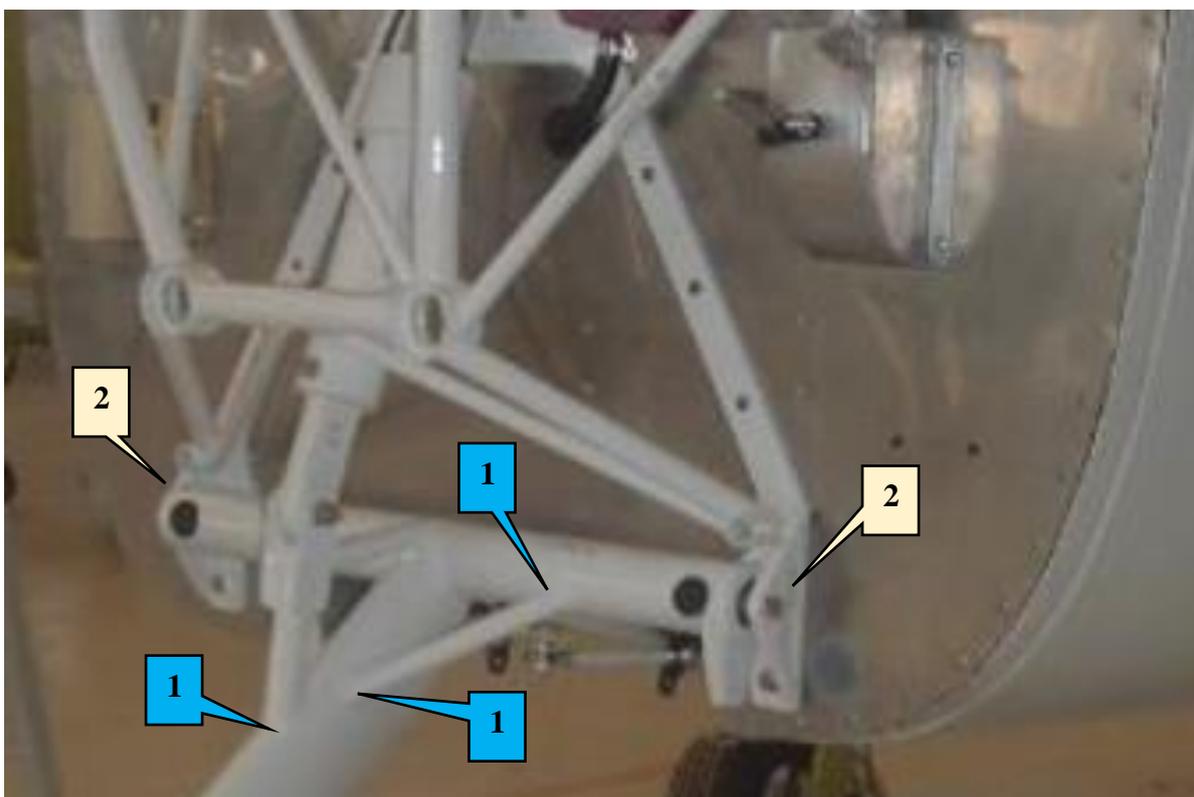
Figure 15. Structure of the nose landing gear of the aircraft

Side impact to the ground by the nose landing gear of the aircraft Tecnam P2008 results in transverse dynamic load which has effect on the nose landing gear leg being “hard” attached to the fuselage firewall of the aircraft, and this load results in the formation of bending stress in angle flanges and the occurrence of fatigue failure of the material of angle flanges (2) (Figure 15).

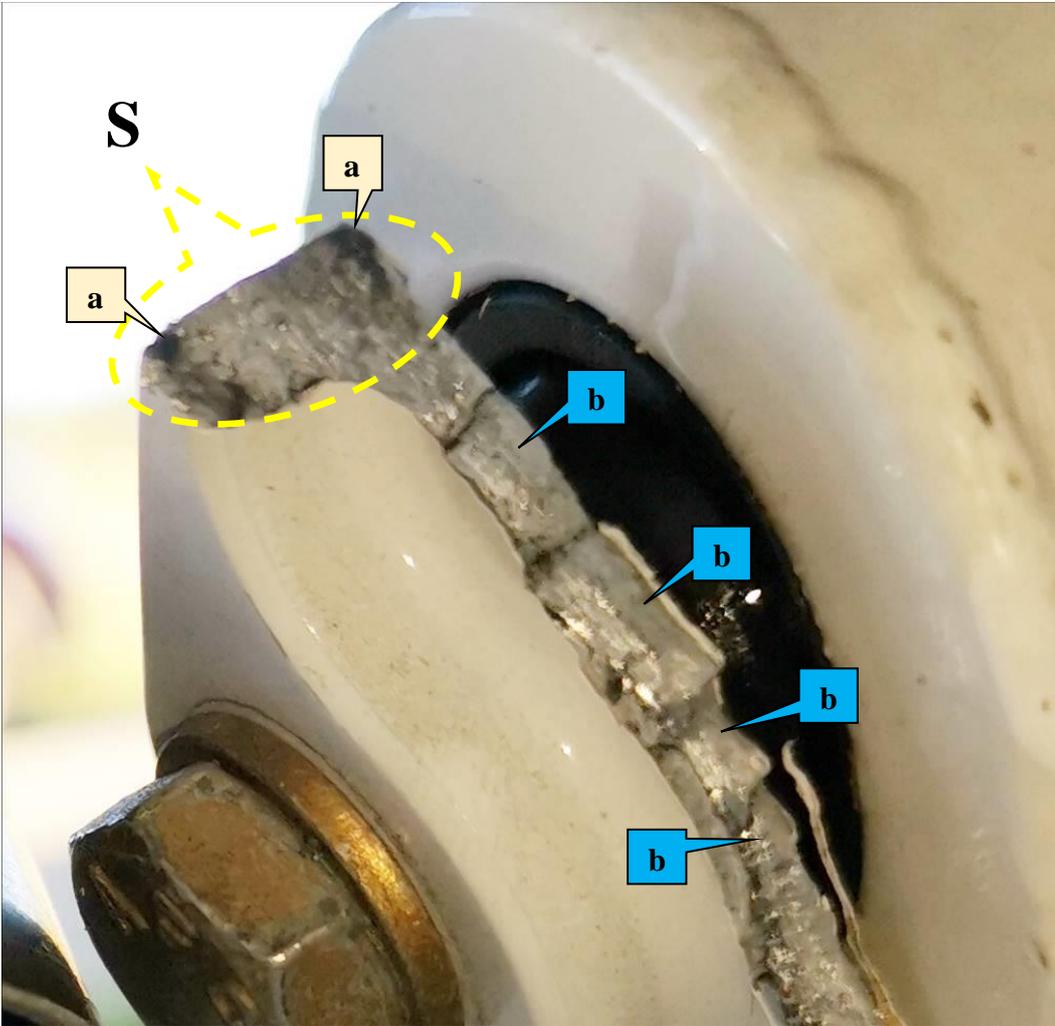
Taking into account the results of the metallurgical analysis of the left-hand angle flange of the nose landing gear leg attachment, it was concluded in investigation that damages to the surface layer visible in the starting point **S** of the fracture of the angle flange had, potentially, occurred from a small admixture in metal (**a**) or due to structural defects that had occurred during the manufacturing process of the angle flange, and they, potentially, might have been the cause due to which the fracture in the angle flange started in the point **S** because the highest concentration of stress occurred in this place (Figure 16).

The fracture started in the upper part of the flange where a micro-crack had formed during service, later transforming into a fatigue fracture. Further development of the fracture displays nature of a low-cycle fatigue fracture, and it developed in several stages (**b**), forming the surface of stage fatigue fracture. During the low-cycle stage, the structure of the landing gear leg continued to operate normally until the aircraft serious incident on 1 September 2020.

Figure 16. The broken-off fragment of the left-hand angle flange

The reason for the fracture on the very day of the event is potentially linked to the fact that the remaining undamaged cross-section of the damaged flange was only around 60 % which was not sufficient anymore for withstanding the dynamic load caused by service. Thus, it resulted in a development where the horizontal longitudinal axis disengaged from the left-hand mounting angle flange and the structure of the nose landing gear leg broke under the weight of the aircraft.

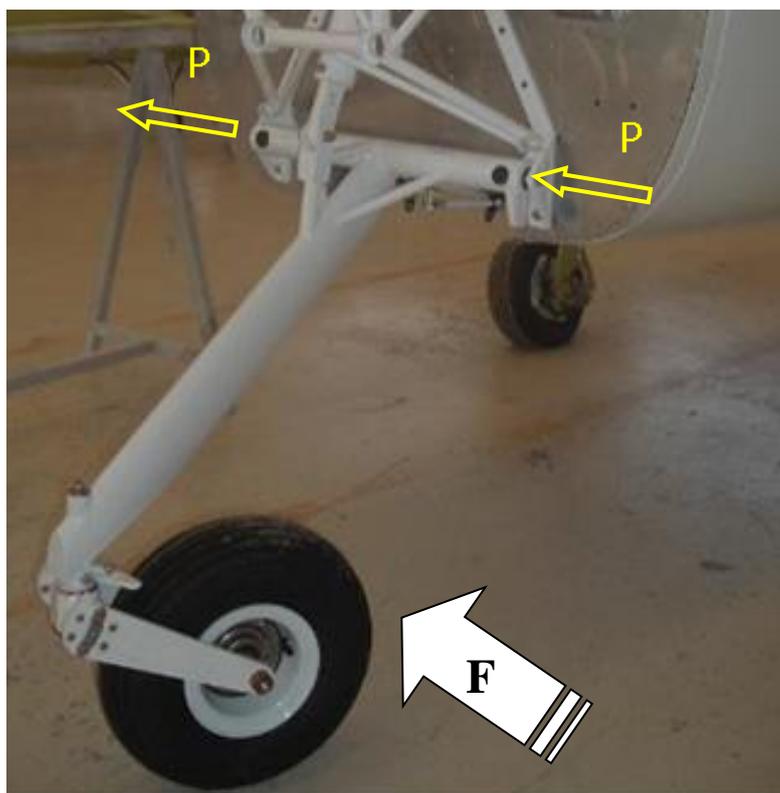
As the fatigue fracture of the left-hand angle flange of the nose landing gear attachment developed gradually, it is possible that the serious incident could have been promoted by several hard landings of the aircraft. It is visible in the video recording (see Paragraph 1.11) at the disposal of investigation that on 21 June 2020 the aircraft, upon performing landing with the left bank at aerodrome Ādaži, hit the surface of the ground with the nose landing gear, causing bending stress **P** in the angle flanges of the nose landing gear as a result of transverse impact (Figure 17). The structure of the nose landing gear attachment of the aircraft Tecnam P2008 allows to absorb shocks in vertical motion only, but the dynamic load of transverse impact **F** has an effect on both mounting angle flanges.

Figure 17. Effect of dynamic load in the structure of the nose landing gear

To find the possibility for carrying out measures for improvement of the structure of the nose landing gear leg attachment of the aircraft P2008 JC in order to reduce gradual fatigue failure of the material of angle flanges under impact of bending stress from transverse dynamic load.

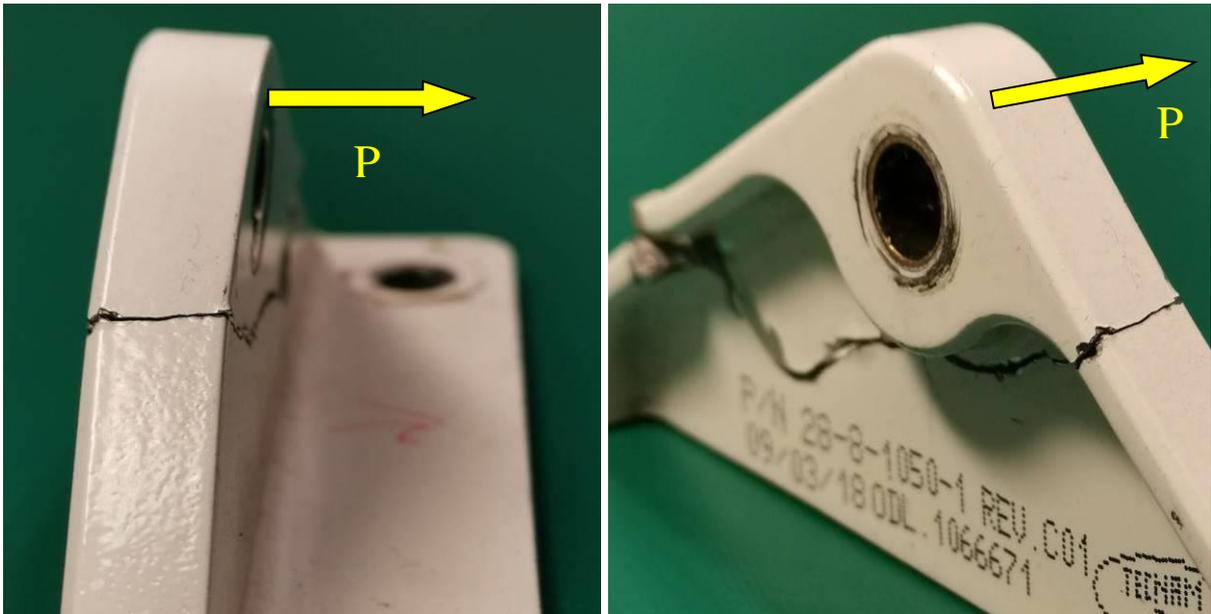
Metallurgical expert-examination proves that metal fatigue of the left-hand angle flange of the nose landing gear attachment formed gradually and the cycle when the fatigue fracture of the flange formed occurred during operation of the aircraft, therefore, flaking of enamel paint in the place where a crack was forming could have occurred and it could have potentially been noticed when surveying, during maintenance, the place where the fracture occurred (Figure 18).

Figure 18. View of the broken angle flange and the direction in which force P operated
