Transporta nelaimes gadījumu un incidentu izmeklēšanas birojs

## **FINAL REPORT 4-02/2-21(2-22)**

### **on accident, collision with ground shortly after take-off at the Cēsis airfield on August 8, 2021 with the amateur built aircraft ANBO-II (replica), registered LY-BDJ (Lithuania)**

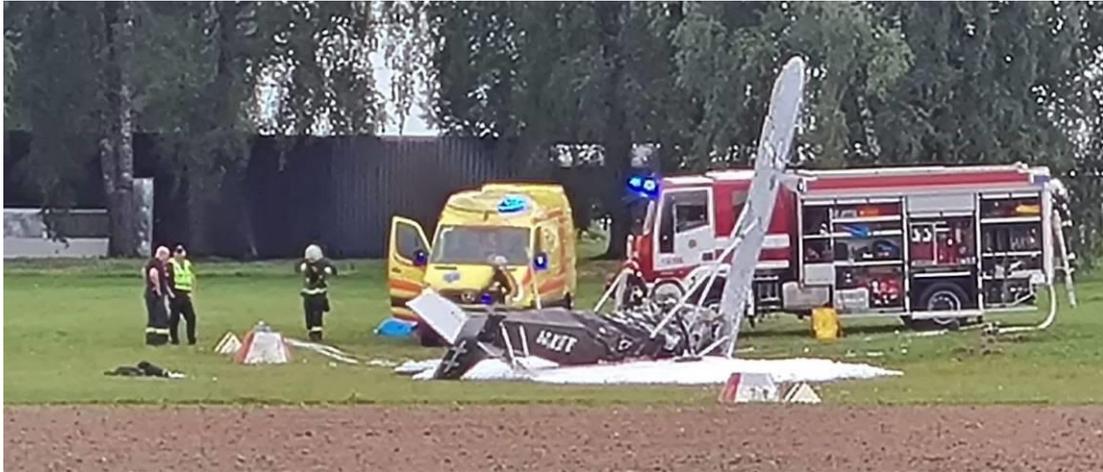
Picture 2: Accident site

The flight was performed during the day's visual meteorological conditions. After take-off from the airfield Cēsis the aircraft ANBO-II suffered engine malfunction due to unstable operation and reduced power. During the left turn the aircraft lost suddenly the altitude and collided with the ground surface (see picture 2).

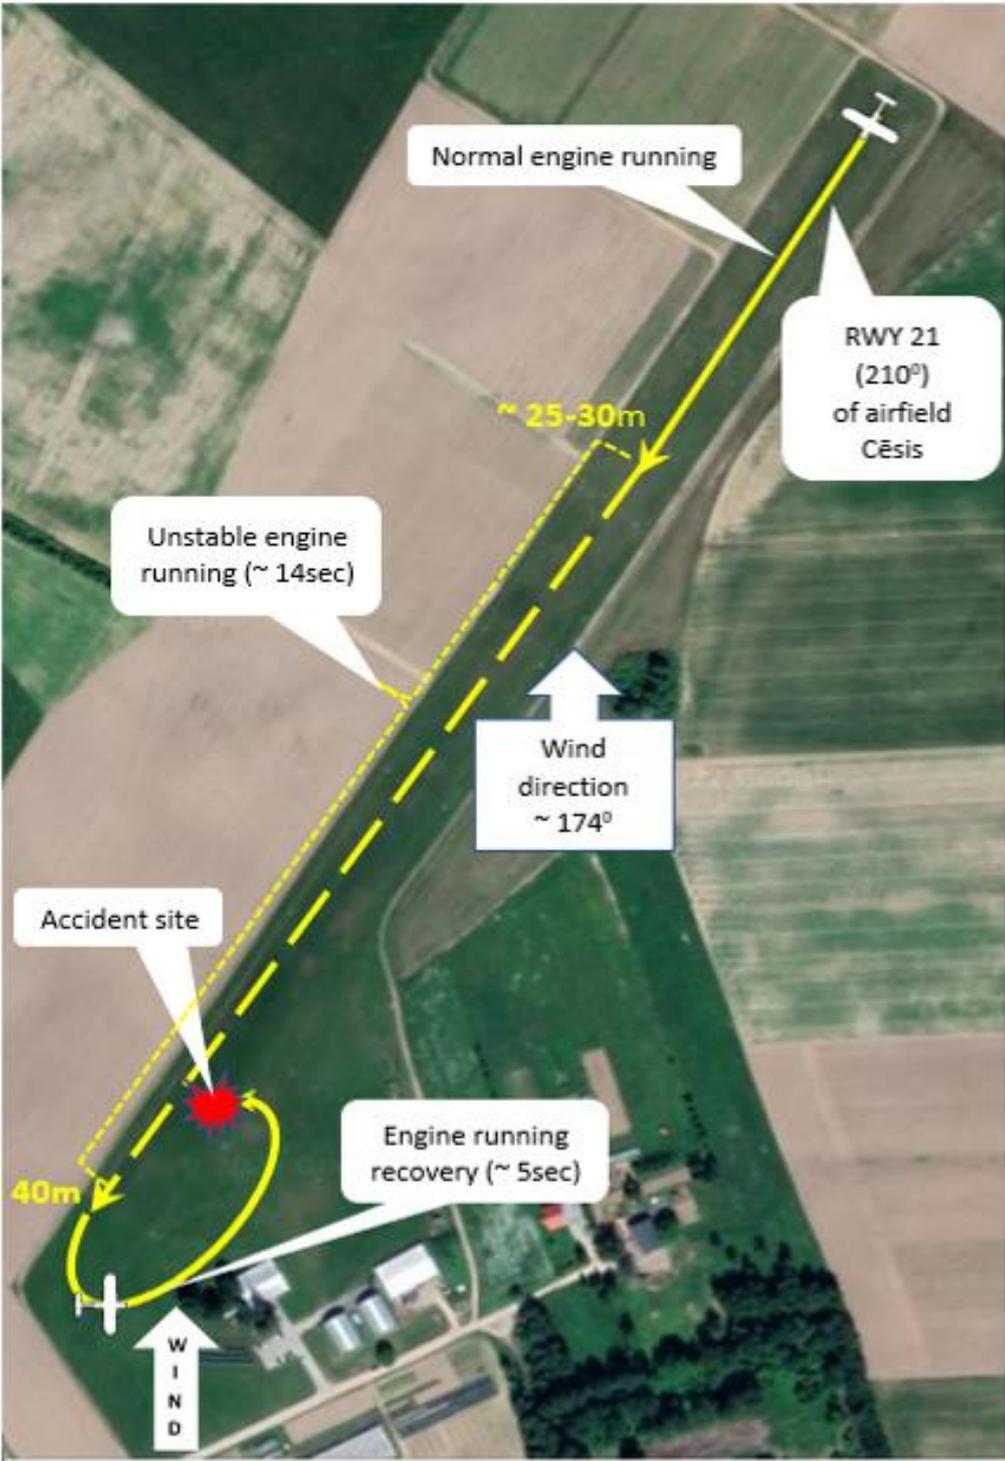
Picture 4: The flight trajectory of the aircraft

According to the video and the testimonials of the passenger, other pilots and witness who observed flying, the aircraft ANBO-II took off from RWY21. After 10 seconds of flight at approximately 25-30 meters above the airfield runway the engine's running became unstable but the aircraft continued climbing during 14 seconds while the aircraft speed was decreasing. When the aircraft was at altitude of about 40 meters, the pilot warned the passenger over the radio about turning left. According to the passenger's testimony, when the aircraft had turned to against the wind until 270 degrees, the pilot informed the passenger in a calm voice that he would give the

full engine power to eliminate the engine running interruptions; at that moment the aircraft speed was up to 80-90 km/h, according to the passenger.

The engine running of the aircraft has stabilized, the aircraft went into a left spin and collided with the ground at the high vertical speed within 5 seconds (see picture 4).

After turning on the full engine power the aircraft received a momentum due to a rapid increasing of the engine torque, as a result of that the aircraft entered a spin with a left sideslip, that was the most likely a primary cause of the aircraft accident.

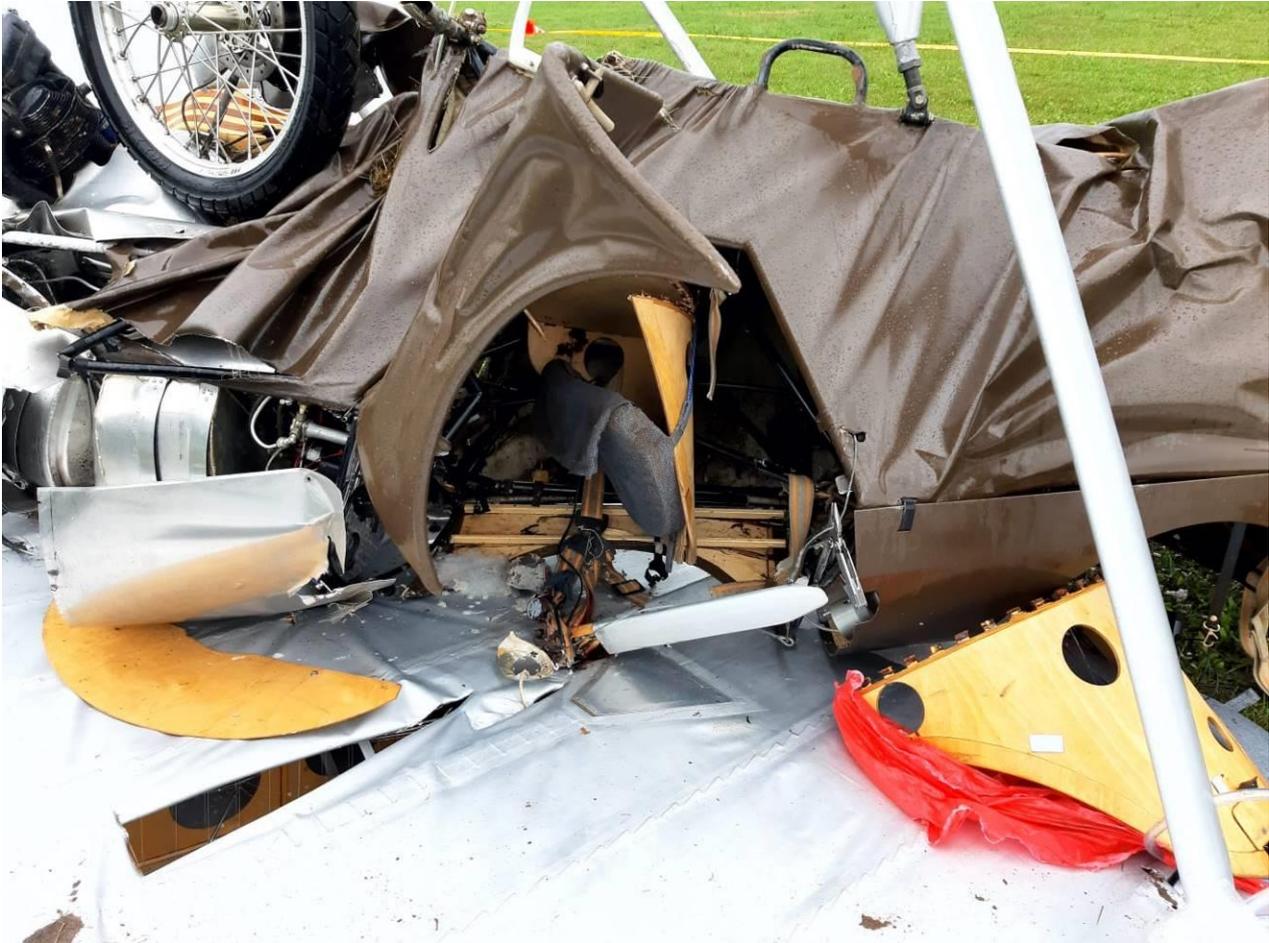
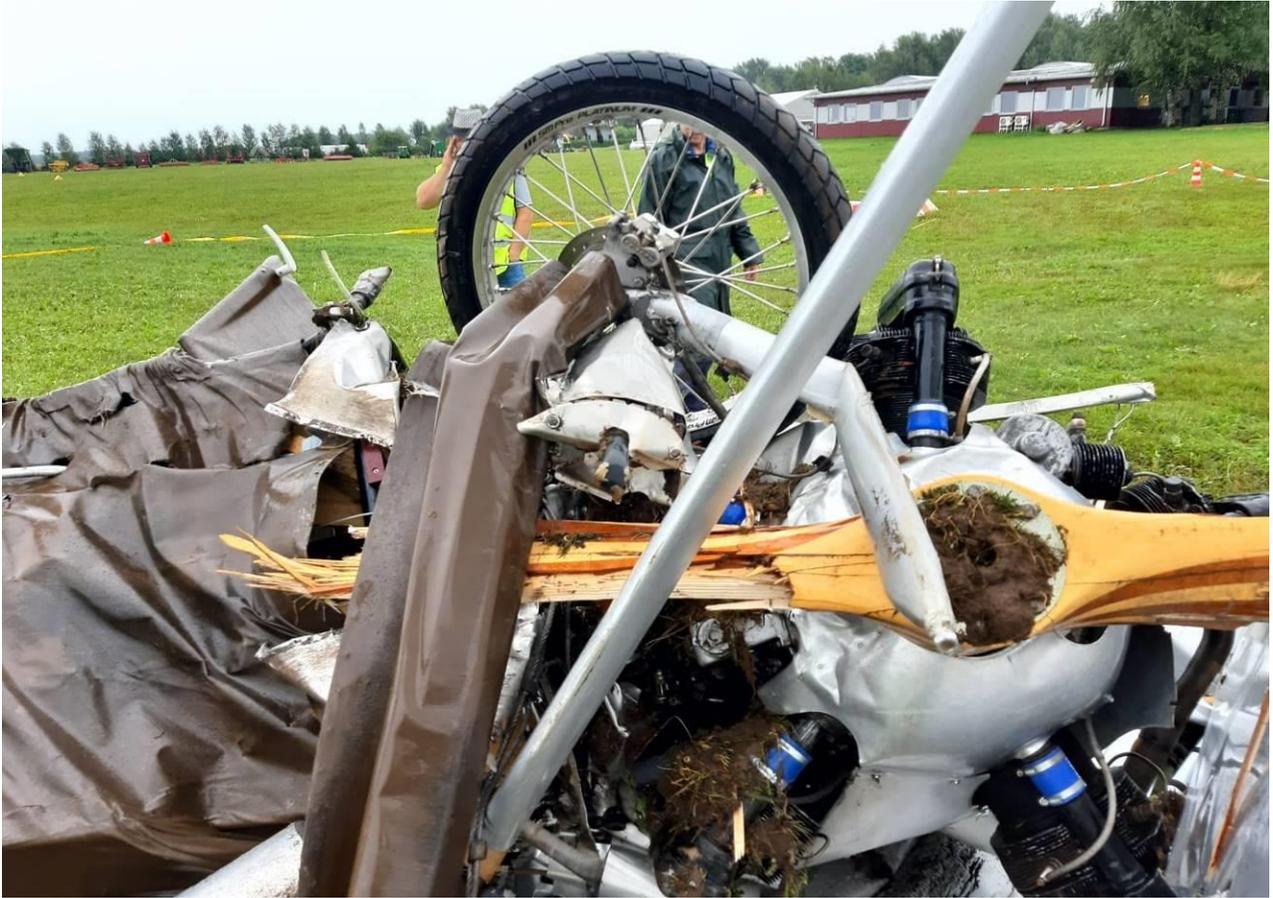
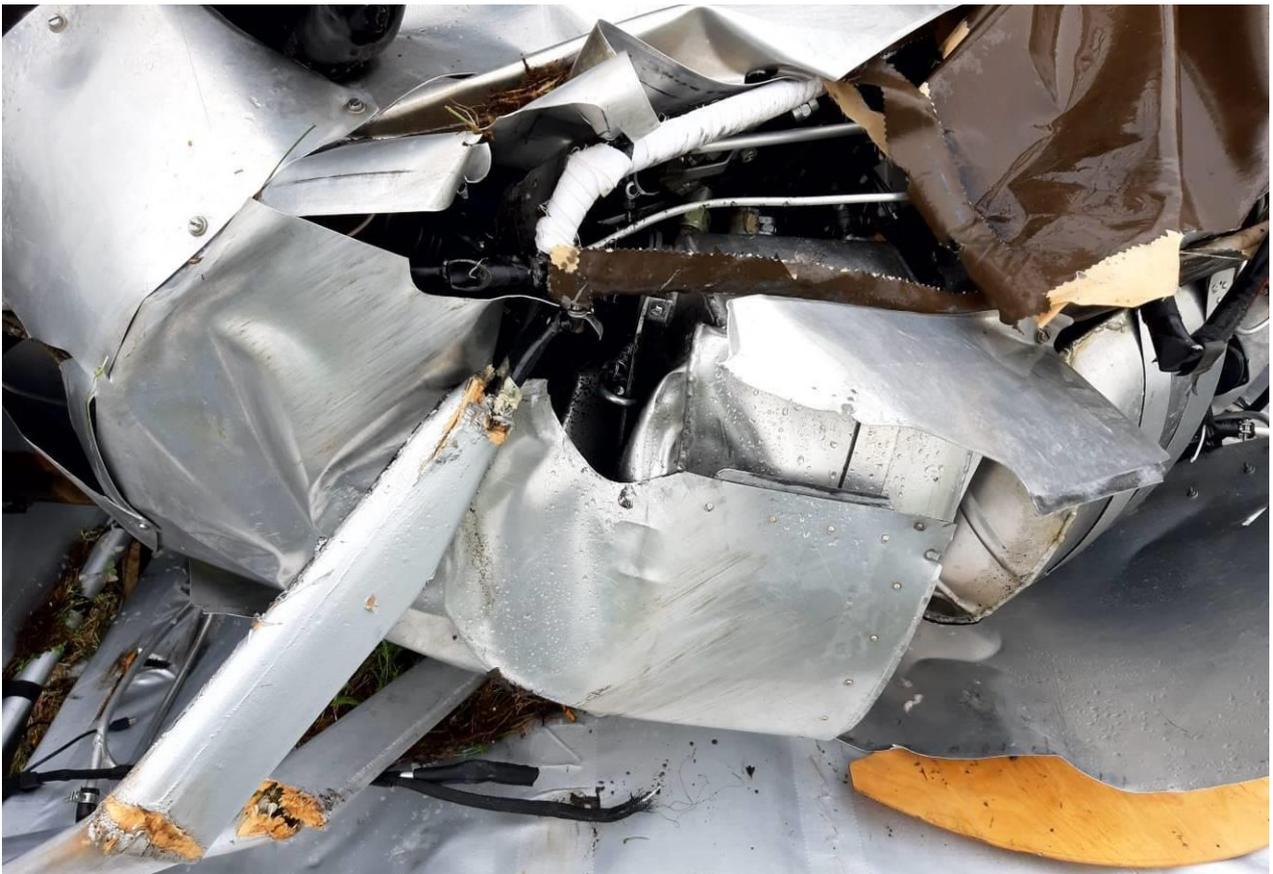
The inspection of the wreckage at the accident site revealed that the aircraft suffered substantial damage to the engine and the fuselage.

Picture 5: The wreckage of the aircraft at the accident site

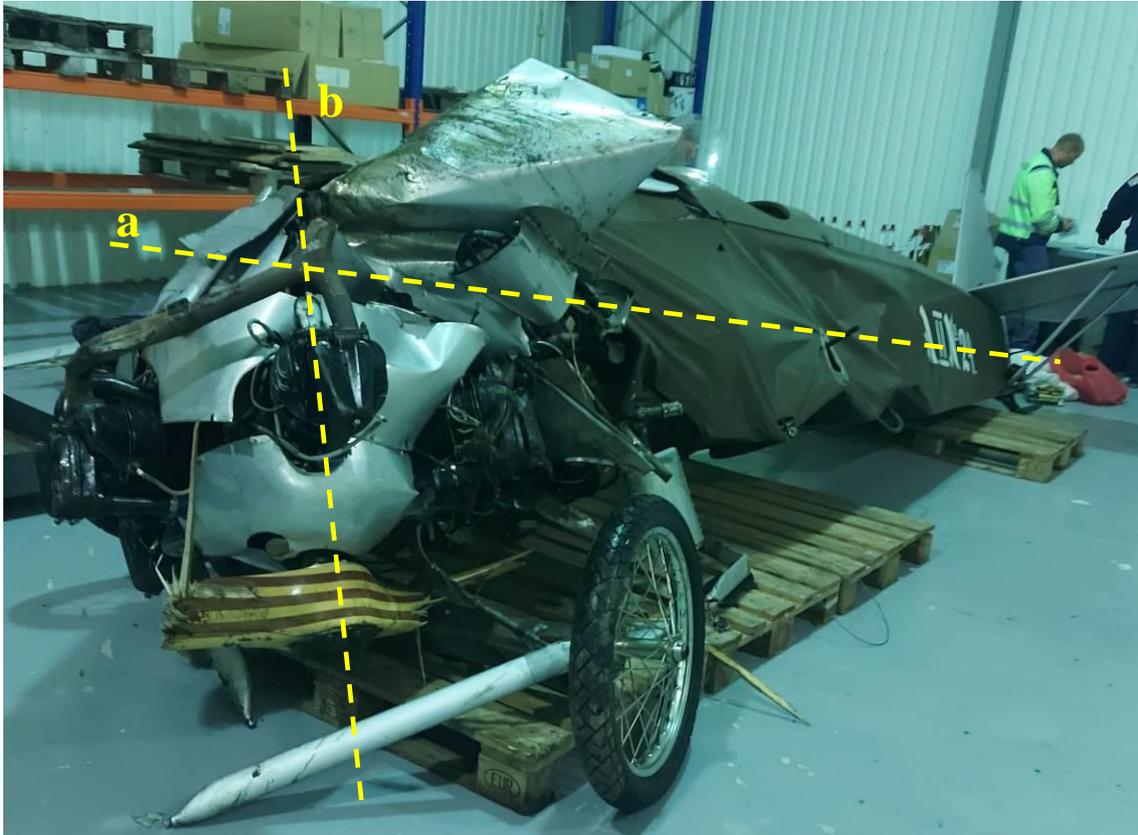
Picture 12: Frontside of the aircraft

The aircraft was transported from the accident site to the hangar of the TAIIB. The inspection of the aircraft revealed that the front part of the aircraft and the engine elements had sustained substantial damages: the landing gear was broken, the aircraft wings were deformed, the control elements were damaged. During the collision, the axis of the engine (see picture 12: **b**) shifted almost perpendicular to the axis of the aircraft (see picture 12: **a**).

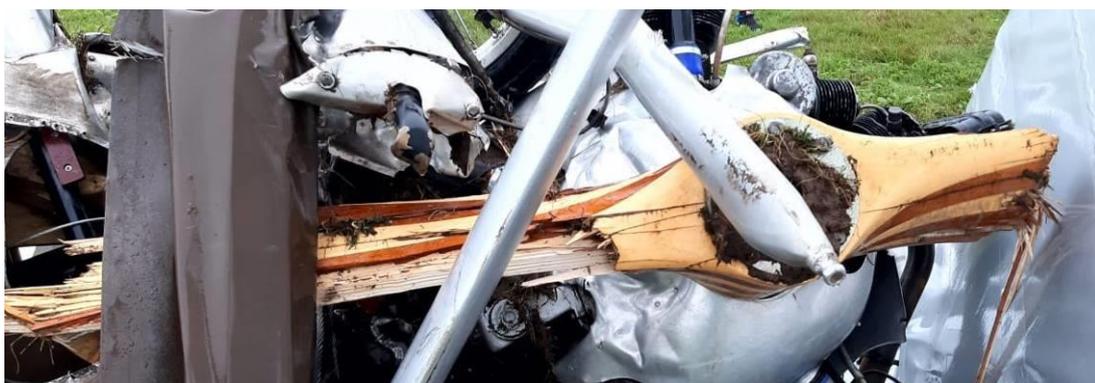
Picture 13: The aircraft propeller

The destructions of the propeller indicate that the engine was running at the time of the collision. (see picture 13).

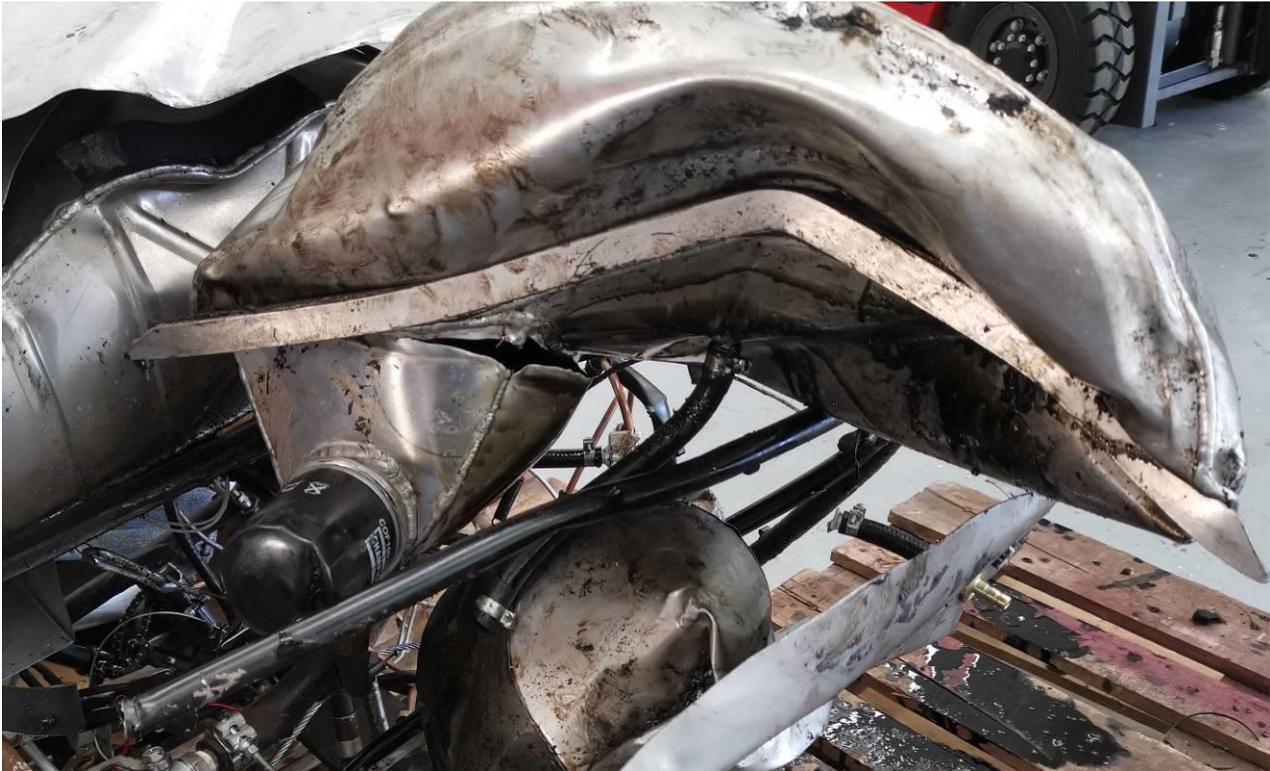
Picture 14: Damaged oil tank

The aircraft oil tank was damaged and had ruptured holes (see picture 14).

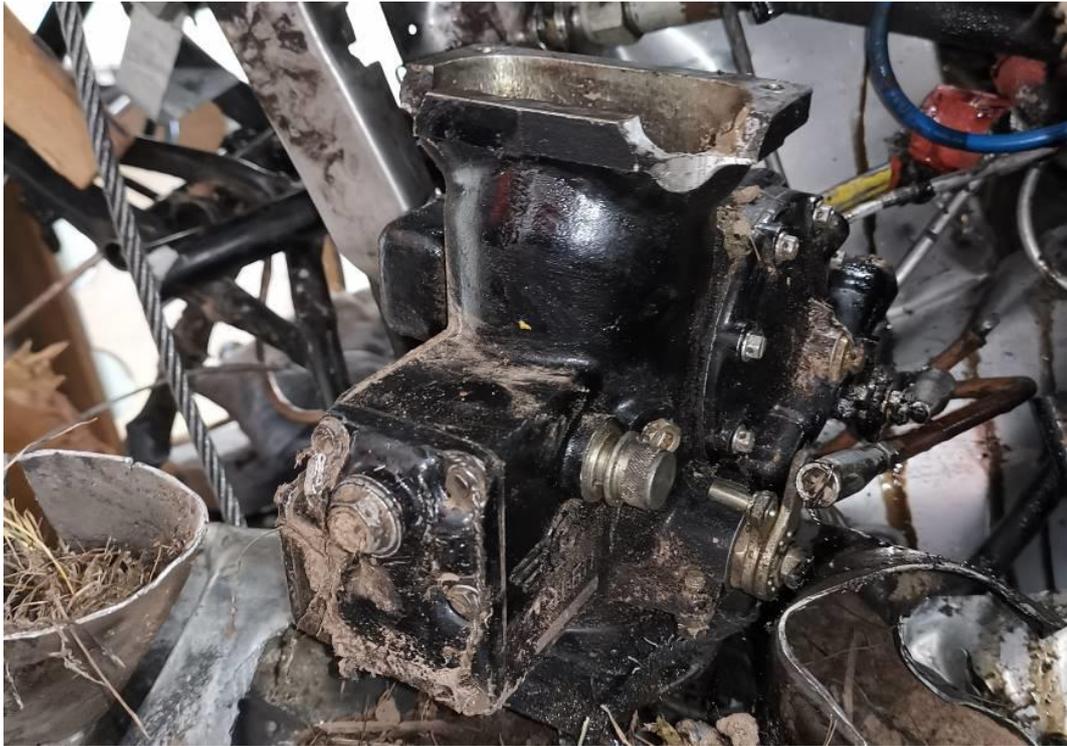
Picture 16: Dismounted carburettor

The carburettor housing was damaged in the collision (see picture 16).

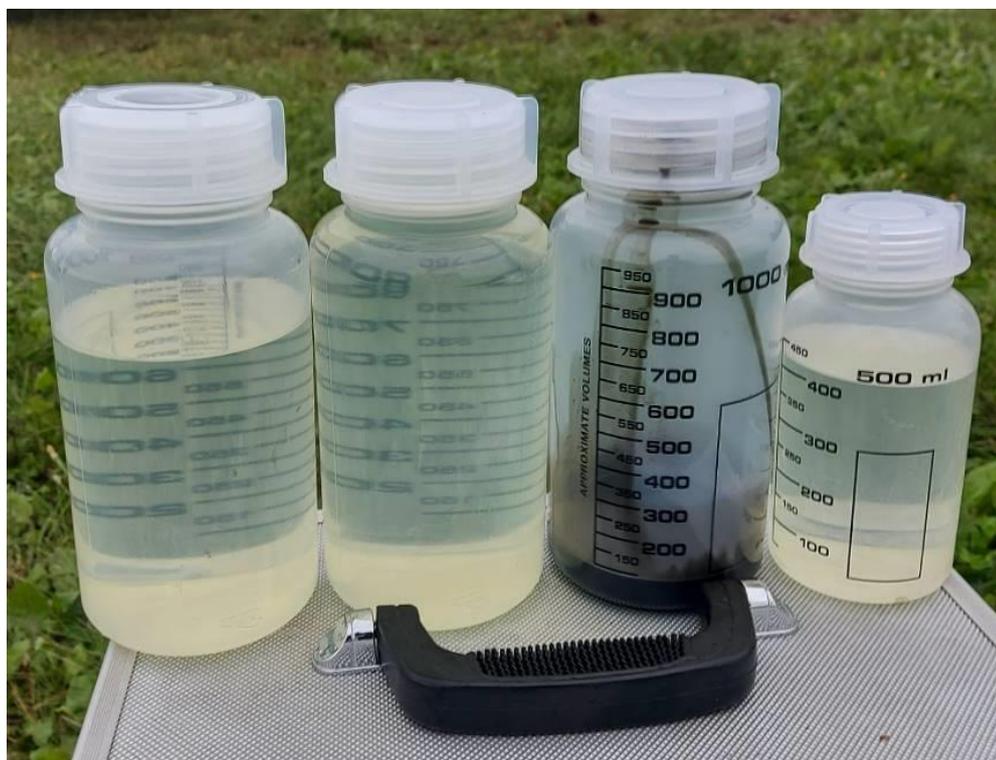
Picture 17: Samples of fuel

The required amount of the fuel has been taken from the aircraft fuel tank at the accident site for expertise and tested in the authorized laboratory "LATCERT" (Latvian Certification Center) (see picture 17).

The aircraft fuel test was carried out at the laboratory in accordance with the standards "LVS EN ISO 3405:2019" and "LVS EN ISO 12937:2002" on August 12, 2021. In the test report No. 92528, the LATCERT laboratory confirmed the compliance of the fuel parameters in the fuel samples with the standards.

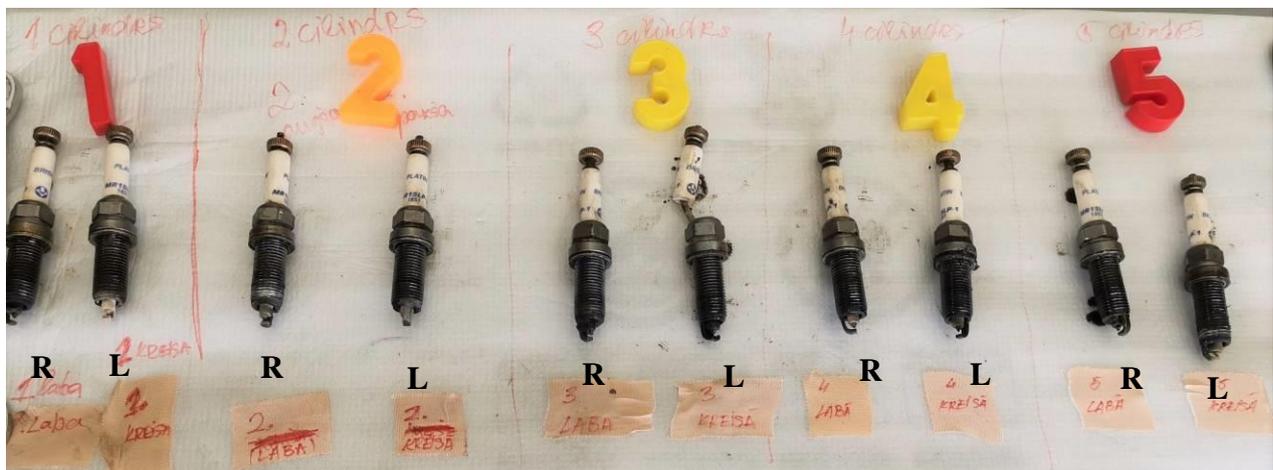
Picture 19: Ten spark plugs from the engine M-11FR

The engine spark plugs were unscrewed from the cylinder's heads and inspected (see picture 19).

The spark plugs of each cylinder were visually inspected: the metal housing, ceramic insulators, electrodes and contact rods. The spark plug ceramic isolation was without cracks, the central electrodes were brown colour, with the exception of the 3<sup>rd</sup> cylinder where both spark plug electrodes were covered with black oily soot (see picture 20) and the 5<sup>th</sup> cylinder where the right spark plug was wet with engine oil (see picture 21). The distance between the spark plug electrodes and contact rods were within acceptable limits.

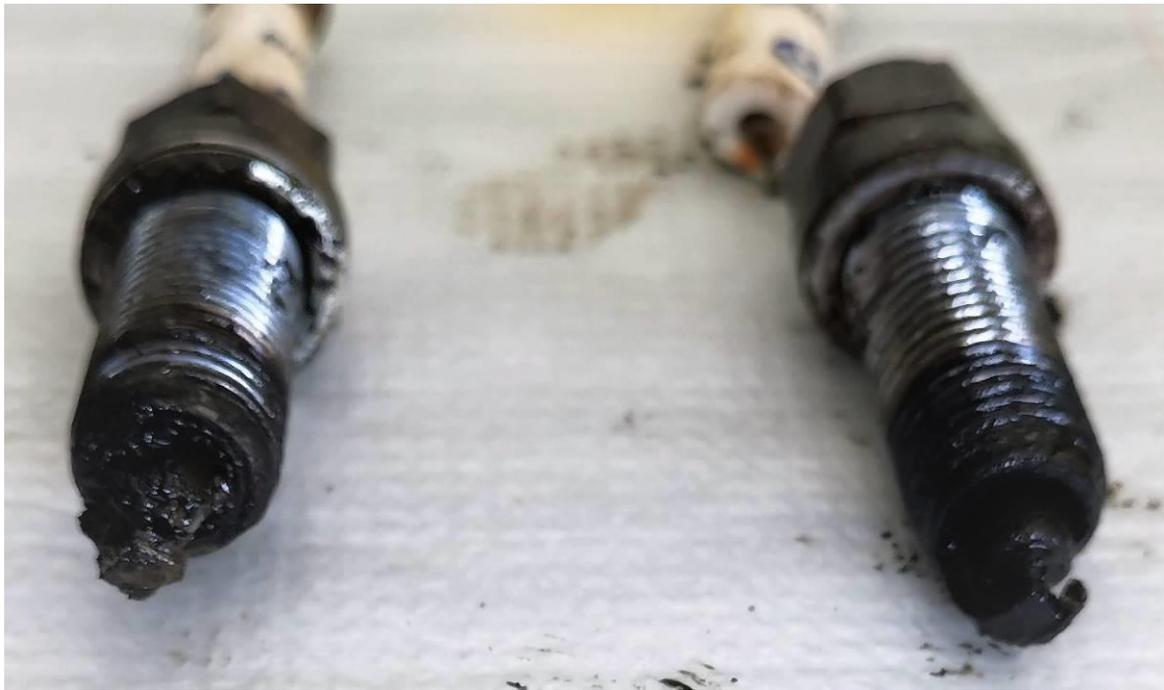
Picture 20: Spark plugs from cylinder No 3

The fact that the 3rd cylinder spark plugs were covered with black oily soot and the 5th cylinder right spark plug was wet with oil lets to suppose that the spark plugs probably did not work during the aircraft take-off. Based on the results of a visual inspection of the spark plugs, it can be assumed that the 3rd and 5th cylinders of the engine could be a contributing cause of the unstable engine running.

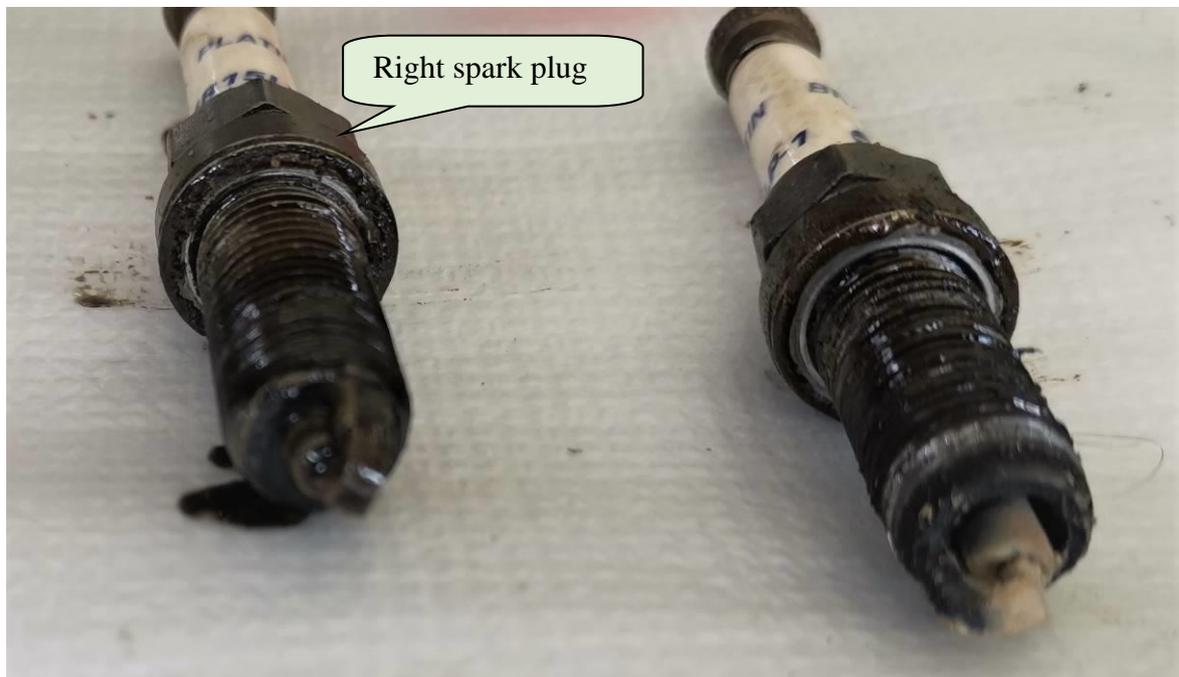
Picture 21: Spark plugs from cylinder No 5

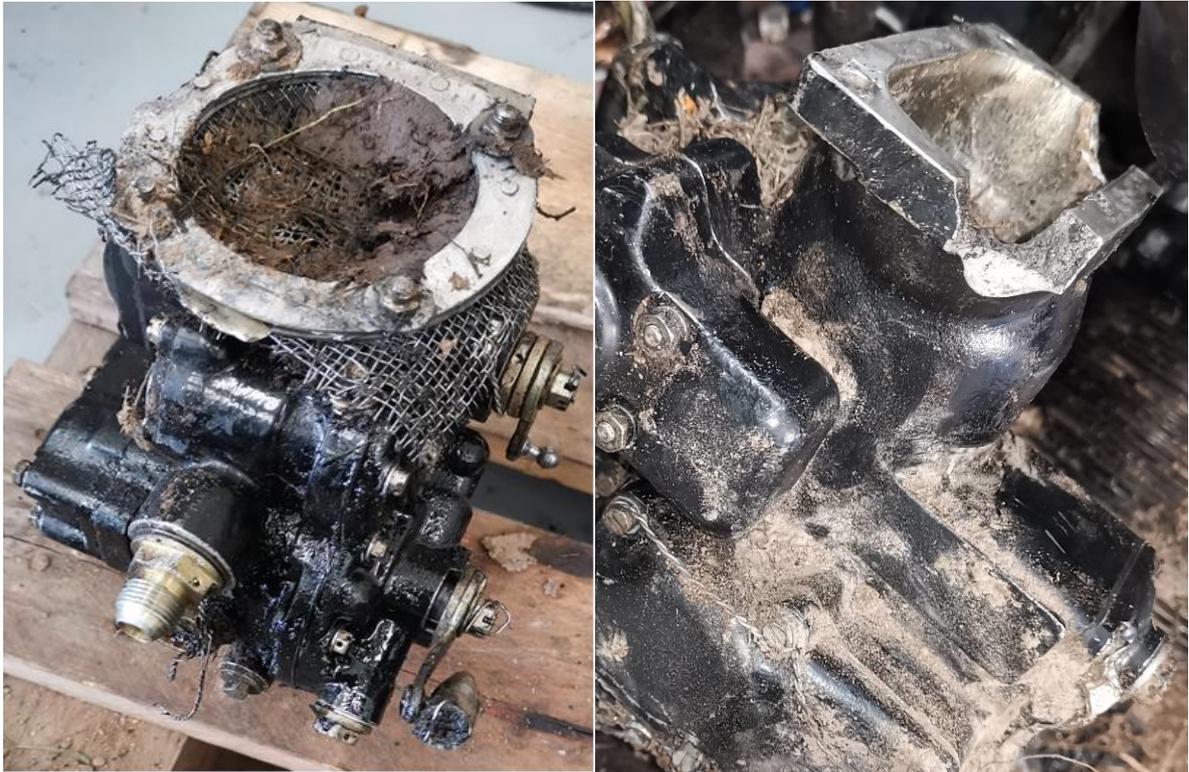
Picture 22: The engine carburettor

After the visual carburettor inspection, the following damages were detected:

- the carburettor body was mechanically broken;
- the metal mesh of the air inlet to the carburettor was damaged (see picture 22).

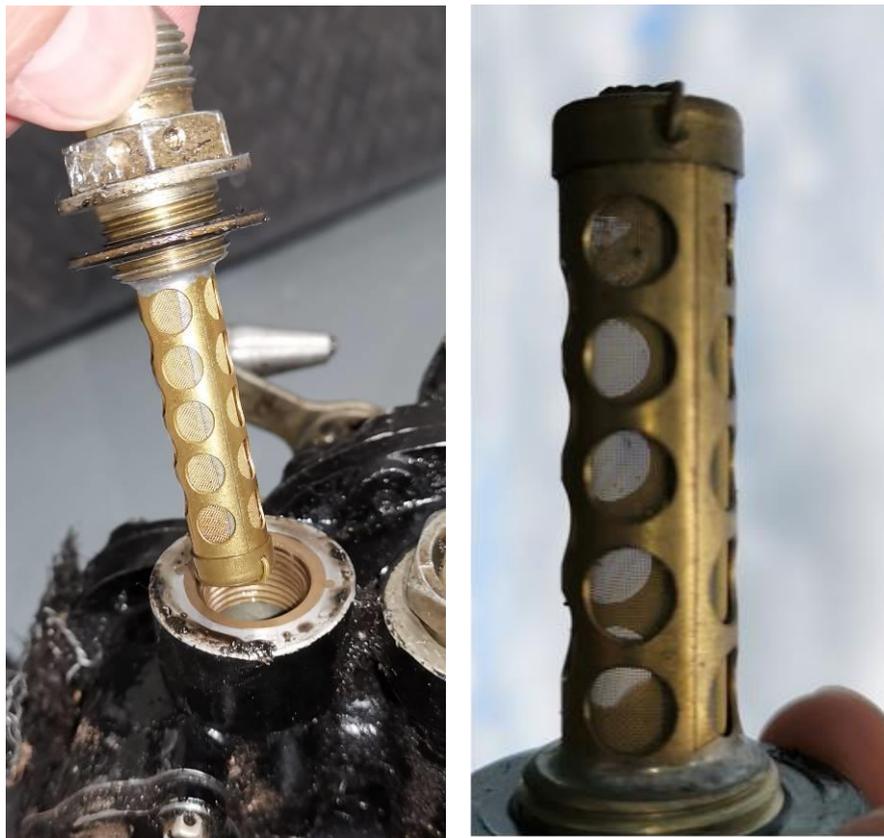
Picture 23: Fuel filter

The fuel filter was unscrewed from carburettor housing and inspected visually. The brass mesh of the fuel filter was without visible damage and had minor impurity particles (see picture 23).

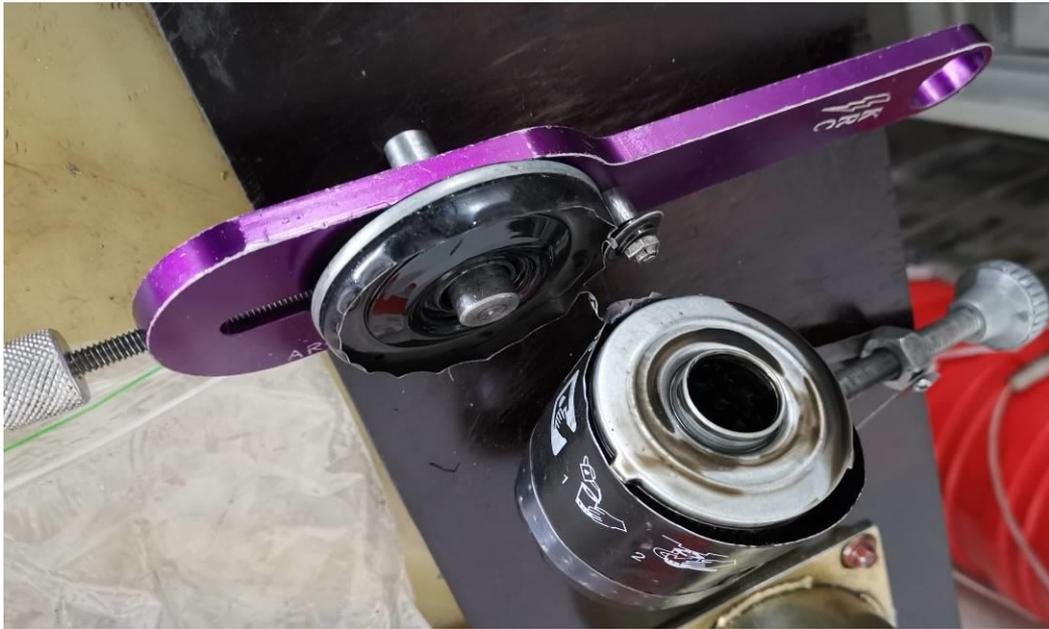
Picture 24: Opened oil filter housing

Due to the engine oil tank damages in the accident the oil had been leaked out at the accident site, as a result the remaining amount of oil was insufficient for examination, therefore the oil filter was opened and checked (see picture 24).

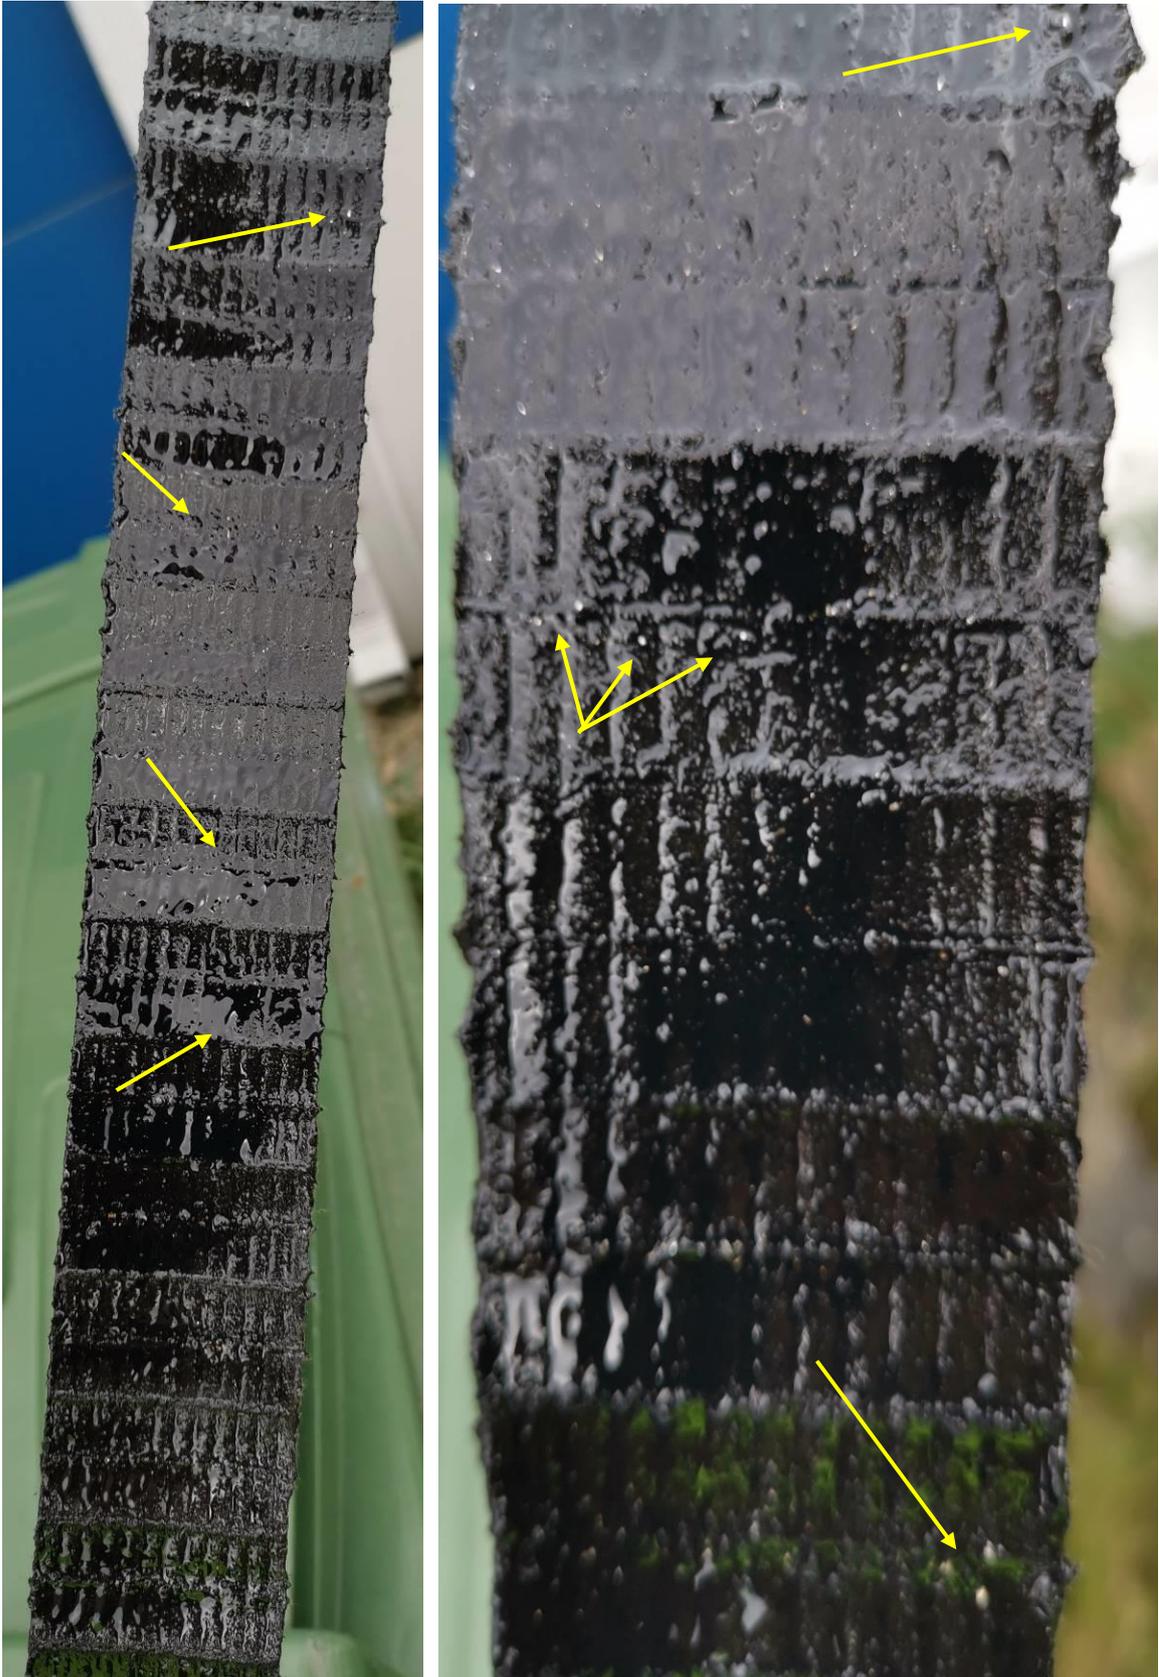
Picture 25: The oil filter element

The oil filter element was visually inspected. Not significant metal debris on the filter element were found (see picture 25).
