**FINAL REPORT No.4-02/6-14(5A-2015)  
OF THE AIRCRAFT SERIOUS INCIDENT  
LOSS OF SEPARATION BETWEEN THE AIRCRAFT Boeing B735, flight BTI97H and  
Piper 34L registration YL-GBS on OCTOBER 11, 2014**

# FINAL REPORT No.4-02/6-14(5A-2015)

LOSS OF SEPARATION BETWEEN THE AIRCRAFT Boeing B735, flight BTI97H and PA34A/L, registration YL-GBS, ON October 11, 2014

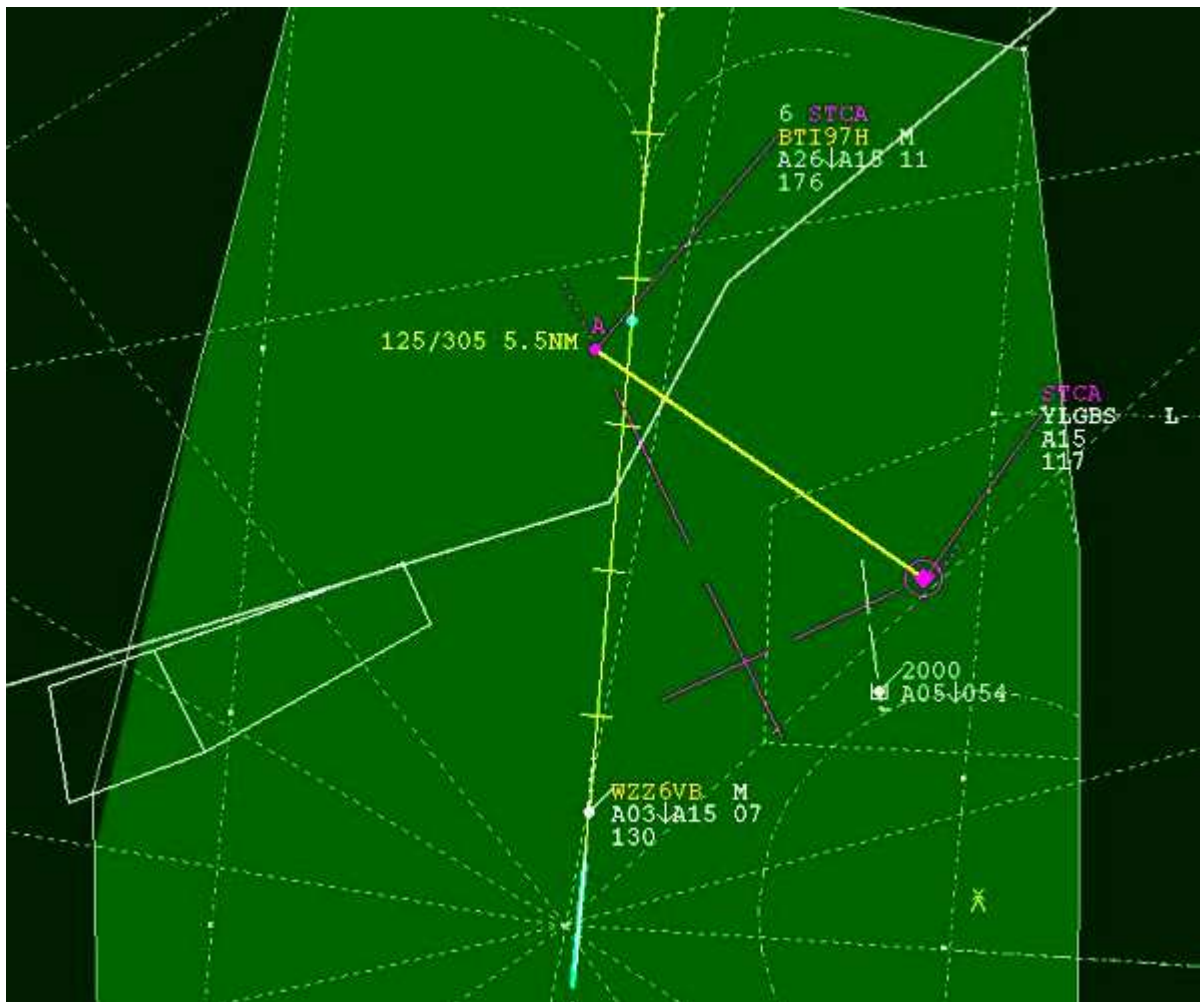
At **13:15:55 BTI-97H** with squawk 6645 descended to altitude **1500** feet and was crossing **2600** feet, with ground speed **176** knots on true track **154** degrees.

**YLGBS** with squawk 1615 was at altitude 1500 feet with ground speed 117 knots on true track 245 degrees.

**Separation between traffic was 5.5NM, STCA signal about potential conflict was on.**

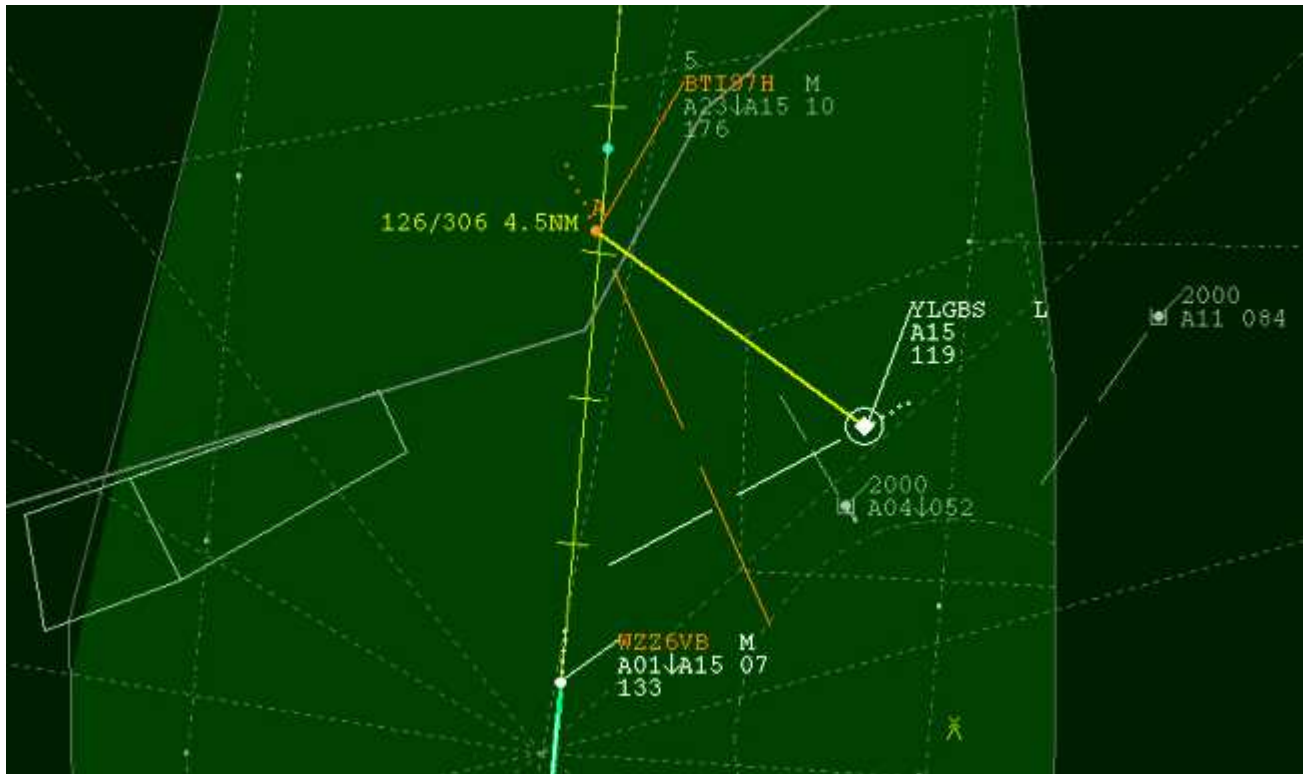
**BTI-97H** descended to altitude 1500 feet was crossing 2300 feet with ground speed 176 knots on true track 156 degrees.

**YLGBS** was at altitude 1500 feet with ground speed 119knots on true track 242 degrees.

**Separation between traffic was 4.5NM.**

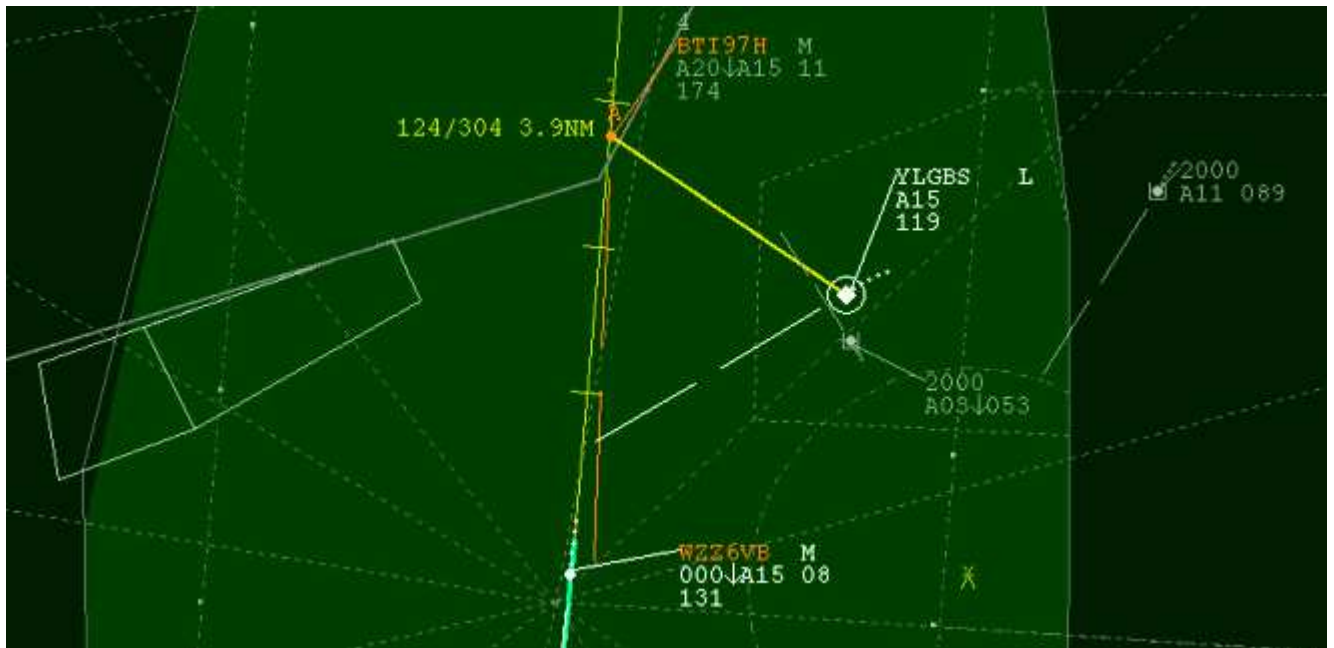
**BTI-97H** descended to altitude 1500 feet was crossing 2000 feet with ground speed 174 knots on true track 182 degrees.

**YLGBS** was at altitude 1500 feet with ground speed 119knots on true track 240 degrees.

**Separation between traffic was 3.9NM.**

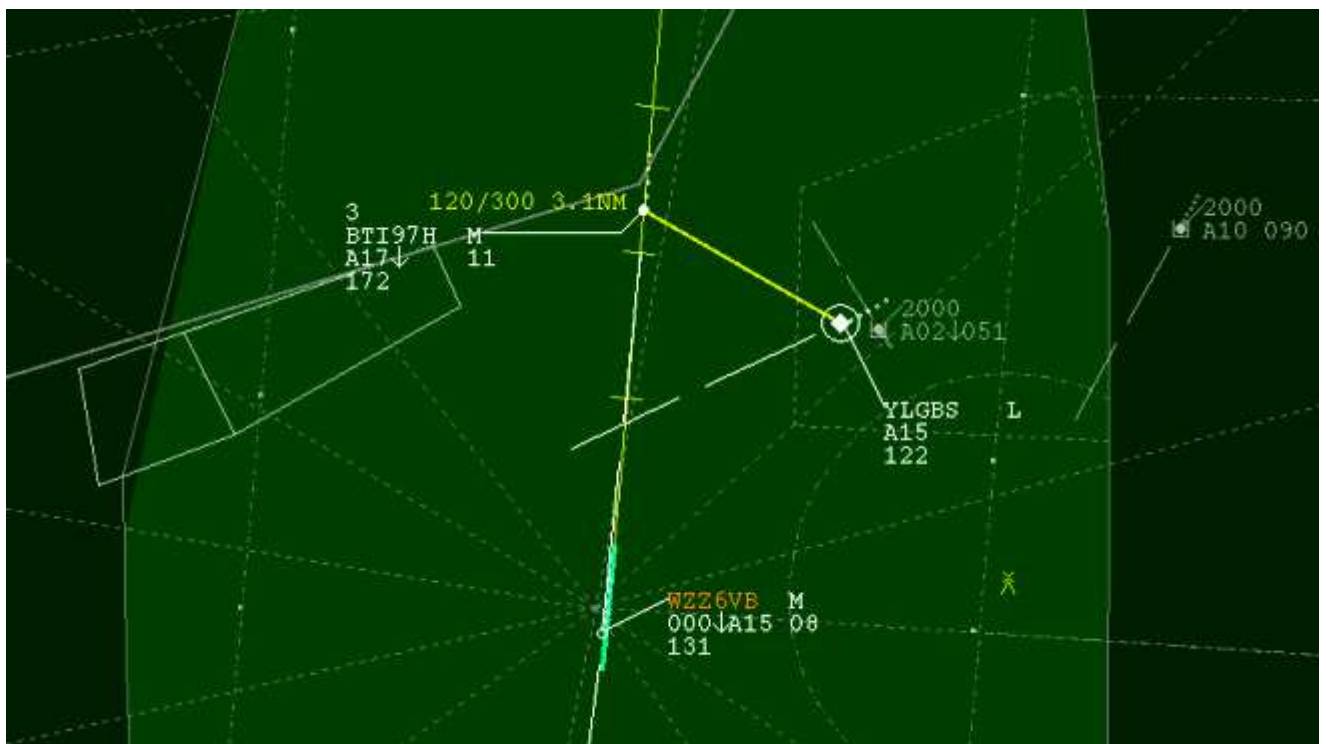
At 13:16:47 YL-GBS started to turn right. Distance between aircraft continued to reduce.

**BTI-97H** descended on final to RWY 18 was crossing 1700 feet with ground speed 172 knots on true track 186 degrees.

**YLGBS** was at altitude 1500 feet with ground speed 122knots on true track 245 degrees.

**Separation between traffic was 3.1NM and aircraft tracks was crossing at the same altitude.**

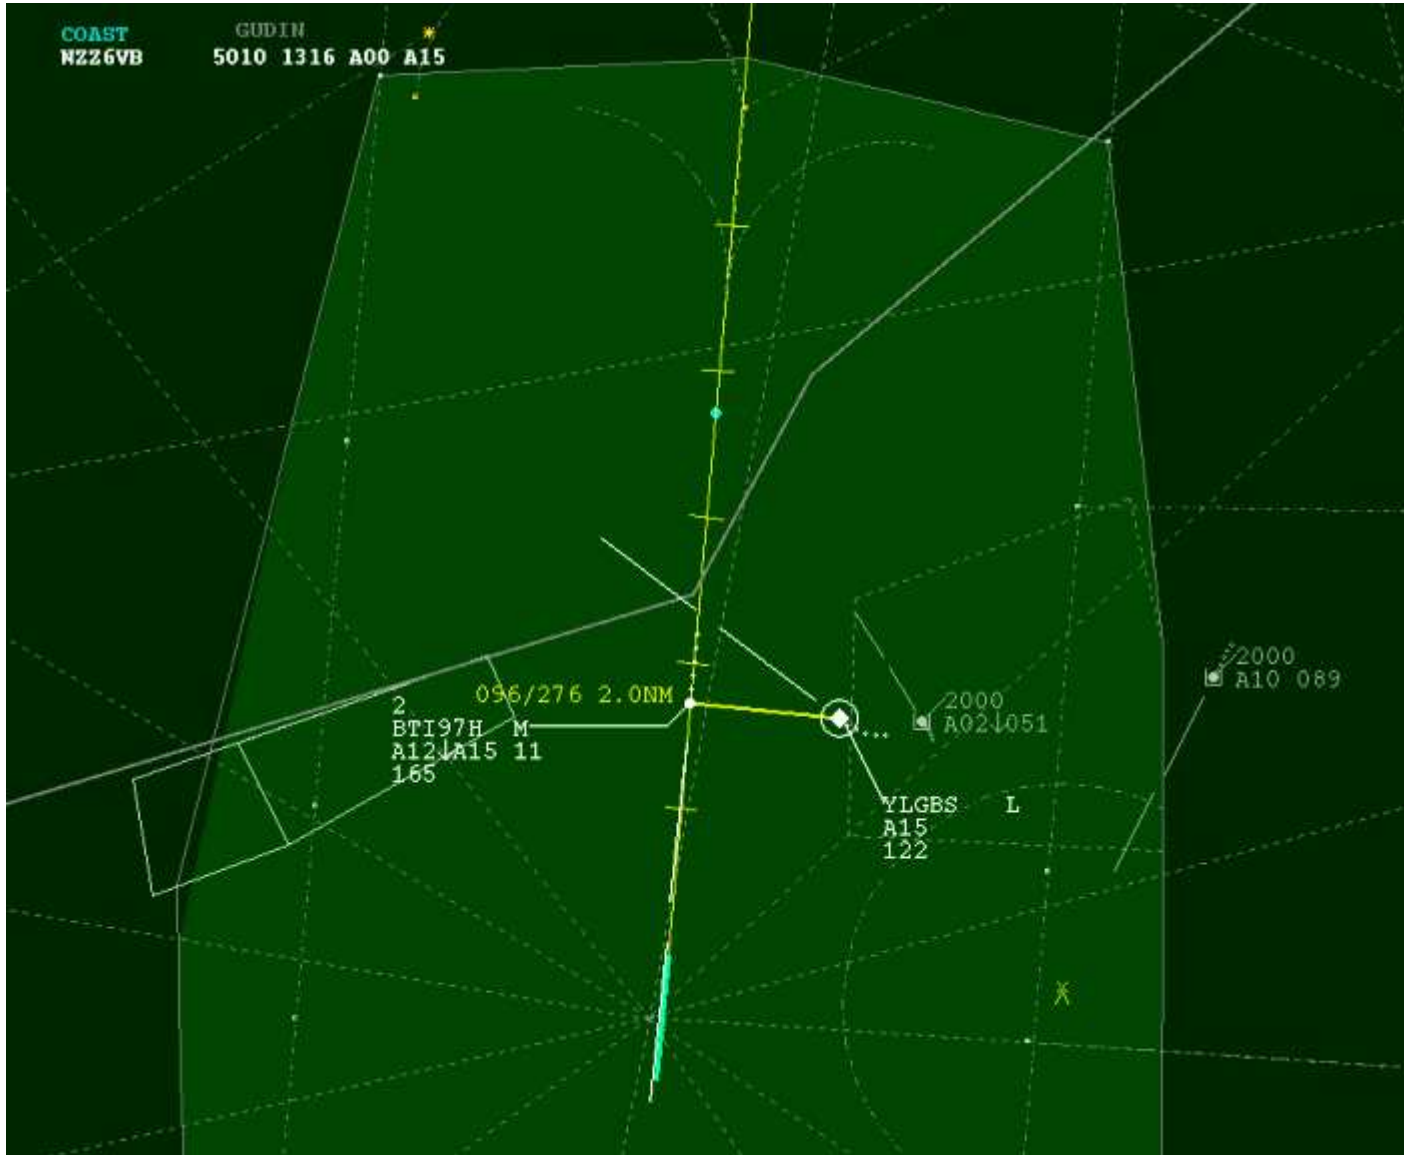
At 13:17:11 **BTI-97H** descended on final to RWY 18 was crossing **1200** feet with ground speed 165 knots on true track 186 degrees.

**YLGBS** was at altitude **1500** feet with ground speed 122 knots on true track 245 degrees.

**Separation between traffic was 2 NM, vertical separation was 300Ft**

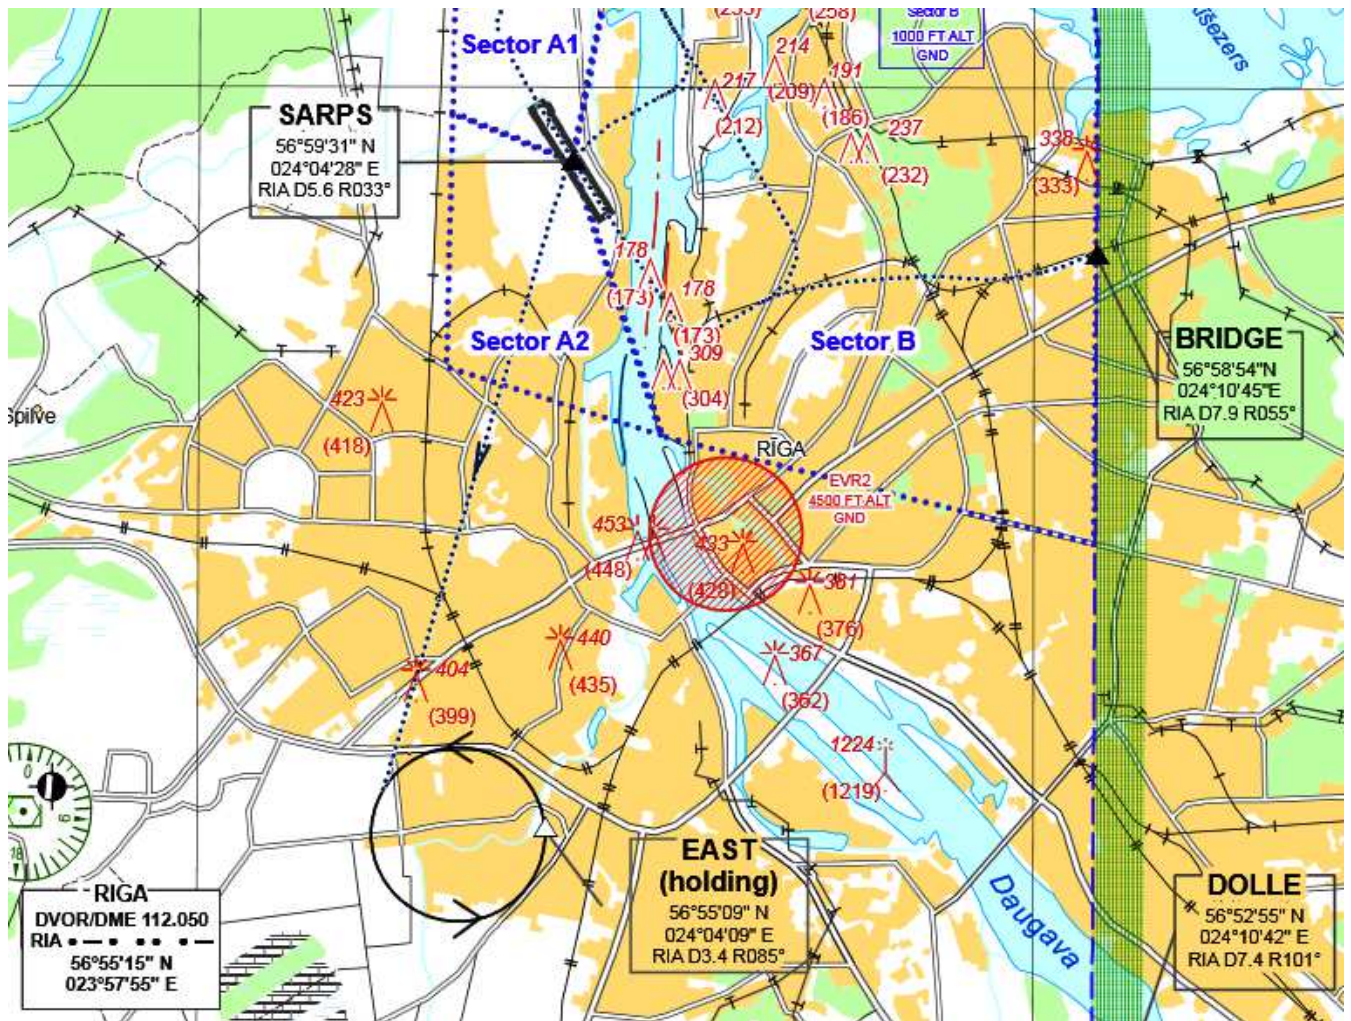
SPILVE (EVRS) ARRIVAL AND DEPARTURE ROUTE CHART

According to radar data when aircraft YL-GBS executed his turn to the north, aircraft was proceeding opposite direction of arriving final aircraft BTI97H and lateral distance between final RWY 18 and aircraft YLGBS was **1.4 NM** at altitude 1500ft.

There was not provided established separation standards by ATC between VFR aircraft in CTR class C and was not provided arriving IFR aircraft with appropriate lateral and vertical separation from light crossing aircraft that entered from uncontrolled airfield Spilve (EVRS) via SARPS.
