Transporta nelaimes gadījumu un incidentu izmeklēšanas birojs

FINAL REPORT No. 4-02/2-17(3-2018)

AVIATION ACCIDENT WITH HELICOPTER R44, REGISTRATION NO. YL-HBH, ON OCTOBER 8, 2017, IN PRIEKULE MUNICIPALITY, GRAMZDA RURAL TERRITORY, IN LOCALITY OF GRAMZDA PIT

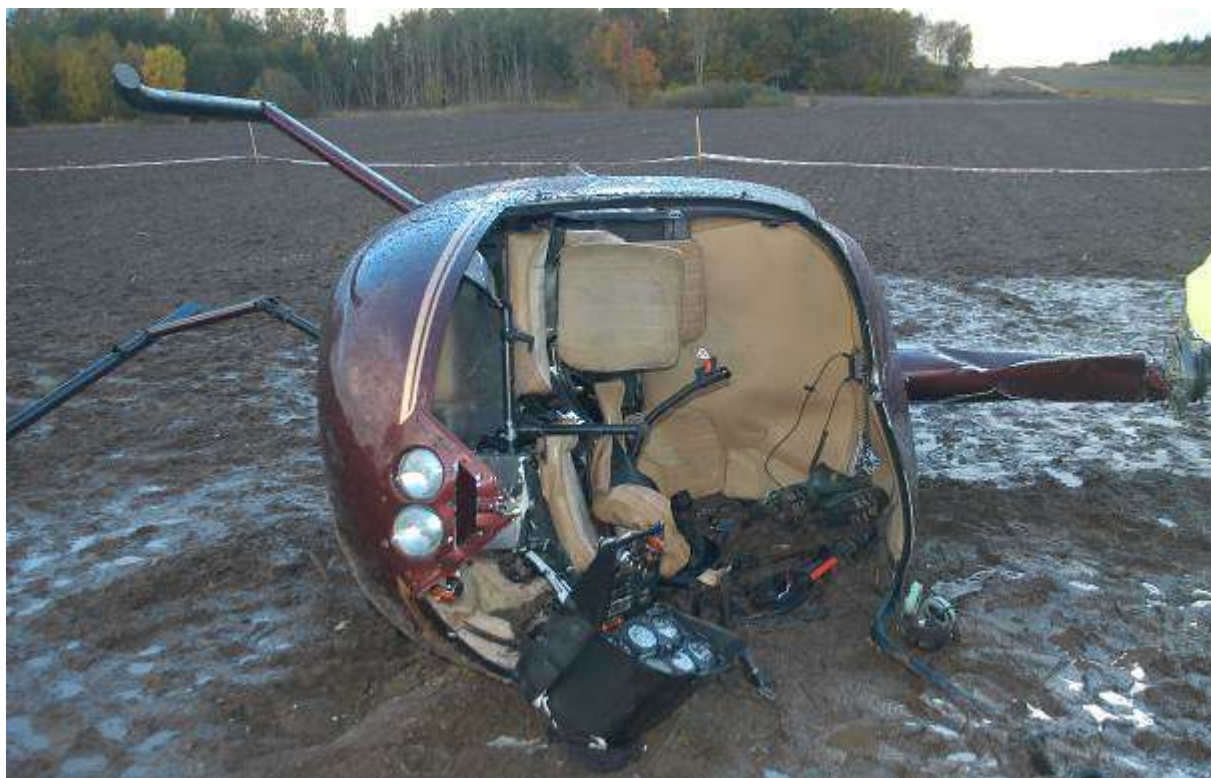
Picture 1. Helicopter R44 at the accident site (frontal look)

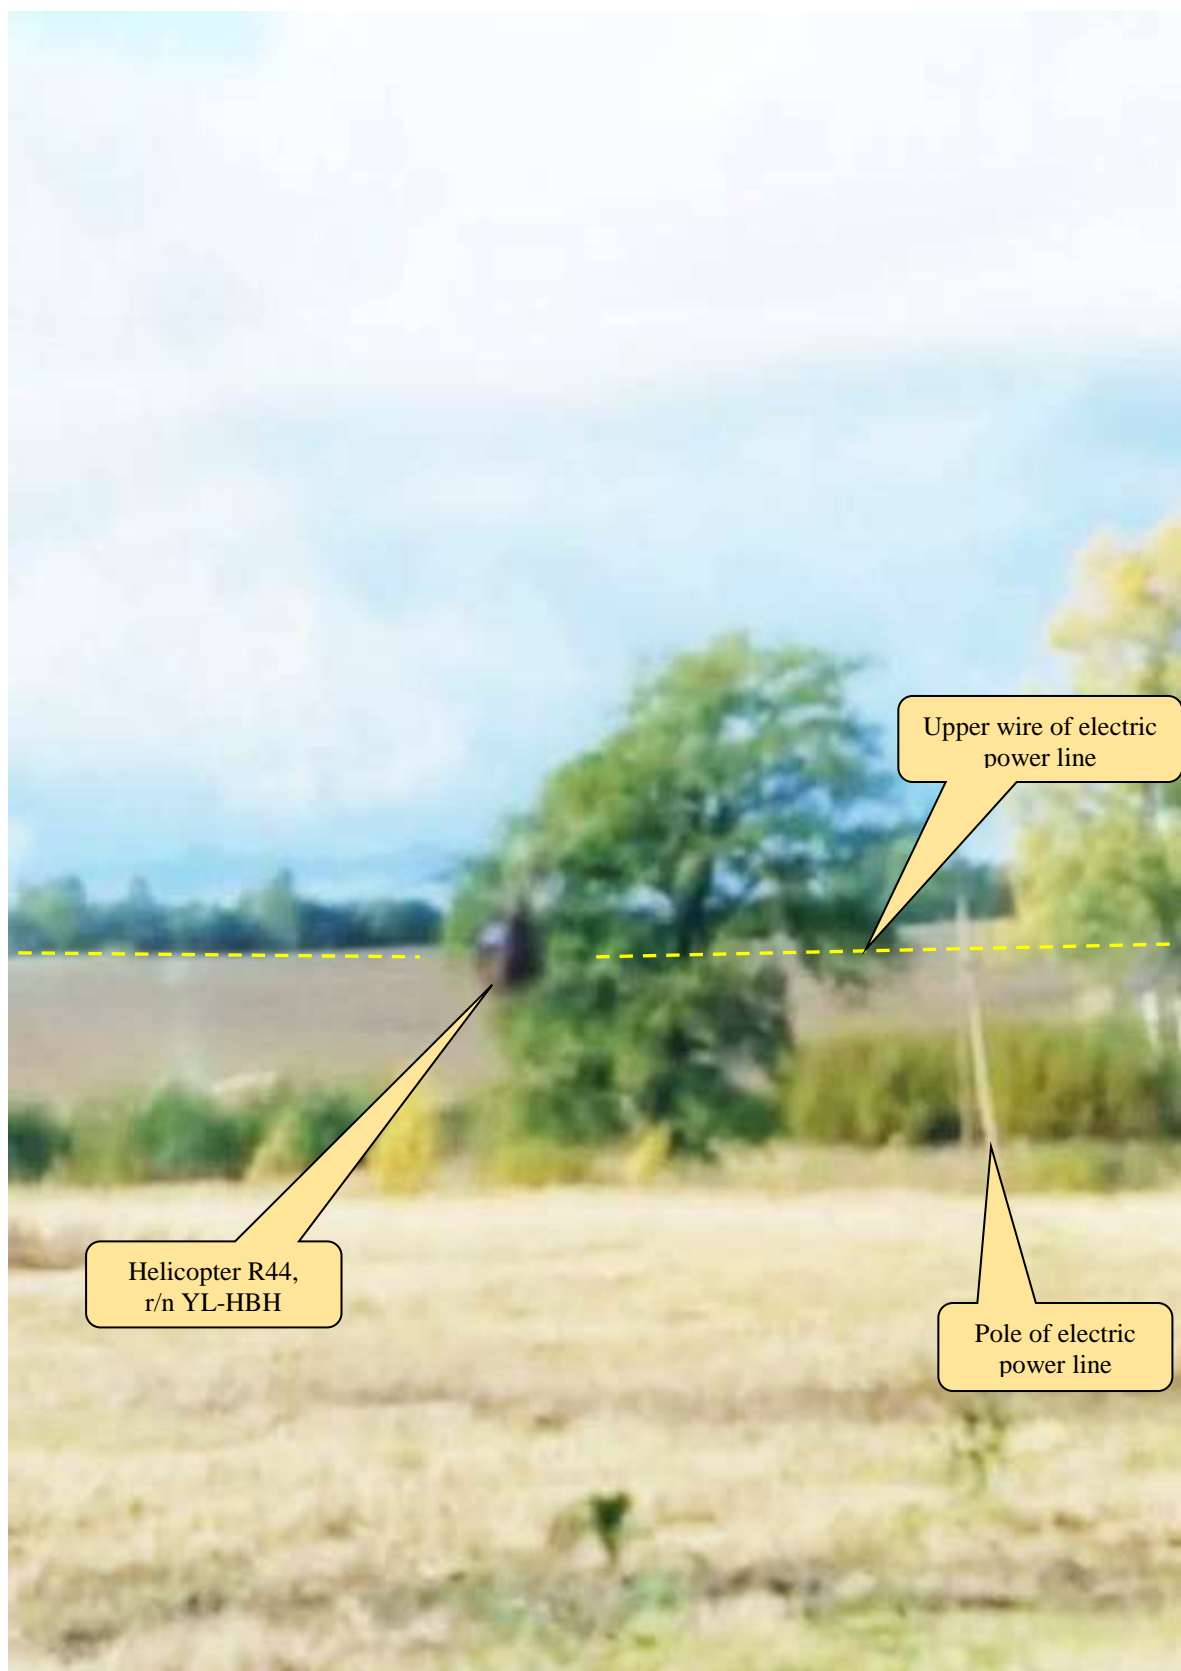
Picture 4.

- Approaching of helicopter to the electric power line, flight under the wires of electric power line (Pic. 4);

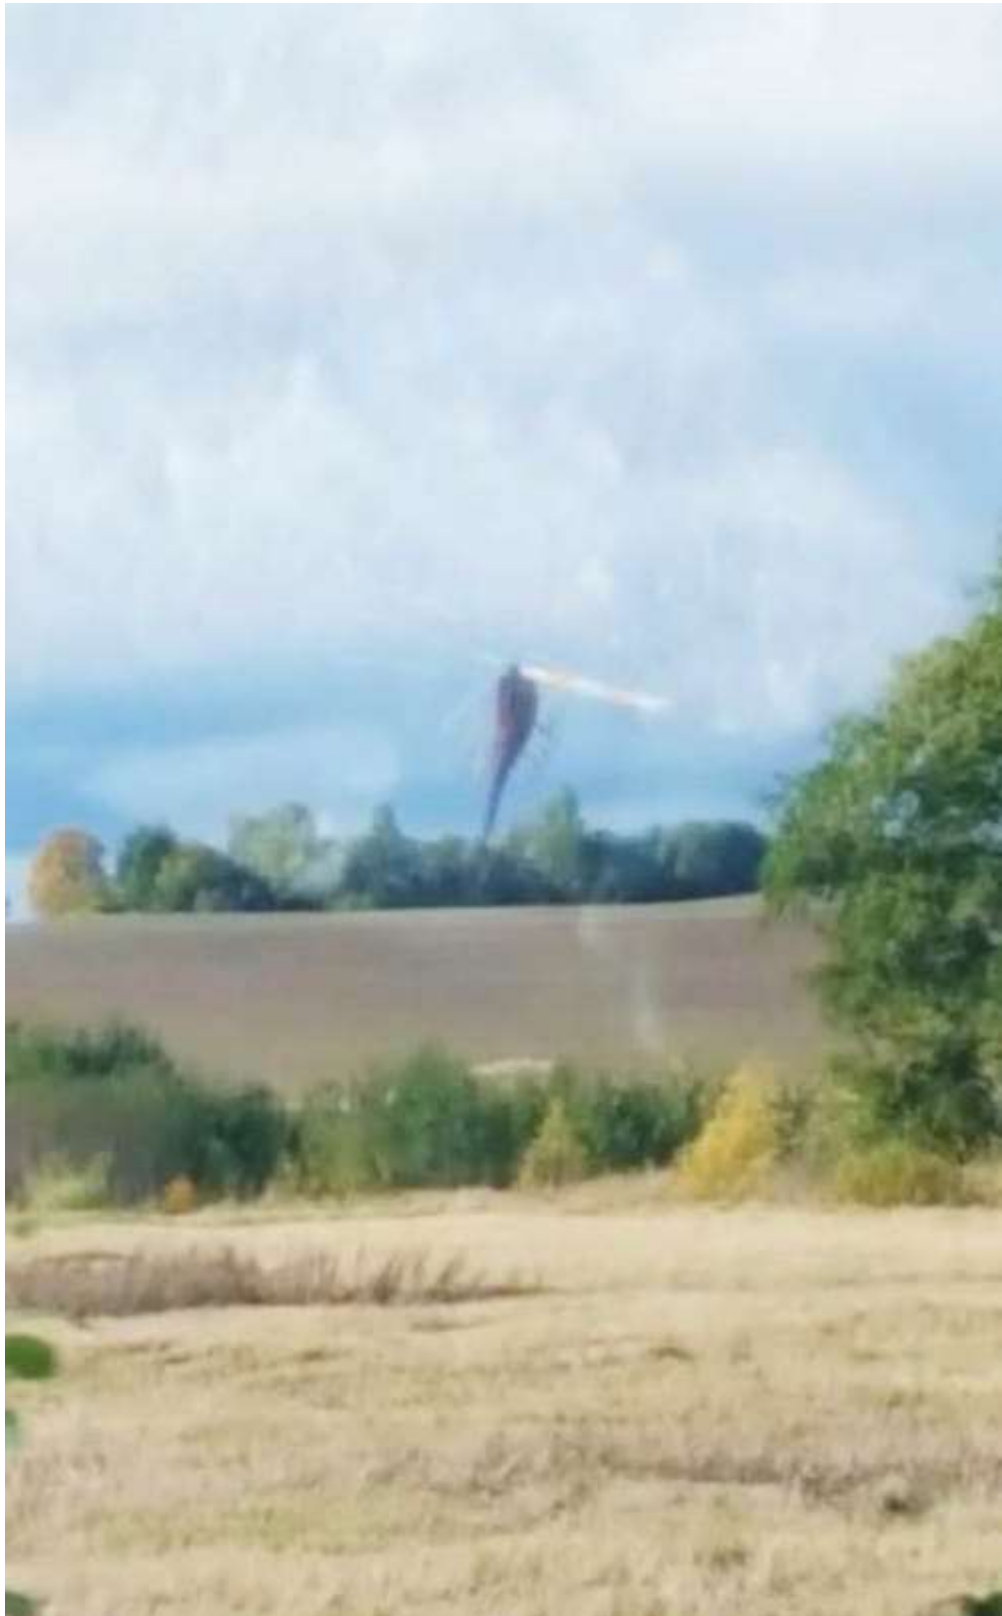
Picture 5.

- Fast climbing of helicopter, in order to avoid colliding the electric power line (Pic. 5);

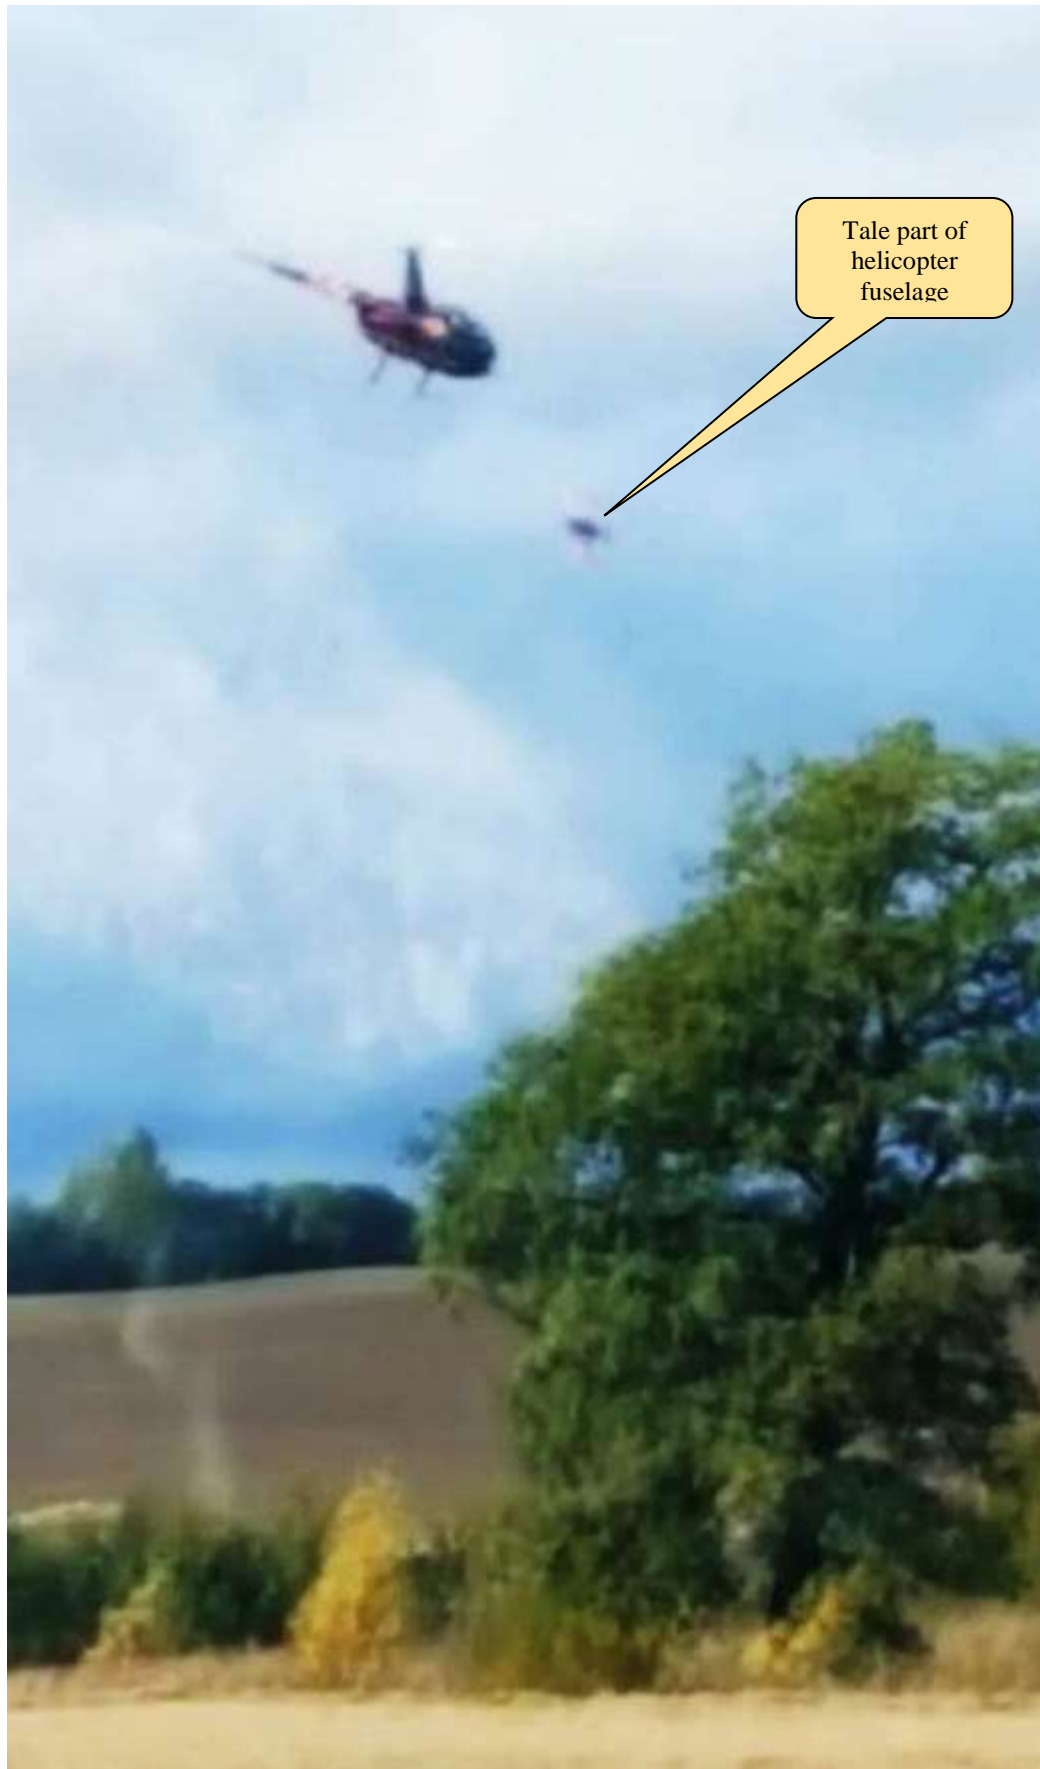
Picture 6.

- Uncontrolled flight of helicopter with rotation in horizontal plane (Pic. 6);

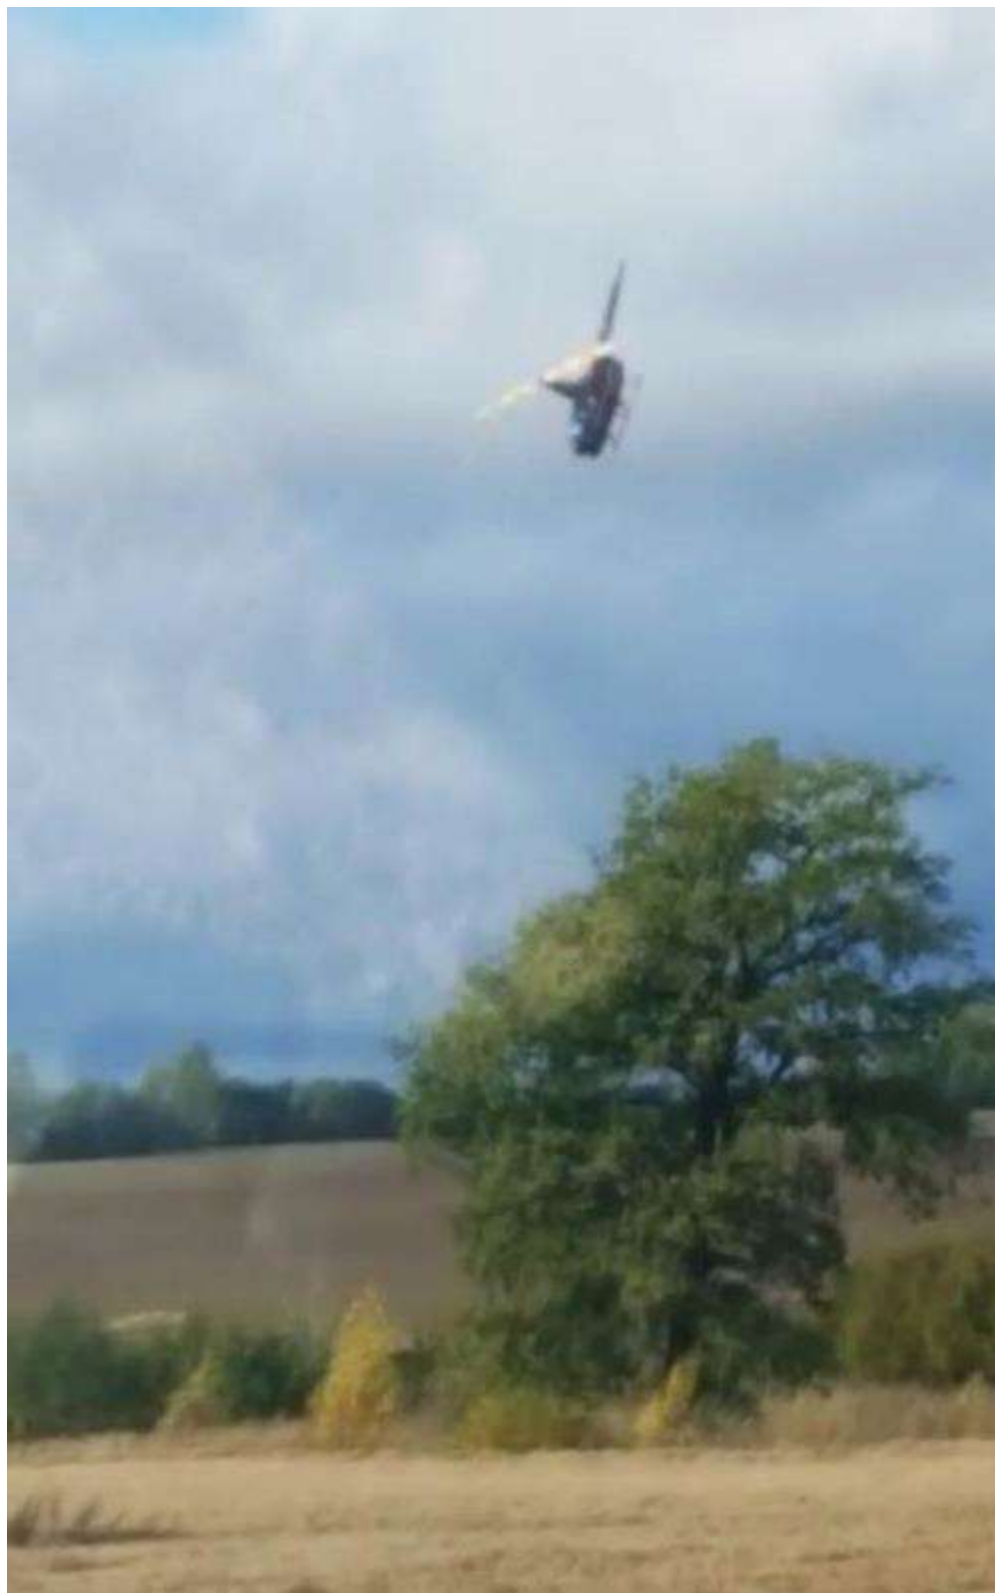
Picture 7.

- Falling of the helicopter with high vertical speed (Pic. 7).

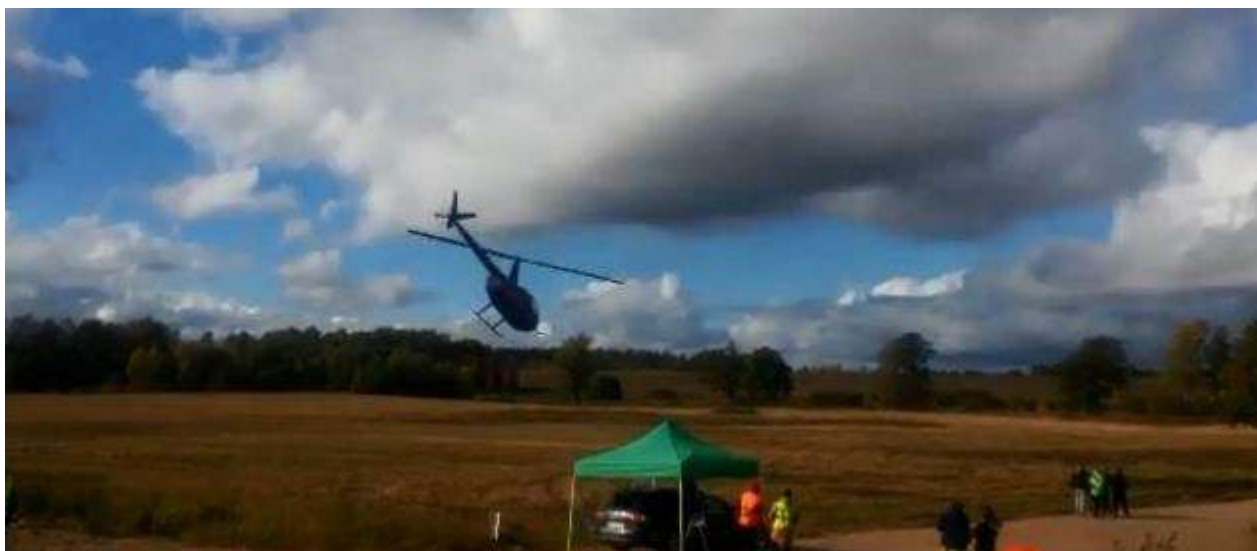
off helicopter carried out horizontal flight around at altitude of 7-8m to the direction of Gramzda pit (Pic. 8).

Picture 8. The altitude of helicopter flight

After aircraft had flown around 300-350m in flight direction, noticing the wires of electric power line, pilot tried sharply to increase the flight angle, but helicopter with tail boom and tail rotor touched the upper wire of electric power line, which was at height of 9.20m. Helicopter by inertia reached the altitude approximately to 50m, tail part together with rotor were separated off from the fuselage of helicopter. Helicopter became uncontrollable, started to rotate around vertical axis until it collided with the ground surface approximately 60m away from electric power line.

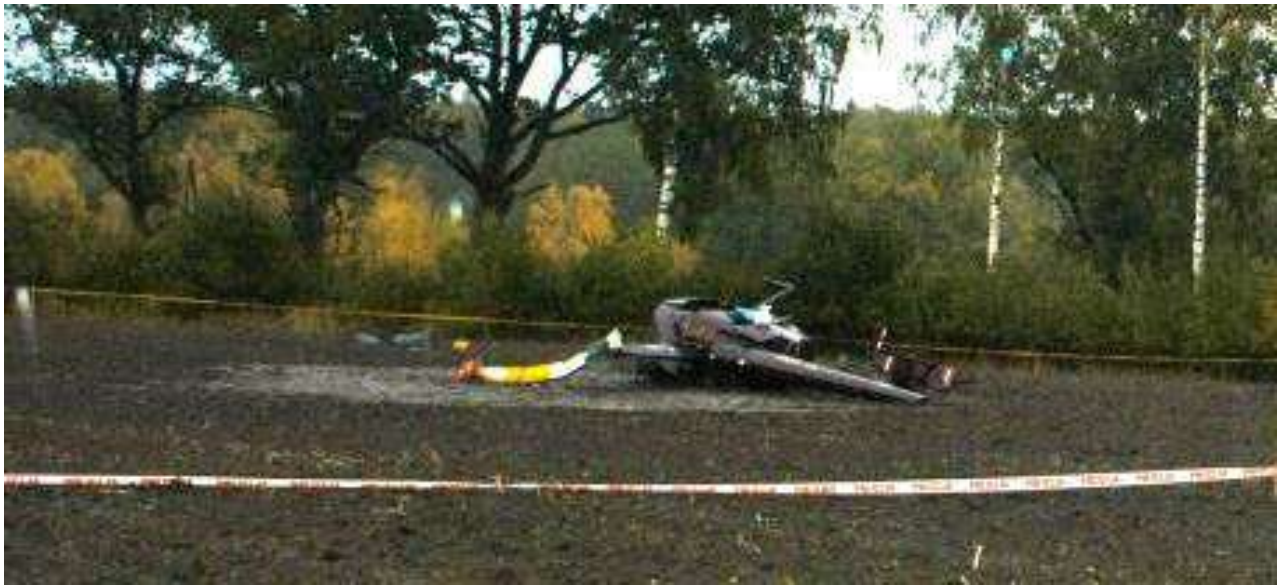
After collision with the ground at the aviation accident site, helicopter R44 stopped without skidding marks on the left side.

Pic. 9. Helicopter at accident site

Helicopter R44 was seriously damaged in aviation accident, its repair and further operation is not possible.

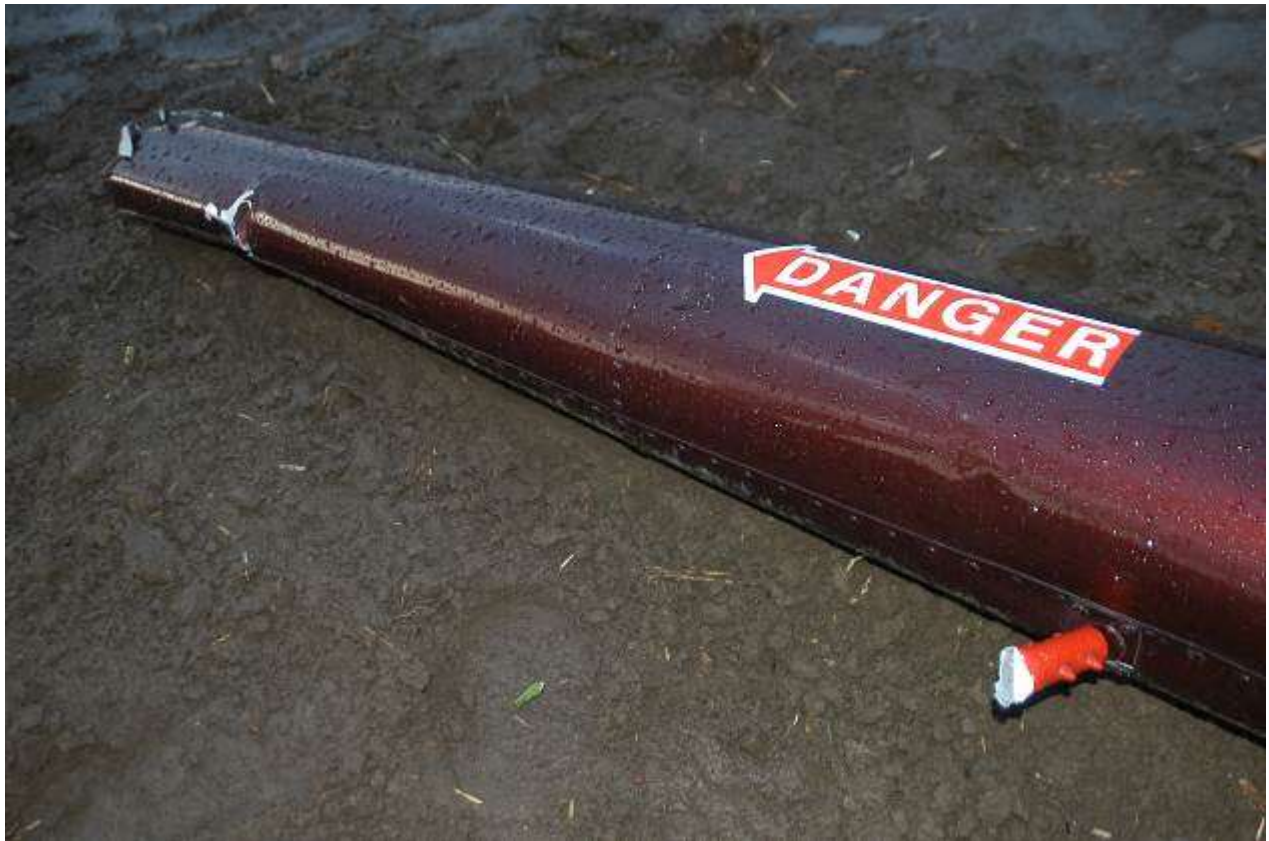
- Separated tail part of fuselage with stabilizers, tail rotor with blade parts were found approximately 50m from helicopter accident site (Pic. 10, 11);

Picture 11. Tail boom of helicopter

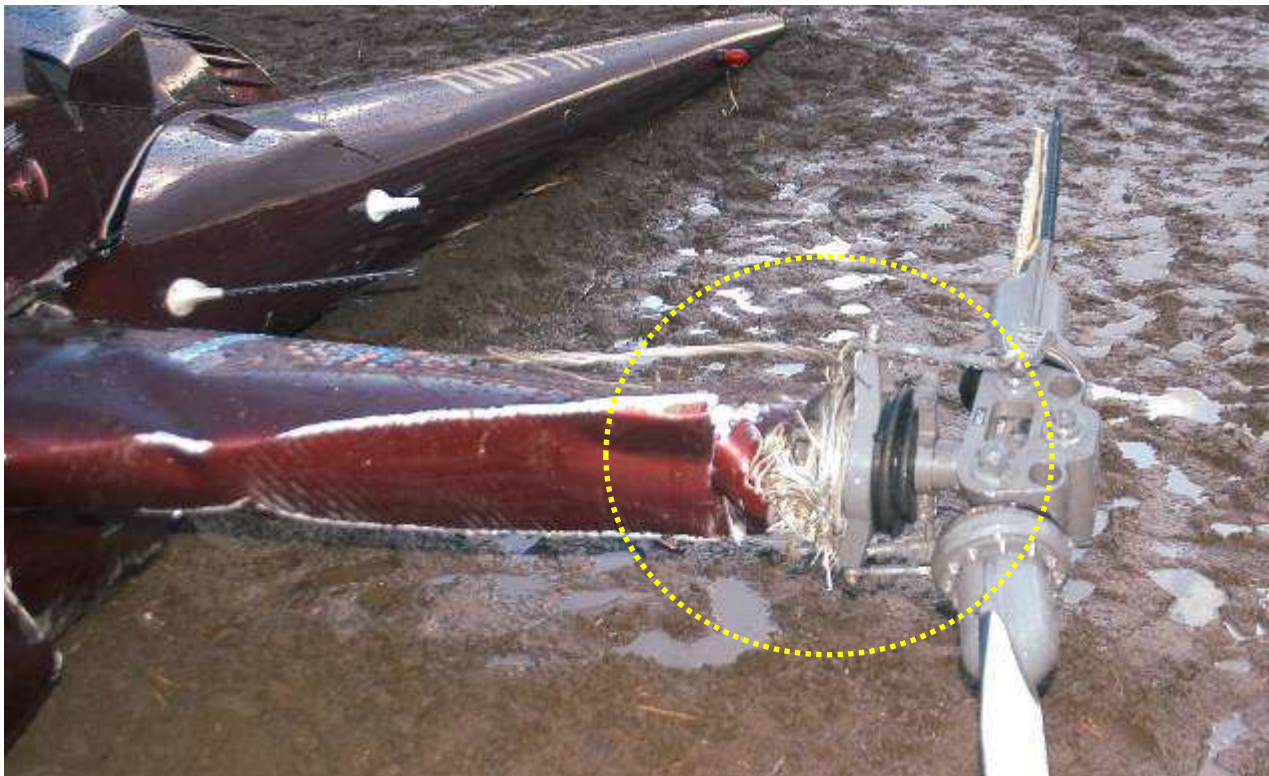
- Main rotor axle of helicopter twisted with wires of electric power line (Pic.12);

Picture 12. Main rotor axle of helicopter

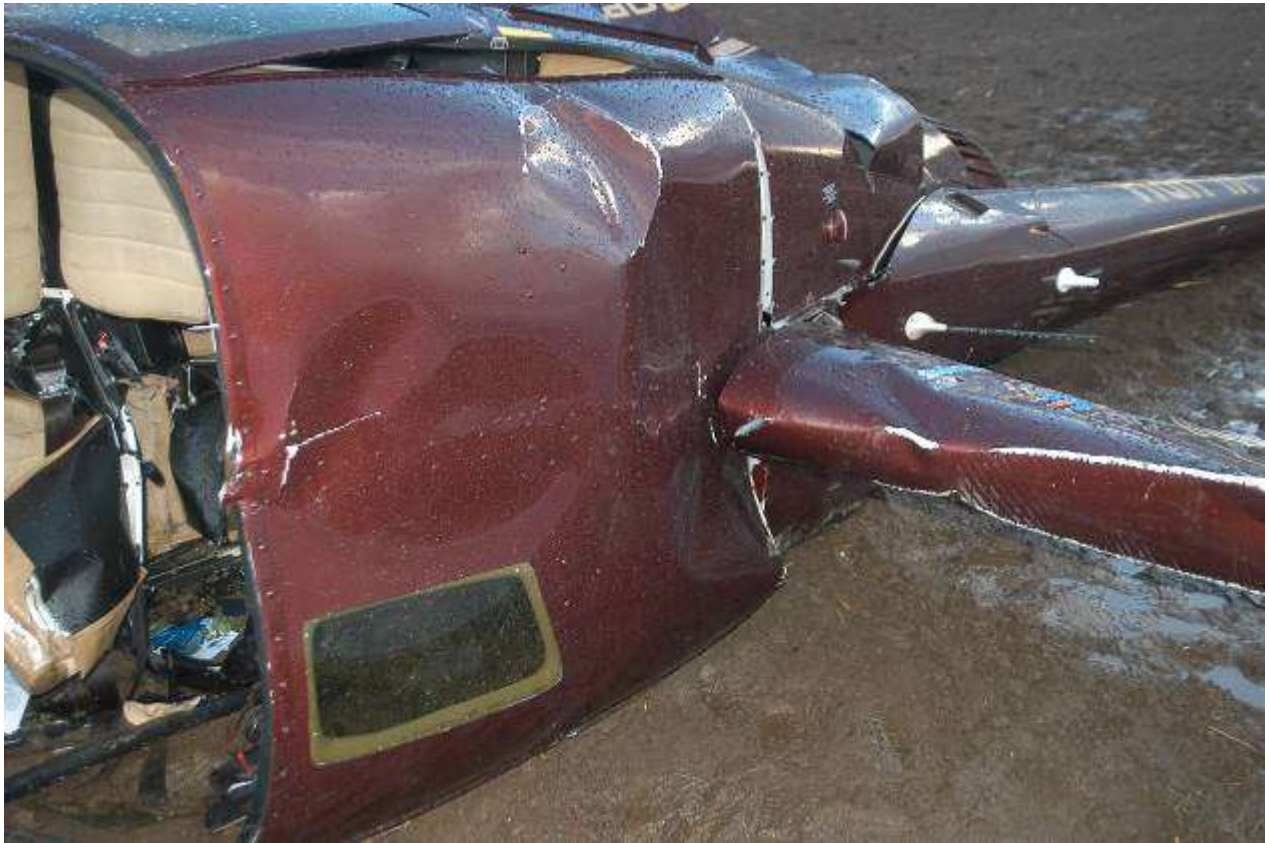
- Skin with deformation and cracks of upper part of helicopter fuselage (Pic. 13);

Picture 13. View on helicopter from above

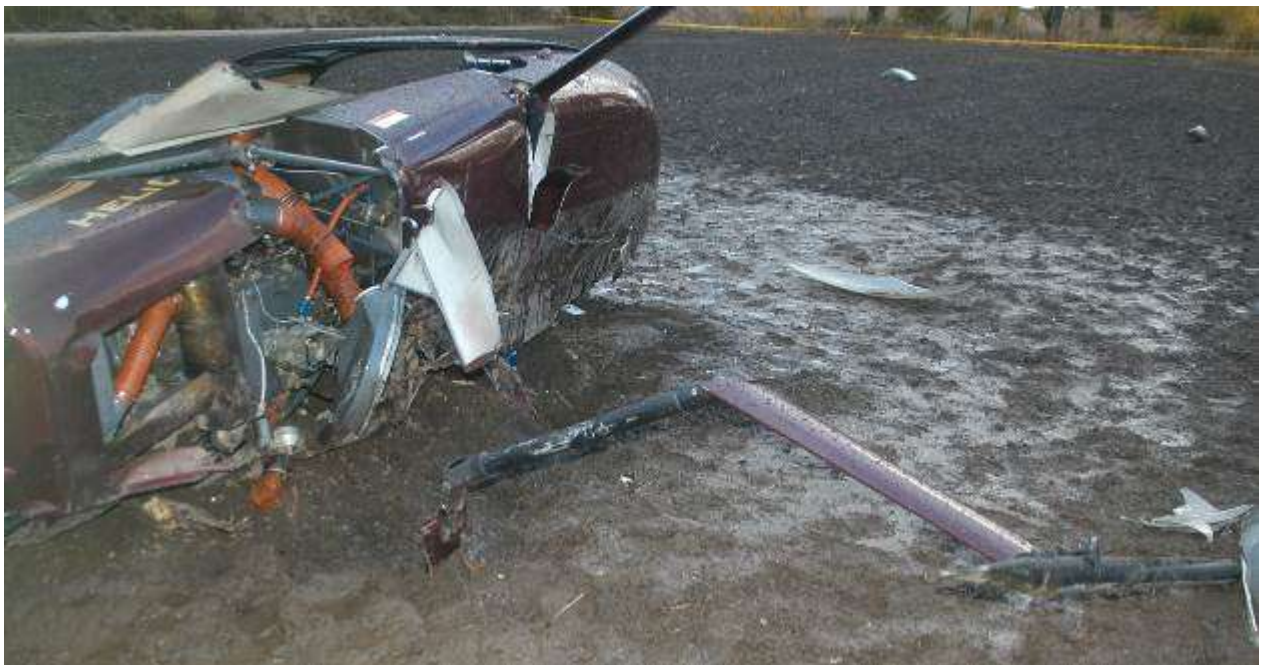
- Broken landing gear skids of helicopter (Pic. 14);

Picture14. View on helicopter from below

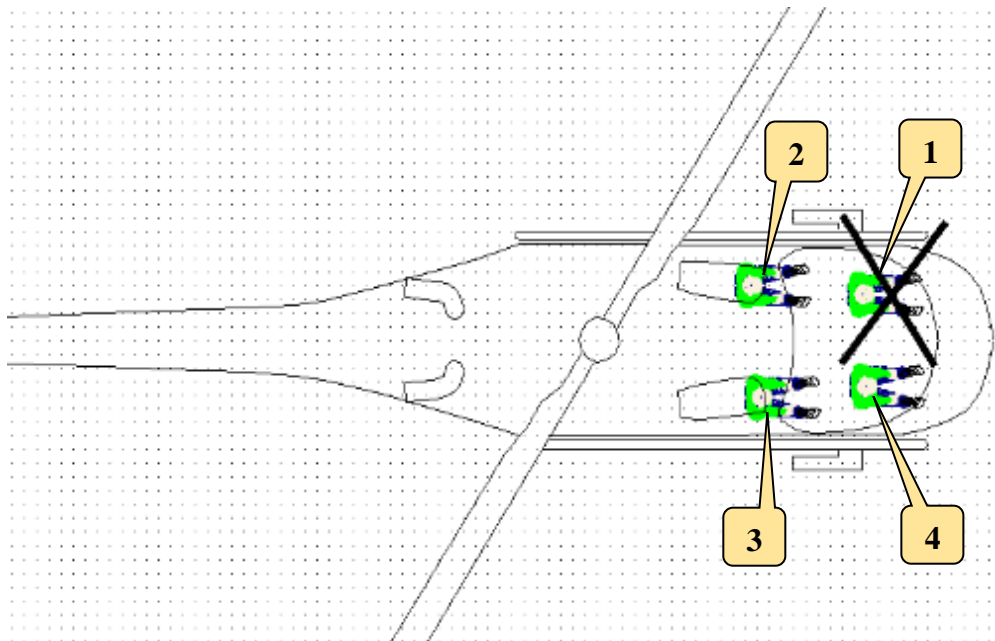
Despite the crashworthiness of helicopter fuselage and of construction strengths elements, as well as safety belts construction (pilot and passengers of helicopter used the safety belt system), as a result of severe impact into the ground with the left side of helicopters fuselage passenger (1), who was sitting in front of helicopter cabin on the left side, sustained fatal injuries, pilot (4) and other passengers (2) (3) sustained serious injuries (Pic.19).

Picture19. Placing scheme of pilot and passengers

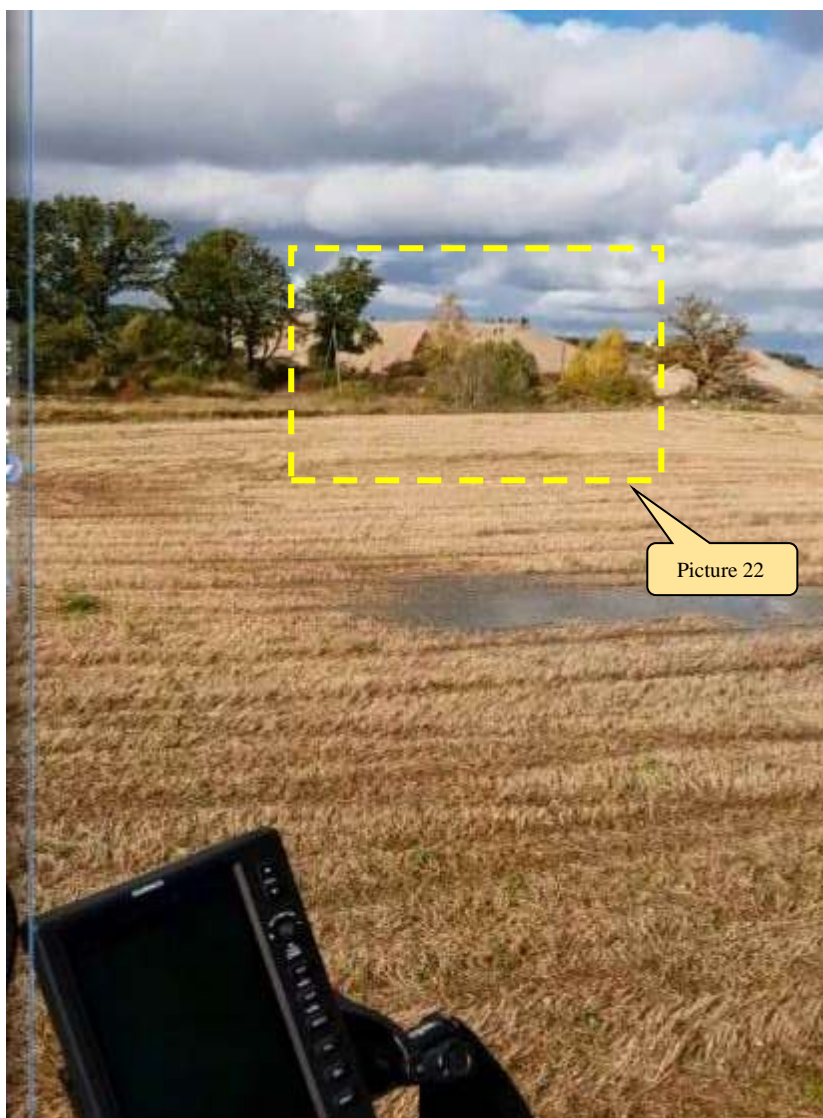
Weather conditions on October 8, 2017, in Priekule municipality, Gramzda rural territory, Gramzda pit area at 13:11 during the flight of helicopter R44, registration No YL-HBH, were corresponding to requirements for performing visual flights. During the take-off sun was behind the pilot's back, maximum wind gusts did not exceed 11 m/s. On video, taken from the cabin of helicopter few seconds before the aviation accident, it is possible to see, that dangerous obstacles to the flight safety (electric power line, poles of electric power line, top of trees etc.), were clearly visible (Pictures 21 and 22).

Picture 21. Snapshot during the flight from cabin of helicopter R44, r/n YL-HBH

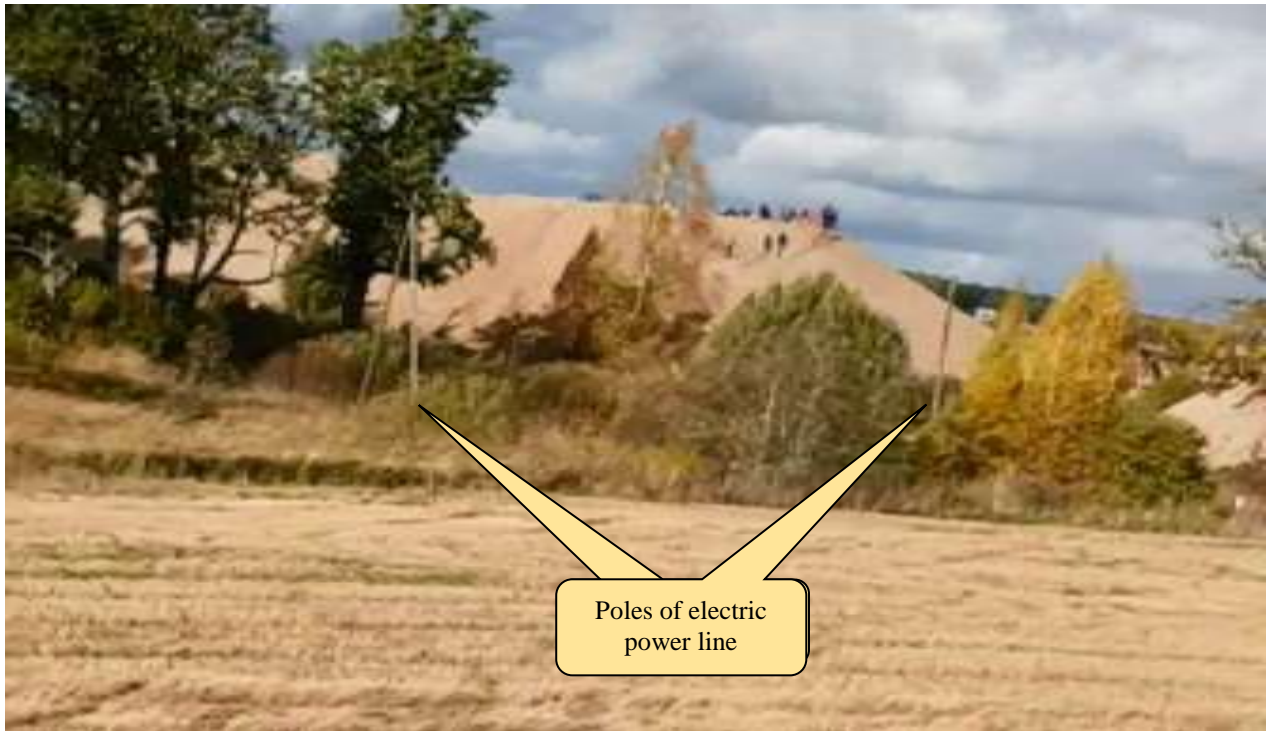
Picture 22. Zoomed in picture 21 from the cabin of helicopter R44, r/n YL-HBH
