Transporta nelaimes  
gadījumu un incidentu  
izmeklēšanas birojs

**Simplified report Nr. 2-2026**

**Occupational accident (leg trauma) onboard of Latvian flagged vessel  
CAPELLA in port of Vasteras (Sweden) on 21th January 2026**

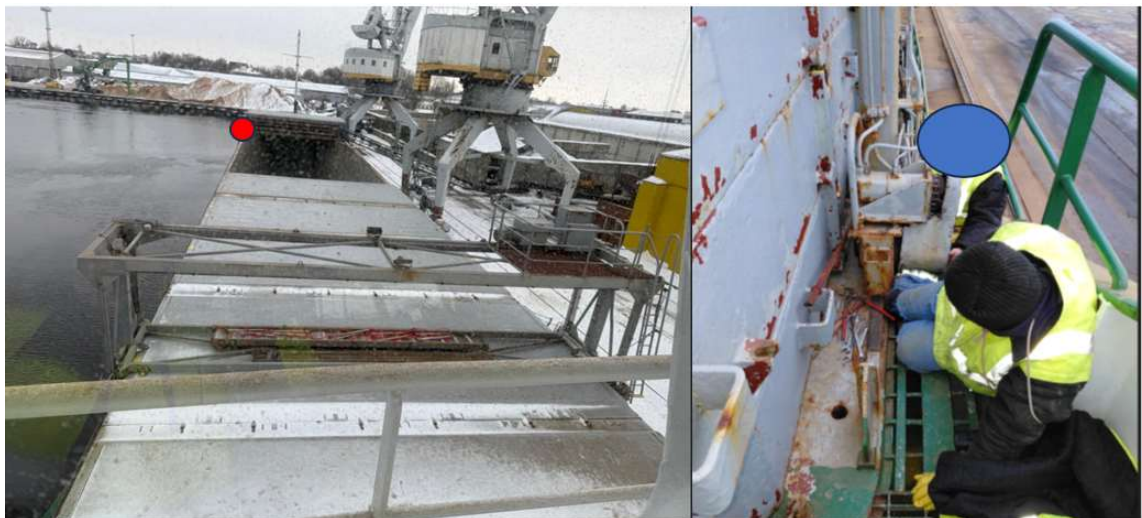
Image 3. Location onboard (by red dot, view from bridge) and visualisation of trapped leg at moving part of gantry crane at vessel's fore deck

During crane's movement at vessel's foredeck in forward direction AB has been walking hereaway, assumingly for visual control of hatch cleats to be closed properly. Stepping on fore

deck's gangway AB's leg got stuck between moving wheels (travelling mechanism) of gantry crane and rail, assumingly it has happened due to momentarily distracted attention from moving parts in vicinity, and general narrowness of the walking path at gangway. After leg being stocked in wheels, AB has shouted in order to draw attention of crane's operator, who acted rapidly, arresting movement of crane and switching out electric supply. Two crew members appeared immediately, it has taken several minutes to release leg safely. Injured crew member has been evacuated to local hospital (paramedics arrived onboard within 30 minutes). Leg injury has been qualified as serious.

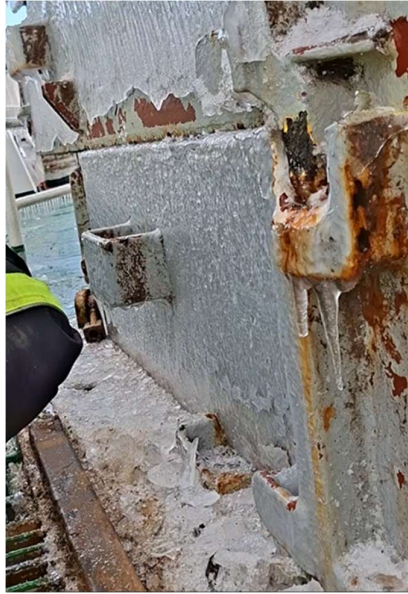
Image 4. Hatch closing cleat onboard

Normally the process of hatch closing/opening procedures are being executed by two crew members under supervision of duty officer. One crew member operates gantry crane console, controlling crane's movement, while another is visually controlling power supply cable proper laying/drumming when winding it along crane movement, as well as smooth locking of cleats

on hatch folding panels (see Image 4.) There are only visual/verbal means of communication between those involved in hatch closing/opening operations. During movement of crane on rails there is permanent warning flashing light and bell sound.

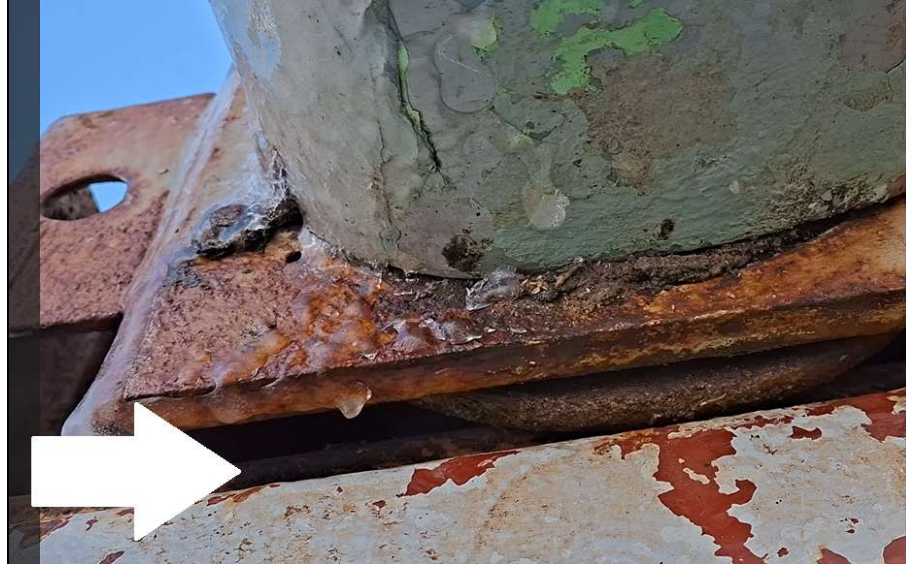
The wheeling transmission assembly and the surrounding structure show advanced deterioration. Confirming proper maintenance as existing on 17 January 2026 while the crane was in the condition visible in the photographs three days later constitutes either a false certification or evidence that the assessment was completed without physical inspection of the equipment.

Image5. Location of nipped leg at wheeling mechanism of the crane

2. **The physical condition of the crane:** photographic evidence obtained by the attending local police patrol demonstrates that the hatch crane was in a condition of advanced deterioration at the time of the accident (as per police protocol, that states extensive corrosion, degraded paint, mechanical wear, and accumulated contamination are visible across the crane's structural and mechanical components). The transmission assembly that caused the injury shows evidence of prolonged inadequate maintenance. This condition is inconsistent with the annual thorough examination required by SOLAS regulation II-1/3-13 and MSC.1/Circ.1663.

1. To revise SMS and make all lifting appliances onboard of CAPELLA and fleet fully compliant with SOLAS regulation II-1/3-13.2.4 and MSC.1/Circ.1663 requirements (hereinafter Ref.A) in all aspects, and *inter-alia*:
  - Annual examination programmes (Ref.A section 3.2.2.1).
  - Physical guarding of possible nip points in compliance with machinery safety standards (Ref.A section 3.5.1.4.2, section 3.6.1.9)
  - Personnel qualification, authorisation, and familiarisation for crane operations ( Ref.A sections 3.6.1.1, 3.6.1.2, and 3.6.1.3)
  - Lifting operations planning, supervision, and risk minimisation (Ref. A sections 3.6.1.8, 3.6.1.9).
