BRAZILIAN NAVY
DIRECTORATE OF PORTS AND COASTS
Marine Safety Superintendence

FATAL CREW MEMBER ACCIDENT IN M/V "PILTENE"

MARITIME SAFETY INVESTIGATION REPORT

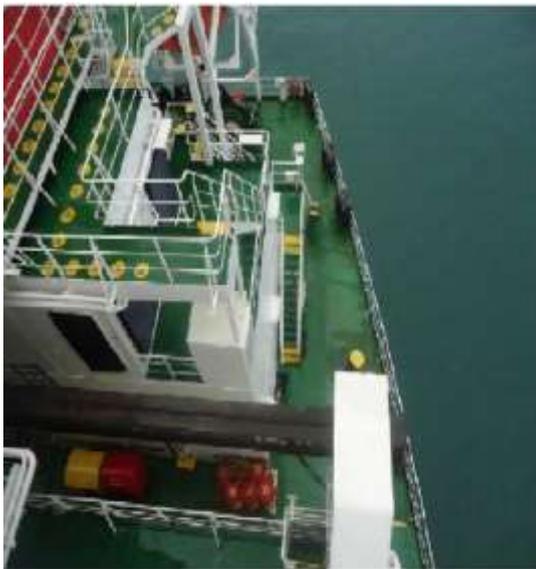
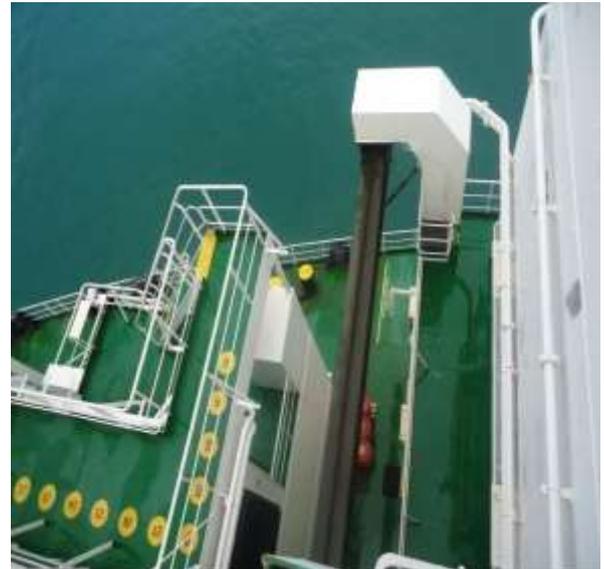
Photos 4 and 5 - Overview of the accident scenario

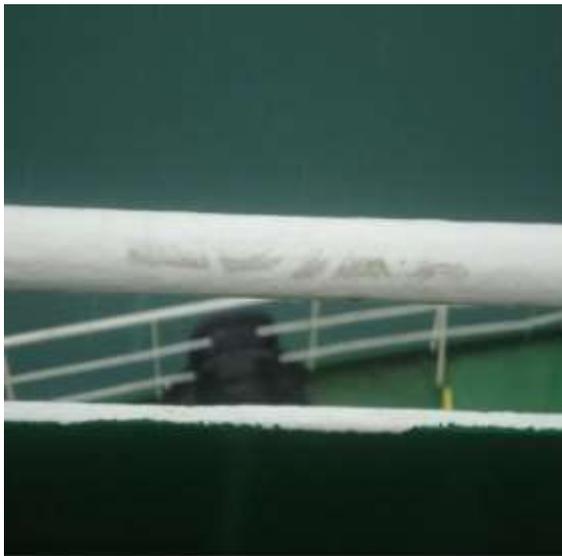
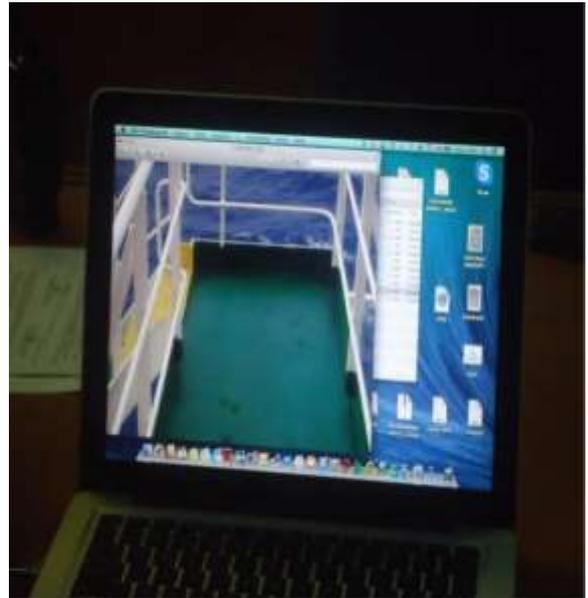
6 - Evidences point to a drop height of 10 to 12 meters of platform on floor at the level of the free-fall lifeboat, signs of footprints of bare feet are found in the place (Photos # 6, 7, 8 and 9);

7 - The platform protrudes for port side and is endowed with baluster (guardrail) with height of approximately 1,20m. Several marks on the side of the first level of the balustrade are observed, inducing a support action aiming at the rise of the body to transpose the baluster (Photo nº 5); The victim, according to his "Physical Examination Report / Certificate", issued by the Administration of the Flag on 01/19/2017, had weight of (____) kg, height (____) cm and had good physical conditions (Document 3); 8 - The area in question is near the chimney of the ship, and its floor is subject to soots coming from the discharge of gases from the generators and main engine (Photos #. 6, 7, 8 and 9);

Photos 6 and 7 - Signs of footprints on the balustrade and on the deck .

1° - In accordance with the SOLAS Convention, Chapter IX, Rule 3 (1), the Company must to carry out an evaluation of Safety Management (ISM-Code) of the vessel, regarding the establishment of rules that allow the isolation, at night, of the doors of the corridors of crew cabins at the level of the decks in the superstructure, not allowing access to the external areas which run the starboard and port platforms;

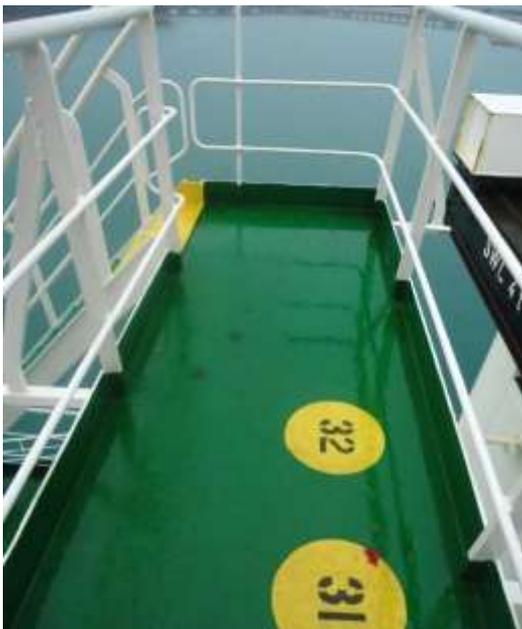
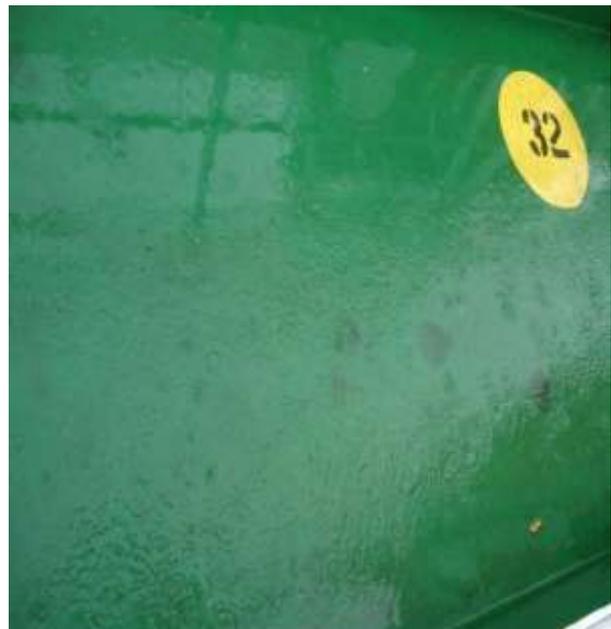
Photos 8 and 9 - Signs of footprints on the balustrade and on the deck of the lifeboat

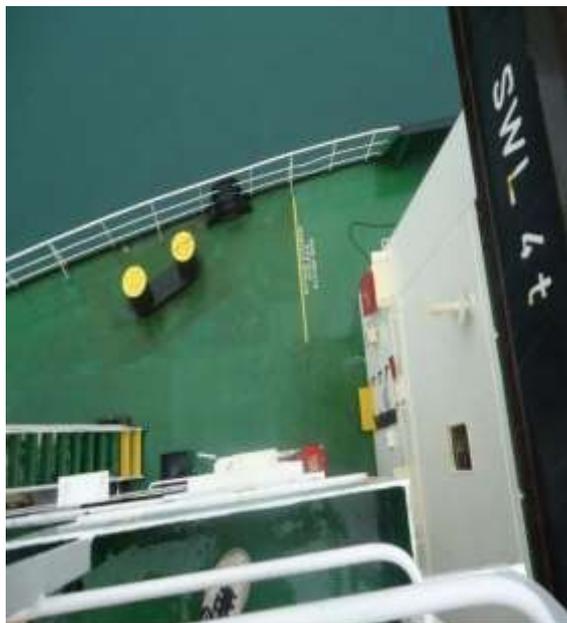
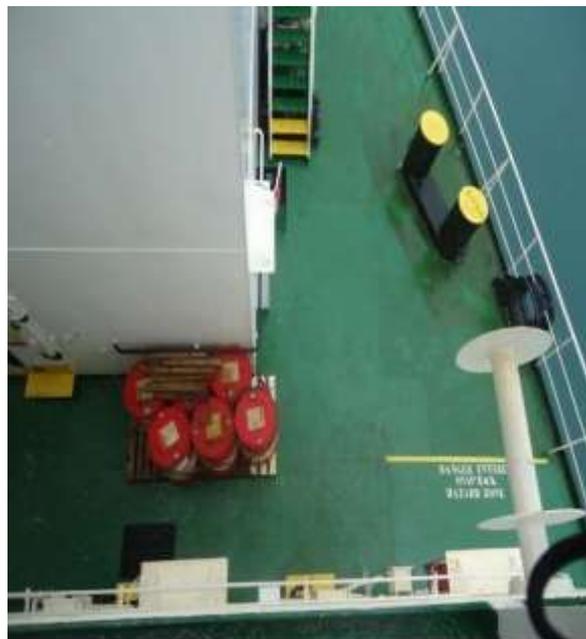
11 - Height of the fall, approximately: 12m (Photos # 10 and 11);

The impact thus justifies the severe injuries suffered: loss of teeth, broken ribs, fractured mandible, forearm near the wrist also fractured and incision on the left side of the breast, hematomas around both eyes and detailed in the "Tanatoscopic Expert Exam" nº (____) of the Legal Medical Institute (____), (Document 9), linked to the Secretariat of Social Defense of the government of the State of Pernambuco.

Photos 10 and 11 - Main deck area (port side), where the body of the victim was found

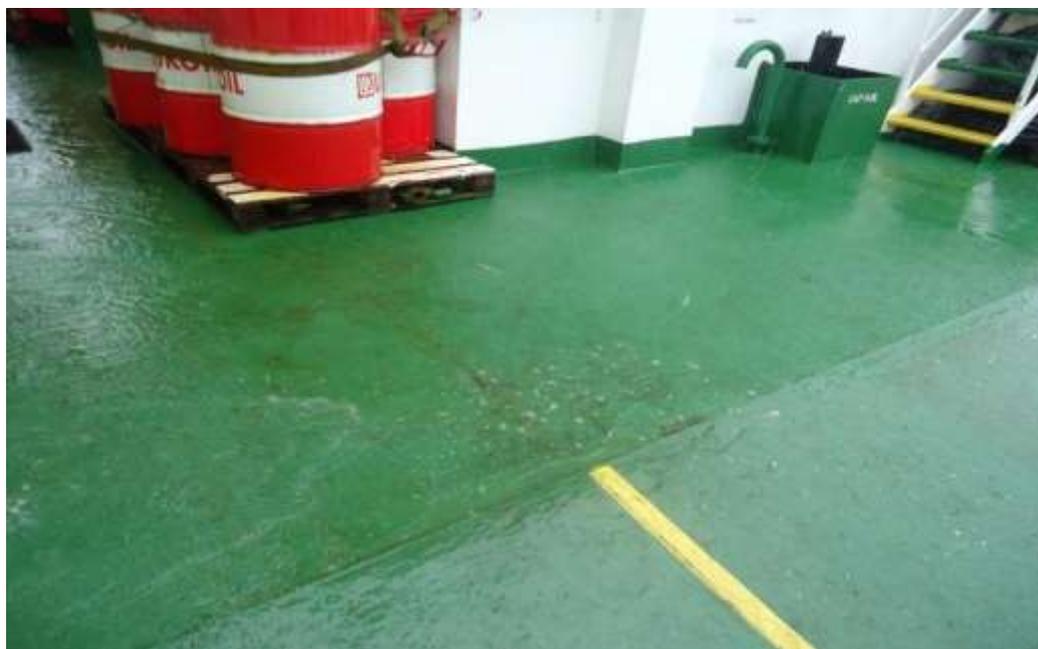
Photos 12 - Main deck area (port side), where the body of the victim was found
