Transporta nelaiemes gadījumu un incidentu izmeklēšanas birojs

## **Simplified report Nr. 2-2018**

# **Grounding of Liberian flagged vessel RABA in vicinity of Liepāja port on 04th July 2018**

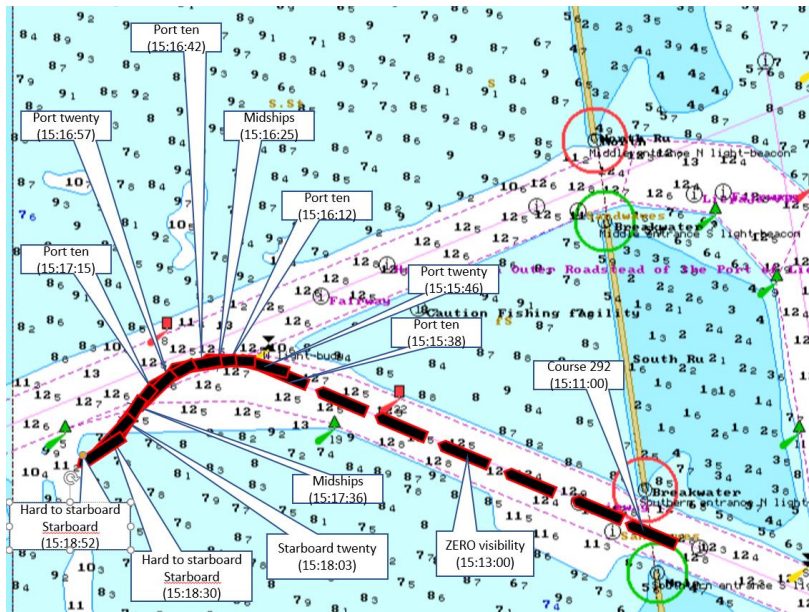
Image1: Excerpt from ECDIS chart with RABA summary movement and commands to helm before grounding on 04.07.19

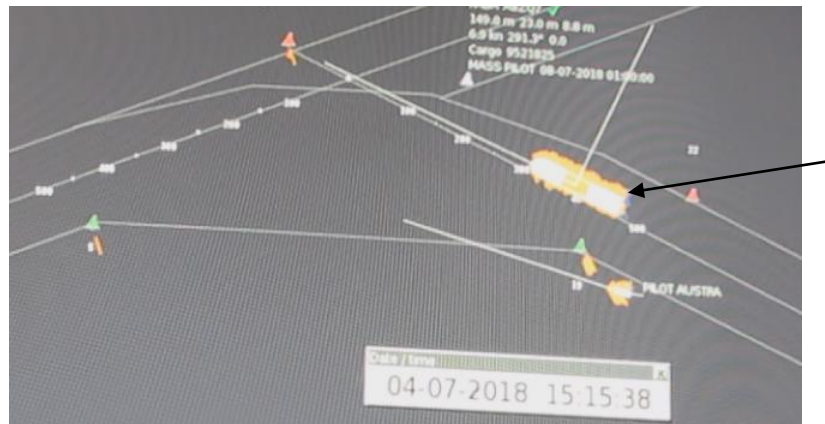
Image 2: VTS Radar image of RABA (marked by black arrow) and her location on fairway, close to turning point, at the moment (15h 15m 38s) when pilot advised “PORT TEN!”: the vessel’s turn to course 248 has started (current course 292, speed 6 kt )

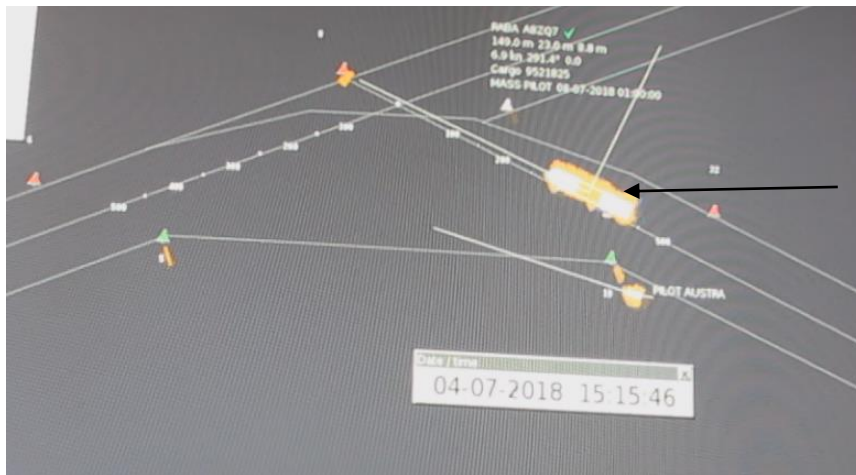
Image 3: VTS Radar image of RABA (marked by black arrow) and her location on fairway at the moment (15h 15m 46 s) when pilot advised “**PORT Twenty!**” (Course 292, speed 6 kt )

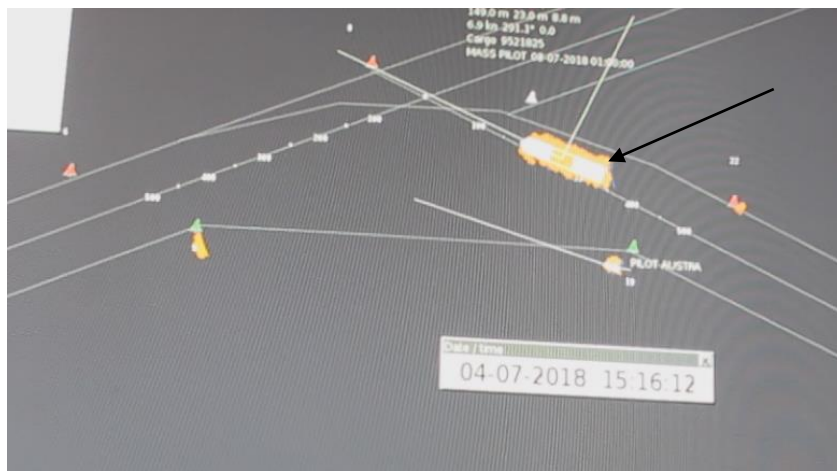
Image 4: VTS Radar image of RABA (marked by black arrow) and her location on fairway at the moment (15h 16m 12s) when pilot advised “**Port Ten!**” (Course 287, speed 6 kt )

5.2.7. Delayed and inappropriate Pilot's advices (in form of commands on helm during the vessel's turn from course 292 to 248 (see Images 4-12)

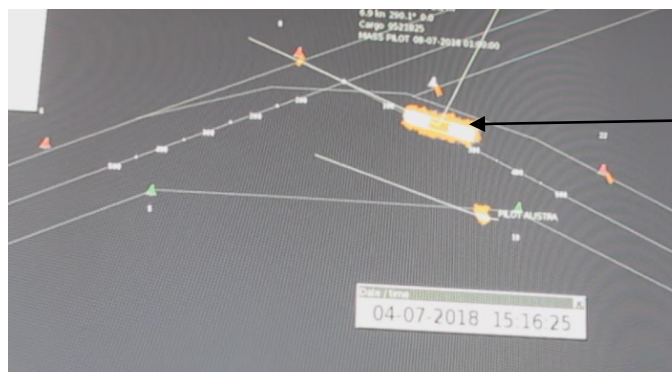
Image 5: VTS Radar image of RABA (marked by black arrow) and her location on fairway at the moment (15h 16m 25s) when pilot advised “**Midship**” (Course 282, speed 6 kt )

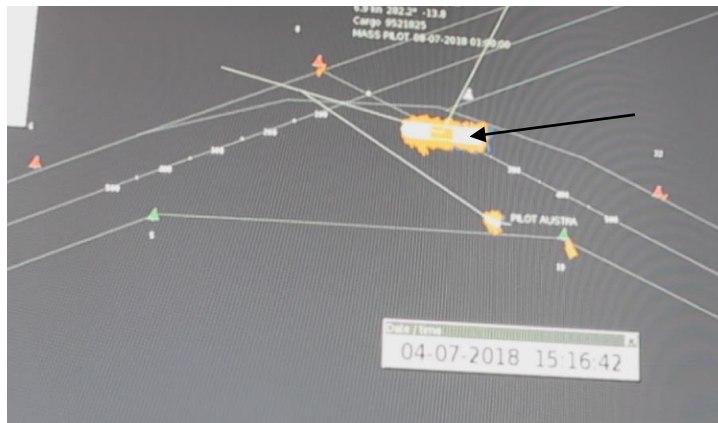
Image 6: VTS Radar image of RABA (marked by black arrow) and her location on fairway, off the centreline, at the moment (15h 16m 42s) when pilot advised “**Port ten!**” (Course 274°, speed 6 kt )

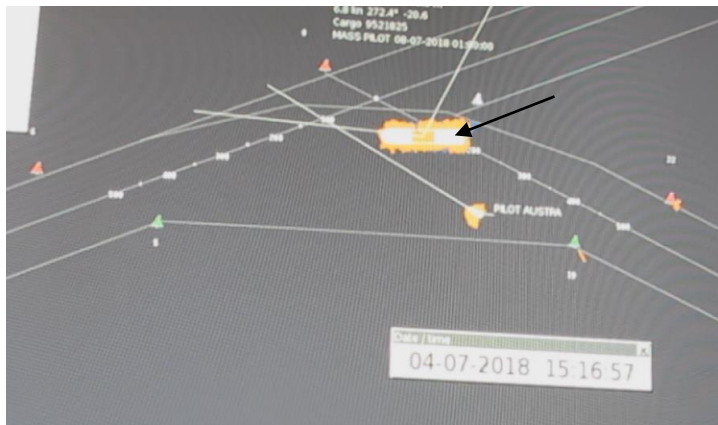
Image 7: VTS Radar image of RABA (marked by black arrow) and her location on fairway (off the centreline) at the moment (15h 16m 57s) when pilot advised “**Port twenty!**” (Course 268 °, speed 6 kt )

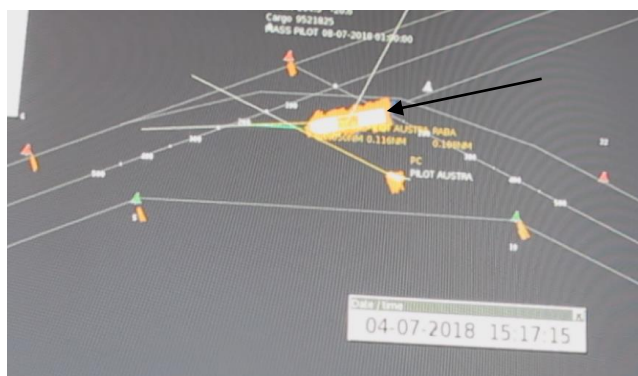
Image 8: VTS Radar image of RABA (marked by black arrow) and her location on fairway (off the centreline) at the moment (15h 17m 15s) when pilot advised “**Port ten!**” (Course 259°, speed 6 kt)

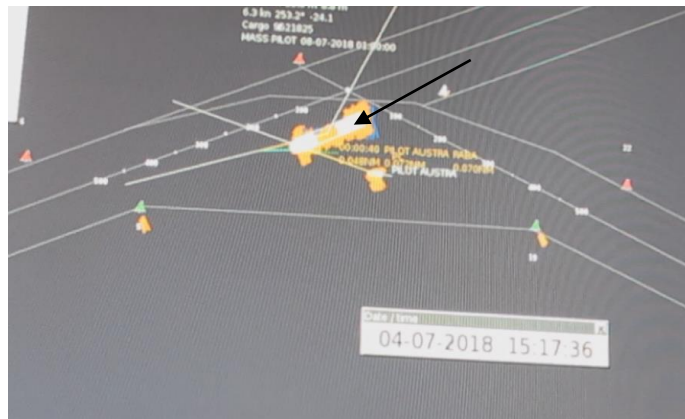
Image 9: VTS Radar image of RABA (marked by black arrow) and her location on fairway (off the centreline) at the moment (15h 17m 36s) when pilot advised **“Midships!”** (Course 247°(!) speed 6 kt)

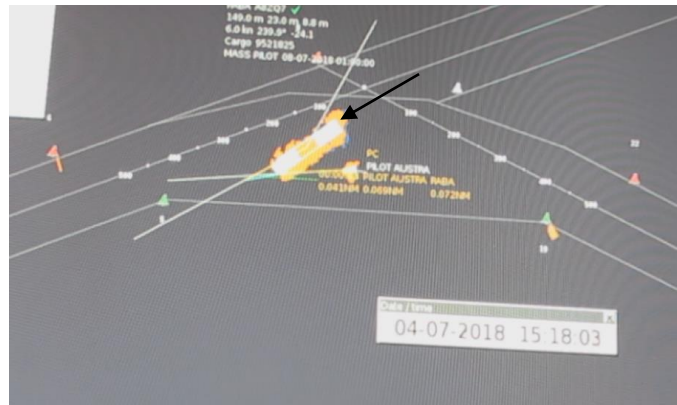
Image 10: VTS Radar image of RABA (marked by black arrow) and her location on fairway (off the centreline) at the moment (15h 18m 03s) when pilot has advised **“Starboard twenty!”** (Course 234°, speed 6 kt)

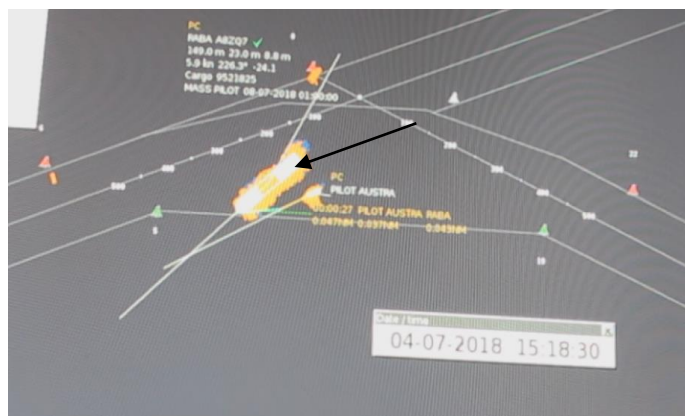
Image 11: VTS Radar image of RABA (marked by black arrow) and her location on fairway (off the centreline) at the moment (15h 18m 30s) when pilot has advised **“Hard to starboard”** (Course 227°, speed 6 kt)

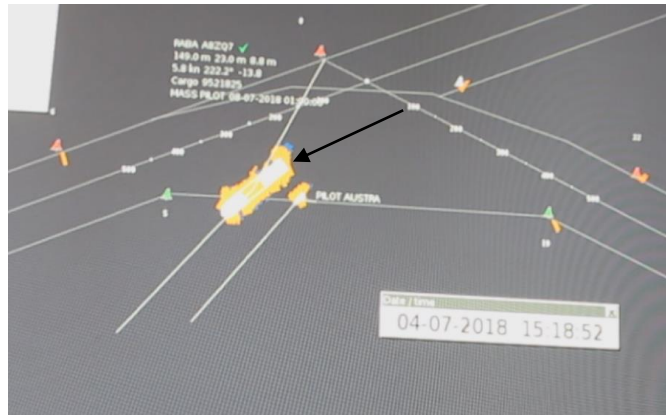
Image 12: VTS Radar image of RABA (marked by black arrow) and her location at the moment (15h 18m 52s) when Pilot has repeatedly advised “**Hard to starboard**” (Course app 220, speed decreasing )

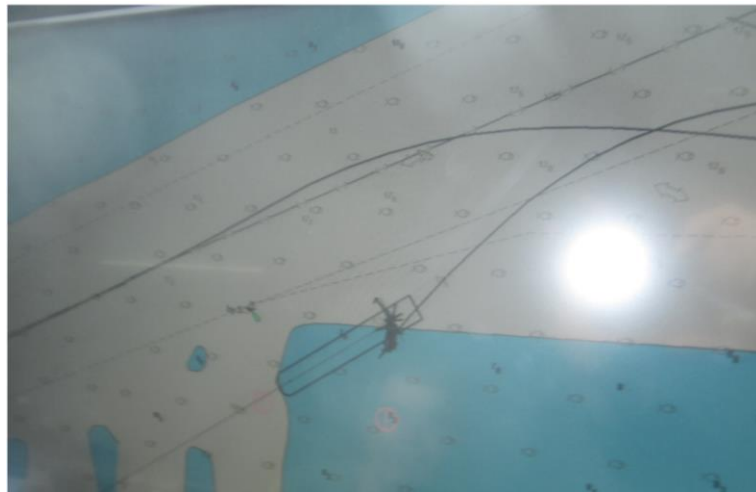
Image 13. Excerpt from RABA ECDIS chart after getting aground in vicinity to green buoy Nr. 5

The vessel got heavily aground at 15h 19m. All further advices of Pilot and Master's commands on helm and engines were without positive results and have not alleviated the situation. The salvage phase of incident has commenced.

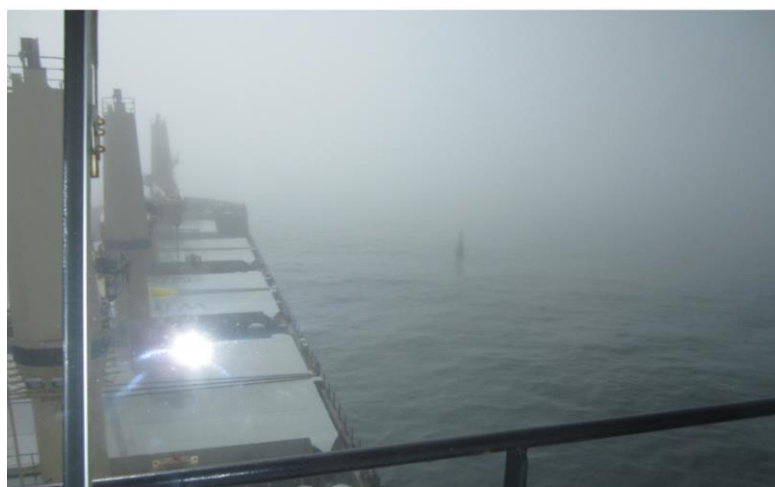
Image 14. Green buoy Nr.5 seen from RABA bridge after getting aground, distance less than 100 meters, visibility: 100-150 meters
