Transport Accident and Incident Investigation Bureau of the Republic of Latvia

MARINE SAFETY INVESTIGATION REPORT Nr.3-2017

Safety investigation into the fire on board the Latvian registered oil tanker ZIRCON on May 25, 2017

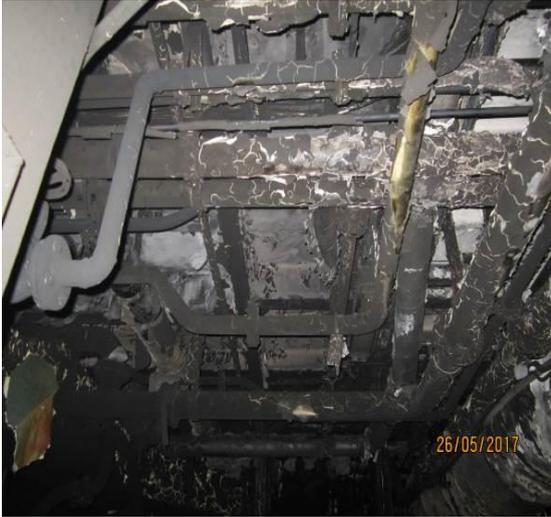
ER space from forward end of the prime-mover to funnel shows traces of extensive heat end fire. Heat and smoke reached up the engine-room casing and resulted in damage to monitoring components of the prime mover, electrical installations, cables, control panels, automation, switch cabinets, ventilation canals, piping systems, rubber components.

Fig.9 ceiling of engine room

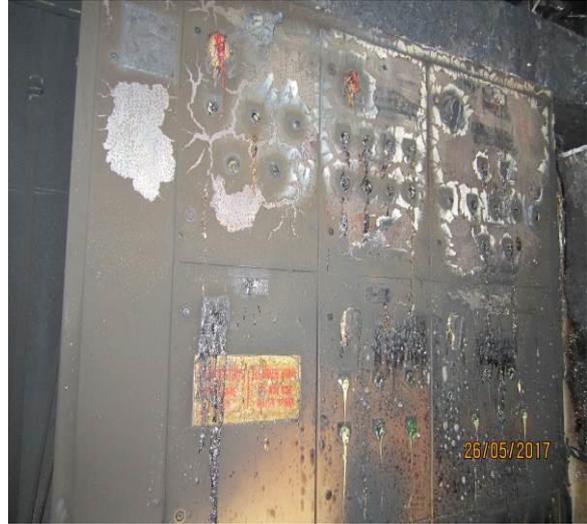
Fig.10 Pumps control board

Heat and smoke damage to electrical components and associated cabling of the fire detection system, general lighting. Cables supporting other equipment and systems that transited through the diesel engine-room suffered from extensive heat. An electrical sub-station located above the area of the diesel engine-room sustained damage to its deck plating, cabling, light fixtures, transformers and breaker cabinets.

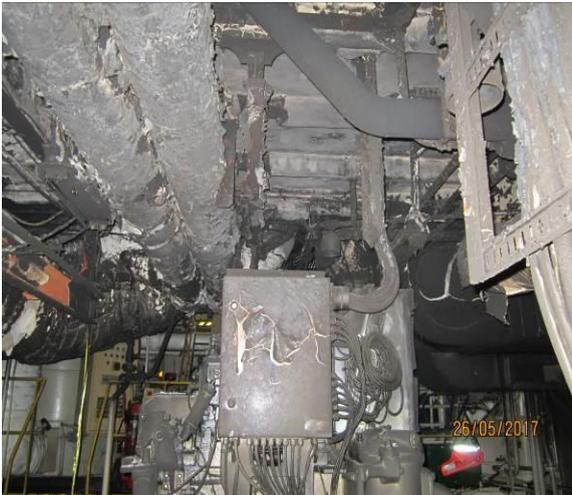
Fig.11 Ceiling DG deck

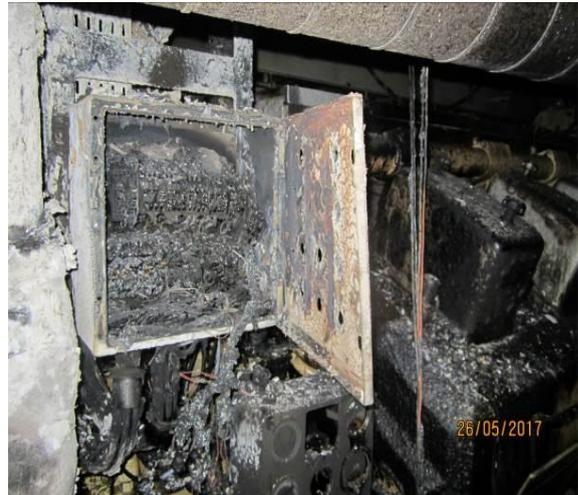
Fig.12 ME control box

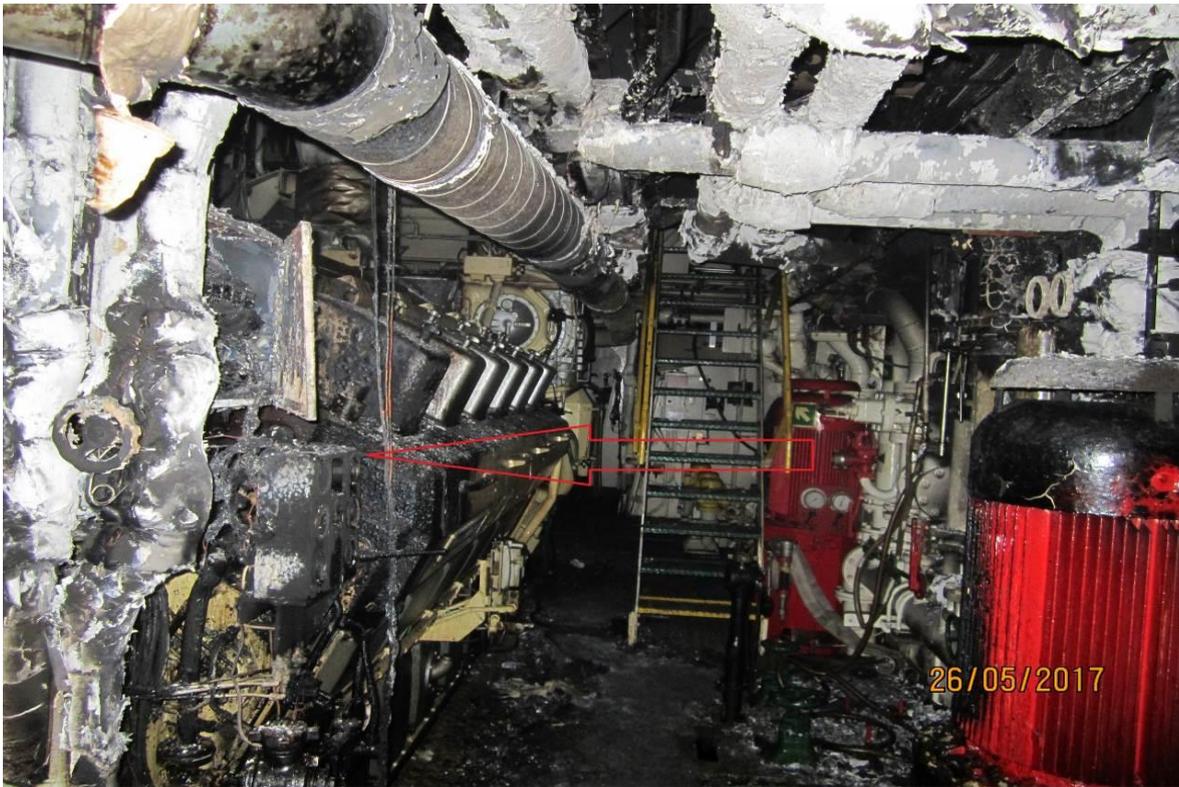
Fig.13 ME Deck Port side forward end, arrow shows where the fire started

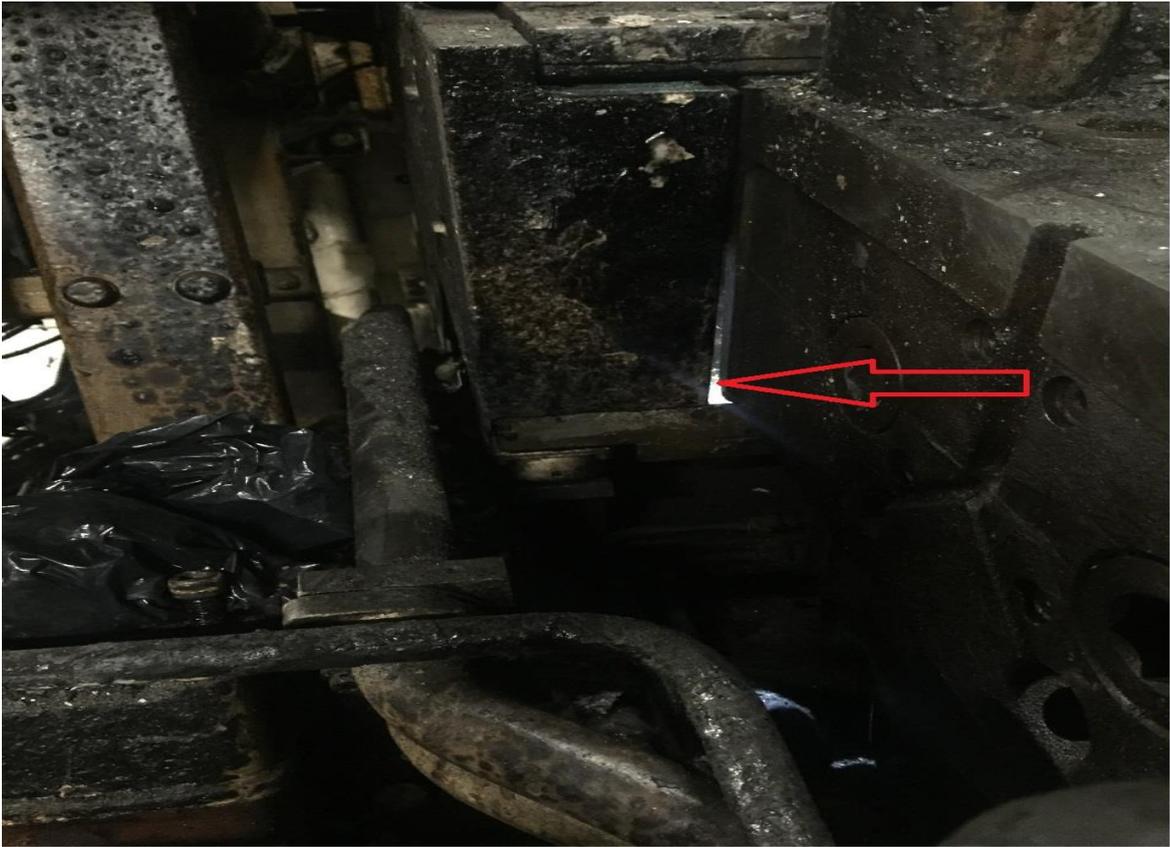
Fig.14 Arrow shows the gap in insulation of manifold cover, illuminated from inside.

Fluids under pressure tend to atomize, that is, become fine mist, when pushed through a small opening or leak in a pressurized system. Because the Fuel Oil leak was in the form of atomized spray, it created a fuel-air mixture that ignited when exposed to the near 400C hot exhaust manifold (Fig.15 and 16) through a little gap (Fig.14) in insulated containment.

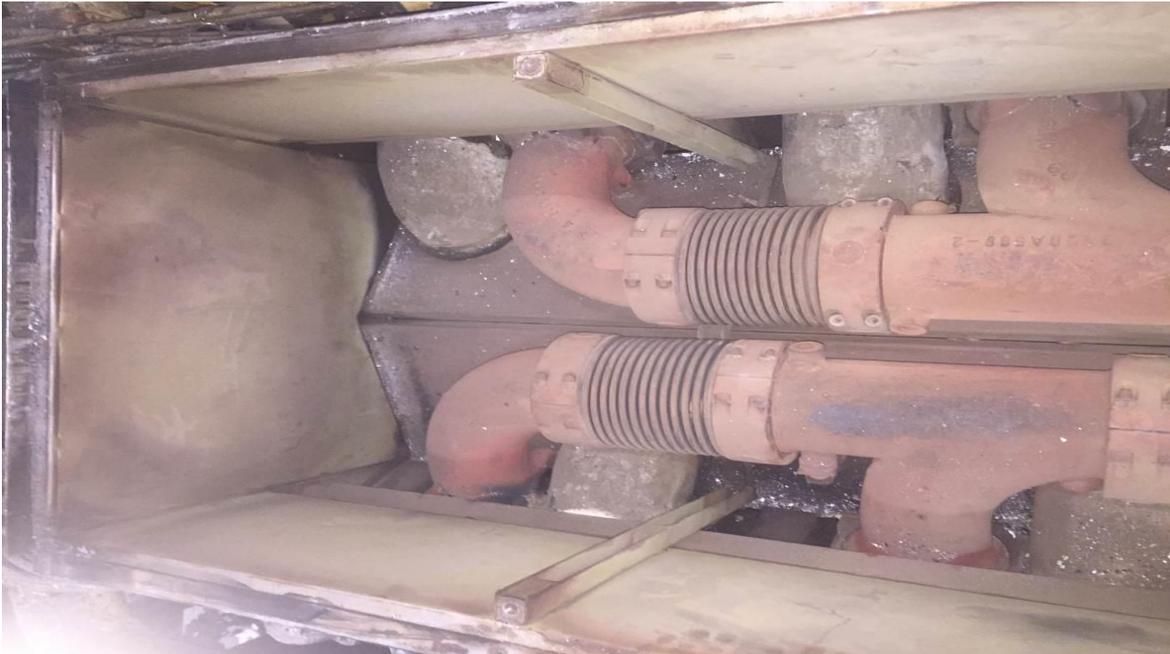
It was apparent from the physical evidence that Fuel Oil spray from a supply pipes flange exposed to a hot surface of the exhaust gas manifold would have been enough to ignite the Fuel Oil mist.

Fig.15 Exhaust manifold on the top of the engine

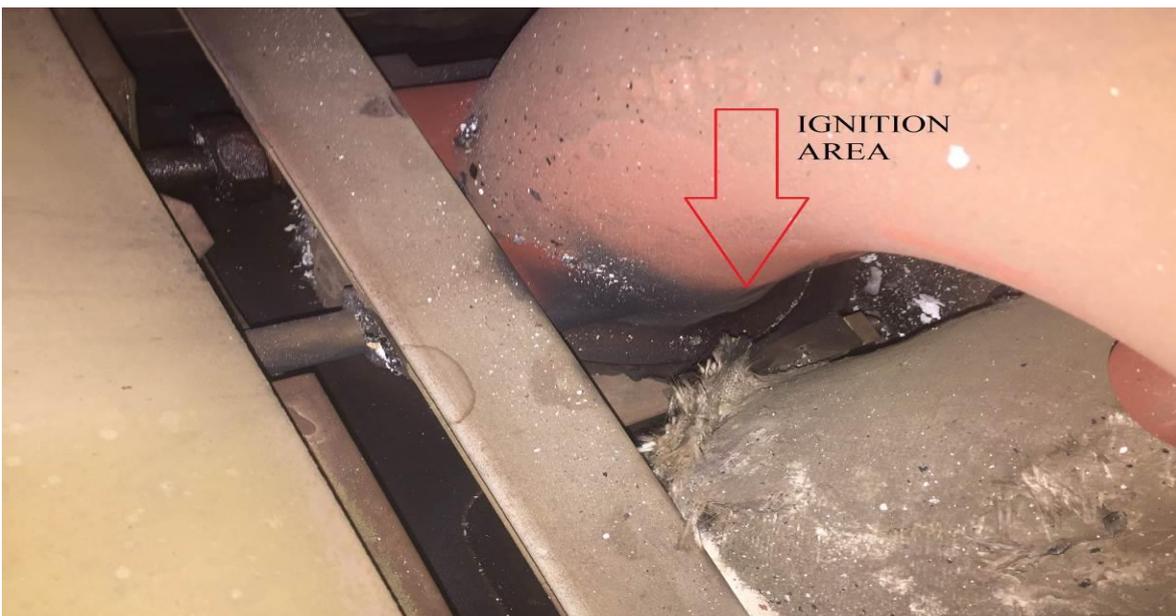
On ZIRCON, as the first screw (Fig.16, arrow 2) become loose, the joint slip on flanges (side sliding relative flange to flange) and bending loads started effecting second screw (Fig.16, arrow 1) leading to fracture.

Fig.16.Exhaust from cylinder A6, ignition of Fuel Oil

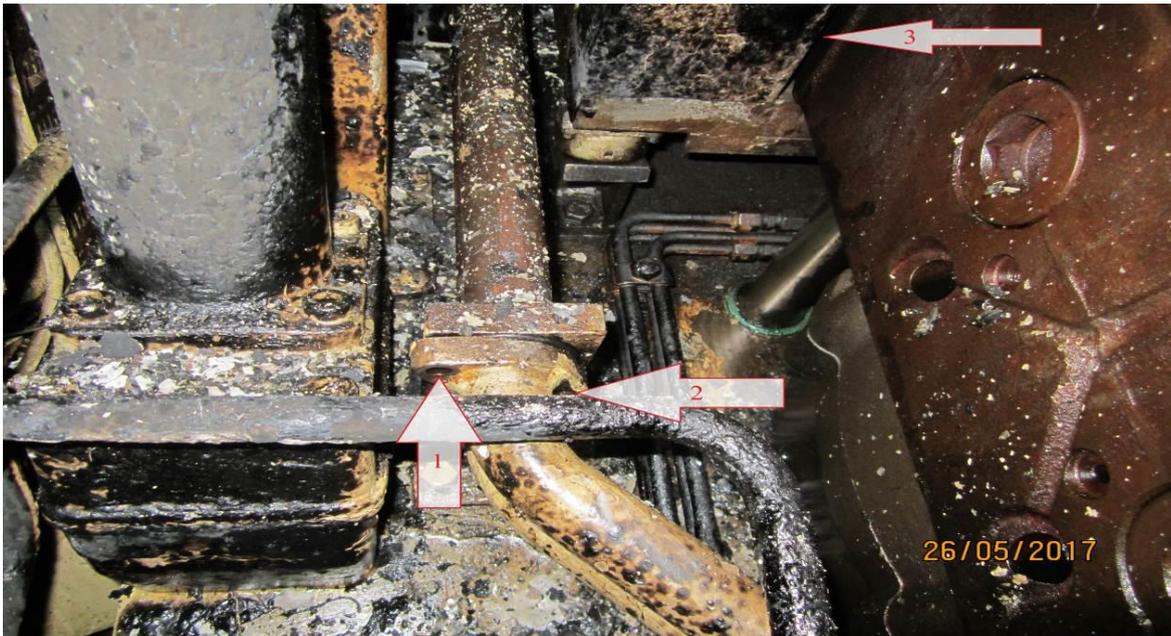
When engineers carry out daily routine engine-room rounds, which include walking through machinery compartments, examining ME, DGs, etc., no one spotted that the lower screw was missing on the flange joint. Another Fuel supply pipe hid the missing screw on flange.

The hot exhaust manifold was the fire's ignition source and spray (leak) was the fire's fuel source. In turn, the missing and fractured screws loosening the joint caused Fuel Oil spray under pressure.

Fig.17: arrow 1-fractured screw, arrow 2-missing screw, arrow 3-gap in manifolds insulation box.

- Post-fire repairs had been completed to full RINA satisfaction.
- ME pipework had been fully replaced with original maker's spare parts. Additional covers and barriers had been installed around pipework flanges.

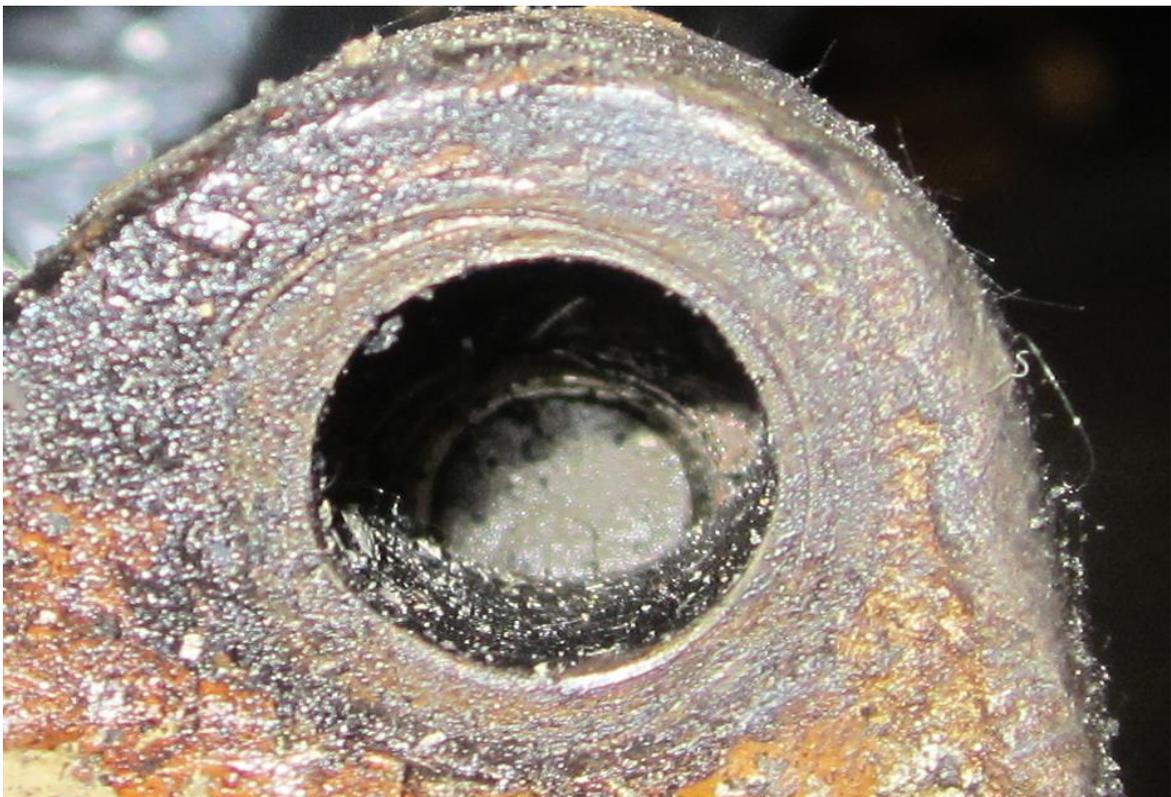
Fig.18 Screw hole on flange.

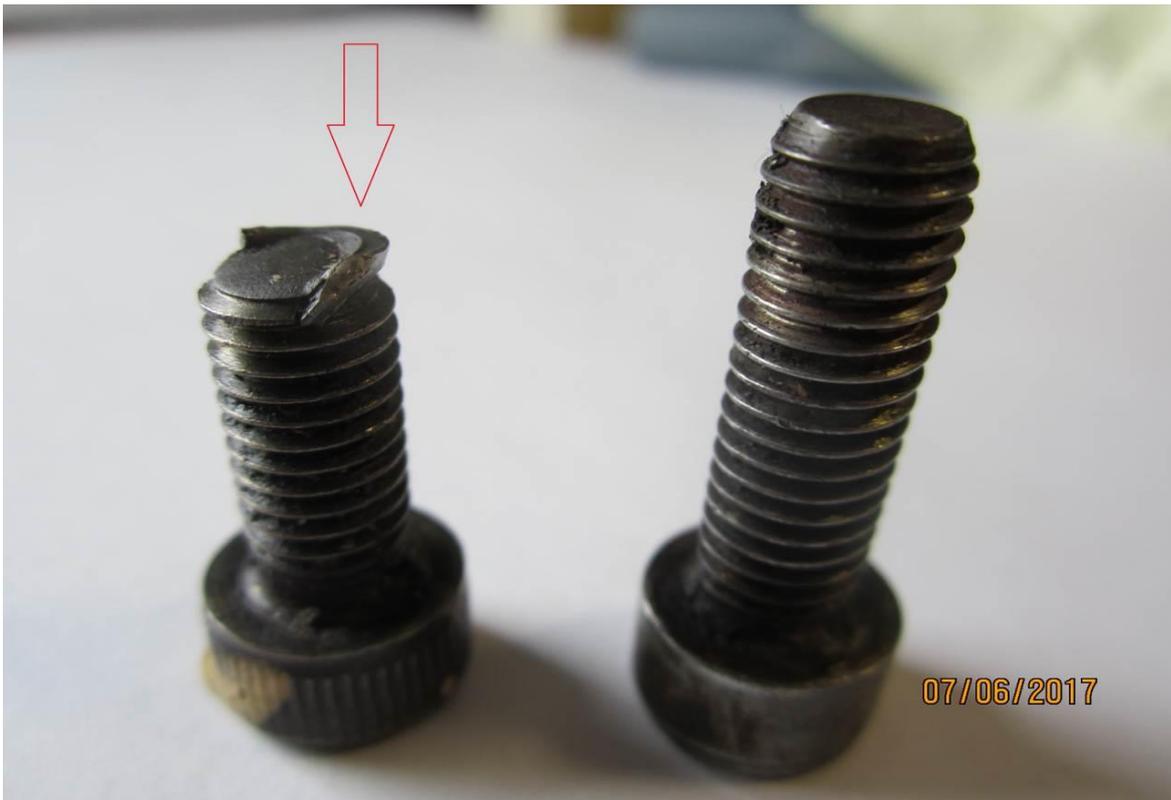
- one M8 screw was missing from its place on flange;
- another M8 screw fractured, loosening the joint completely;
- hot surface of the exhaust gas manifold ignited the fuel oil mist;
- both screws were found under the cover of high-pressure fuel oil pump cyl.A6

Fig.19 Fractured screw and missing one

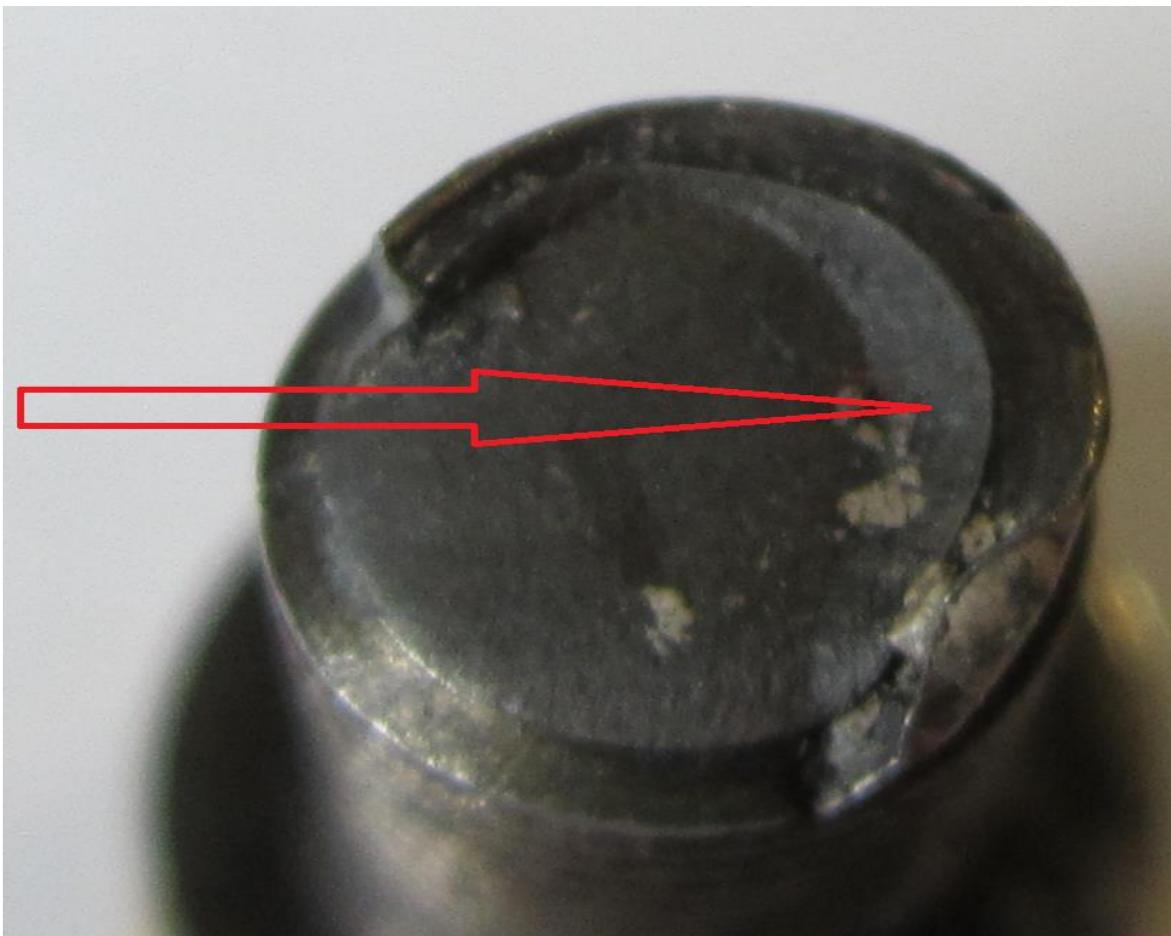
Fig.20 Area where fatigue developed under banding loads.

The fractured screw was sent to Riga Technical University Department of Material Processing Technology for expertise. Examination of the fractured screw revealed that the failure was caused by fatigue. Fatigue occurs when a material is subjected to repeated cyclic stresses, the magnitude of which is below the strength of the material.

As from laboratory analysis, the cause of the fracture of the screw is of a variety of operating loads: engine vibrations, fuel pressure change and maintenance errors. The output of the lower screw from the flange developed banding loads in remaining one. Screw breaking occurred in the second, third full wind, in the screwed part of the housing, where higher load concentration exist. Fractured screw has fatigue, fracture nature. Screw materials are fine-grained.

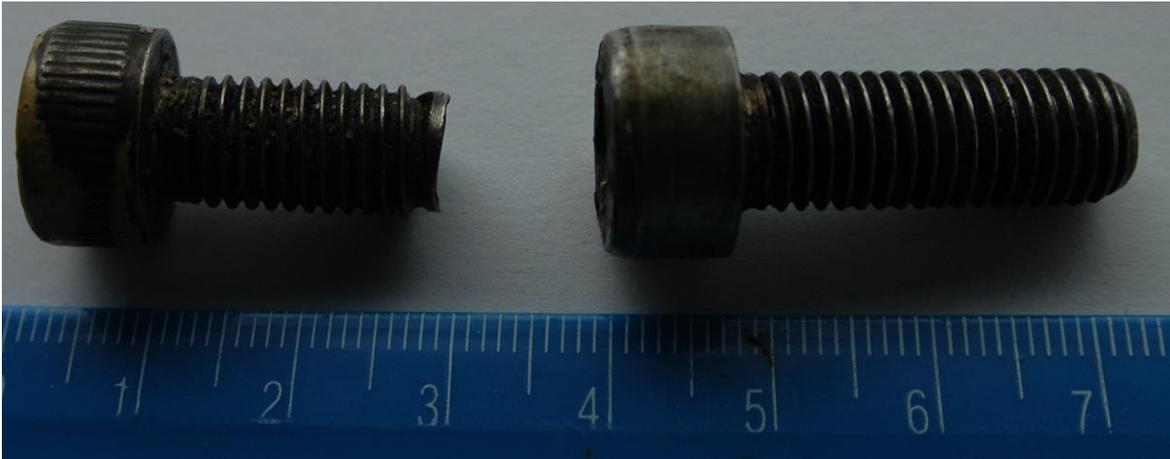
Fig.21 Size of screws (M8).
