Transport Accident and Incident Investigation Bureau of the Republic of Latvia

Report Nr.2-2017

Fall of stevedore on container ship Wes Janine during cargo loading operation with loss of life in Riga port on 20.02.2017.

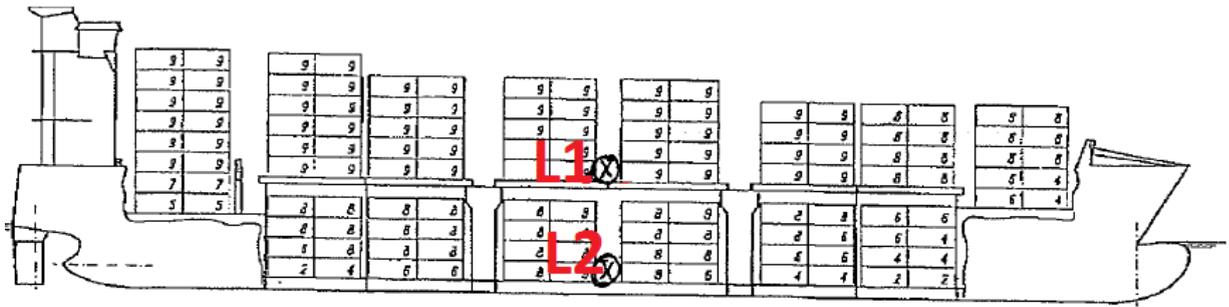
Fig.1. Outline of vessel's cargo tiers; "L1"-location of stevedore on twindeck during cargo loading operations; "L2"-location of stevedore to be found on deck after fall ($\Delta H=10,36m$).

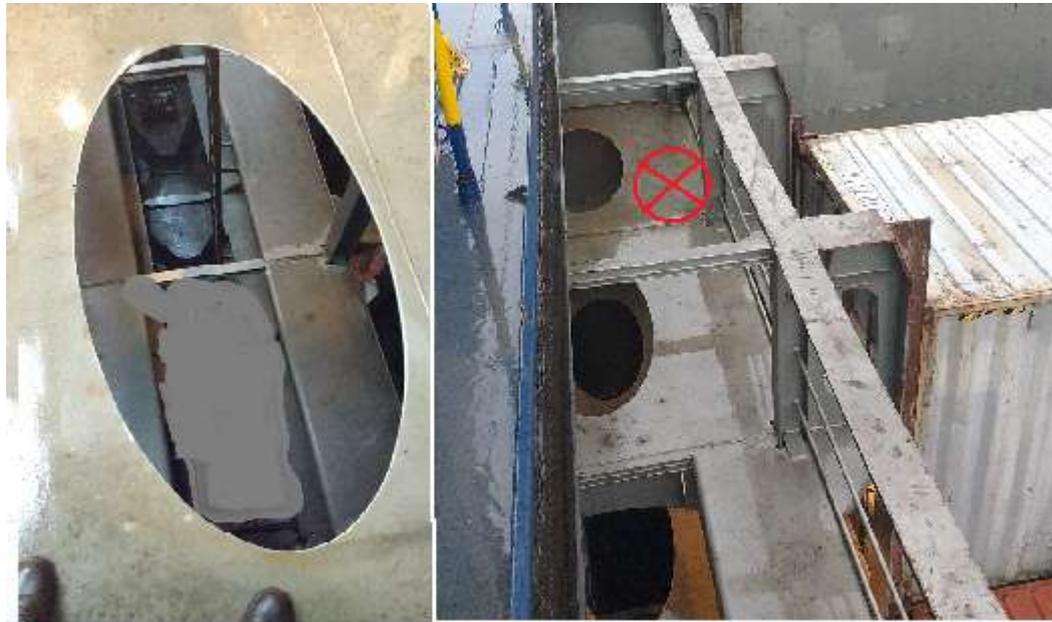
apertures normally are not guarded by any means of physical barriers neither warning signs. The overall height of vertical open space beneath two sequenced lightening opening is 10.36 meters on site of accident (Bay18 (Hold No.2))

Fig. 2. Left: Lightning hole in guide cell area of the ship; Right: twin deck within cell area; assumed standing point of stevedore (between guardrail and opening) before the accident is marked by red symbol.

6.2. Without any witnesses to the accident, it is not possible to establish what stevedore was doing prior to the fall while standing in guide cell area. Reportedly conscientious in his duties, as well as according to port crane integrated CCTV records, he could have been engaged in a number of activities to monitor the cargo operation. In these circumstances, it would have been possible for him to have stepped into unguarded lightening hole and fallen (10 meters down) onto the bottom of cargo hold.

The general policy of crew was "delegate responsibility" completely to RUT in matter of cargo handling operation. Walking in the guide cell area does not present an inordinate hazard. However, when the cargo loading operation is in progress and coastal personnel are involved, the same activity is potentially very hazardous. The risks of falling into an opening, also when the surface could be slippery from ice or water must be assessed by the ship's managers and practical control measures introduced to prevent accidents. Even primitive temporary barriers such as plywood sheet above lightening hole might help.

RECCOMENDATION 7.-2017: in framework of Wes Janine and other vessels' SMS re-assess safety procedures and control measures for containers loading/unloading operations: additional risk assessment, including guide cell areas, putting physical barriers in dangerous areas, specified instructions for watchkeepers and standards of ship-shore interactions (see Para 5.7.3.)

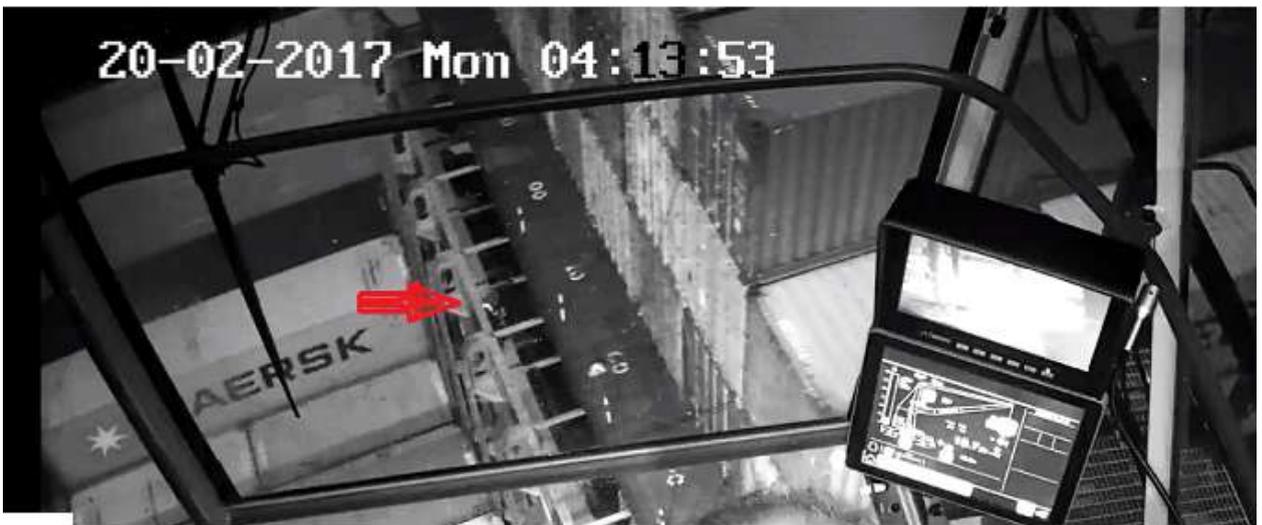
5.1.3. Crane operator and Signaller interaction: Signaller, while executing normal loading operations, stood in guide cell area on tween deck, which is designed as set-forward athwartship gangway (in relation with the inner space of adjacent cargo hold) restricted by guardrail toward bow. Periodical exchange of information between designated Signaller and crane operator have being done between 02.00 -05.00 LT by radio. Crane operator was alarmed by stevedore's silence (not answering on radio and phone) around 05.00 LT. Crane has installed closed-circuit television camera: video recording during loading operations displays Signaller standing within guide cell area before 04:13:53 LT, when the stevedore is seen last time.

Fig.3. Snapshot of crane's integral CCTV. Stevedore (in fluorescent coloured jacket) is noticeable last time on the screen (marked by red arrow)

It is impossible to define precise time, when stevedore assumedly fell into floor opening; it is likely that he fell between 04.14 and 05.00 even though his body was not discovered until 06.00.
