**FINAL REPORT No.4-02/8-12/5-13
ON THE AIRCRAFT SERIOUS INCIDENT**

**LOSS OF SEPARATION STANDARD BETWEEN THE KLM AIRCRAFT B737-800,
flight KLM903, REGISTRATION PH-BXN and FINAIR AIRCRAFT E190, flight
FIN746L, REGISTRATION OH-LKH IN THE VICINITY OF THE POINT ATRAK
ON OCTOBER 20, 2012**

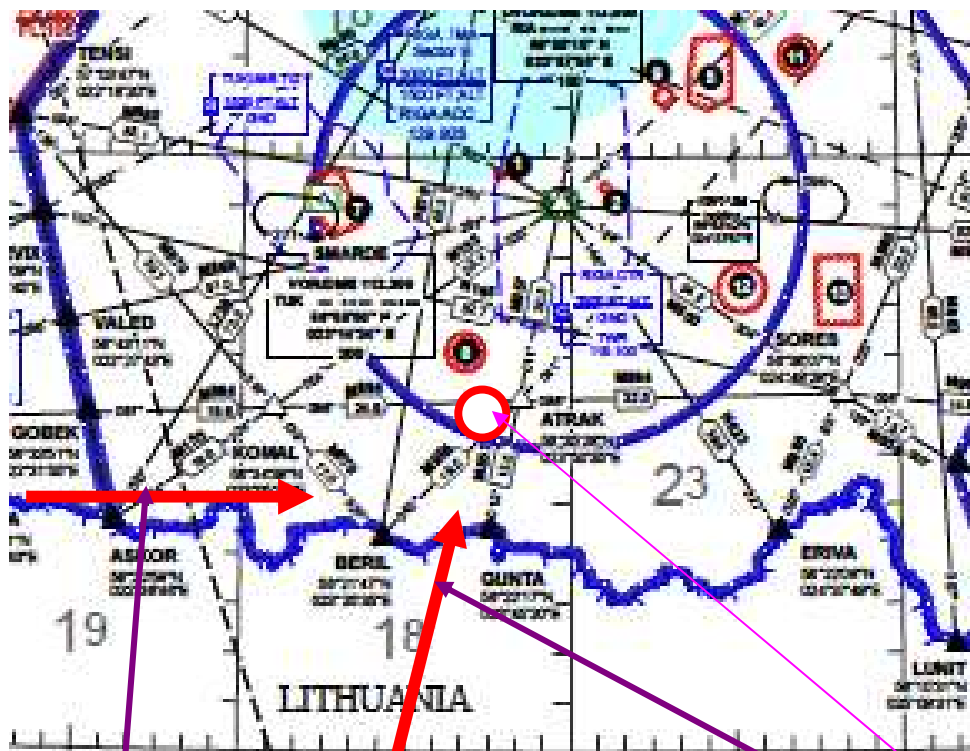
Aircraft were flying on crossing tracks, FINNAIR, EMBRAER 190, aircraft call sign FIN746L with 86 passengers on board was cruising at FL390 to North, KLM BOEING 738, aircraft call sign KLM903 with 157 passengers on board was cruising eastbound at FL380.

KLM903, FL380; Figure 1 Crossing tracks of aircraft FIN746L, FL390; point ATRAK

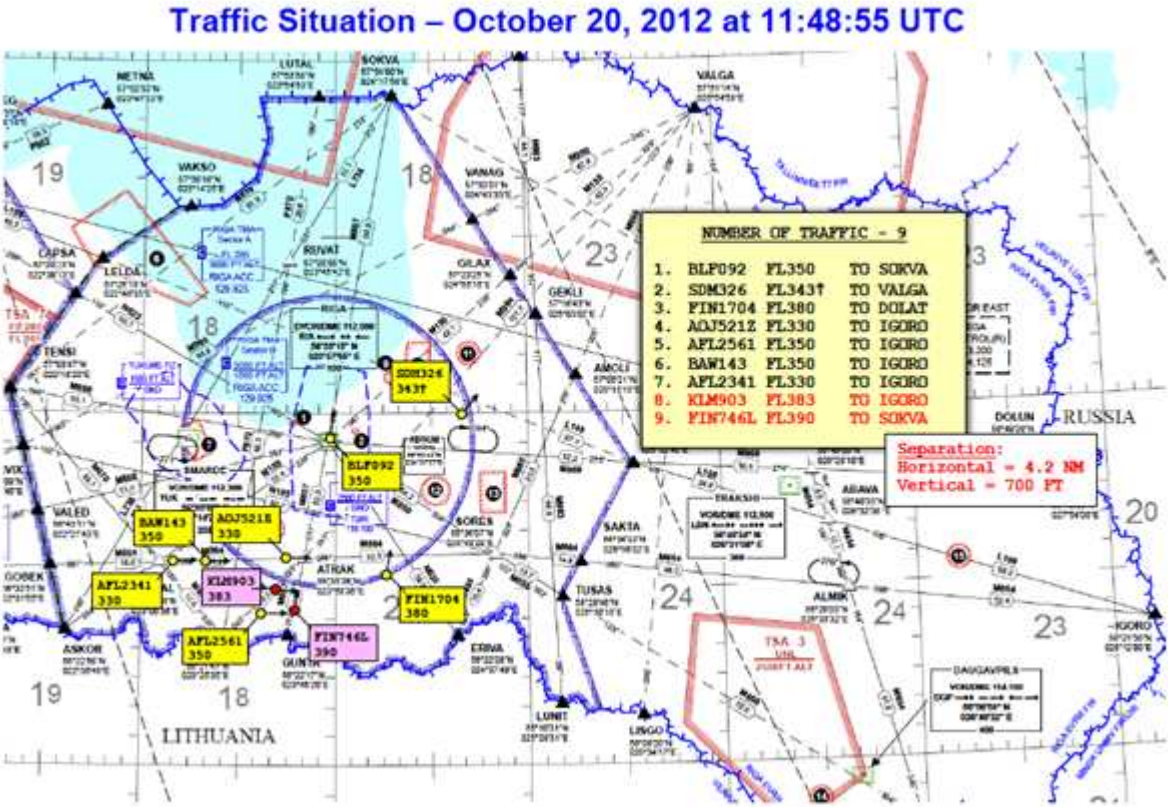
Figure 2 Traffic situation in sector EAST

At the time of incident at the Riga ATCC, in sector EAST for controller with operational role “EAST Executive” AoR were 9 (nine) aircraft.

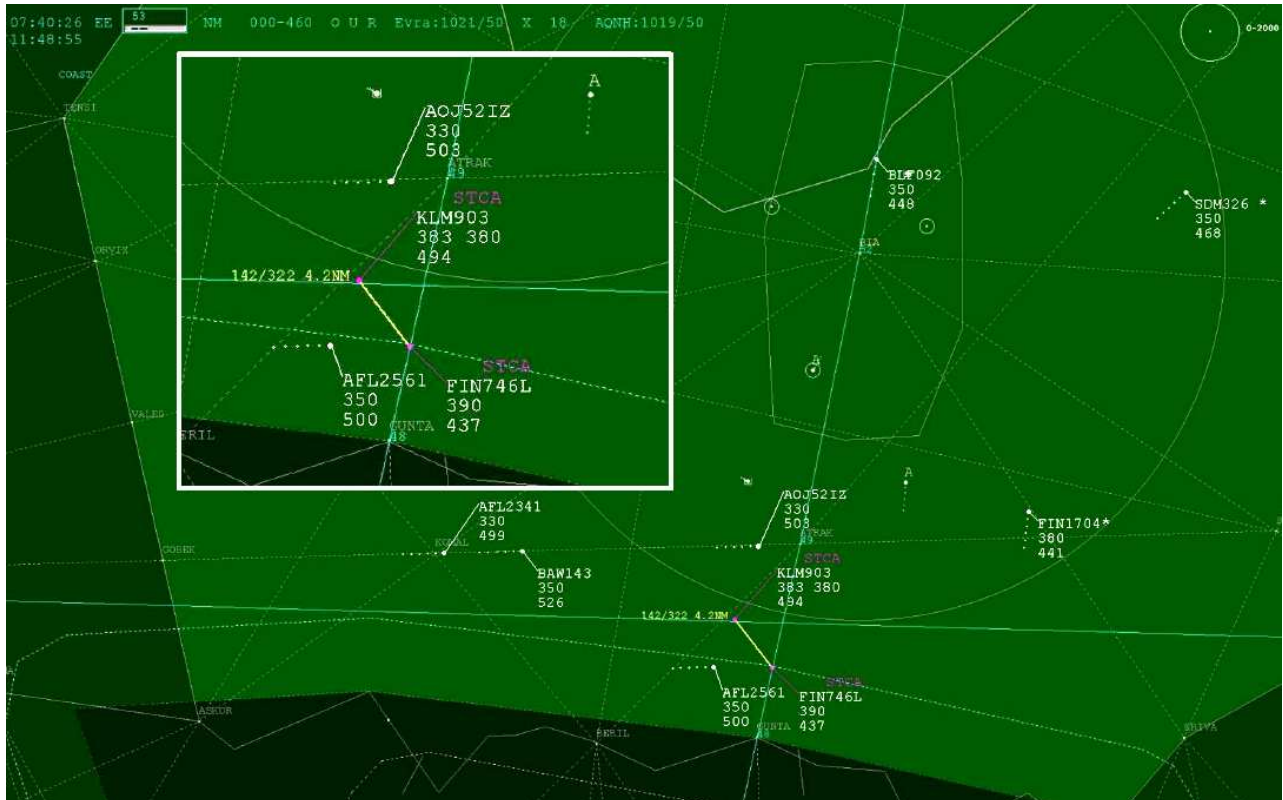
Figure 3 Aircraft at the AoR of sector East controller (radar recording)

At **11:43:19** involved in the incident Boeing B738, KLM903 coming from Amsterdam at FL380 established radio contact with the sector EAST controller executive on frequency 133,2MHz. Controller identified KLM903.

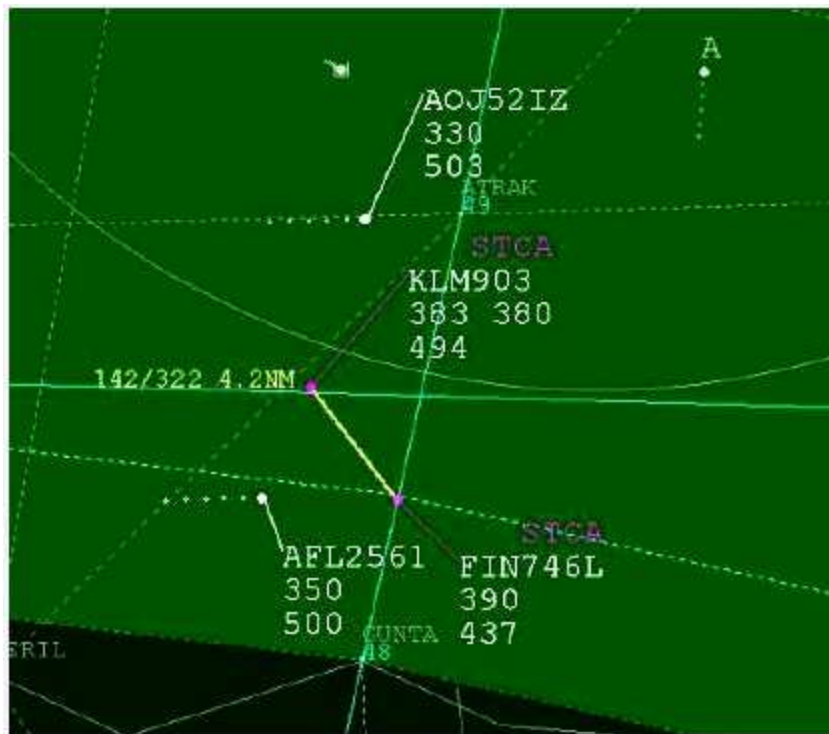
Figure 4 Radar data

At **11:48:55** KLM 903 was at FL383 at ground speed 494KN on heading 092 degrees,

FIN746L was at FL390 at ground speed 437KN on heading 012 degrees. Separation between traffic was **4,2NM**.

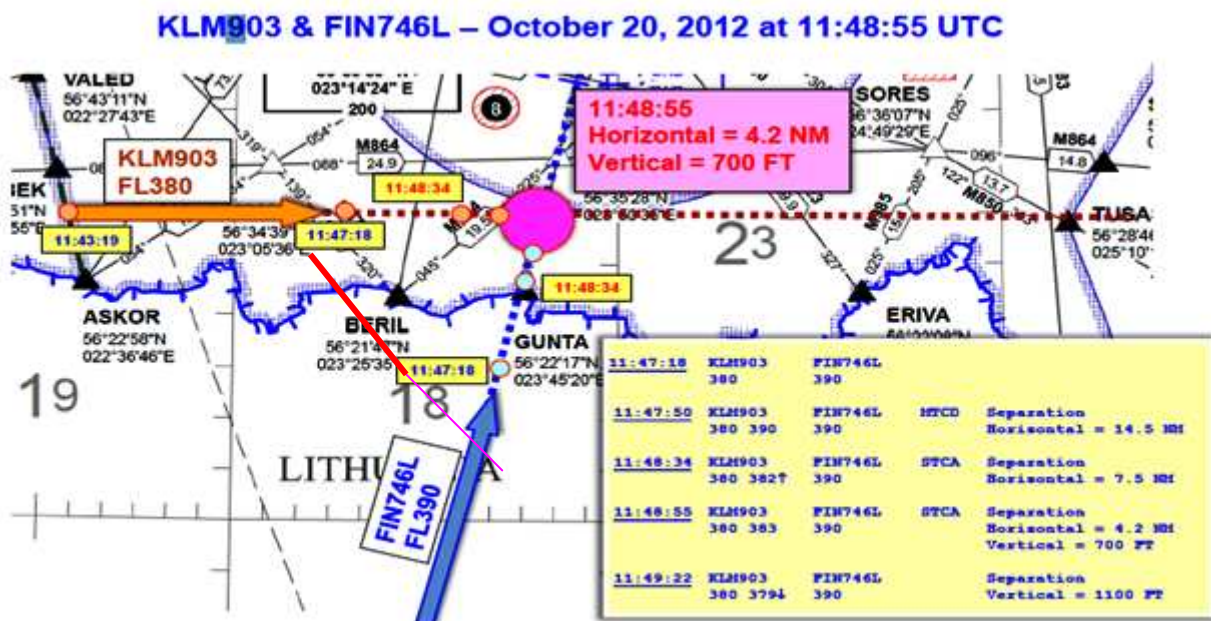
Figure 5 Traffic situation during incident

Conflict situation was resolved now, but separation standards were infringed between aircraft.

Horizontal separation between aircraft was **4.2NM**, vertical **700FT**.
