FINAL REPORT No.4-02-9/2012(4-2014)

on THE ACCIDENT

of AIRCRAFT TECNAM P2006T, REGISTRATION YL-SVN ON NOVEMBER 13, 2012, GARKALNE MUNICIPALITY, IN THE LOCALITY OF BUKULTU VILLAGE

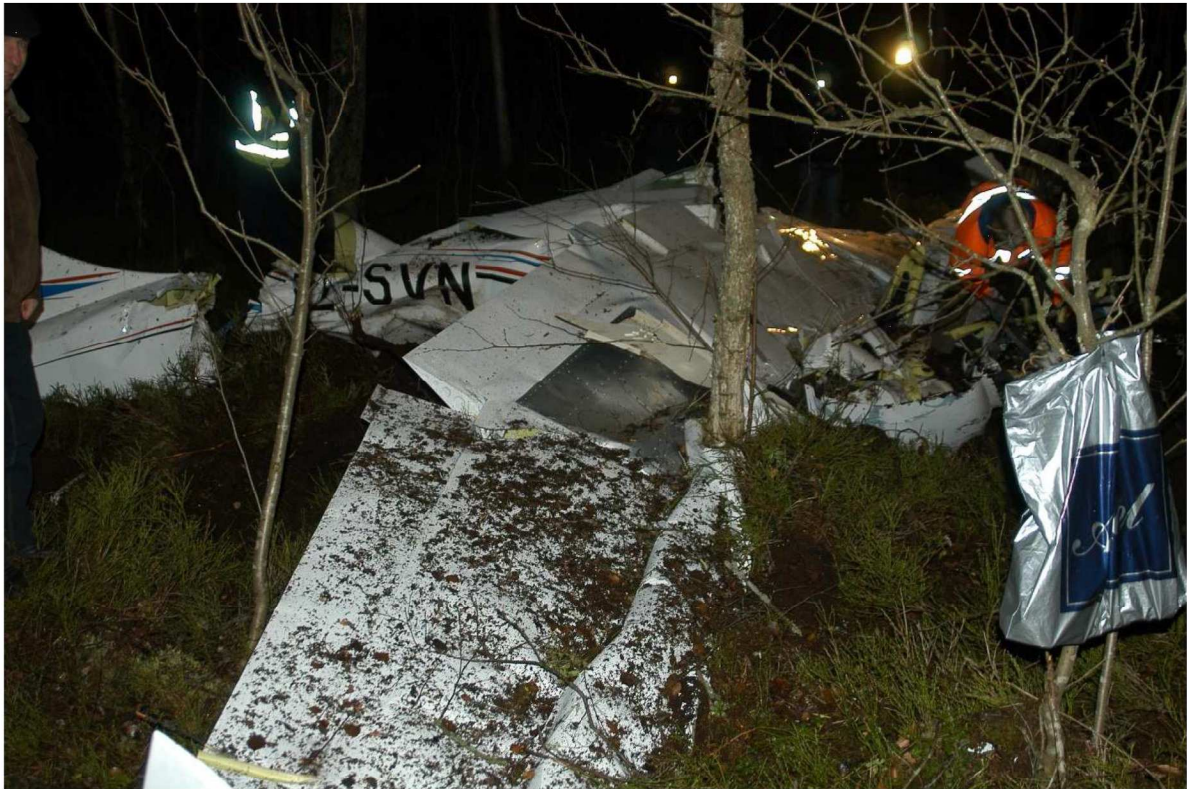
Image2. Aircraft TECNAM P2006T reg. No.YL-SVN after the aviation accident

Colliding with ground the aircraft was completely damaged, the wings were deformed and broken, the tail part with vertical stabilisers and rudder was broken off from fuselage, the front side, and pilot cockpit with instrument panel and both engines were sank in marsh and completely destroyed.

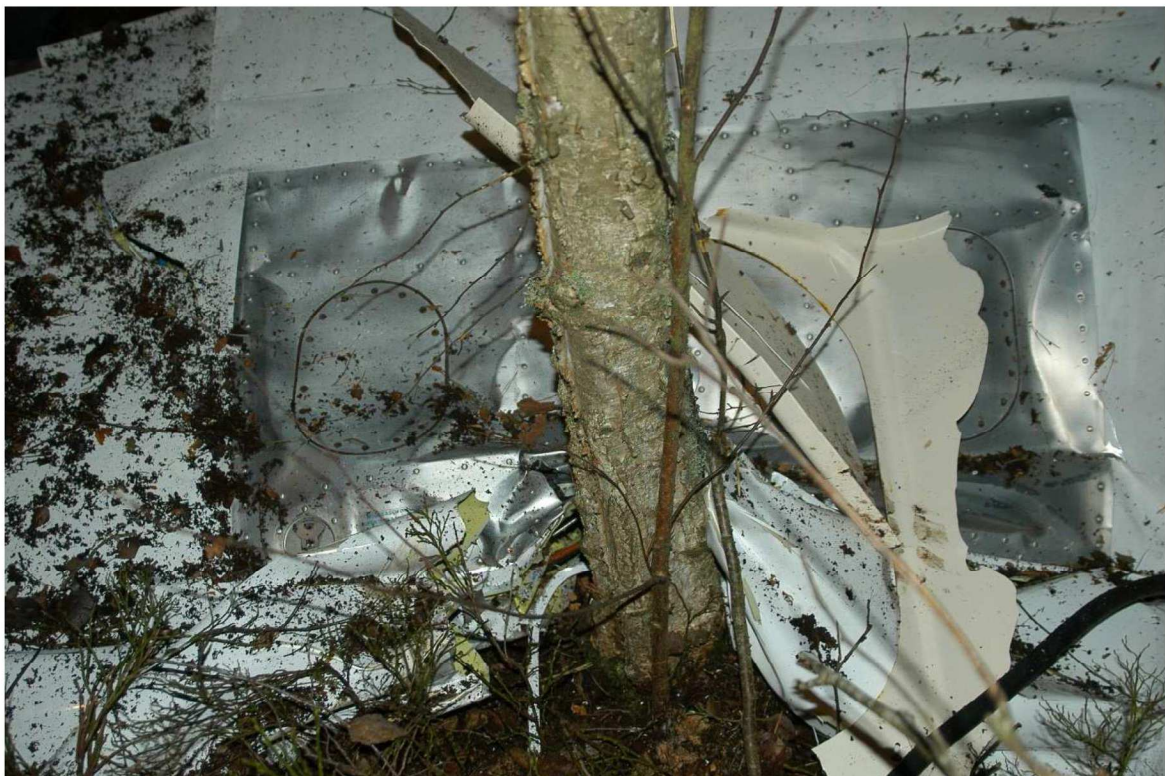
Image6. The right wing has been deformed due to the impact, colliding with the tree stem;

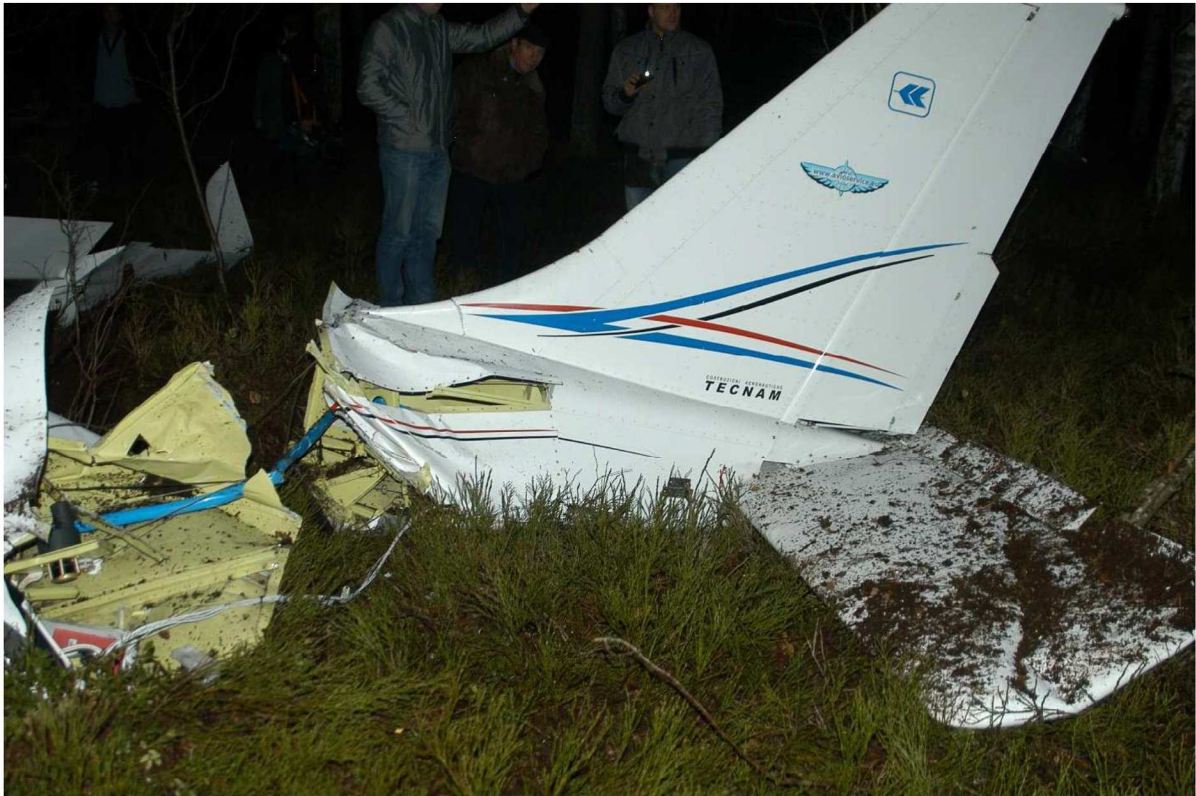
Image7.Tail of the aircraft fuselage (rudder, fin and vertical stabiliser) is broken off from fuselage.

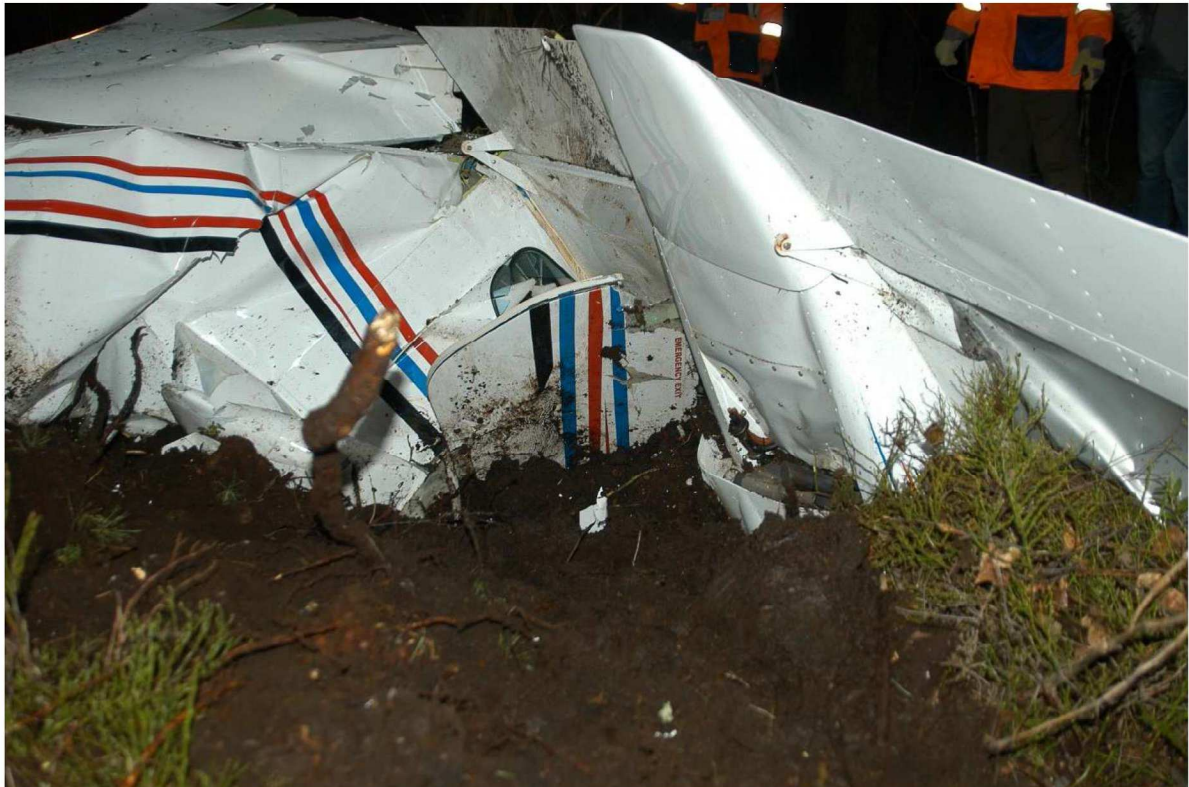
Image8.The aircraft fuselage is deformed, the forepart of fuselage and engines due to the impact are immersed in the ground.

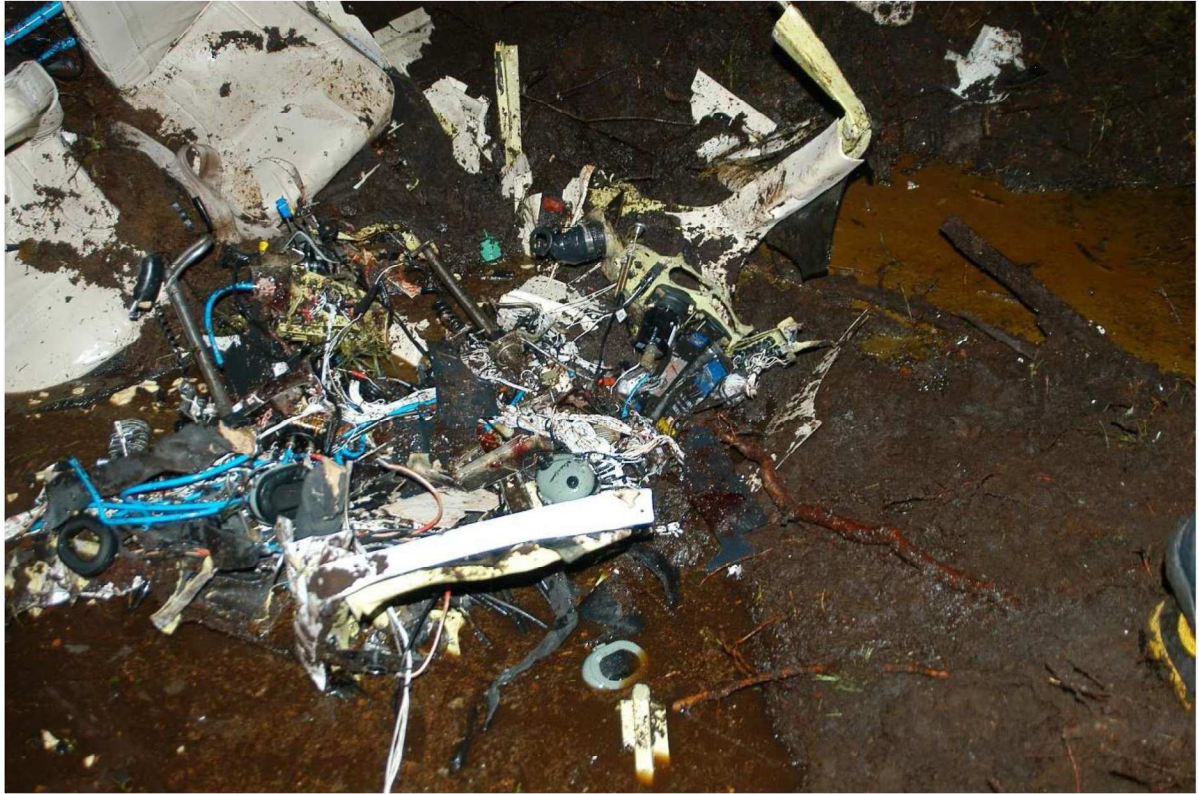
Image9. Forepart of the aircraft including instrument panel is fully destroyed.

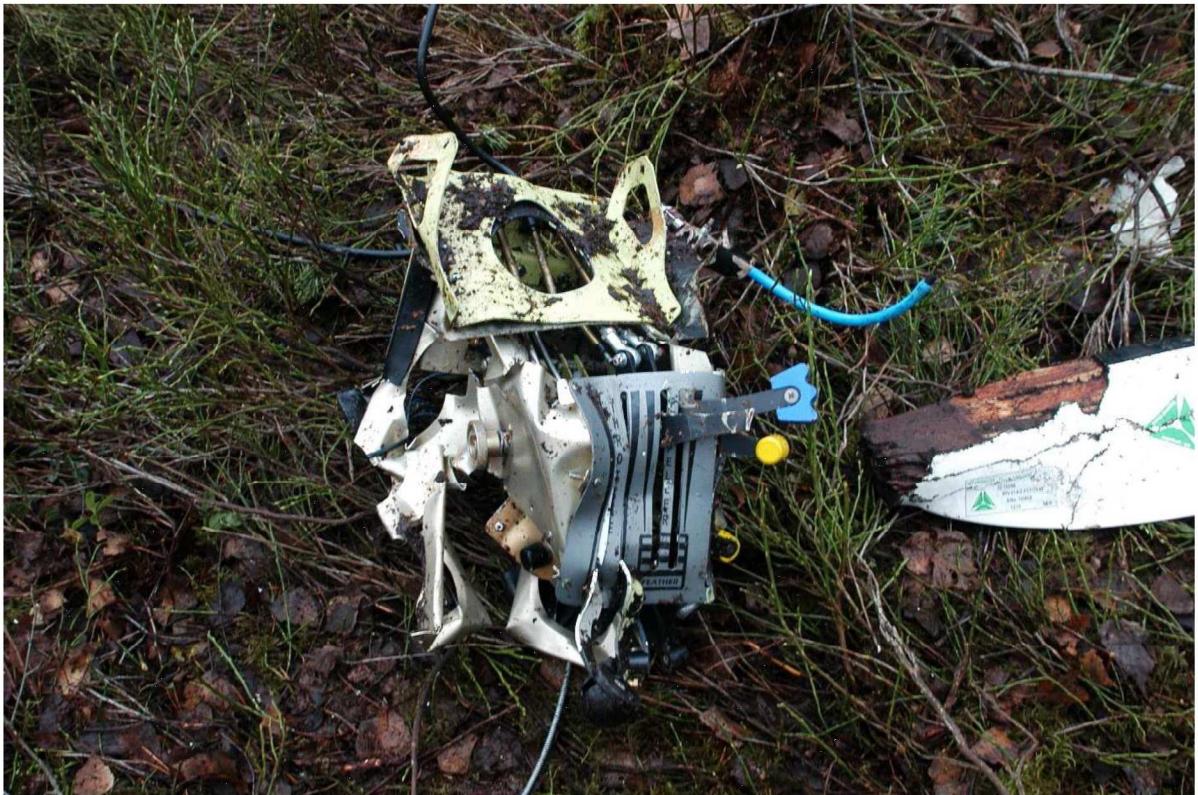
Image10. Handles of the controlling device „Central Pedestal” body are deformed and broken

On „Central Pedestal”, found at accident site, the throttle levers were in closed position, the propeller levers are in turned on position, heating of the left side engine carburettor is turned on, for the right side is turned off. Due to serious deformation it was not possible to ascertain with proof evidence the actual position of levers during flight.

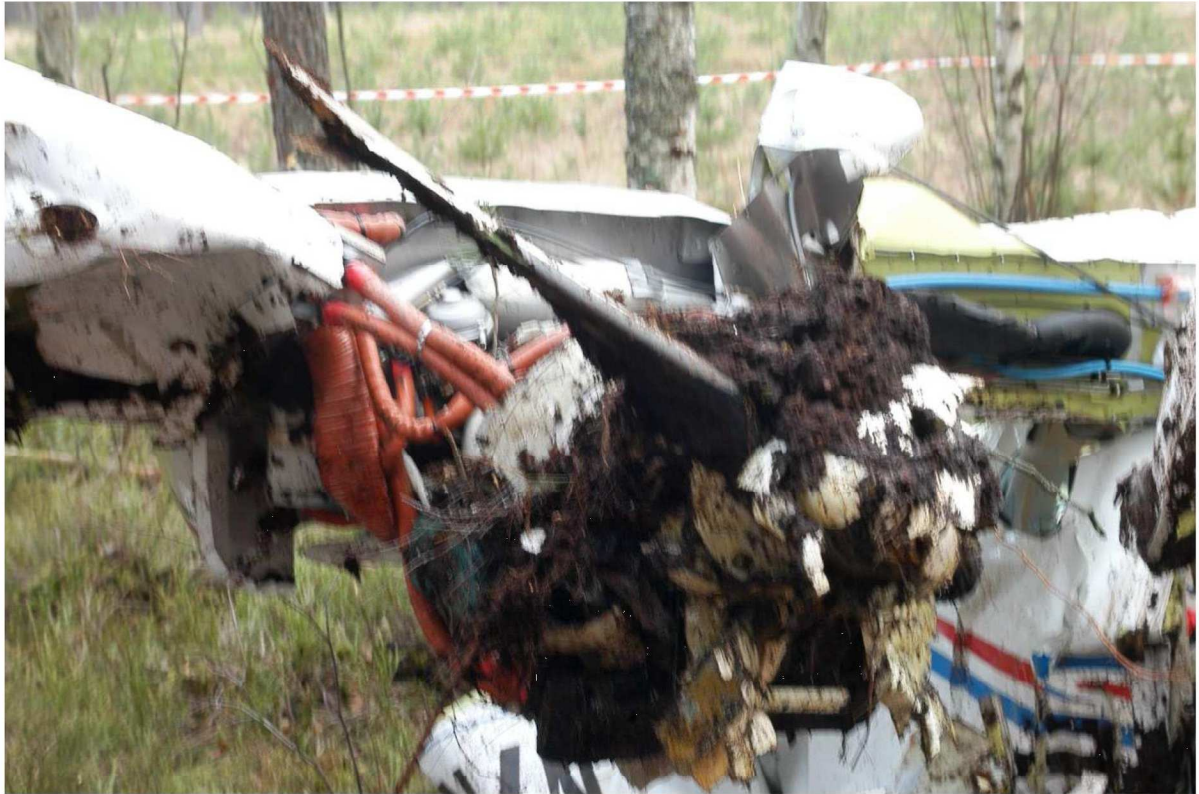
Image17. Right side engine after pulling out of the ground
Propeller blade of the right side engine was in position parallel to the airflow (propeller feathered)

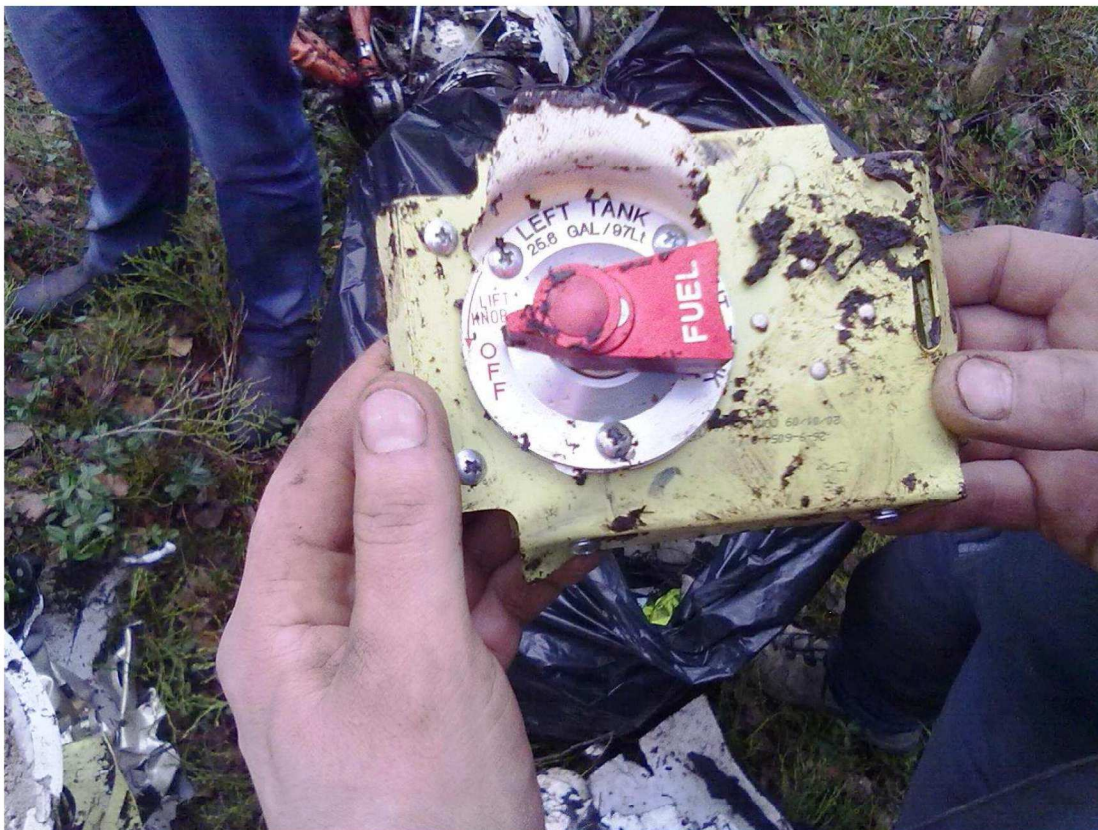
Image18. On the Right hand Fuel selector, found at the accident site, valve was in the position
"OFF"

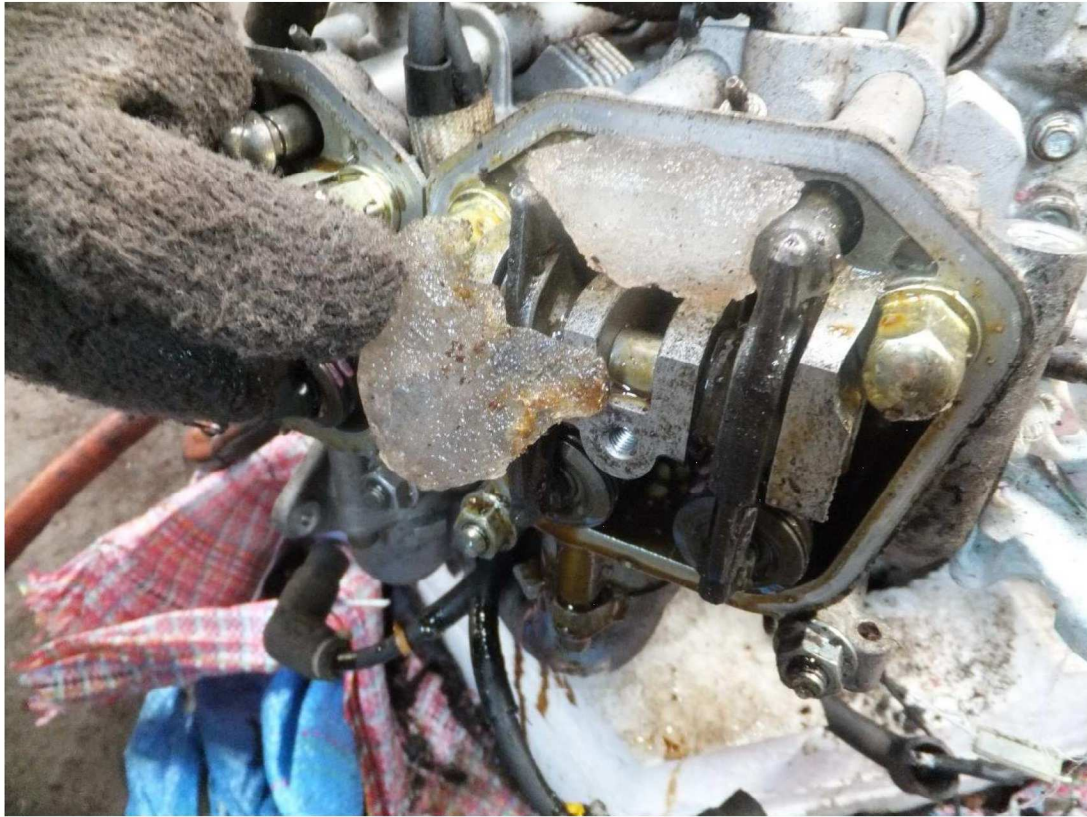
Image29. Engine parts

- In the engine cylinders due to the water the pistons are covered with rust and mechanical details attached to them is not possible to move;
- At water access points bearings and gearwheels are covered with corrosion;
- Cooling system radiator is completely deformed;
- Oil radiator is completely deformed;
- All exhaust system including the engine exhaust tubes is completely deformed;
- Due to the impact the oil radiator has damaged the 1st and 2nd engine cylinder.

- Inlet - exhaust valve pusher cases are deformed;
- Oil filter fastening flange at oil pump is broken;
- engine reducer shaft is bent, mechanical details and bearings are covered with corrosion which is caused by water;
- Engine inlet collector is completely damaged;

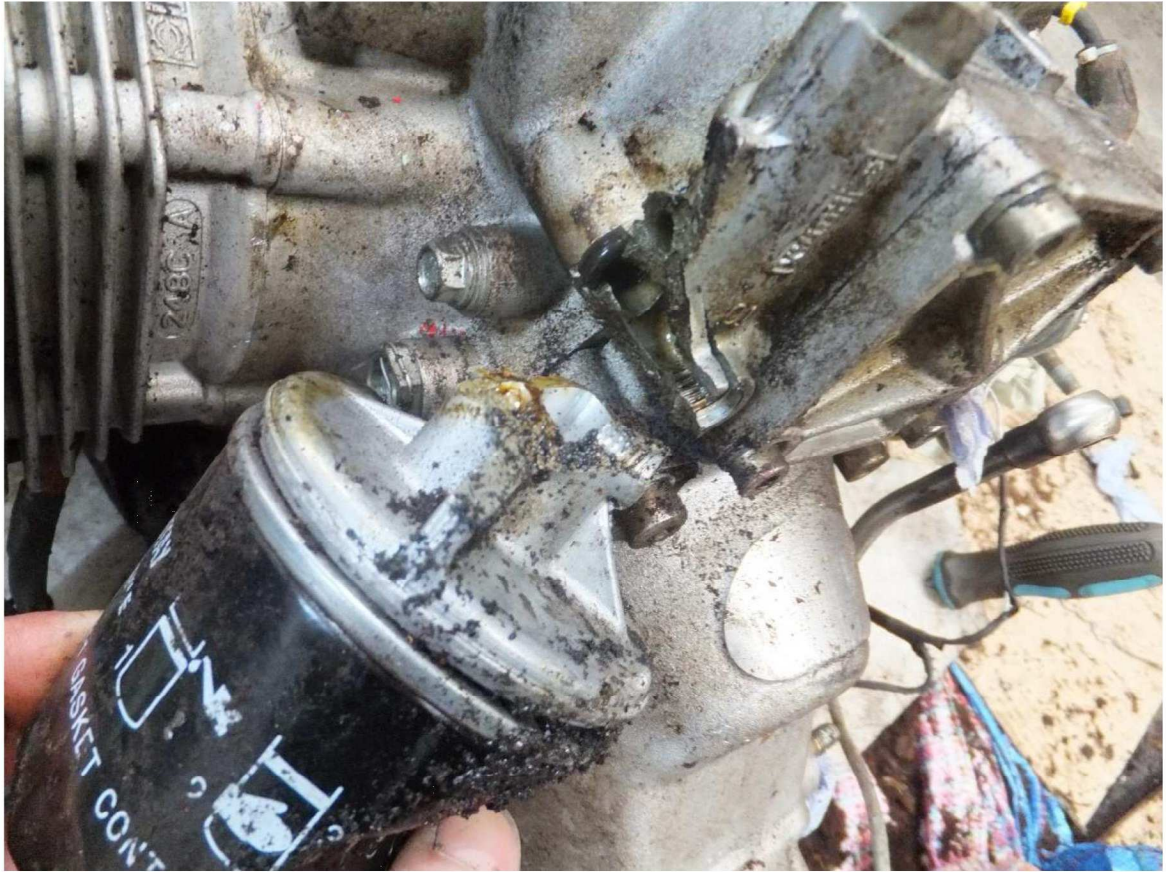
Image 30. Oil filter fastening flange at oil pump is broken

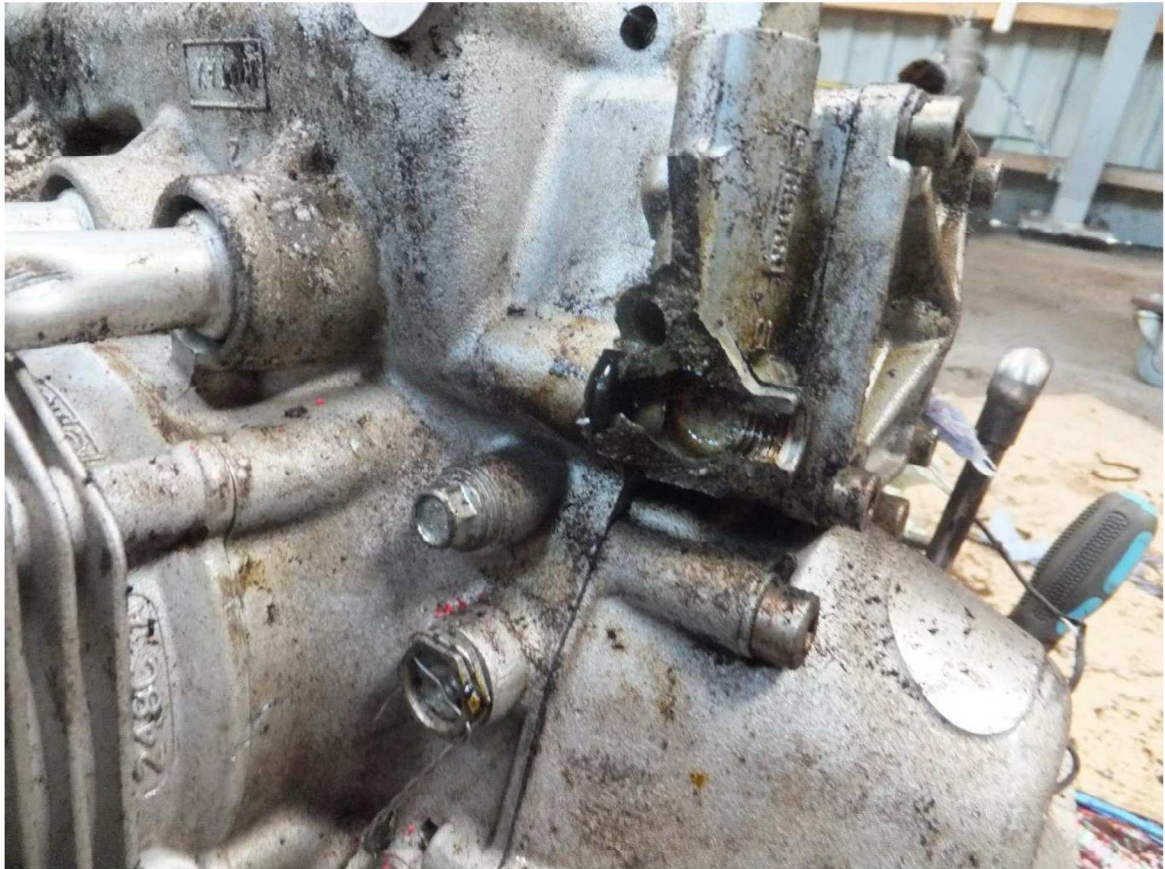
Image31. Engine damages

- Additional generator can not be restored due to the penetration of moisture and dirt;
- Oil pump gearwheel are rusty;
- Carburetor gear details are damaged;
- All fuel and oiling system tubes are damaged;
- Air supply and cooling system tubes are damaged;
- Oiling system metallic tubes are damaged;

Due to the damages of parts of control and regulation mechanism it was not possible to establish actual condition of the propeller of engine No.1; After the partial disassembling and examination of the engine No.1, Bombardier ROTAX 912 S3, series No. 4924100 it was found that starting of the engine for testing in the operating mode is not possible due to the damages, resulted from the aircraft collision with ground.
