Transporta nelaimes gadījumu un incidentu izmeklēšanas birojs

Simplified report Nr. 1-2020

Collision of Faroe Islands vessel NOSSAN with Latvian fishing vessel MARITA in Baltic Sea on 15th July 2020

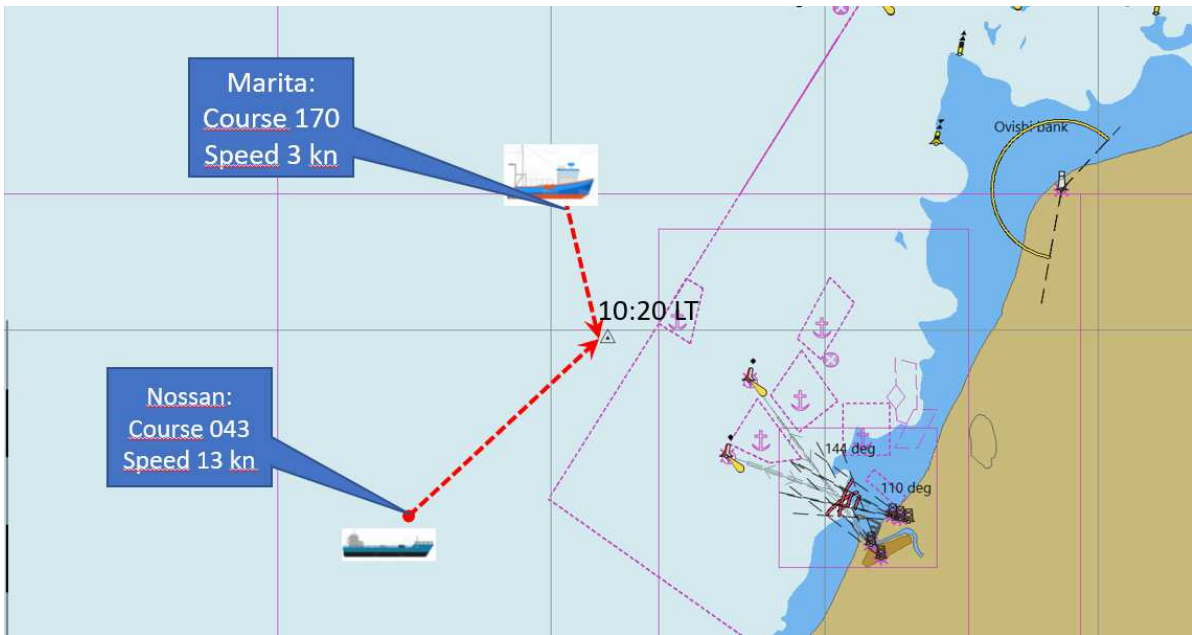
Image1: Visualization of geographical location of the accident and mutual movement NOSSAN-MARITA

Nossan & Marita : Master of Marita has noticed NOSSAN on close quarter situation at distance 5-6 nm and has started to call her at VHF 16 channel 16. NOSSAN has not respond/has not changed course. At 10:16 Master of Marita has realised the imminence of collision and has started manoeuvre turning helm hard-to-port in order to avoid from unresponsive NOSSAN. At around 10:20 NOSSAN has tangentially collided with the aft part of MARITA damaging superstructure. After collision NOSSAN has not decreased speed, has not changed course, continuing her voyage to port of Riga, where NOSSAN has arrived at 06.00 on 16 of July and consequently detained by Latvian Coast Guard. MARITA has hoisted all her trawls and immediately departed to port of Pavilosta, reporting the accident to Ventspils Port authorities..

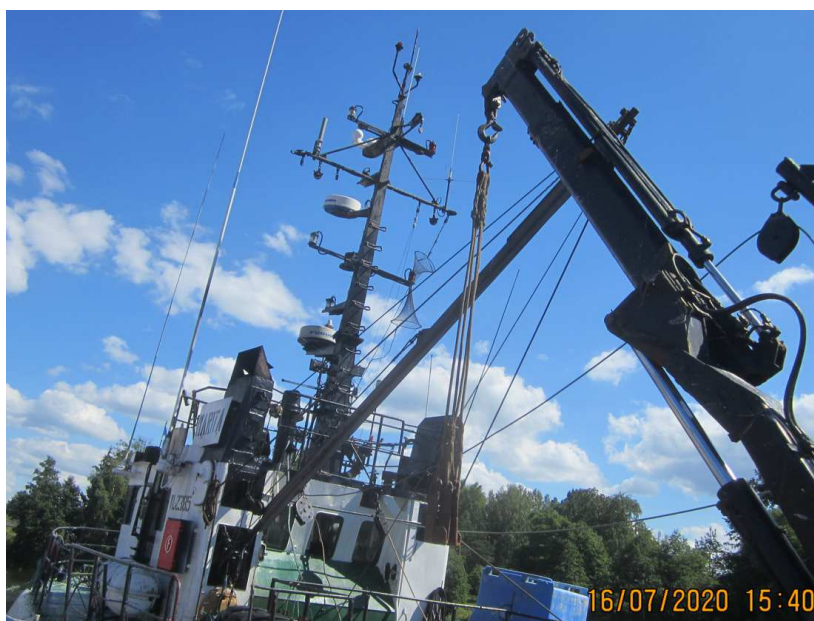
Image2: Fishing cone, hoisted on MARITA mast starboard side iaw COLREG Rule 26 “vessel engaged in fishing”.

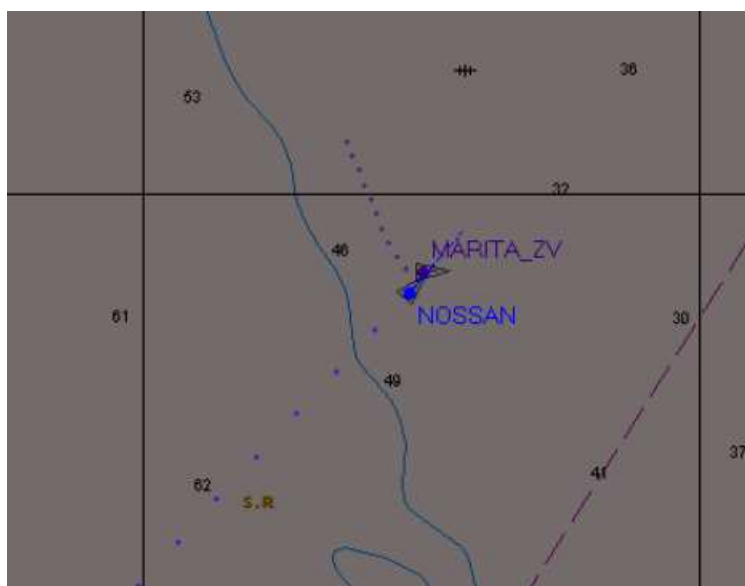
Image 3: AIS playback’s snapshot of collision moment. MARITA’s trajectory exposes avoidance manoeuvre 1-3 minutes before collision.

4. At 10: 17 Master of MARITA puts helm “ hard to port” and increase engine power to “full ahead” (putting fishing gear on risk of damage)
5. At 10: 20 MARITA and NOSSAN collides; NOSSAN’s bow hits aft superstructure of Marita.

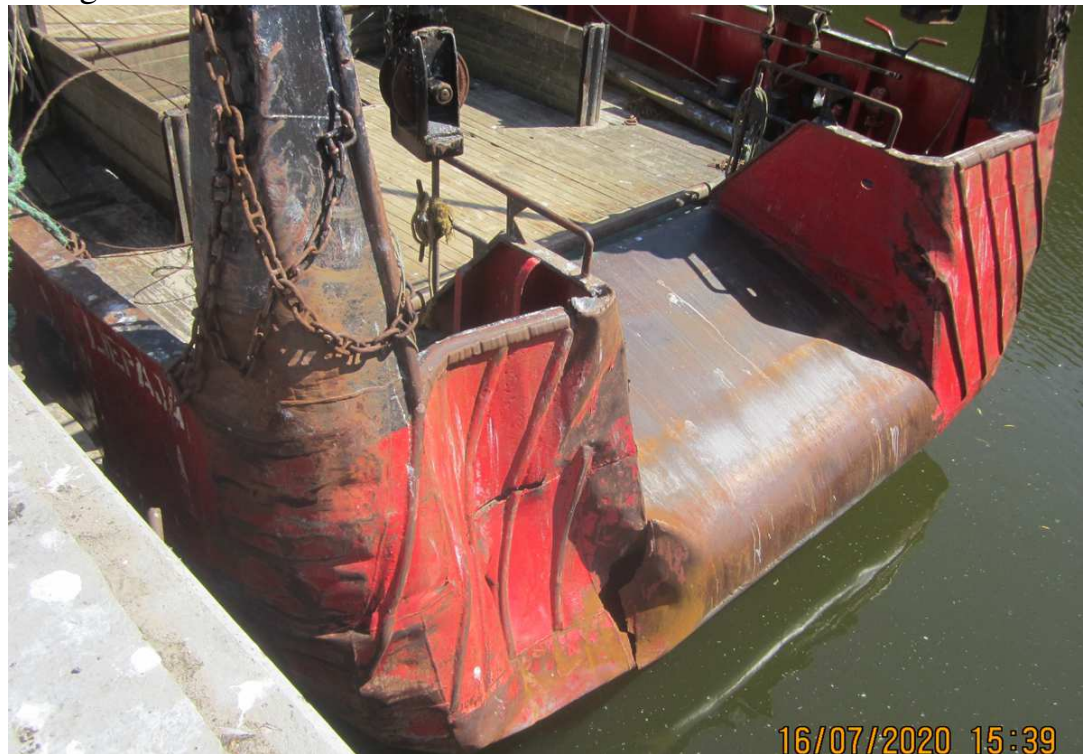
Image 4: Damaged part of MARITA on her aft

MARITA superstructure is damaged. App 1,5 x 1,5 meters of impacted area.

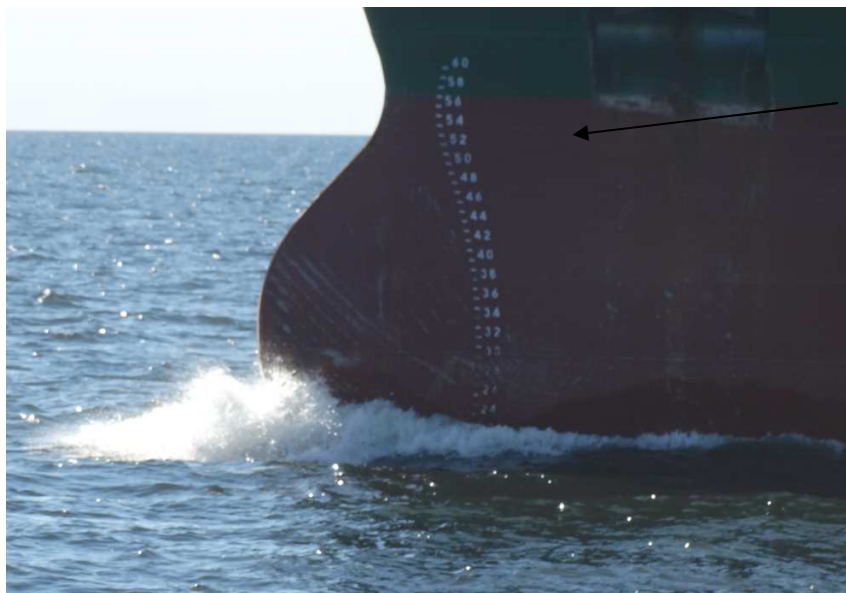
Image 5: NOSSAN' bulb with visible scratches on. Photo has taken by Coast Guard shortly after collision with MARITA

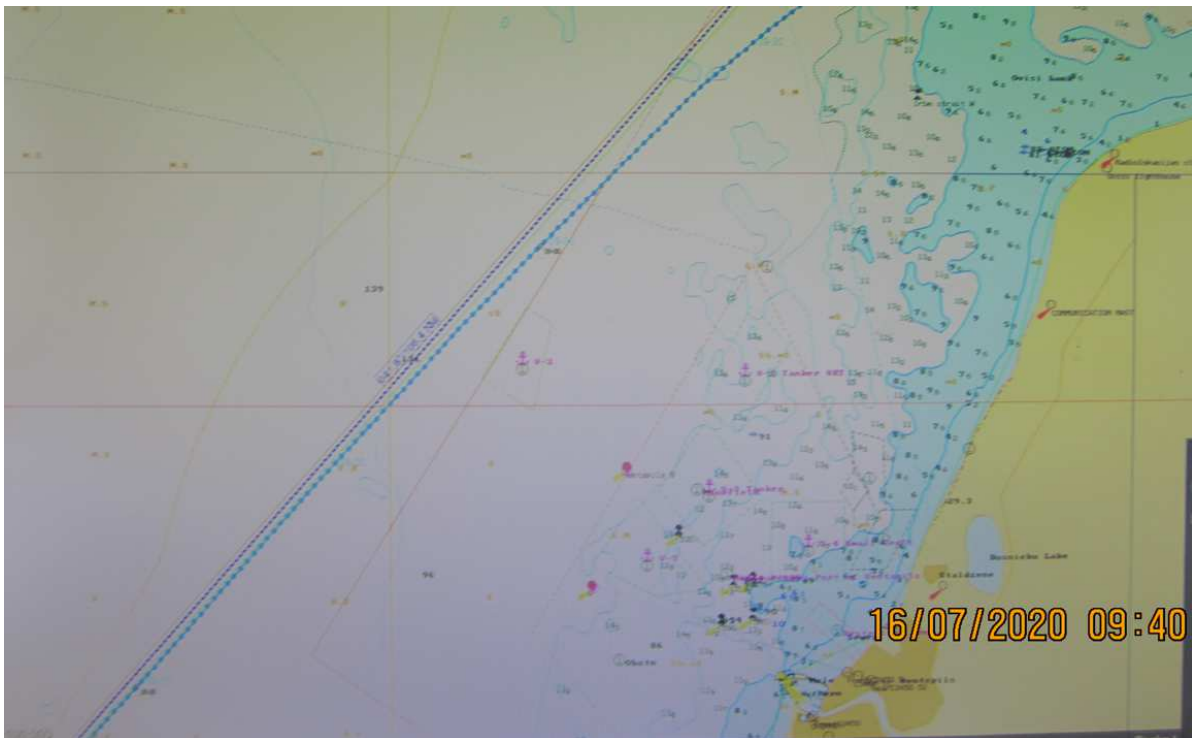
Image 6: Snapshot of NOSSAN voyage plan and factual transit in ECDIS.
