FINAL REPORT No 4-02/3-21(1-23)

on the serious incident to the aircraft Airbus A220-300 (CS300) registered YL-CSE operated by airBaltic runway excursion at the Riga International Airport (RIX), on December 3, 2021

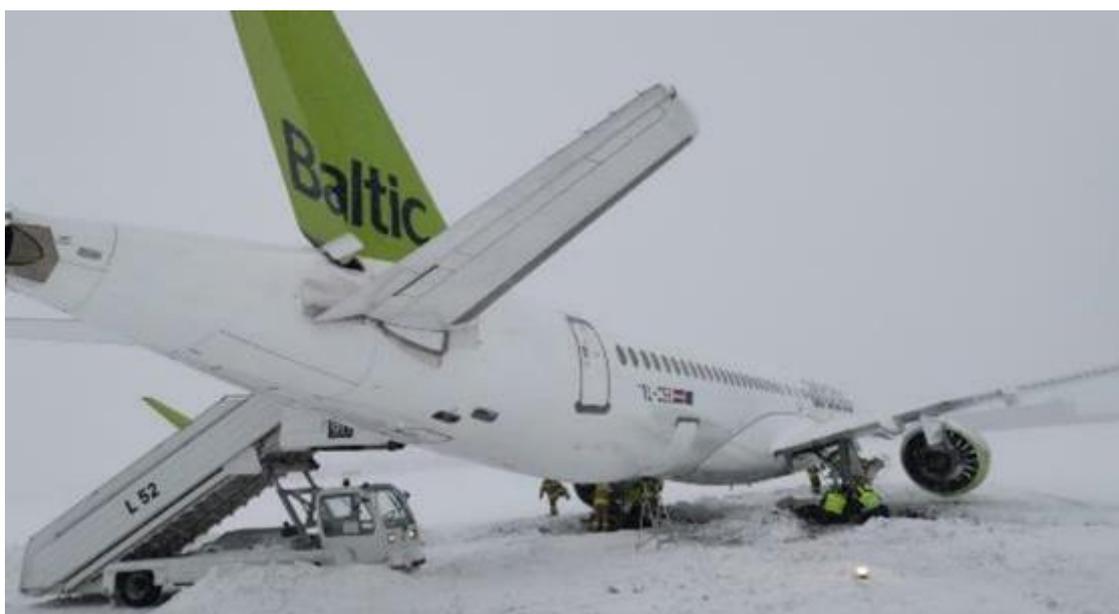
At **9:55** a.m. the flight BTI1M2 of the AirBaltic airline aircraft suffered a runway excursion after landing on the RWY 36 in the Riga International Airport (RIX). In adverse weather conditions (heavy snowfall) and reduced visibility conditions the aircraft lost directional control, skidded to the right side of the runway, broke the runway exit sign “Y” of the TWY with the LH engine inlet cowl and stopped in snow (see picture 1). The passengers of the aircraft were disembarked safely.

Picture 1: The aircraft at the incident site

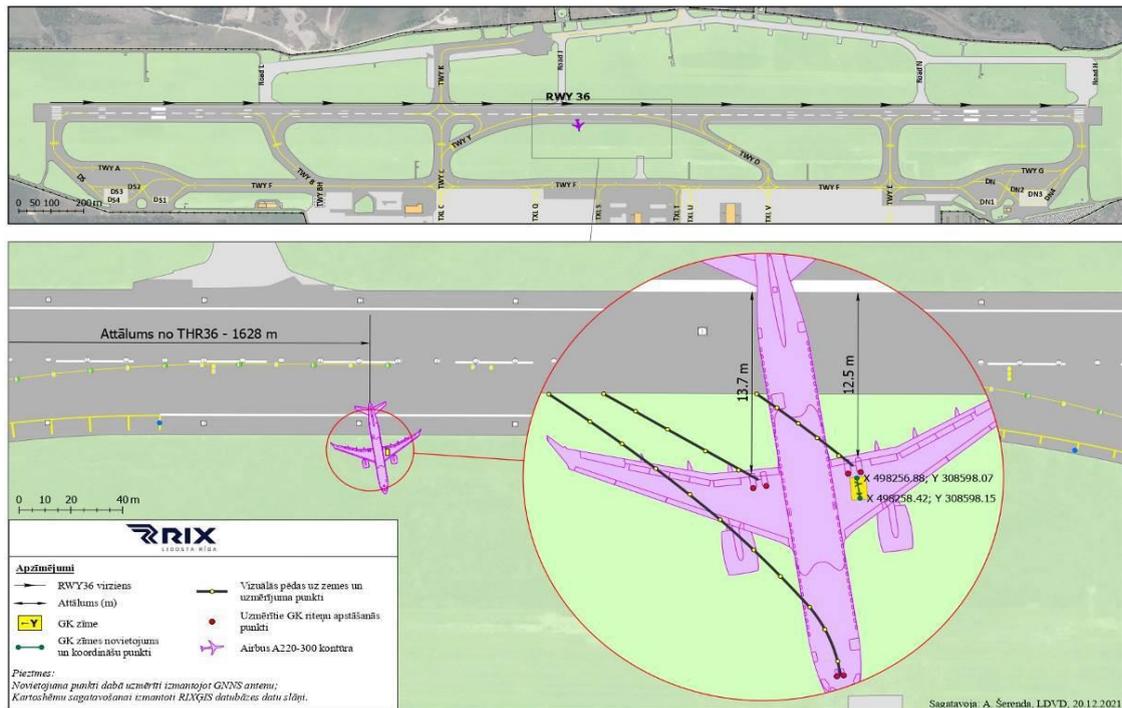
Picture 2: Location of the aircraft after the occurrence (source RIX report DP 8203F)

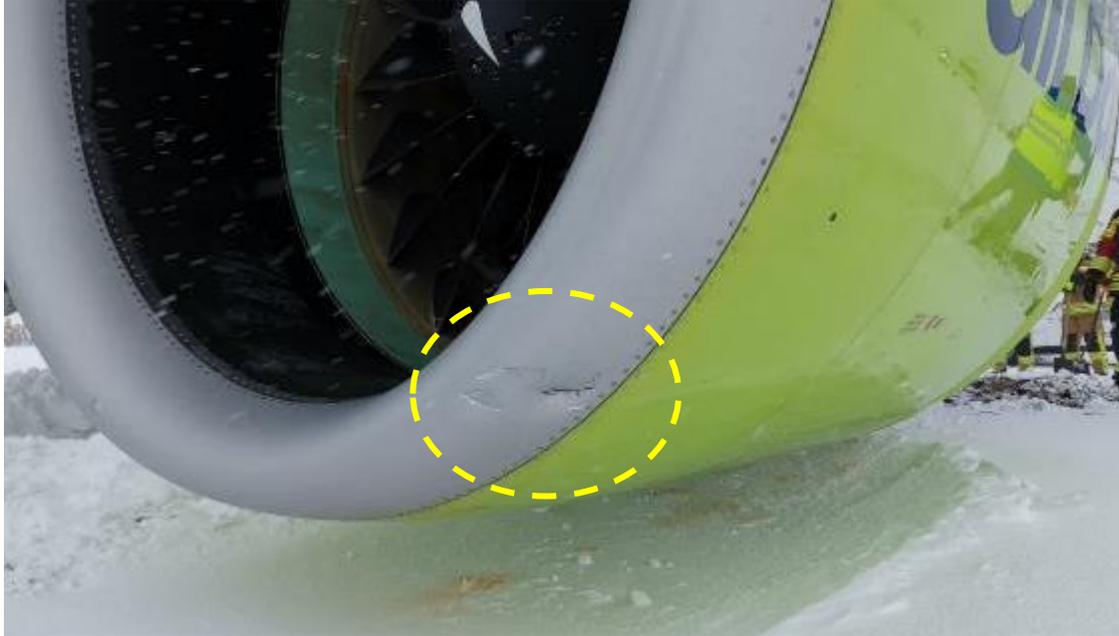
Picture 7: Damage of the Inlet Cowl of the LH Engine

Performing a visual inspection of the aircraft at the incident site some damage of the Inlet Cowl of the LH Engine was detected, caused by contact with a taxiway marking sign (see picture 7).

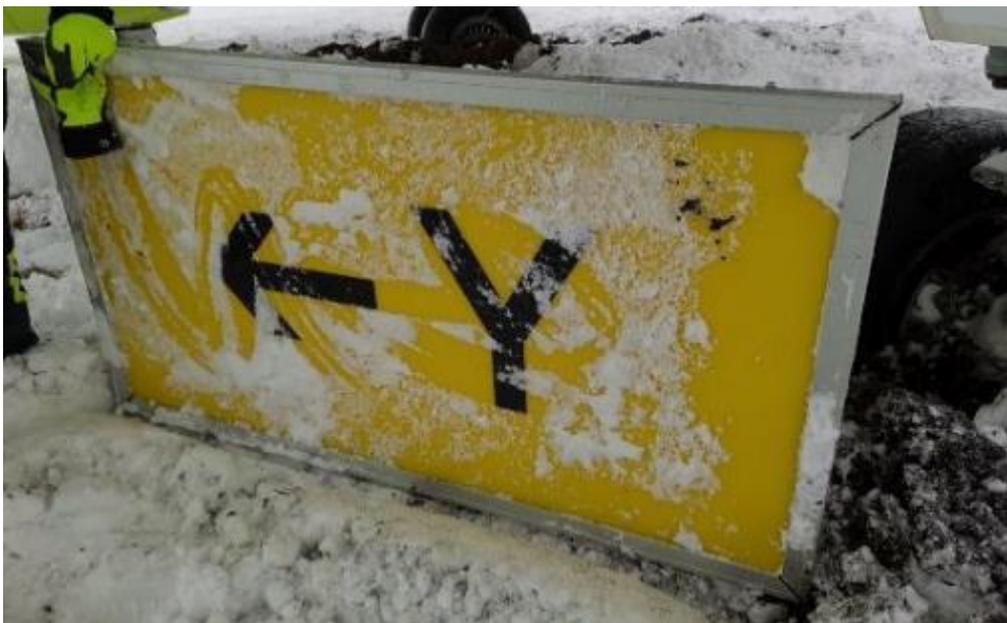
Picture 8: The taxiway sign “Y”

During the runway excursion the aircraft collided with the taxiway sign “Y” (see picture 8) located on the right side of the runway 36, 1628m from the threshold.

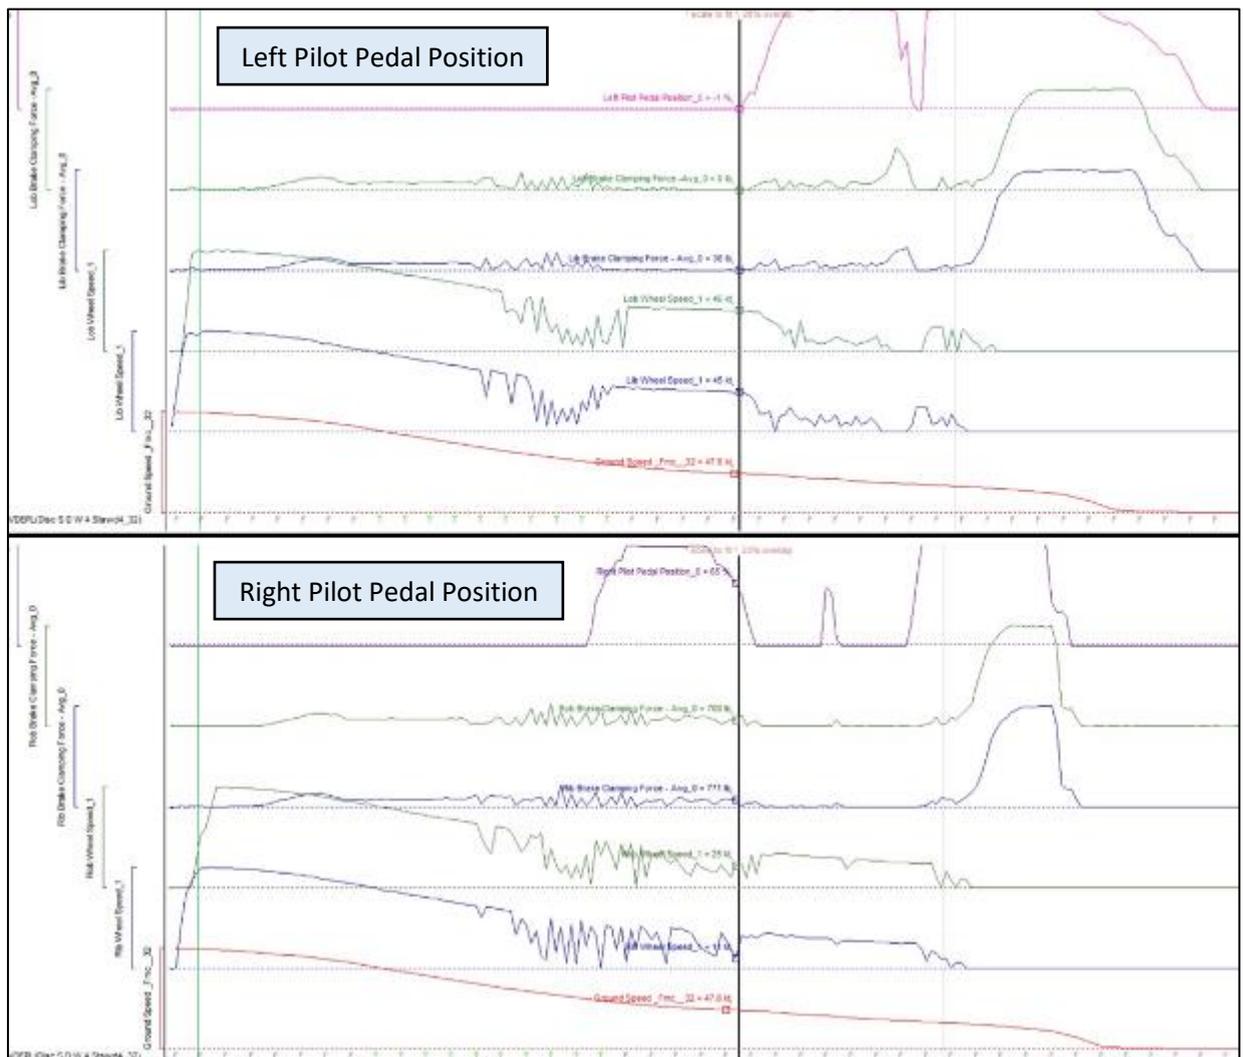
A slippery runway condition with anti-skid activation and uneven brake clamping force and wheels blocking were recorded during the braking process until the aircraft left the runway's paved surface (see picture 19).

Picture 19: FDM plots of the aircraft brake application

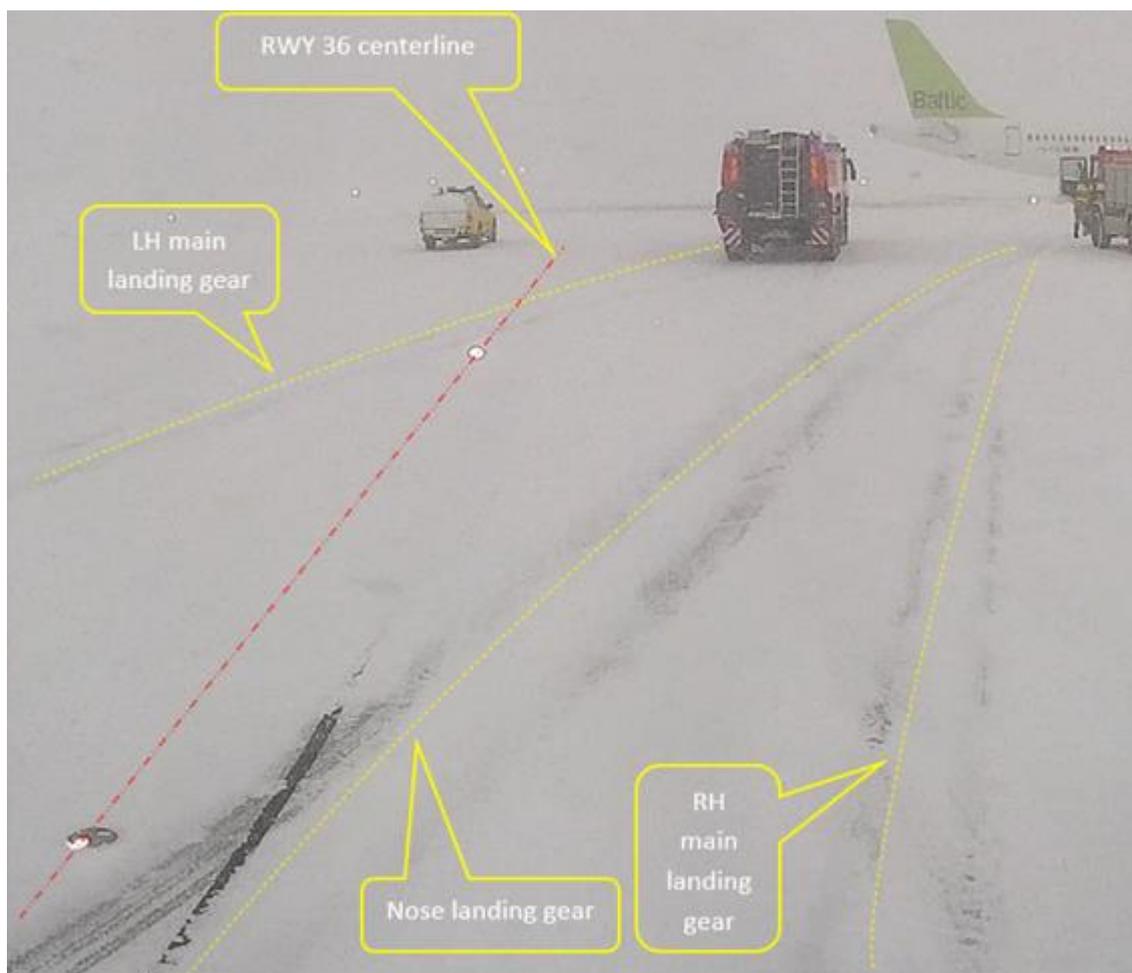
At 150-200 m, before the aircraft left the paved surface of the runway and stopped, the tire marks of the aircraft indicated a crossing of the trajectory of the nose landing gear and the right main landing gear, after the nose landing gear deviated to the right from the runway centerline and the aircraft began to move perpendicularly to the runway (see picture 20a and 20b).

Picture 20a: The aircraft tires marks were visible on the runway

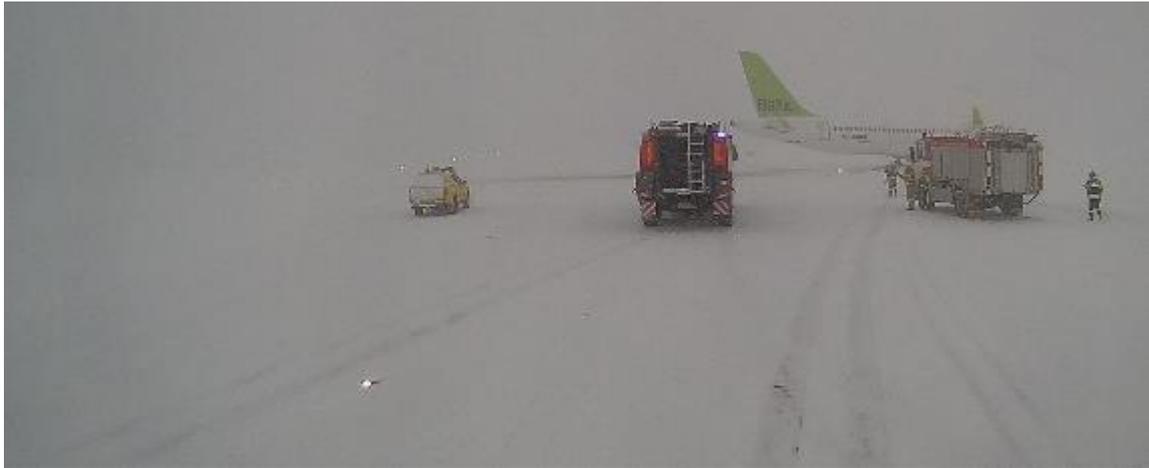
Picture 20b: The aircraft tires marks were visible on the runway
