DRAFT FINAL REPORT No 4-02/3-21

on the serious incident to the aircraft Airbus A220-300 (CS300) registered YL-CSE operated by airBaltic runway excursion at the Riga International Airport (RIX), on December 3, 2021

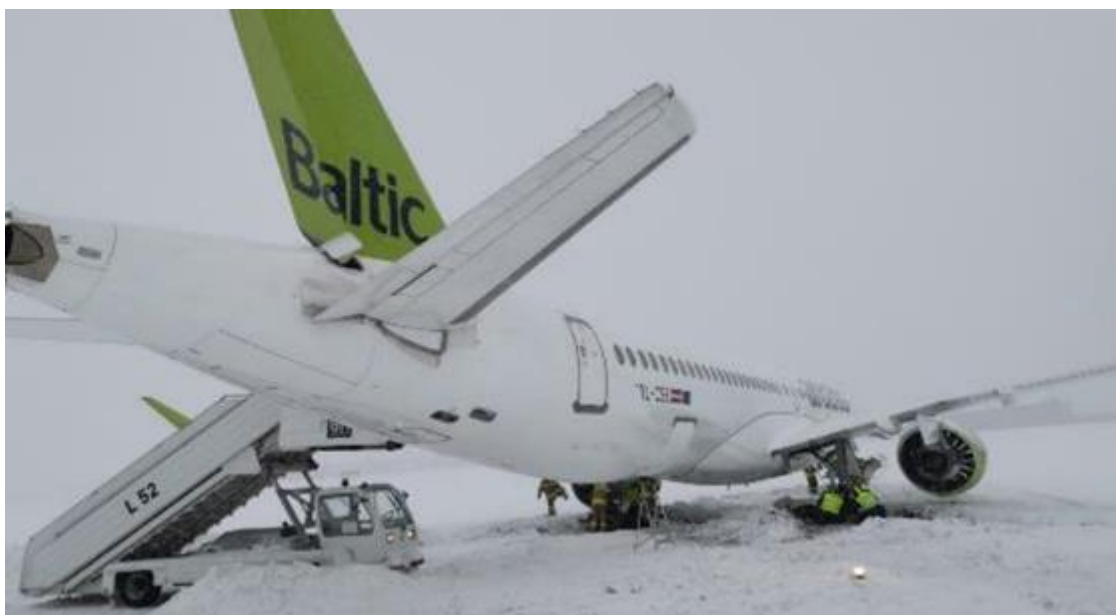
Picture 1: The aircraft at the incident site

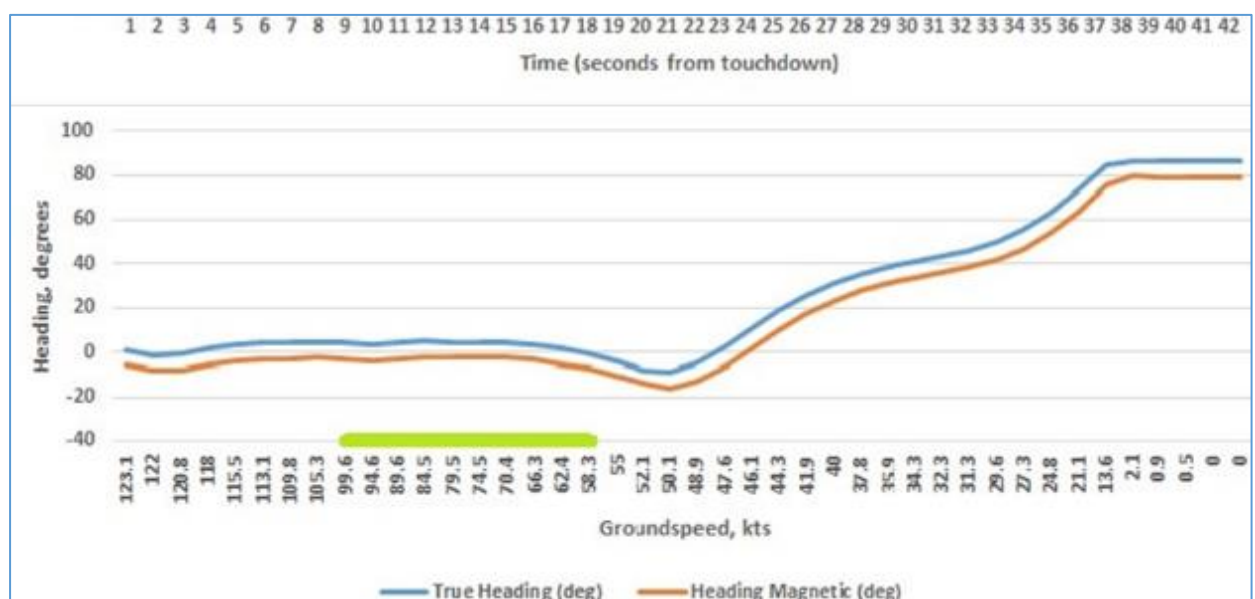
At **09.54.58** the aircraft stopped; The longitudinal deceleration was -0.83g and the lateral deceleration was 0.45g (ground speed **0 kt**), (see picture 5).

Picture 5: Aircraft deviation after touchdown on the RWY36 (Fragment from FDR data plots)

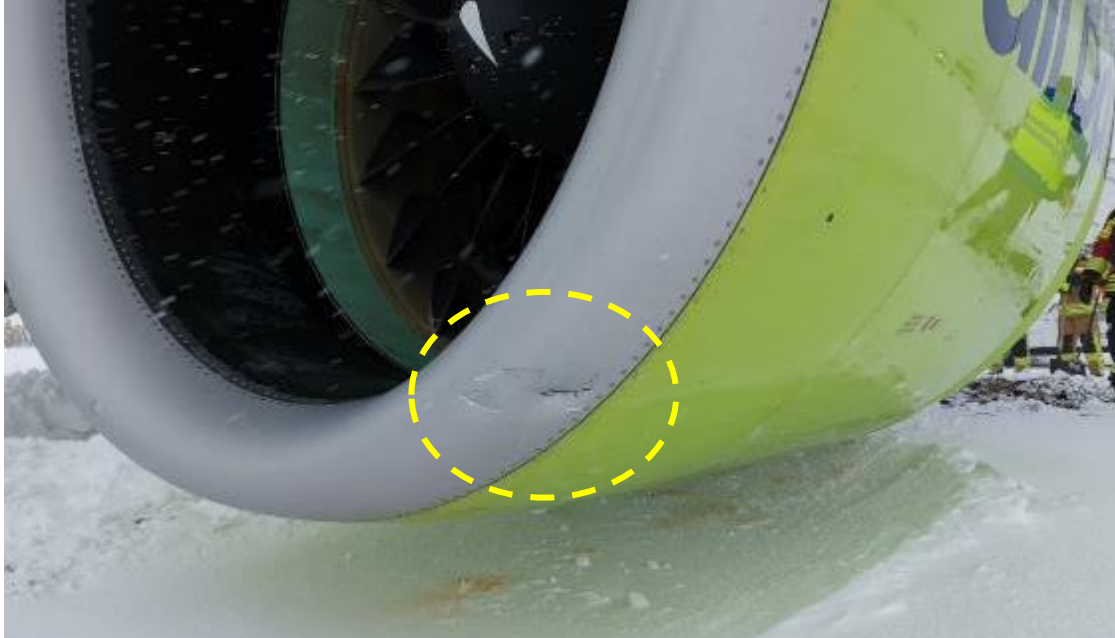
Performing a visual inspection of the aircraft at the incident site some damage of the Inlet Cowl of the LH Engine was detected, caused by contact with a taxiway marking sign (see picture 7).

Picture 7: Damage of the Inlet Cowl of the LH Engine

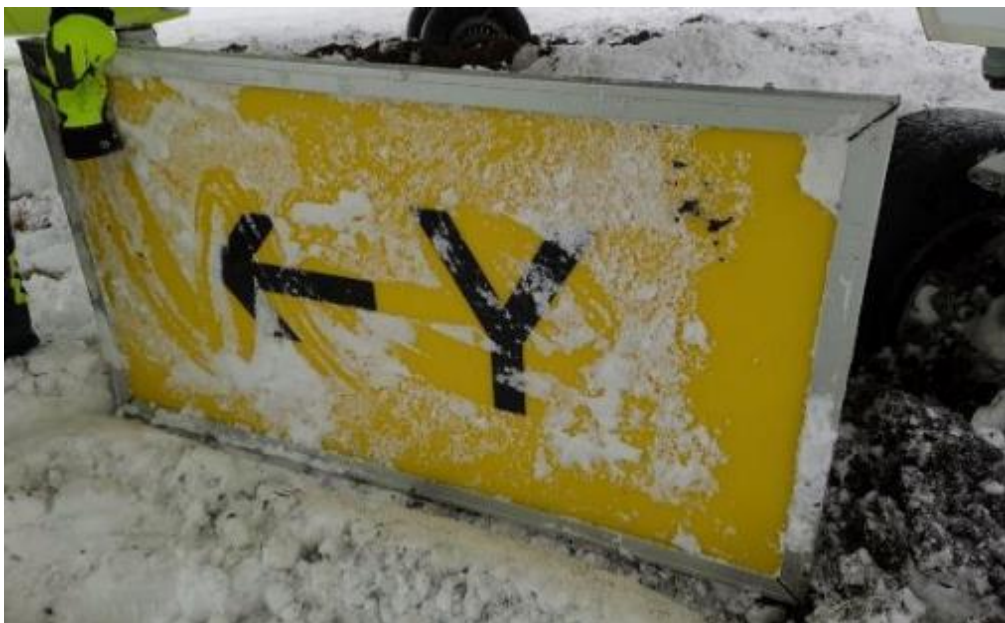
During the runway excursion the aircraft collided with the taxiway sign “Y” (see picture 8) located on the right side of the runway 36, 1628m from the threshold.

Picture 8: The taxiway sign “Y”

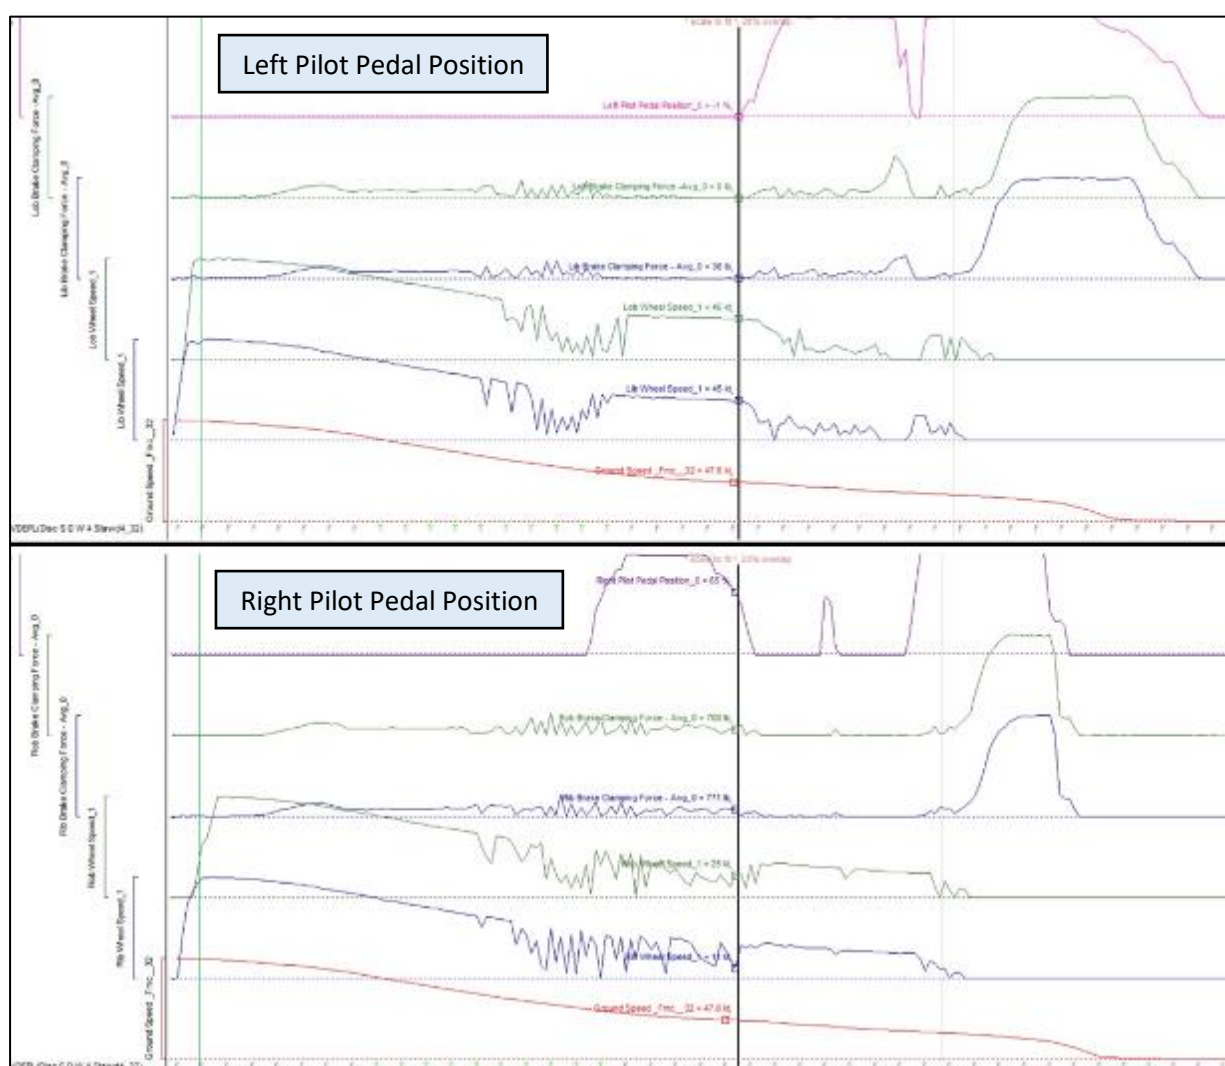
A slippery runway condition with anti-skid activation and uneven brake clamping force and wheels blocking were recorded during the braking process until the aircraft left the runway's paved surface (see picture 19).

Picture 19: FDM plots of the aircraft brake application

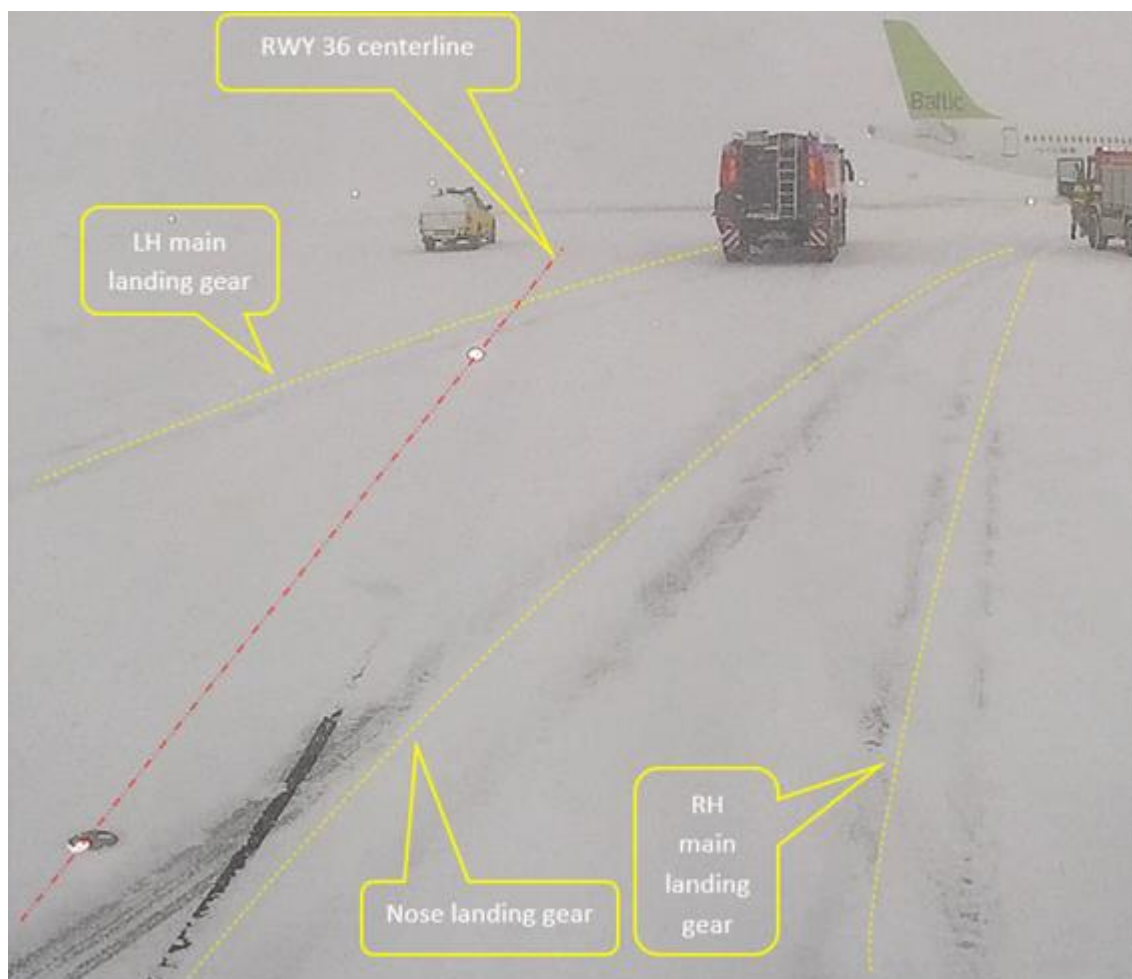
At 150-200 m, before the aircraft left the paved surface of the runway and stopped, the tire marks of the aircraft indicated a crossing of the trajectory of the nose landing gear and the right main landing gear, after the nose landing gear deviated to the right from the runway centerline and the aircraft began to move perpendicularly to the runway (see picture 20a and 20b).

Picture 20a: The aircraft tires marks were visible on the runway

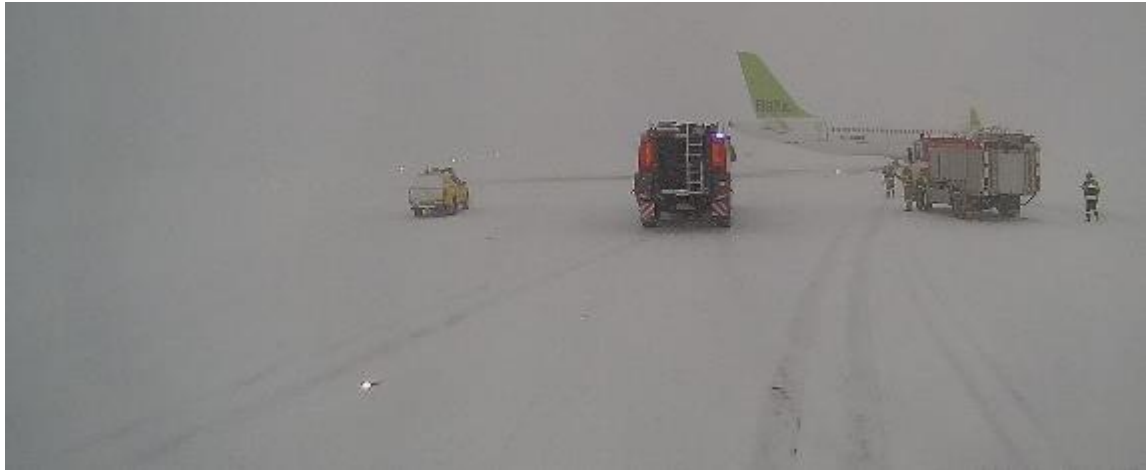
Picture 20b: The aircraft tires marks were visible on the runway
