## **FINAL REPORT No.4-02/3-17 (4-18)**

### **OF THE AIRCRAFT SERIOUS INCIDENT LOSS OF SEPARATION AFTER DEPARTURE BETWEEN THE NORWEGIAN AIR SHUTTLE AIRCRAFT Boeing B738, registration LNN-II and Air Baltic Bombardier DH8D, registration YL-BBT, at Riga FIR, TMA on November 23, 2017**

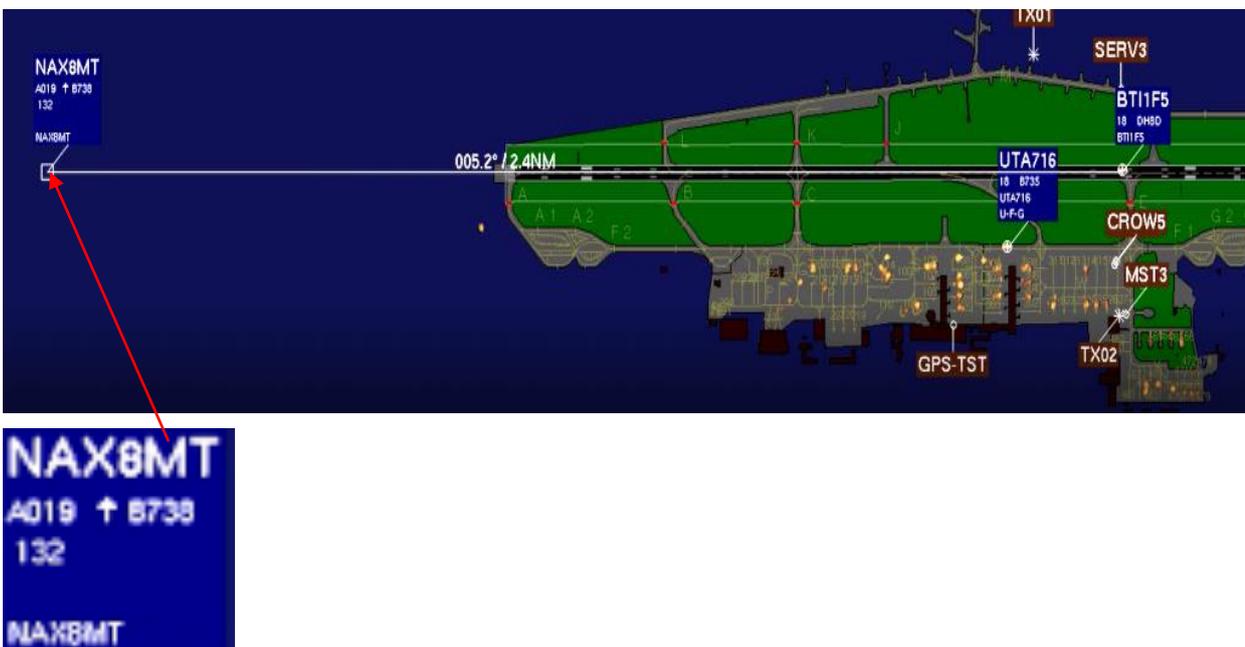
**Figure 5.** Air Baltic 1 Foxtrot 5 cleared for take-off and started rolling.

According to recordings of SMGCS take-of clearance for aircraft “Air Baltic 1 Foxtrot 5” actually was issued when the aircraft was at line up position of the runway-in-use “18” intersection with TWY E. Preceding departing aircraft Boeing 738 had crossed the end of RWY in use, crossing altitude **1900ft** and had passed a point of **2.4 NM** from the line up position of succeeding departing aircraft DHC-8-402.

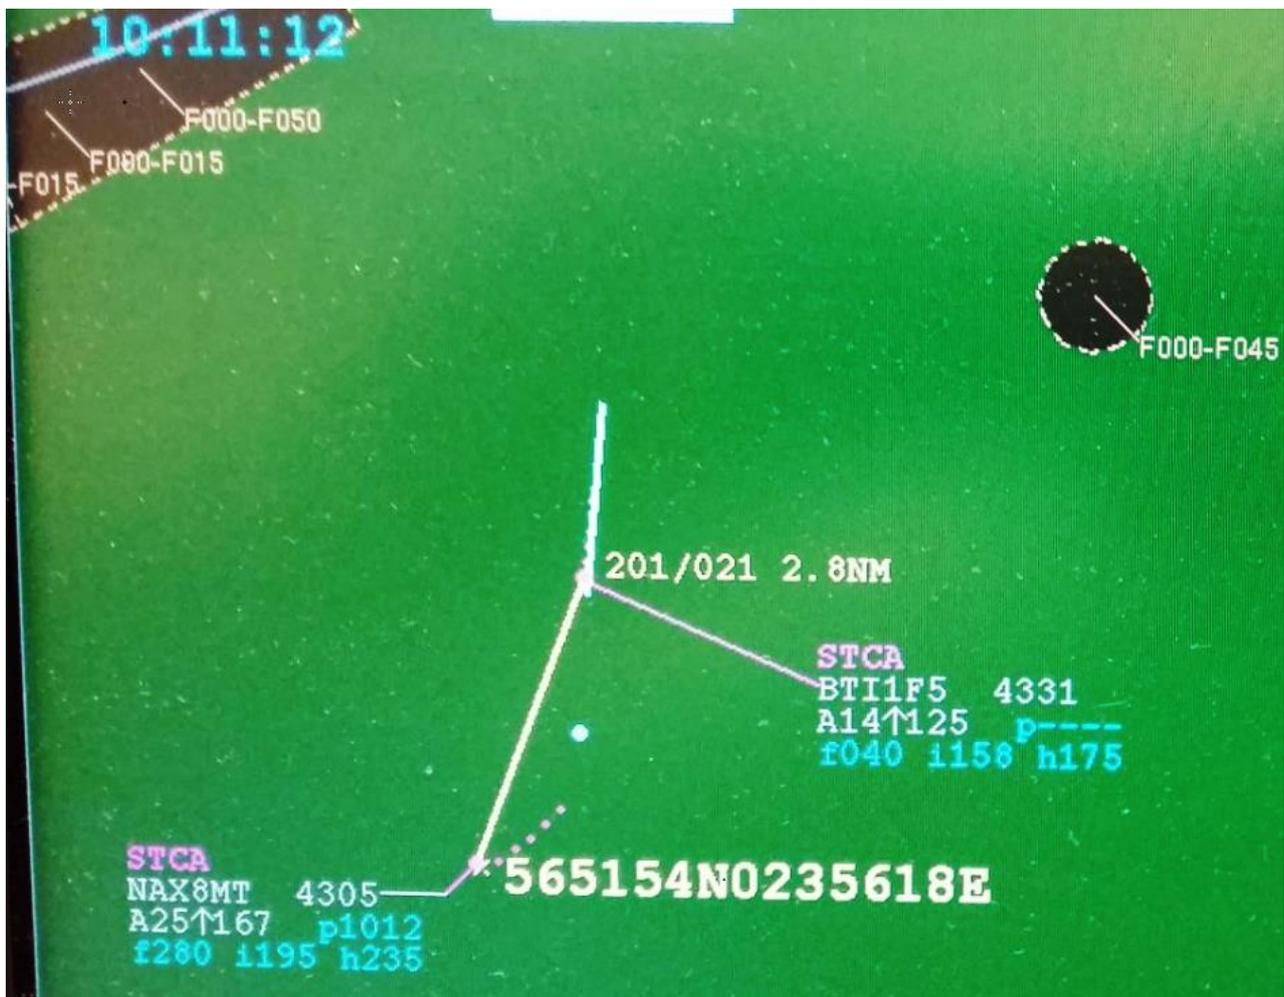
Figure 6. STCA warning signal switched on

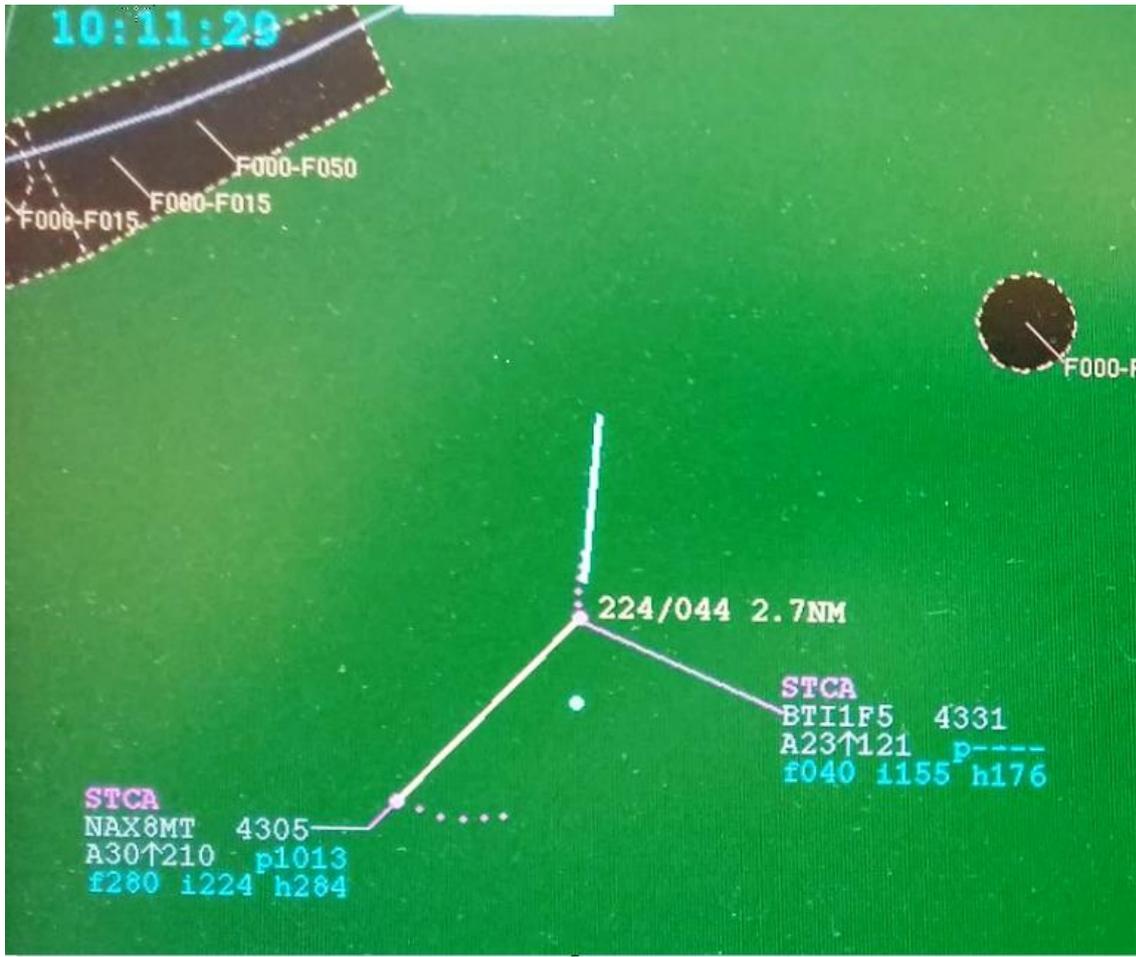
Figure 7. STCA an alert of a potential or actual infringement of separation minima.

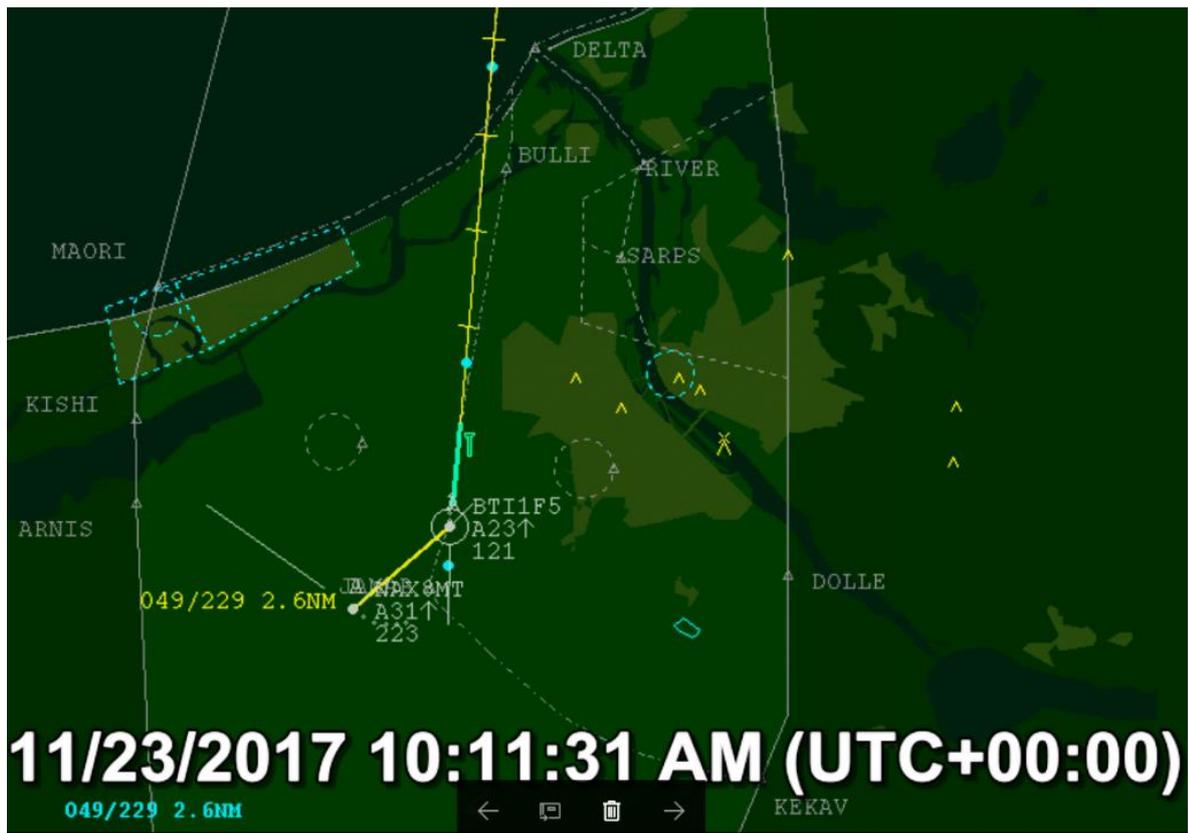
**Figure 8.** Traffic situation, horizontal distance between aircraft 2.6NM

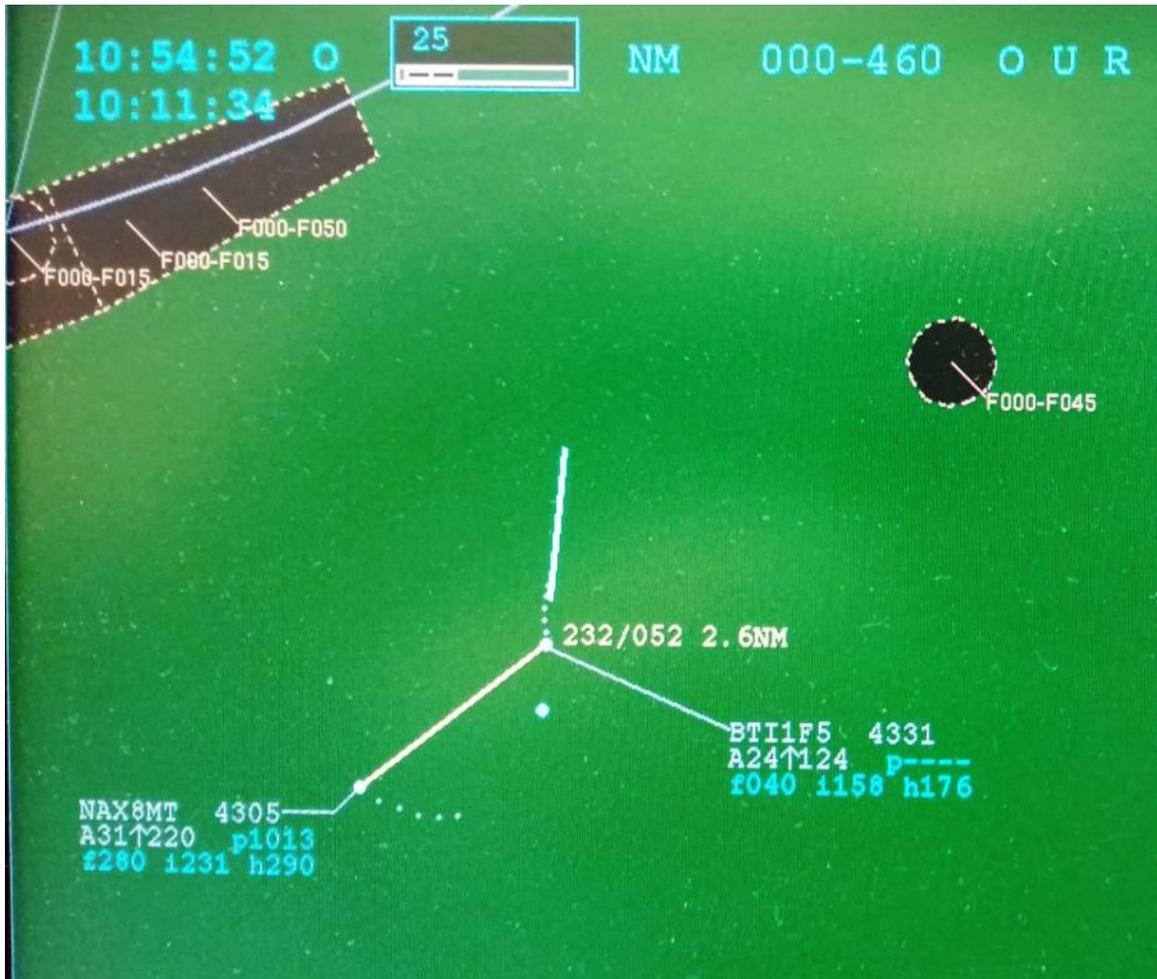
**Figure 9.** Radar picture –min. horizontal distance 2.6NM, vertical 700ft.

Separation standards were infringed between aircraft. Minimal horizontal separation between aircraft was **2.6NM**, vertical **700ft**.

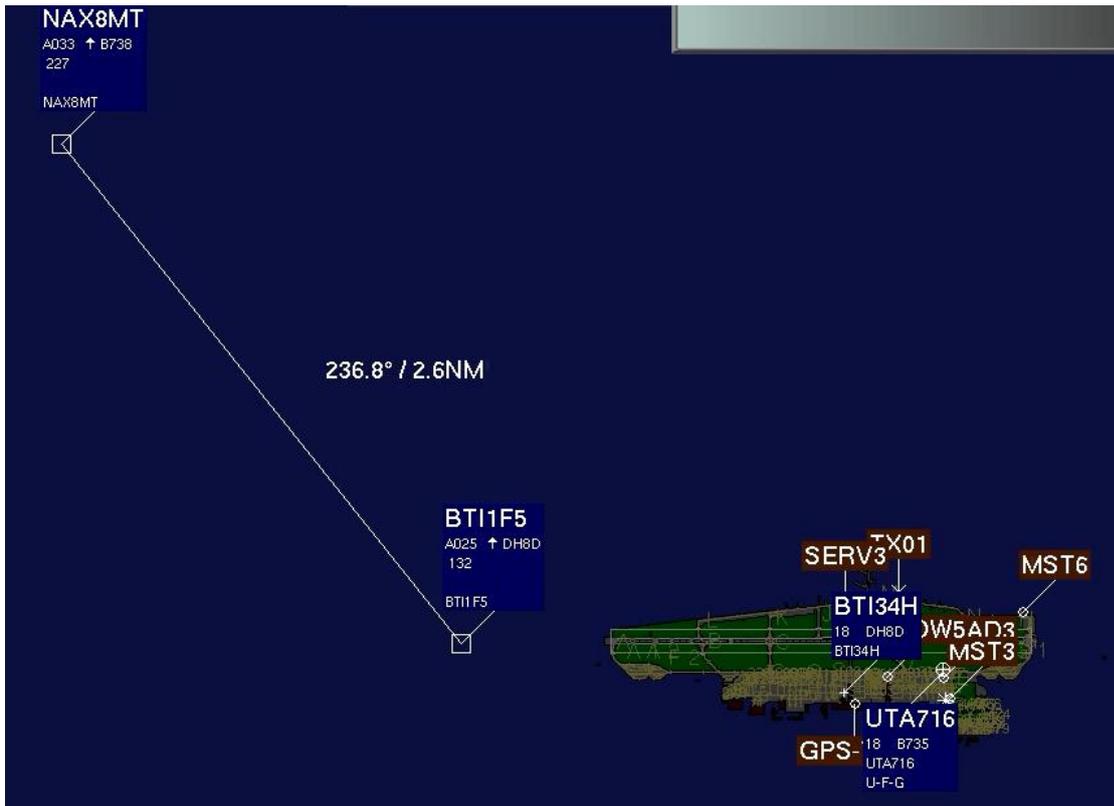
**Figure 10.** Traffic situation, horizontal distance between aircraft 2.6NM

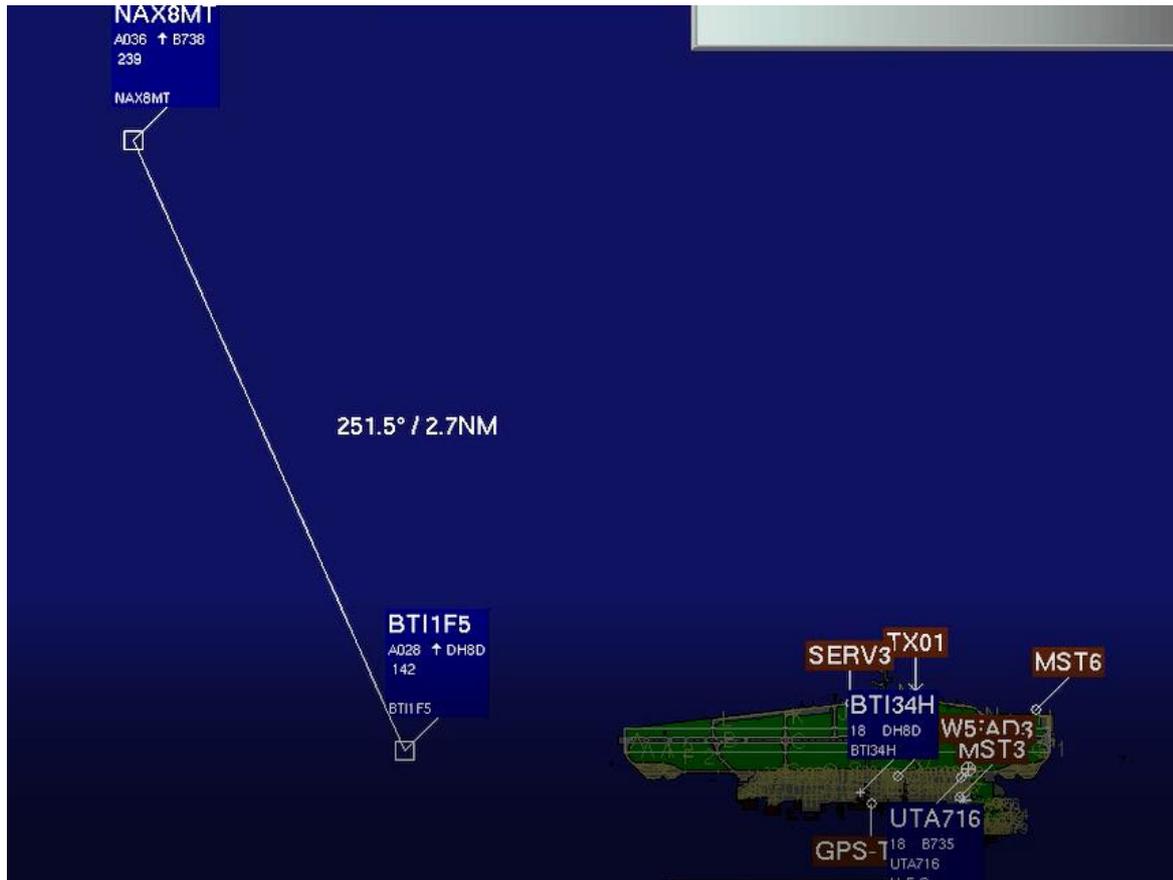
**Figure 11.** At **10:11:42**: The crew responded: “Left 170 **already 2900**. Air Baltic 1 Foxtrot 5.”

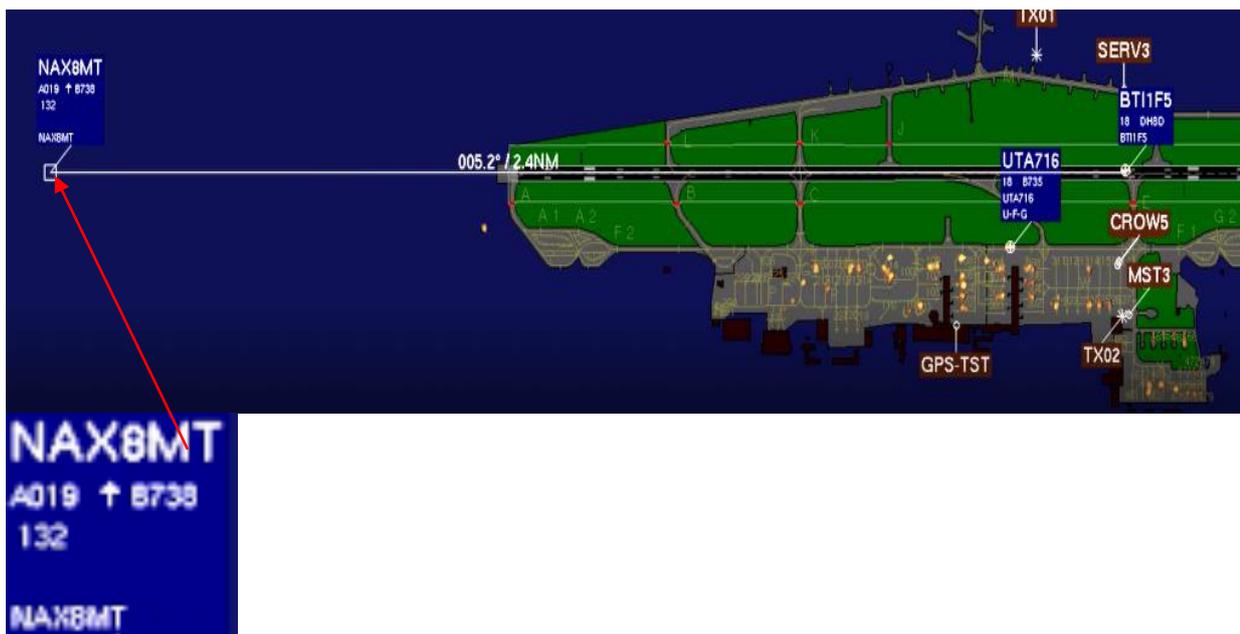
Analysing the recordings of SMGCS it was stated that when Bombardier DH-8D was cleared to take off and started rolling distance from line-up position and point of preceding aircraft was less than 2.5NM.

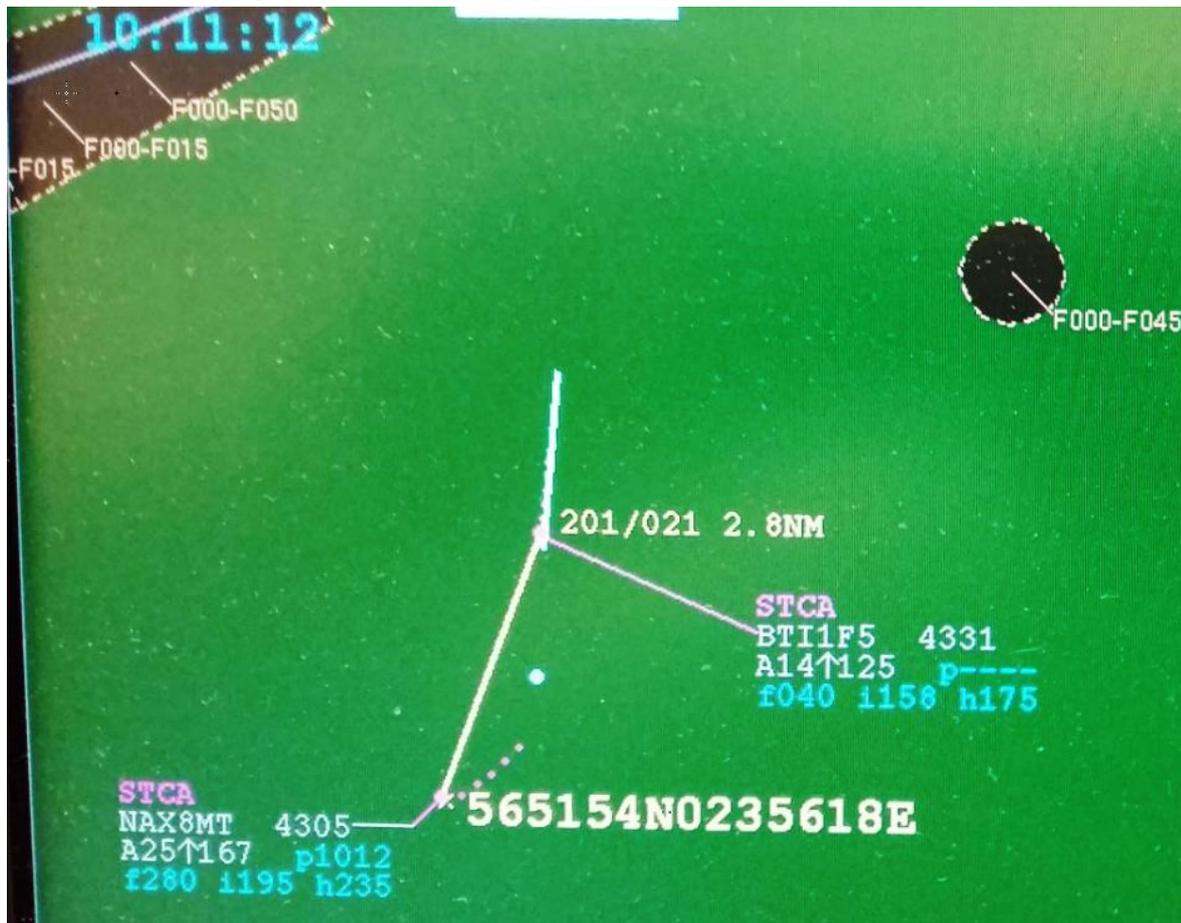
At **10:10:11**: The Tower Controller gave clearance for Air Baltic BTI1F5 to take-off.

The Norwegian NAX-8MT at that time crossed altitude 1900ft and had passed a point of 2.4 NM from the line up position of succeeding departing aircraft DHC-8-402.
