**FINAL REPORT No. 4-02/1-17(2-2018) on
THE AIRCRAFT SERIOUS INCIDENT**

**RUNWAY EXCURSION RIGA INTERNATIONAL AIRPORT (RIX), ON 17
FEBRUARY 2017
AIRCRAFT BOEING 737-524, VP-BVS**

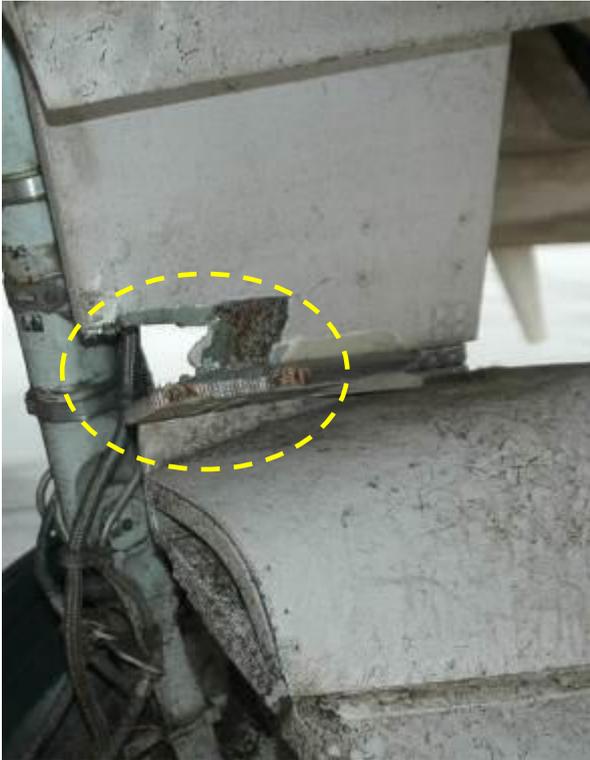
Photo 1: L/H Main gear Center door

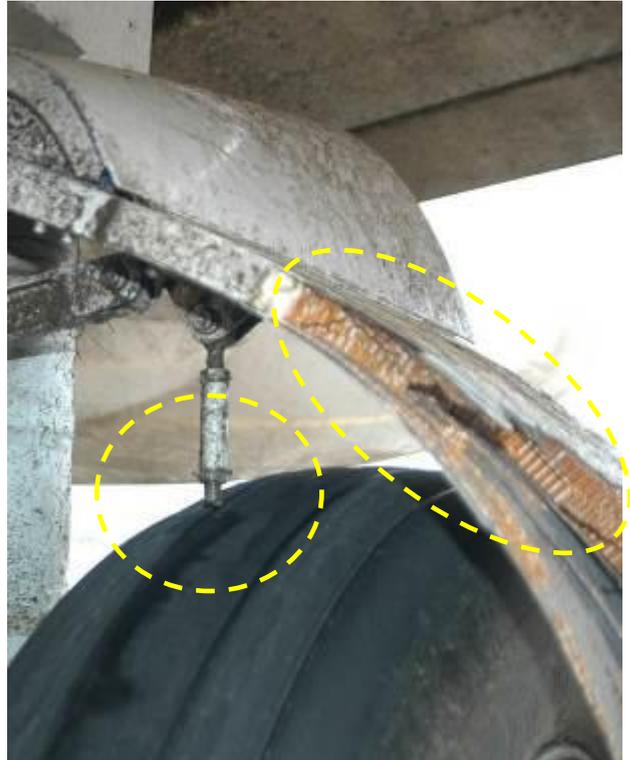
Photo 2: L/H Main gear Inner door with broken Inner pushrod

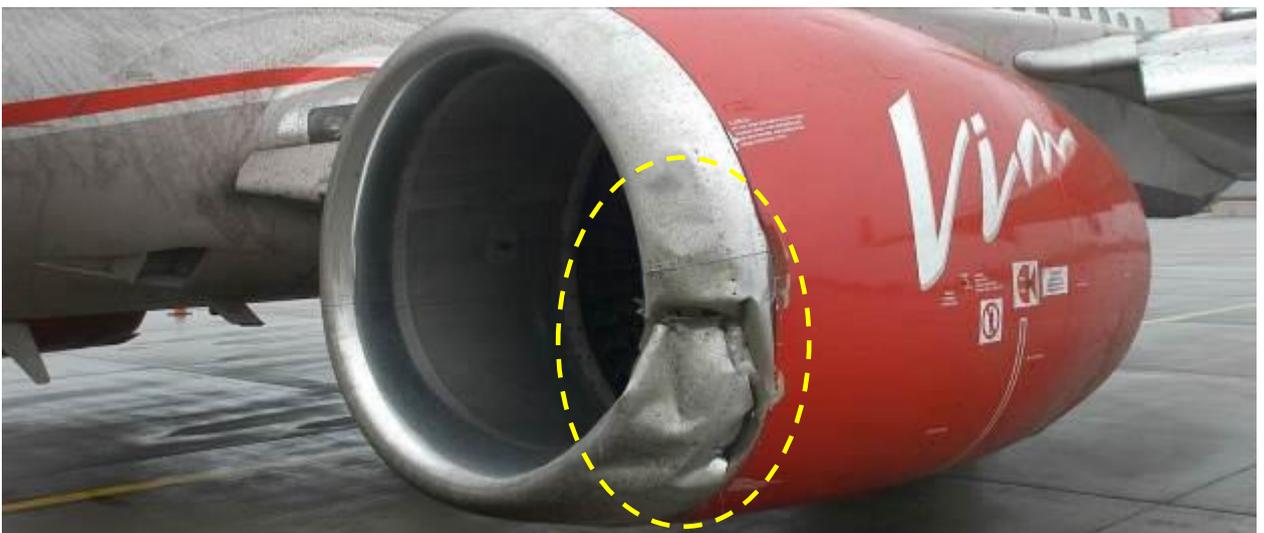
Photo 3: L/H Engine Inlet Cowl Inner and Outer, Overboard Fan Cowl Panel

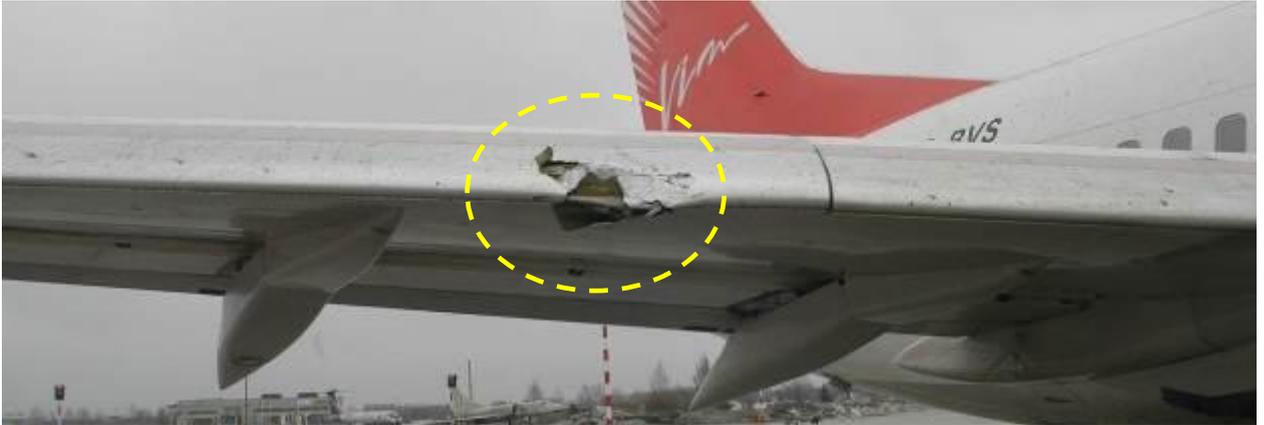
Photo 4 R/H Leading Edge Slat No 5 damages

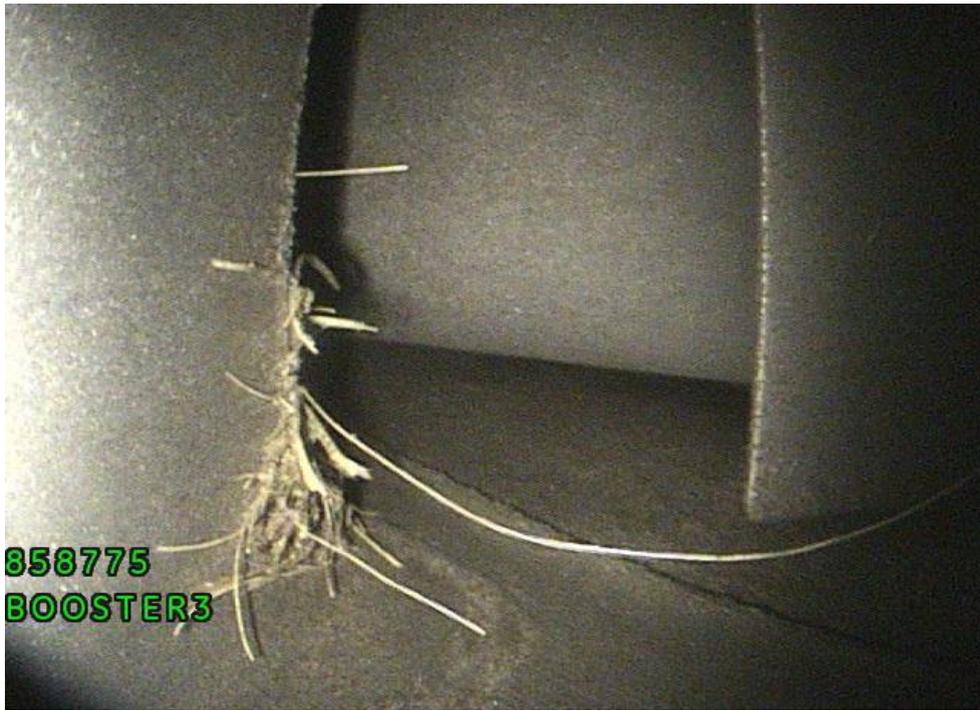
L/H engine: Because the engine has ingested with in large amounts of dirt and grass in Boost section, it was not possible to perform and verify borescope inspection in Boost section and first stage of High Pressure Compressor. Dirt/ mud built up was found in VBV outlet, condition not normal.

Photo 5: Grass and mud on the booster ST2

As a result of BSI it was concluded that there are the need to carefully perform the gas path cleaning and re-inspection of Boost and HPC sections for verification of cleanliness and lack of damage in Boost and HPC sections.

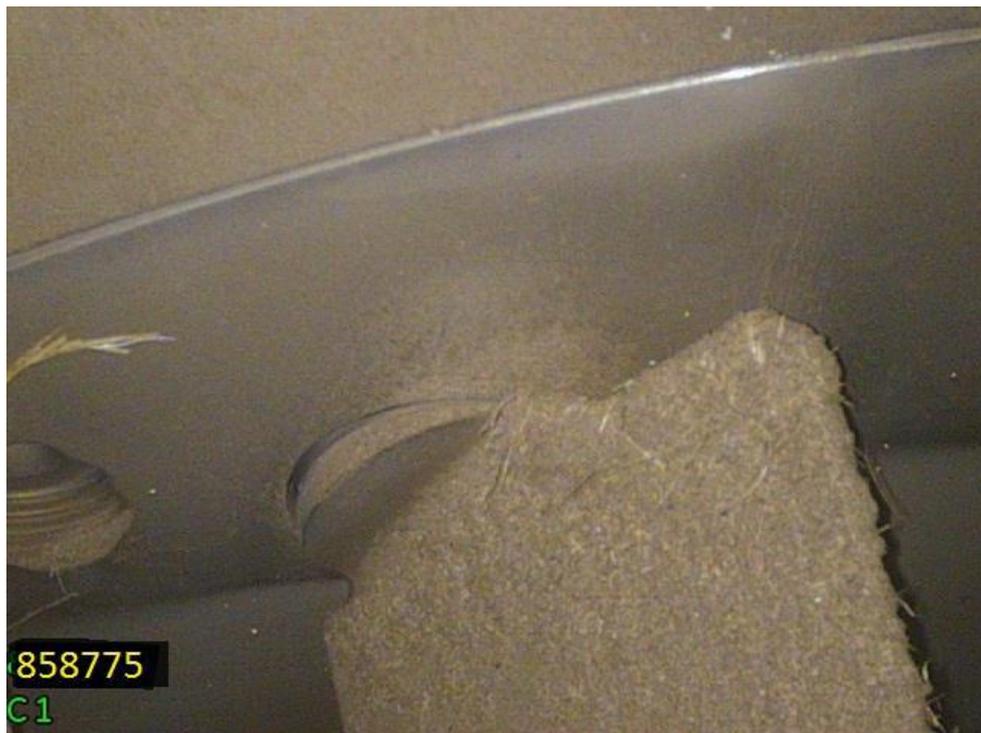
Photo 6: Grass and mud on the HPC ST1

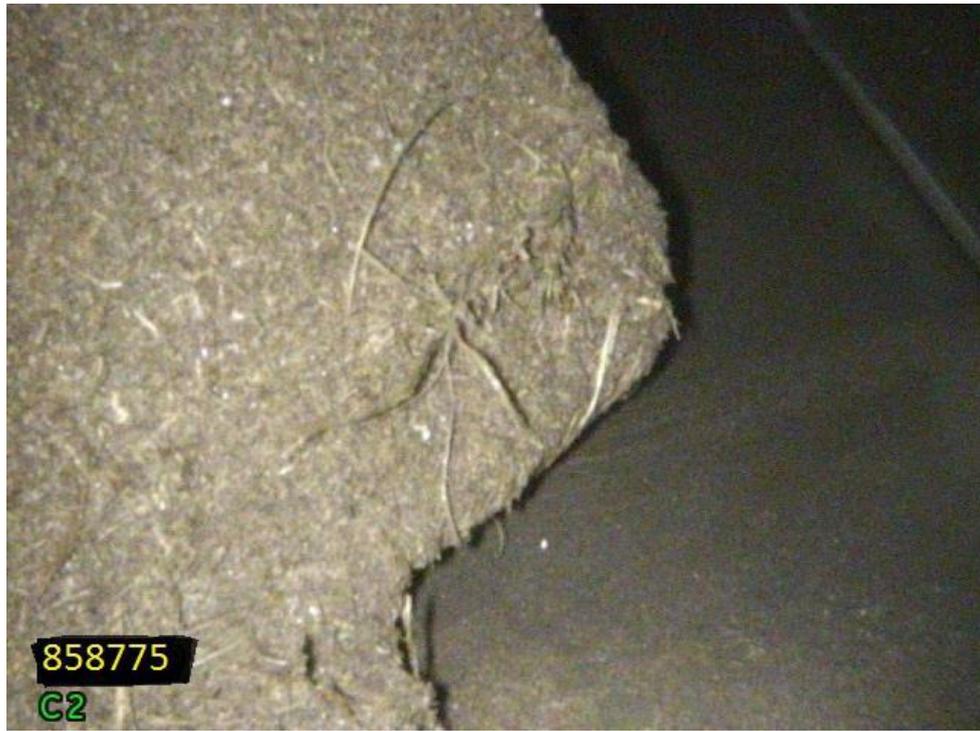
Photo 7: Grass and mud on the HPC ST2

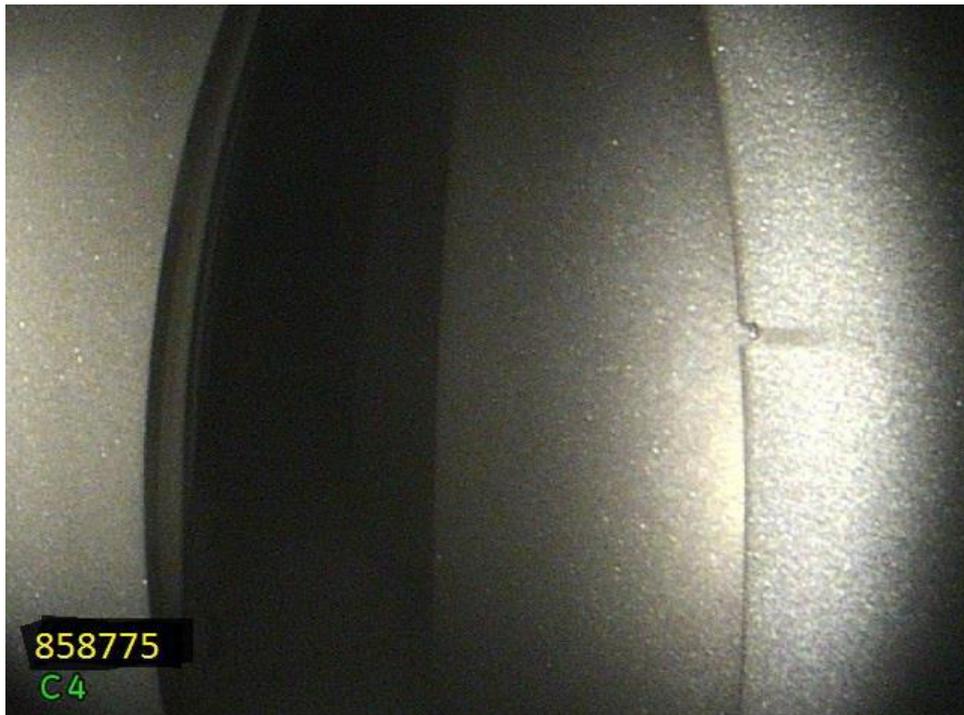
Photo 8: HPC ST4 surface damage

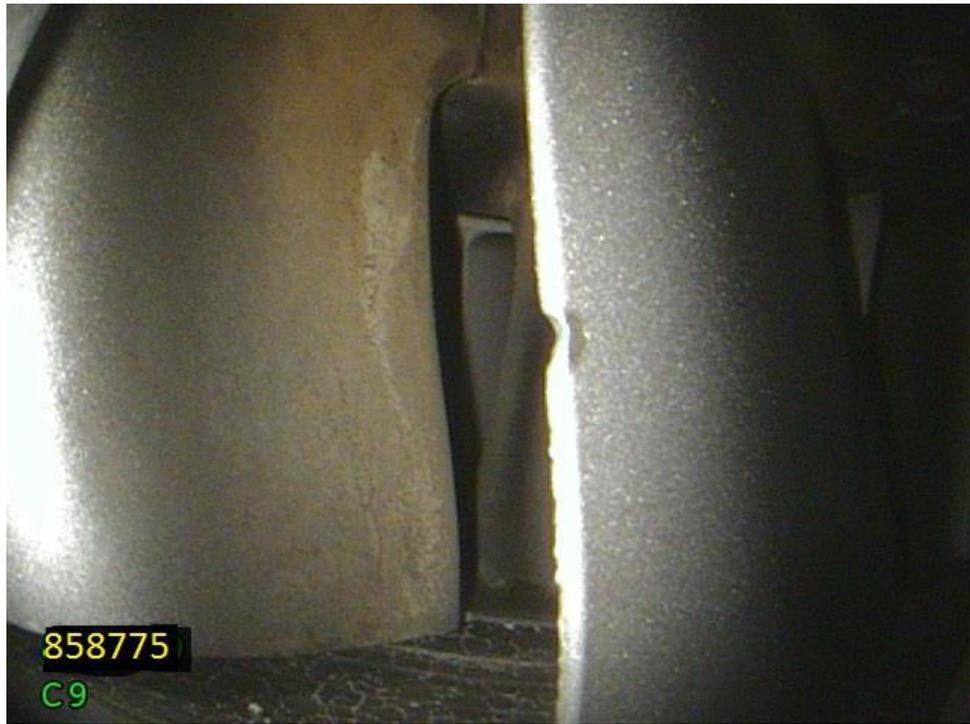
Photo 9: HPC ST9 surface damage

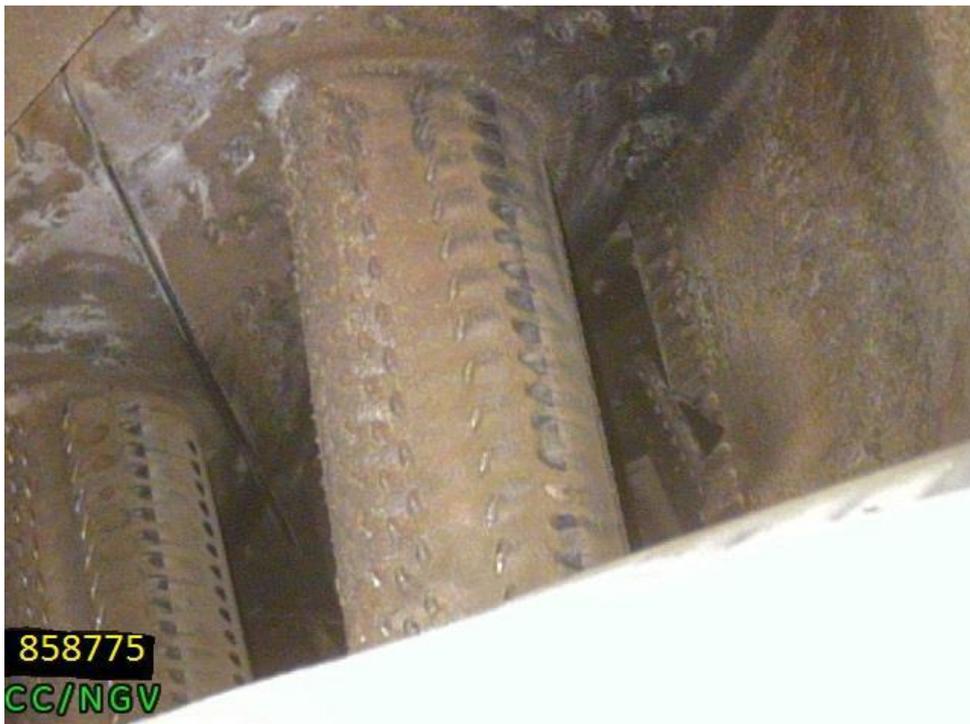
Photo 10: Dirt on the Nozzle Guide Vanes

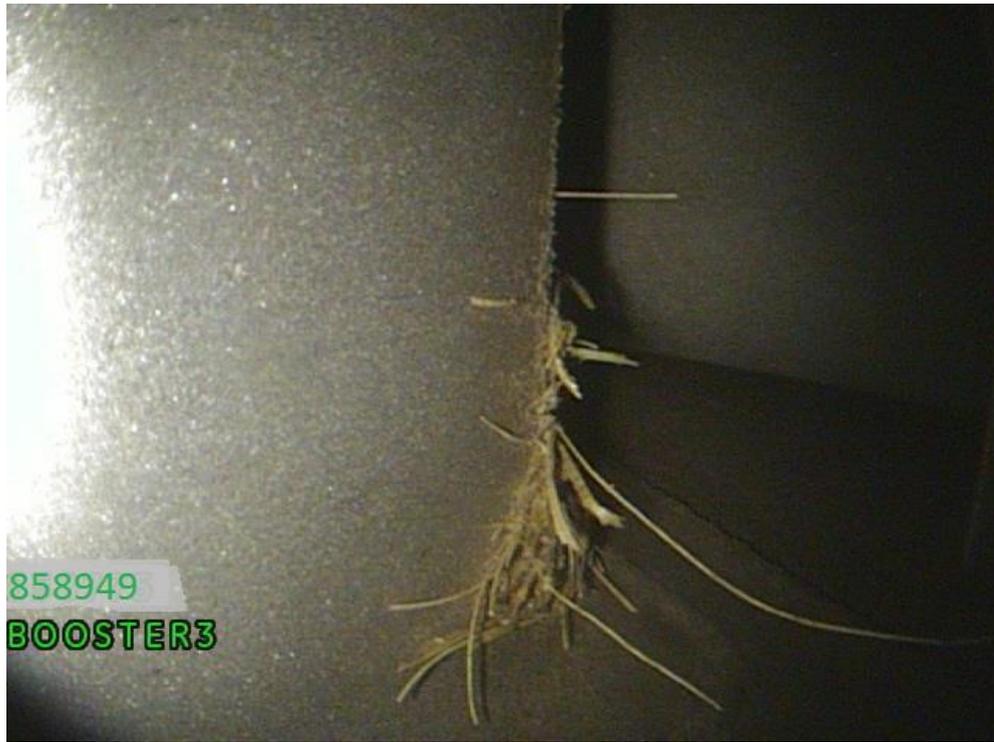
R/H engine: Because the engine has ingested with in large amounts of dirt and grass in Boost section, it was not possible to perform and verify full gas path borescope inspection in Boost section and first stage of High Pressure Compressor. Dirt/ mud built up was found in VBV outlet condition, not normal.

Photo 11: Grass and mud on the booster ST3

As a result of BSI it was concluded that there are the need to carefully perform the gas path cleaning and re-inspection of Boost and HPC sections for verification of cleanliness and lack of damage in Boost and HPC sections.

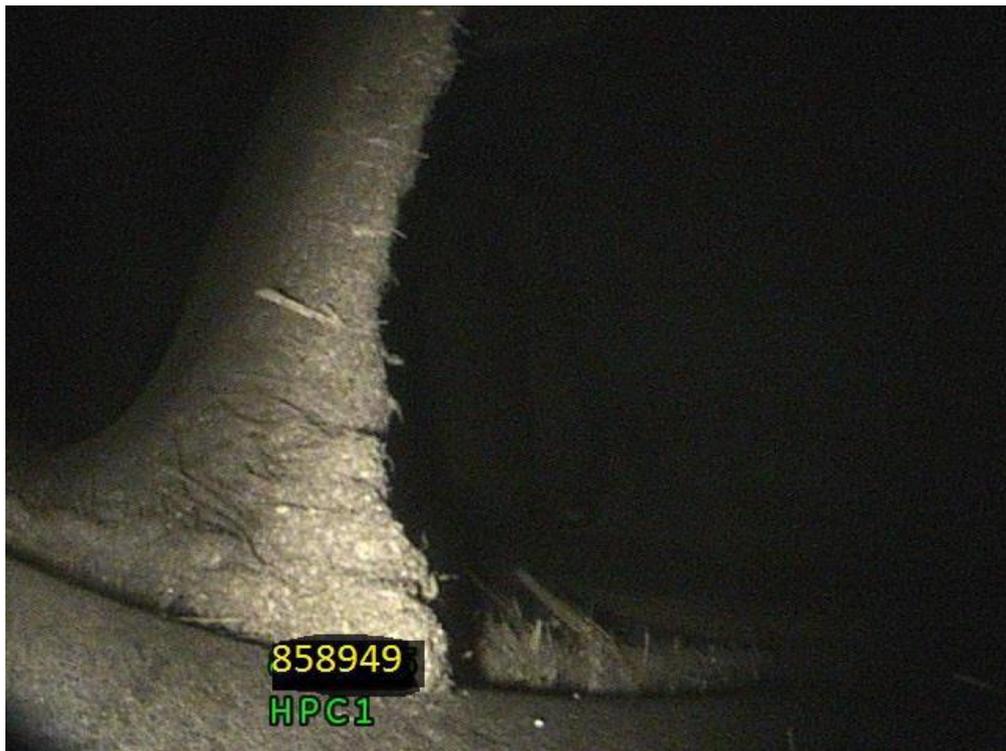
Photo 12: Grass and mud on the HPC ST1

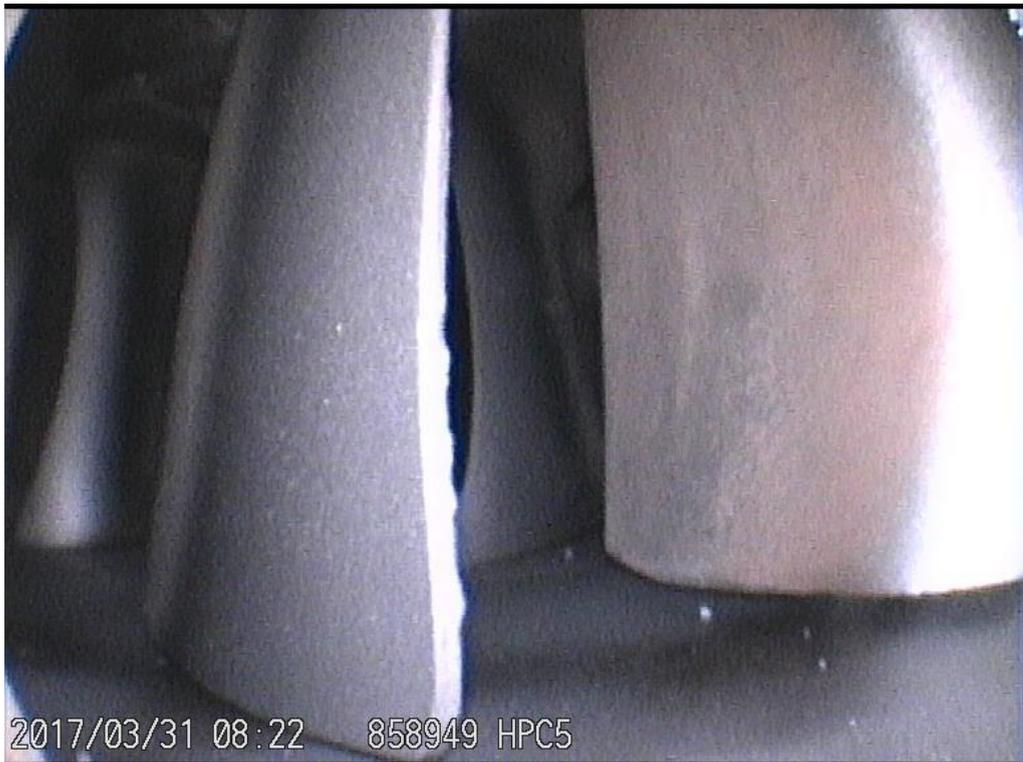
2017/03/31 08:22 858949 HPC5

Photo 13: HPC ST5 damaged surface

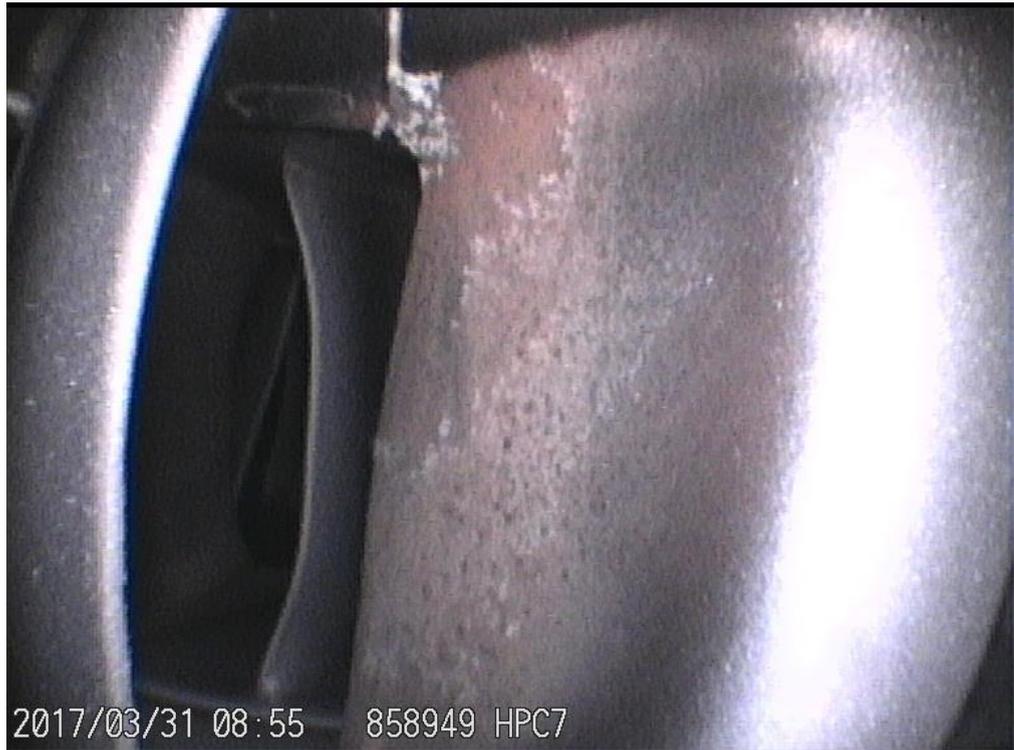
2017/03/31 08:55 858949 HPC7

Photo 14: Corrosion marks on the HPC ST7

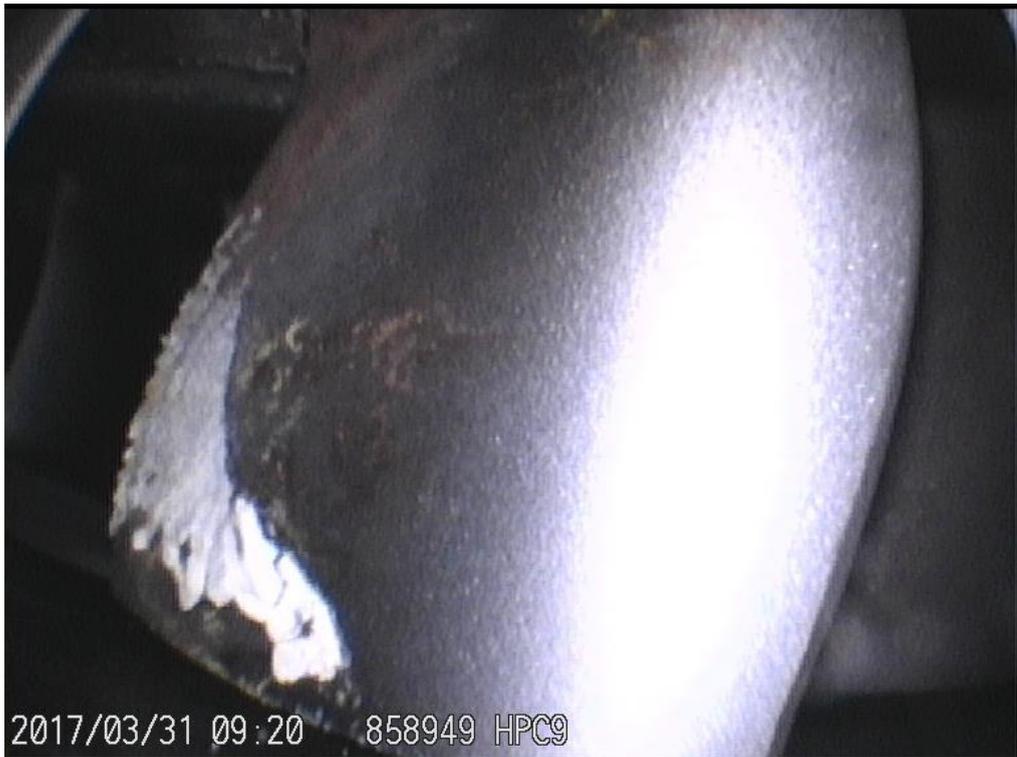
Photo 15: Corrosion marks on the HPC ST9

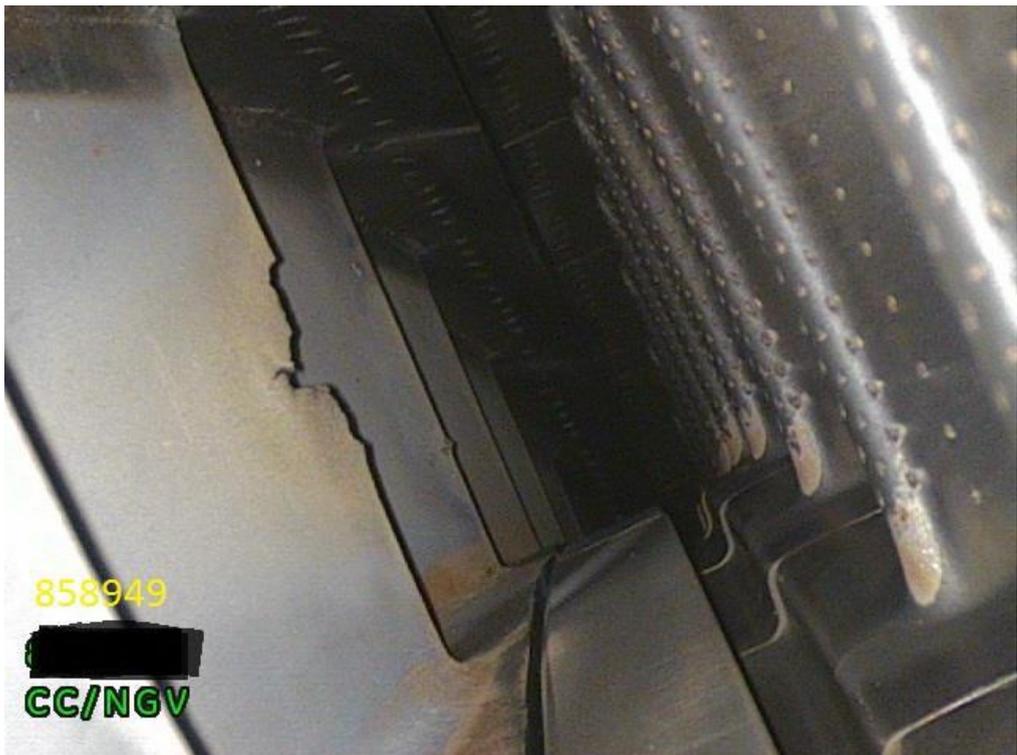
Photo 16: Nozzle Guide Vanes and HTP

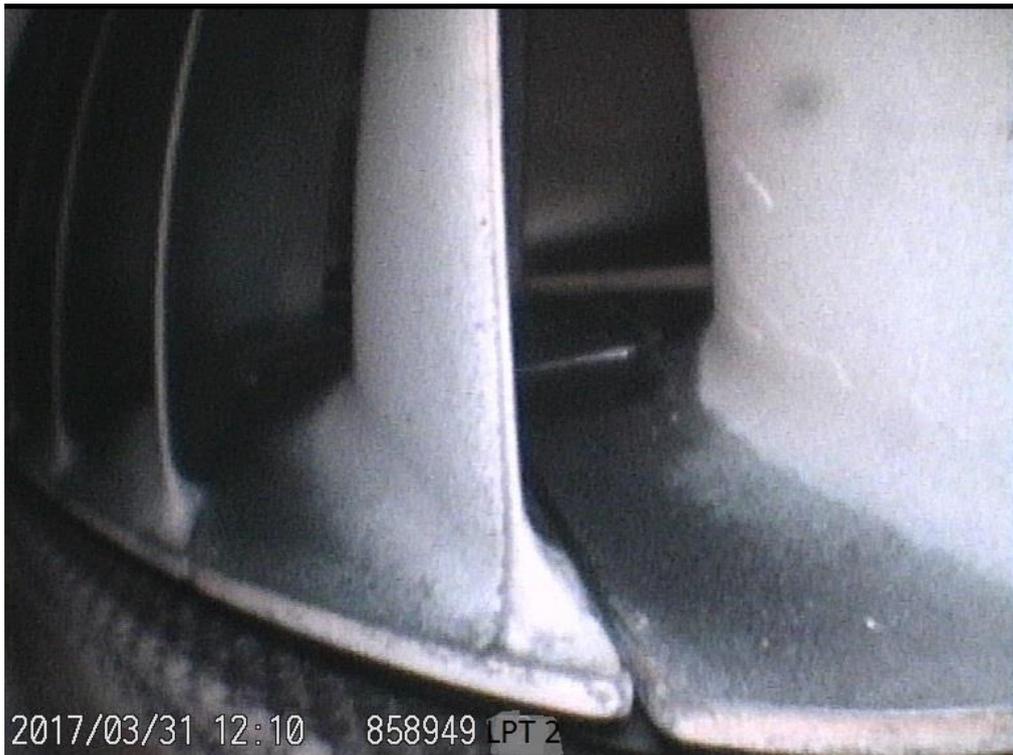
Photo 17: LPT ST2 surfaces damages

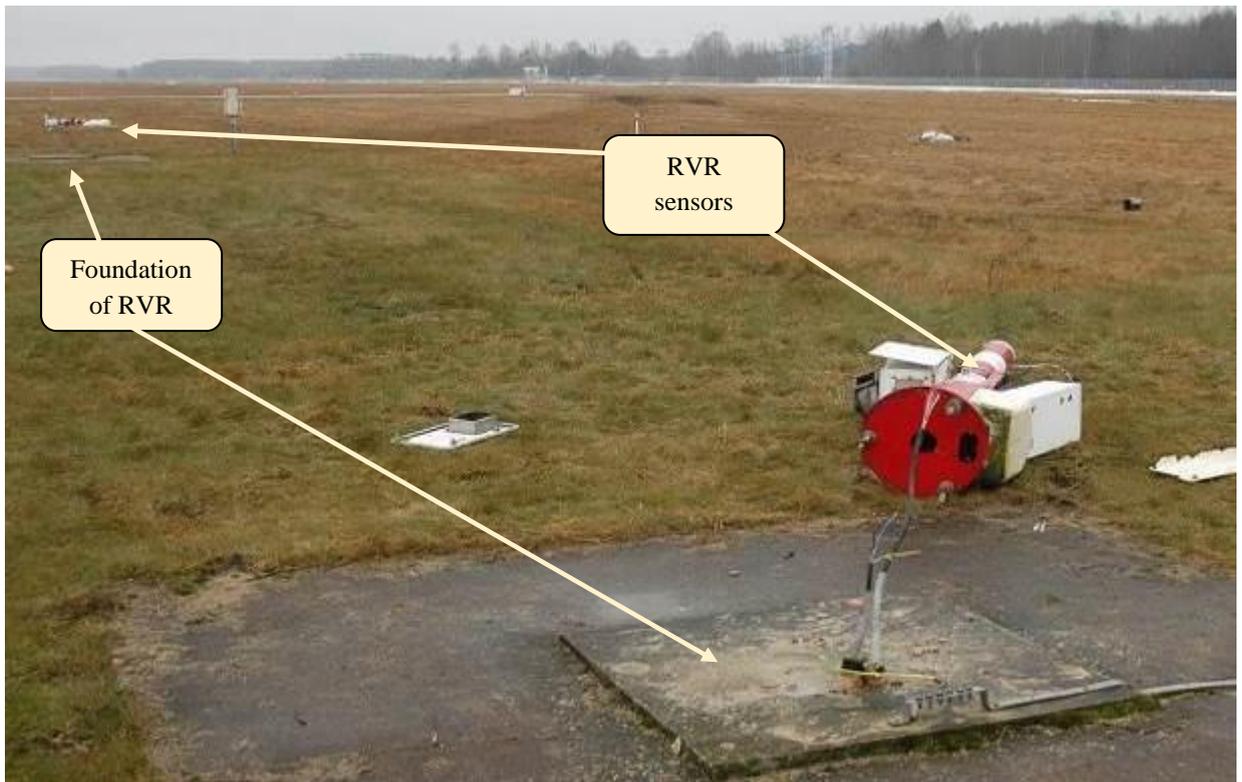
Photo 18

Due to the runway excursion occurred the aircraft collided with the runway signs, broke two RVR sensors (Photo 18) and a power box (Photo 19).

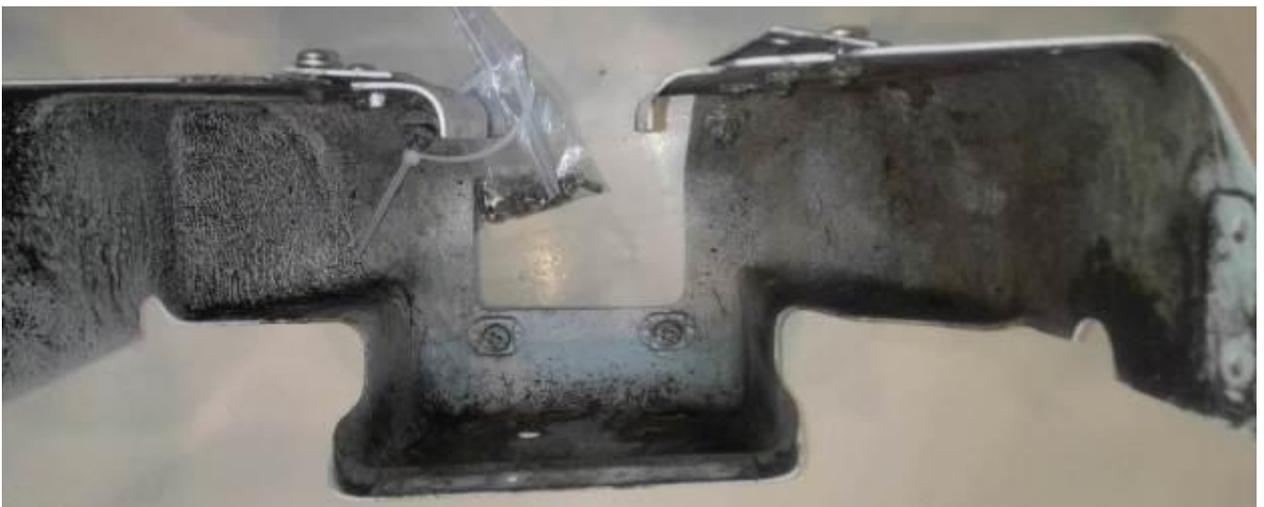
The nose gear steering metering valve during disassembly of the protective cover did not reveal any wear and tear, abrasion of ropes and signs of tension roller inclination (Photo 31).

Photo 31: The protective cover inside after disassembly

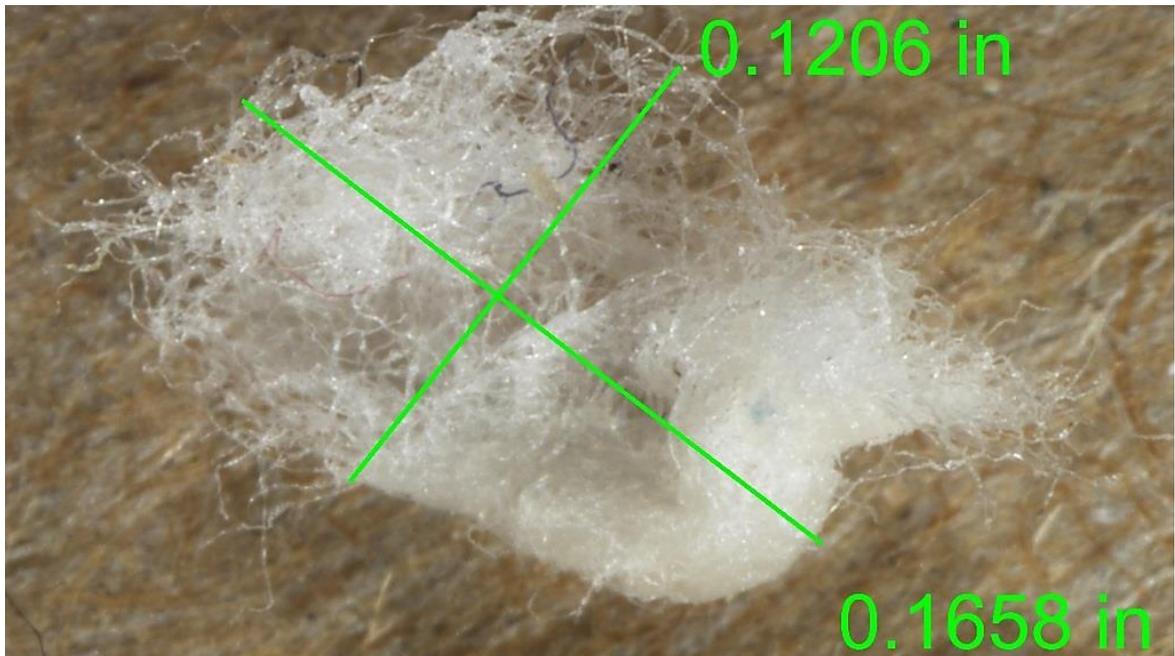
The spool, sleeve and centering spring assemblies were removed from the steering metering valve. After the sleeve was removed, a piece of fibrous debris was found in the body of the steering metering valve inside.

Photo 37: Detailed view of fibrous debris with measurements

The fibrous debris that was removed from the steering metering valve was sent to Boeing Research and Technology for material analysis. The fibrous material was identified as cellulose acetate.

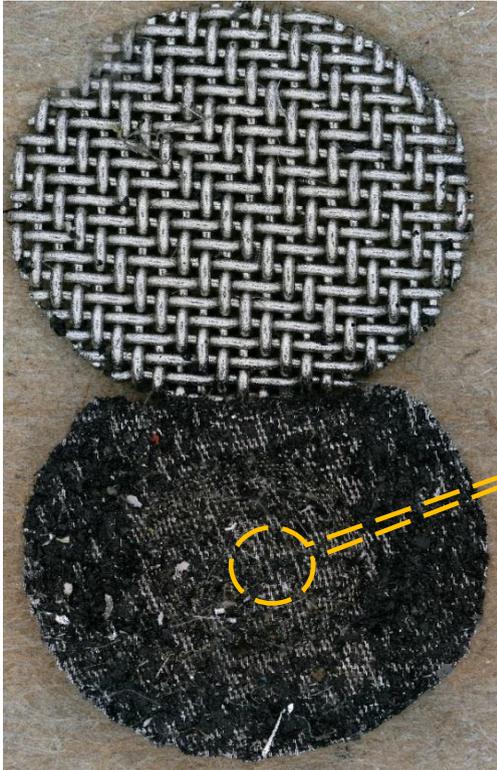
The bleeder orifice filter was a two-layer filter. One layer was coarse mesh, and the other was fine mesh. The filter was separated into the two layers and examined. The fine mesh filter appeared to have debris in it. A tear 0.0255 inch long was found in the fine mesh filter.

Photo 40a: Bleeder filter separated in two

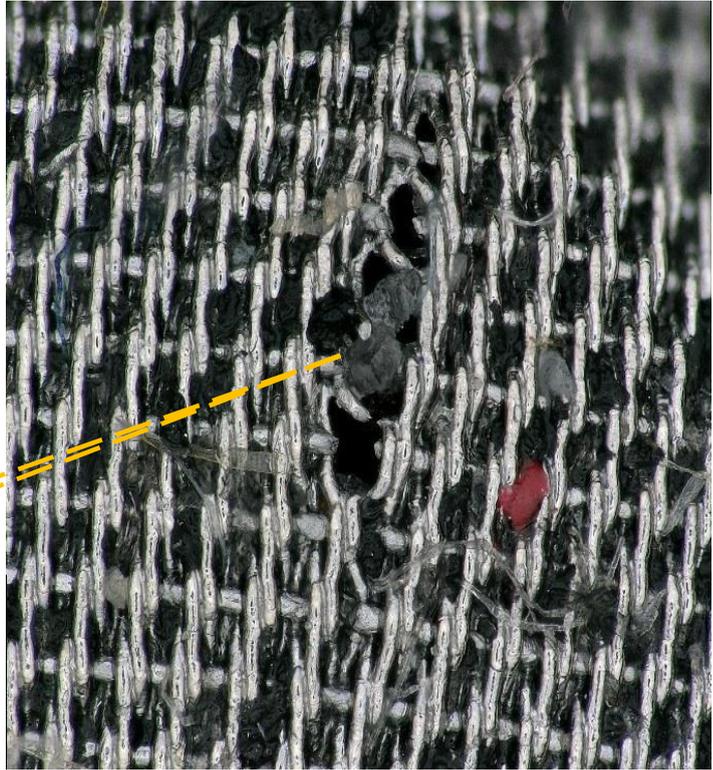
Photo 40b: Magnified view of tear

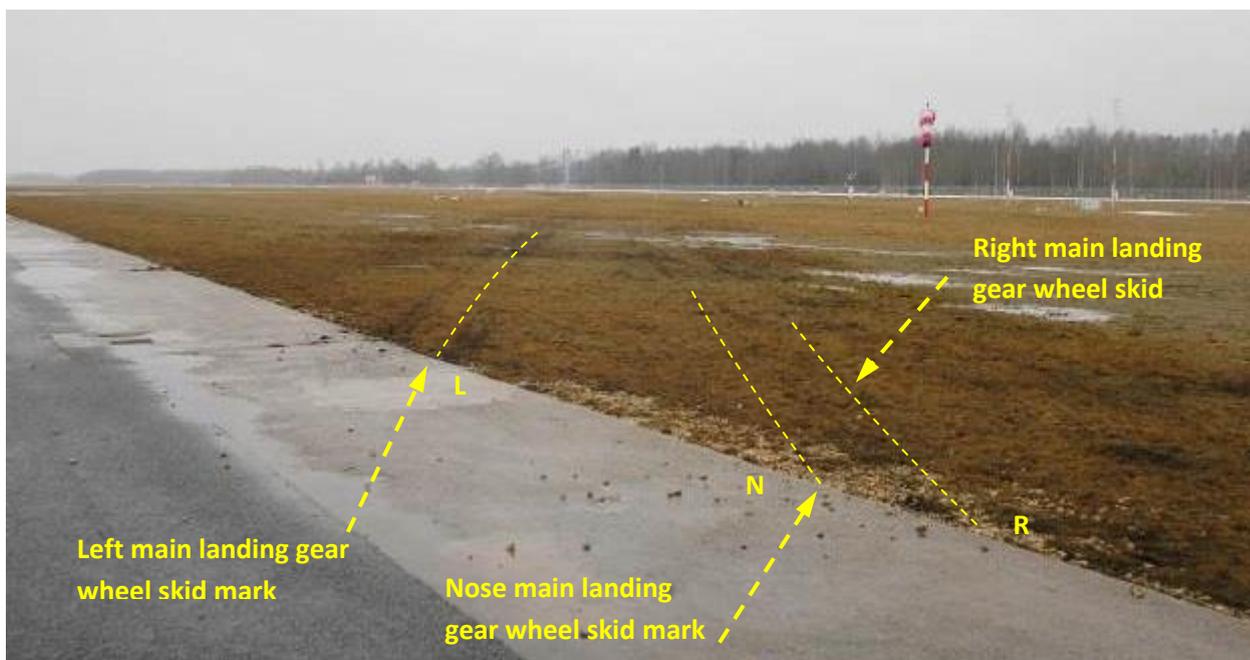
Photo 41, Aircraft takeoff roll trajectory

The smaller space between the trajectory of the right main gear wheel “R” mark and the nose gear wheel “N” mark than the left main gear wheel “L” mark and the nose gear wheel mark evidently points of increasing the aircraft’s moving turn right from the runway heading (Photo 41).

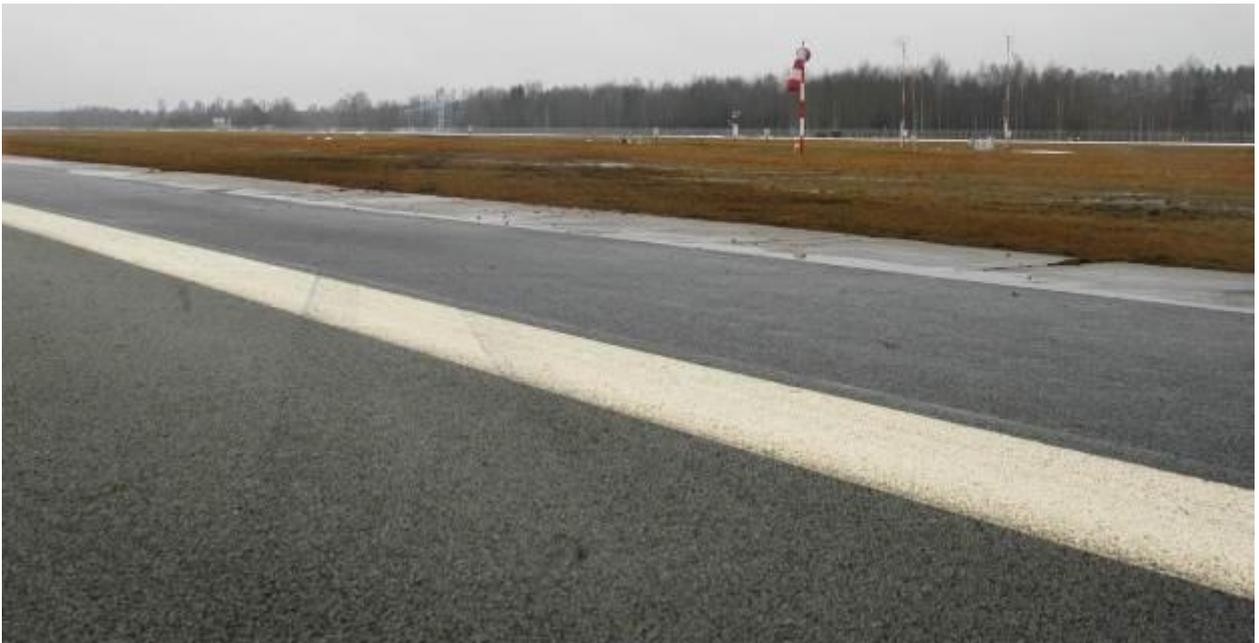
No skid marks of wheels were found on the runway surface after using of brakes of the main landing gears (Photo 43).

Photo 43, Runway 18 right border
