FINAL REPORT No. 4-02/4-16 (1-2018) on

THE SERIOUS INCIDENT of AIRCRAFT BOMBARDIER- DHC-8-402, REGISTRATION YL-BAI

ON SEPTEMBER 17, 2016 AT RIGA INTERNATIONAL AIRPORT

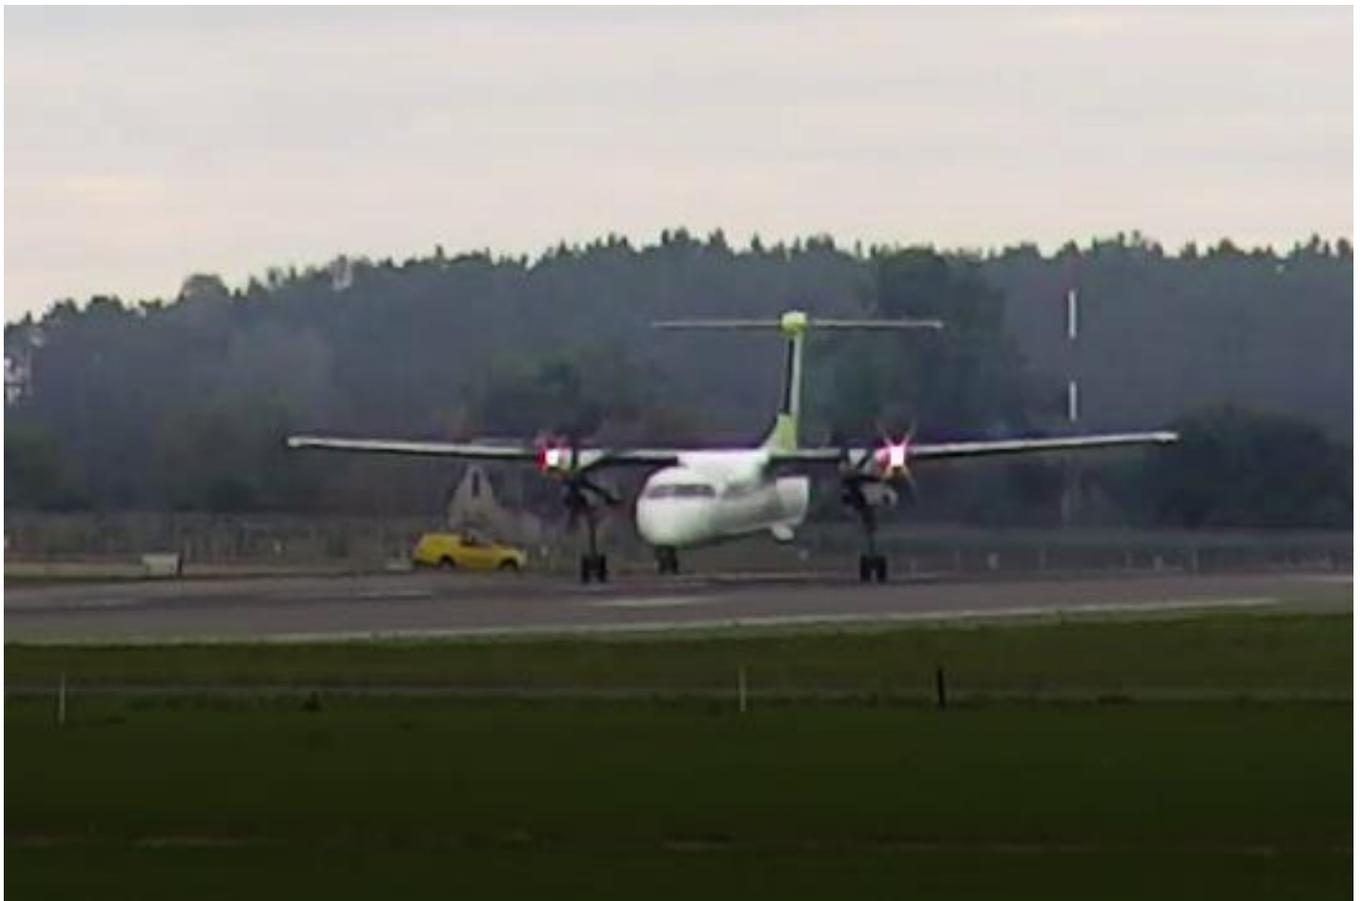
Picture 13 Aircraft touched RWY

At the moment of touching RWY NLG wheels are visible outside aircraft fuselage and lower then opened NLG front doors.

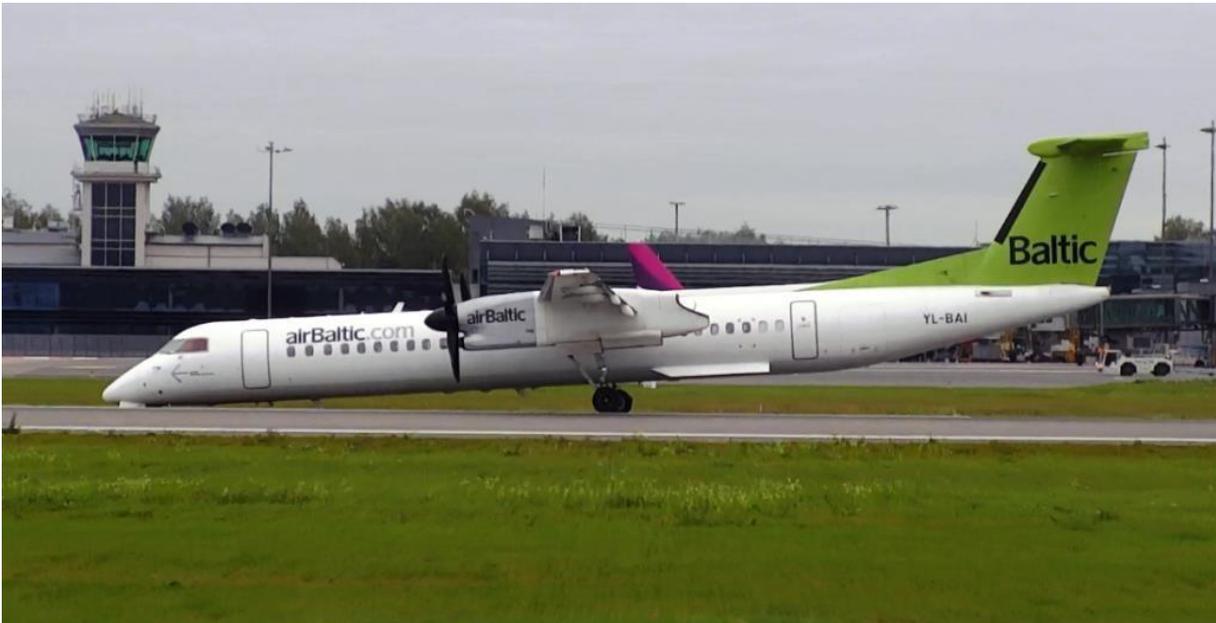
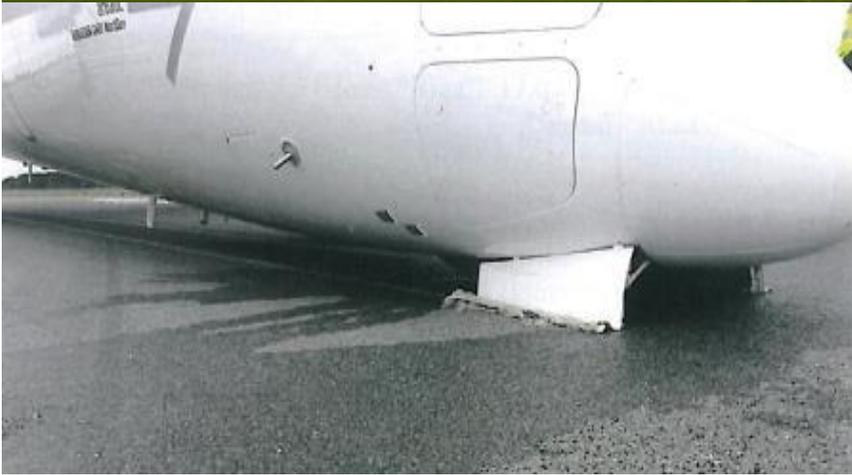
Picture 16 and 16A After the aircraft had come to a complete stop on the runway the NLG appeared to have fully collapsed, which resulted in NLG front door damage.

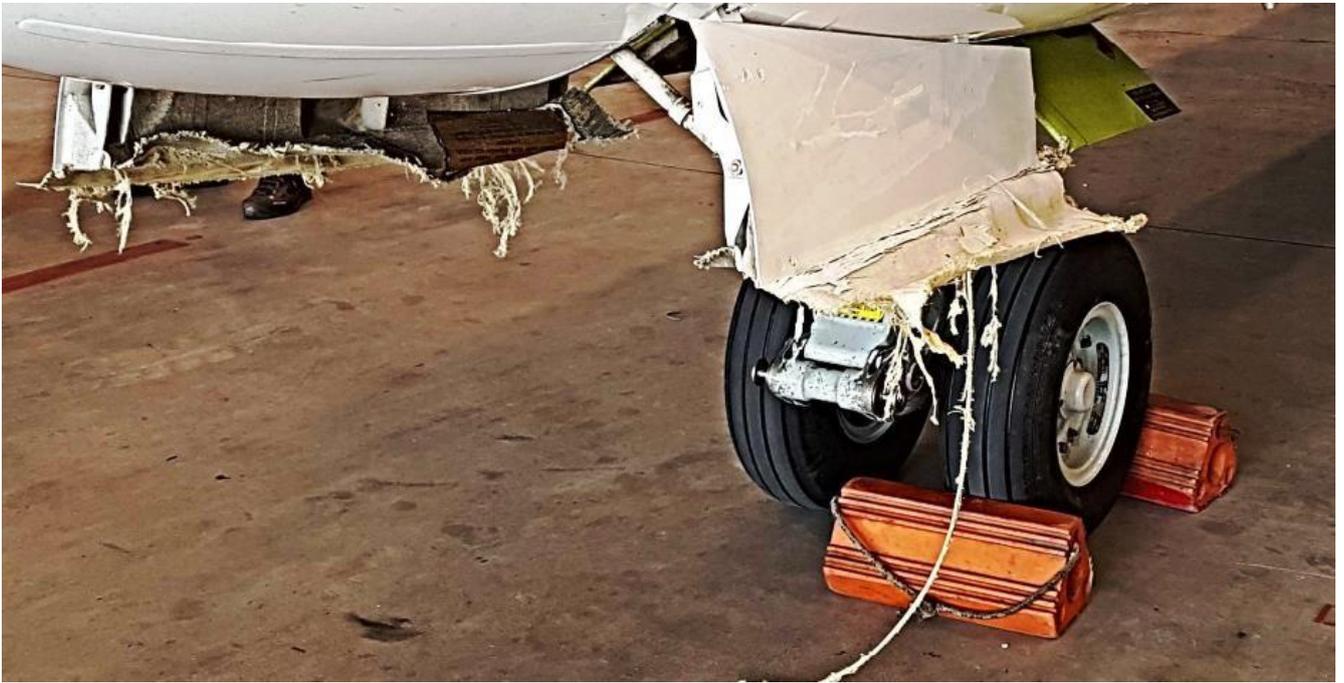
The fuselage of aircraft was not damaged. The NLG front doors were seriously damaged.

Picture 17 Damages of NLG front doors

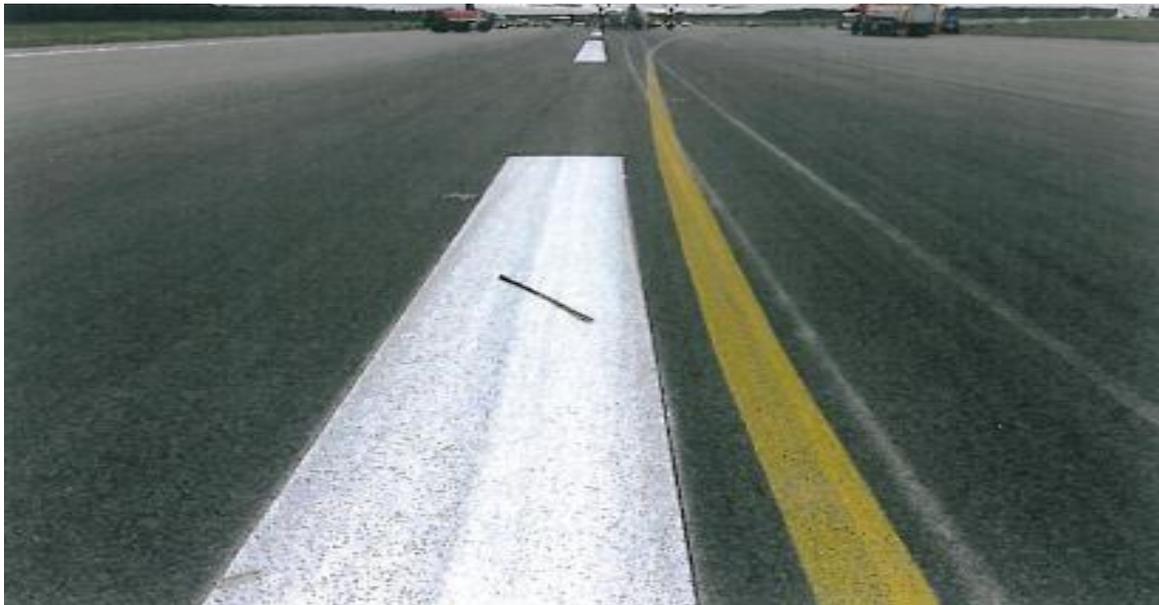
1.4. Other damage On the runway surface was found different small pieces of the aircraft and traces of braking.

Picture 18 Fragments of aircraft

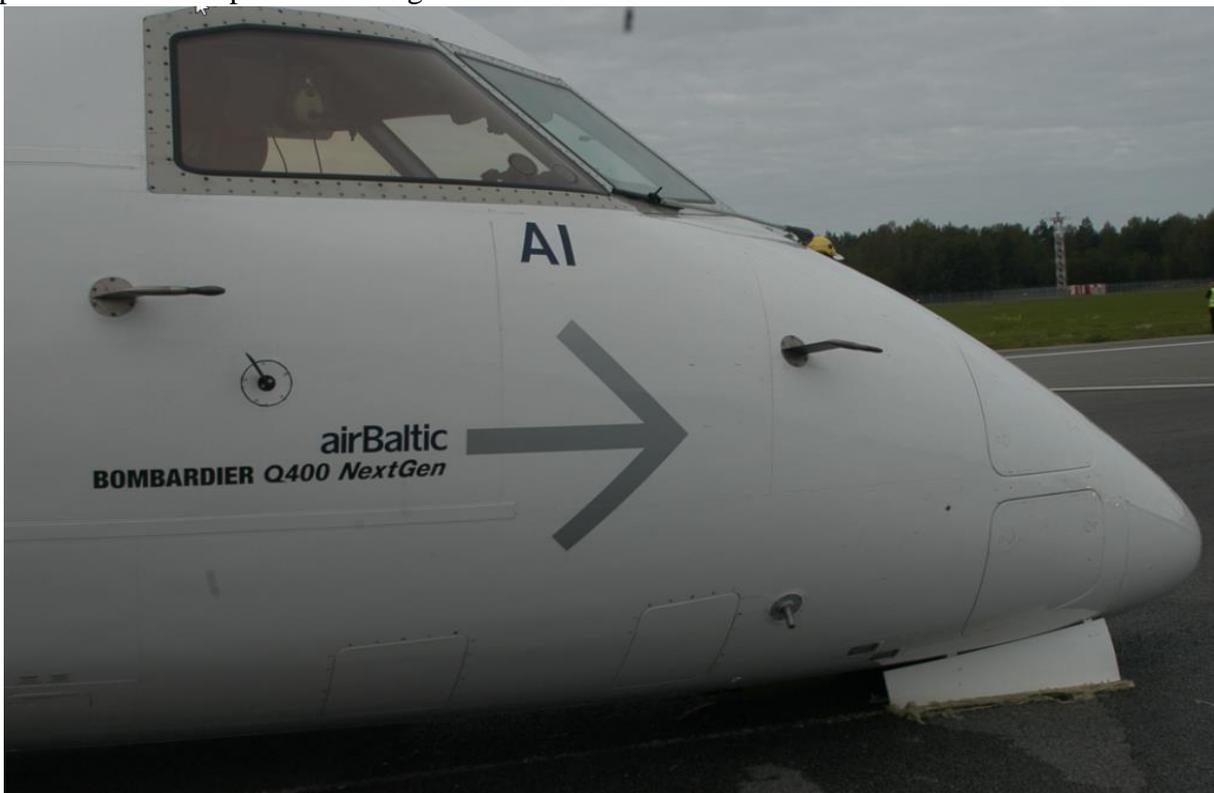
Picture 21 NLG front doors damage

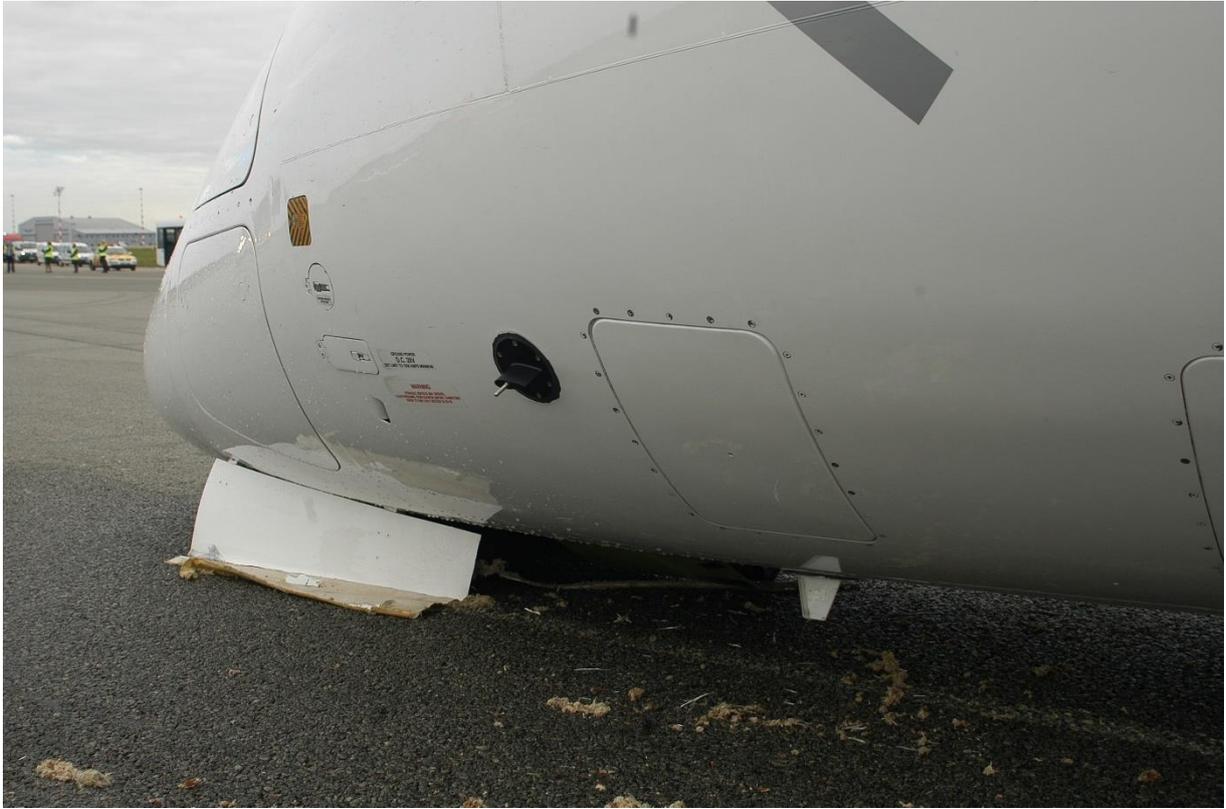
Picture22 NLG front doors damage

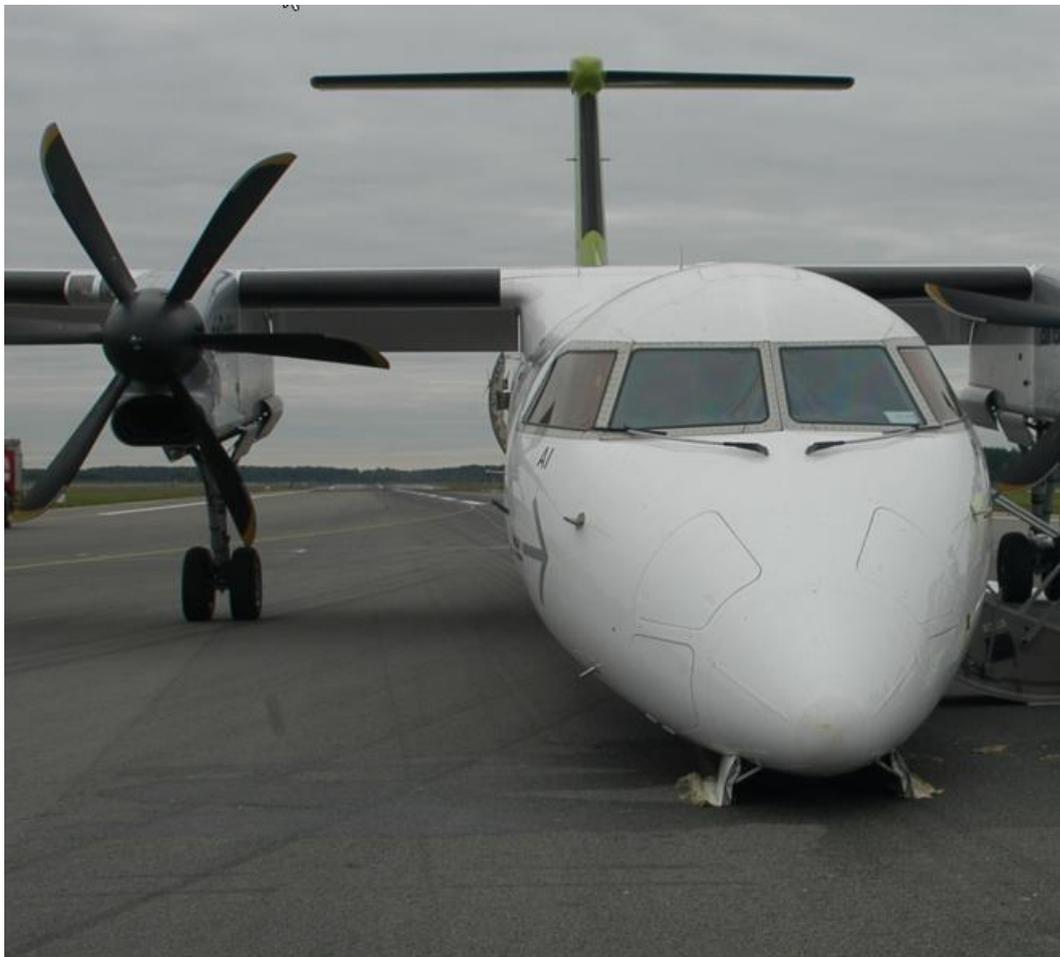
Picture 23 NLG front doors damage

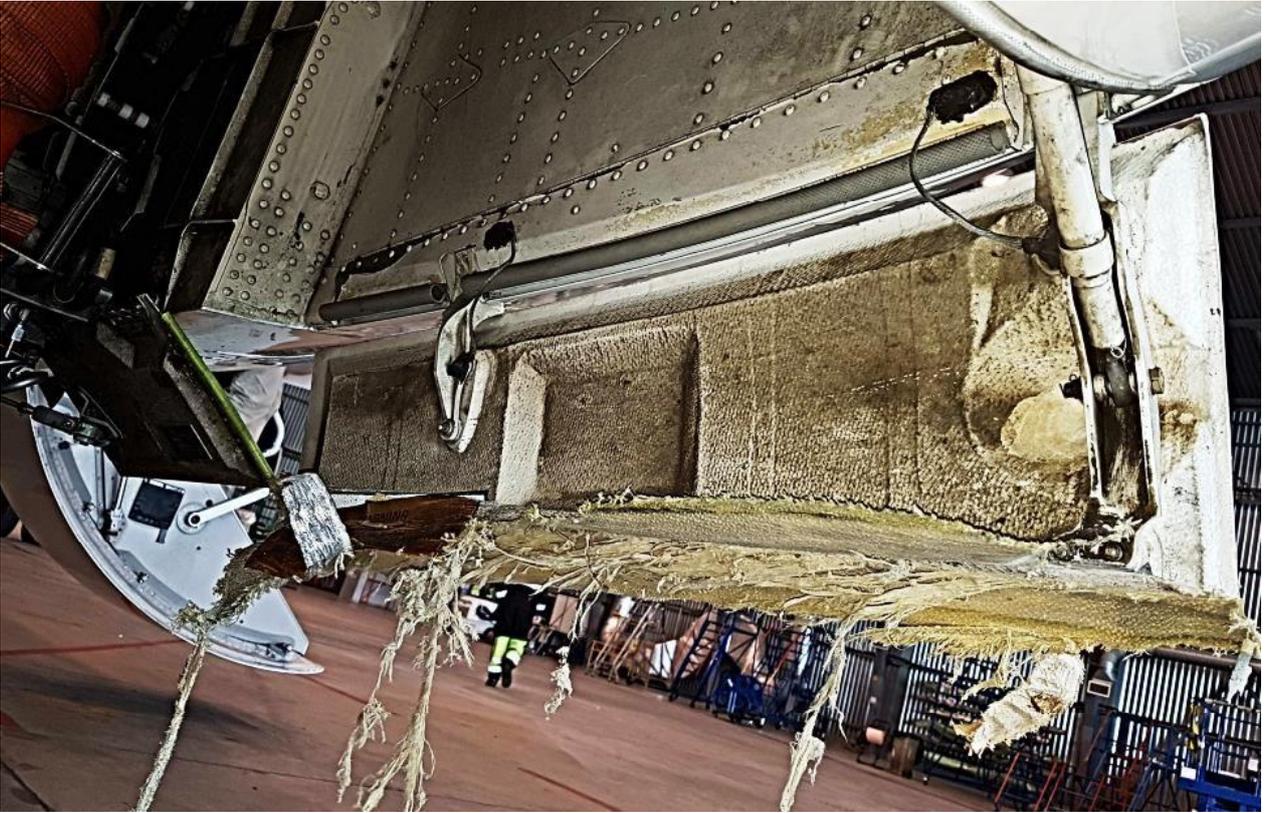
Picture 24 View of NLG front doors damage from inside NLG compartment

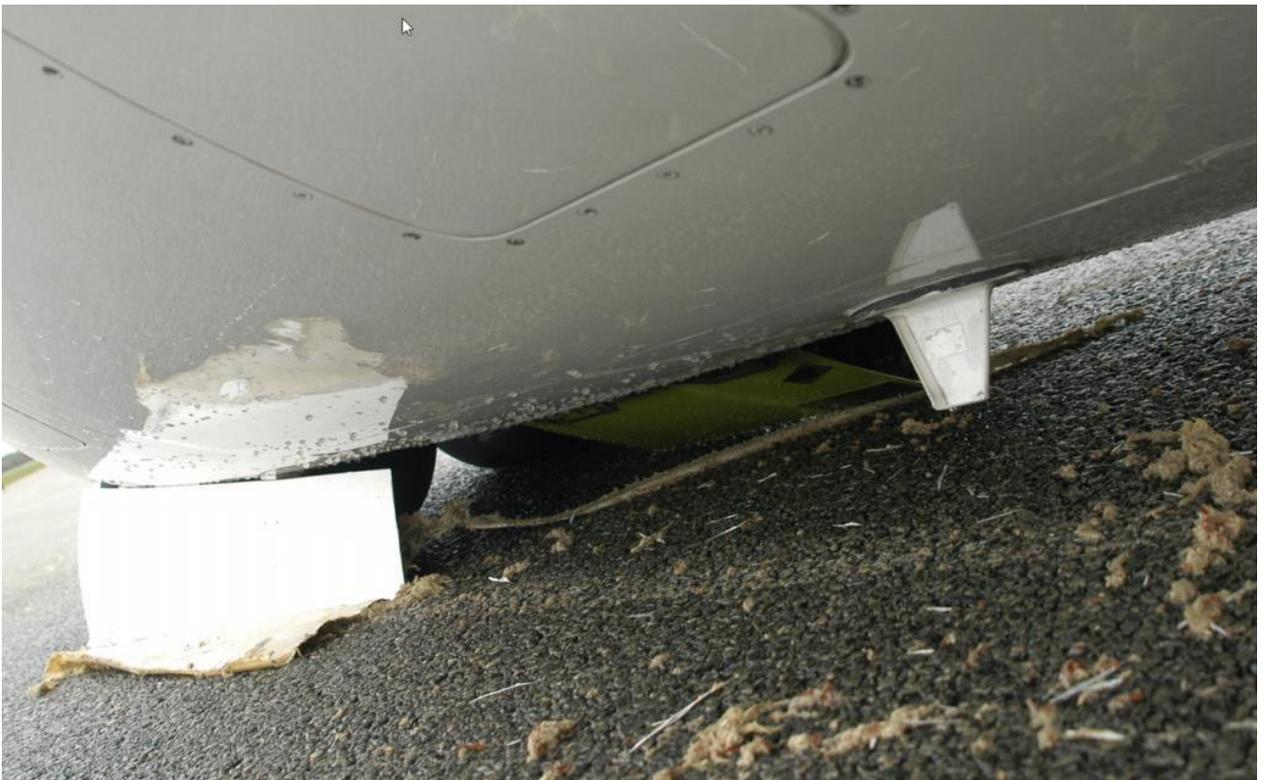
Picture 25 NLG front doors damage

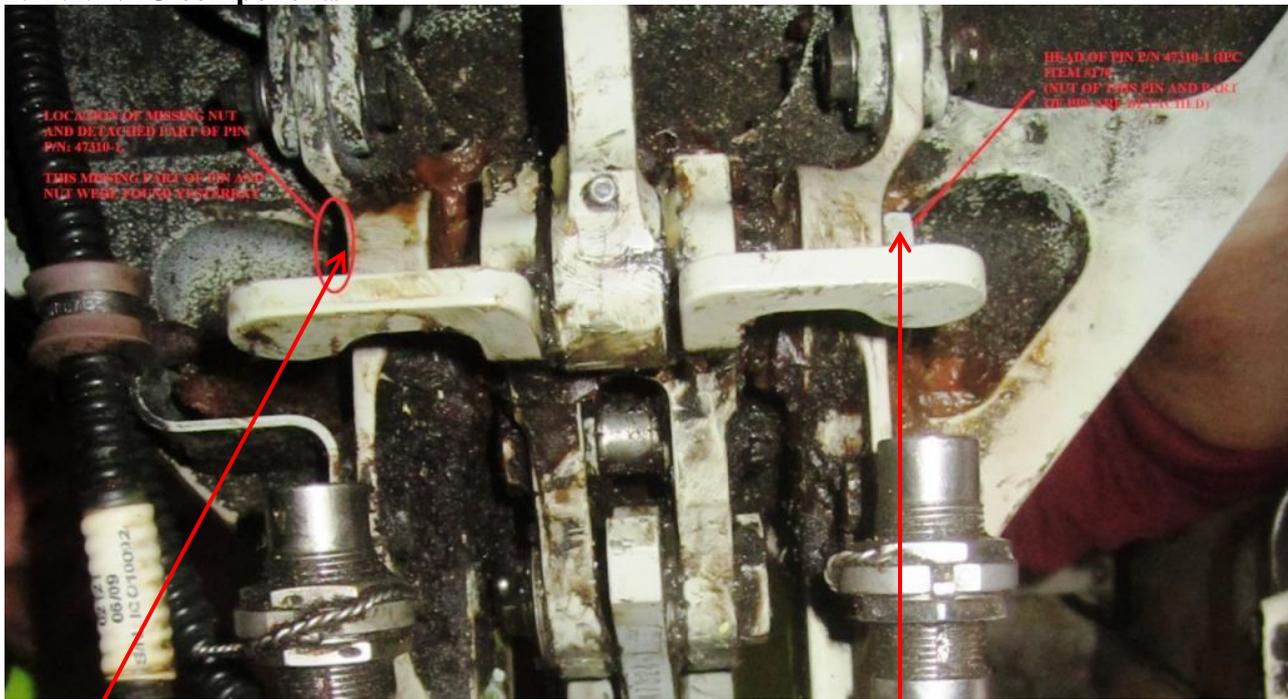
Location of missing nut and detached part of pin P/N47310-1

Head of pin P/N47310-1, IPC item 170 (nut of this pin and part of pin was detached)

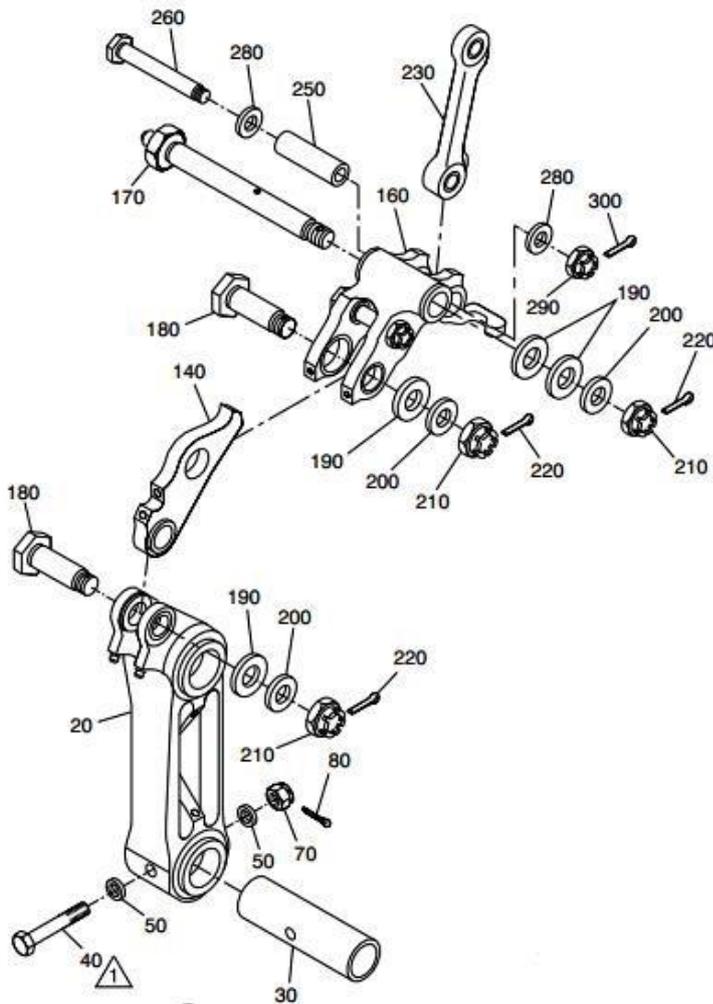
Picture 25 NLG Drag Strut Assembly, Illustrated Parts Catalog (IPC) During the first inspection was found that nut 210 of pin 170 of upper lock drag strut and part of pin was detached. NLG Drag Strut Assembly was removed from aircraft for inspection.

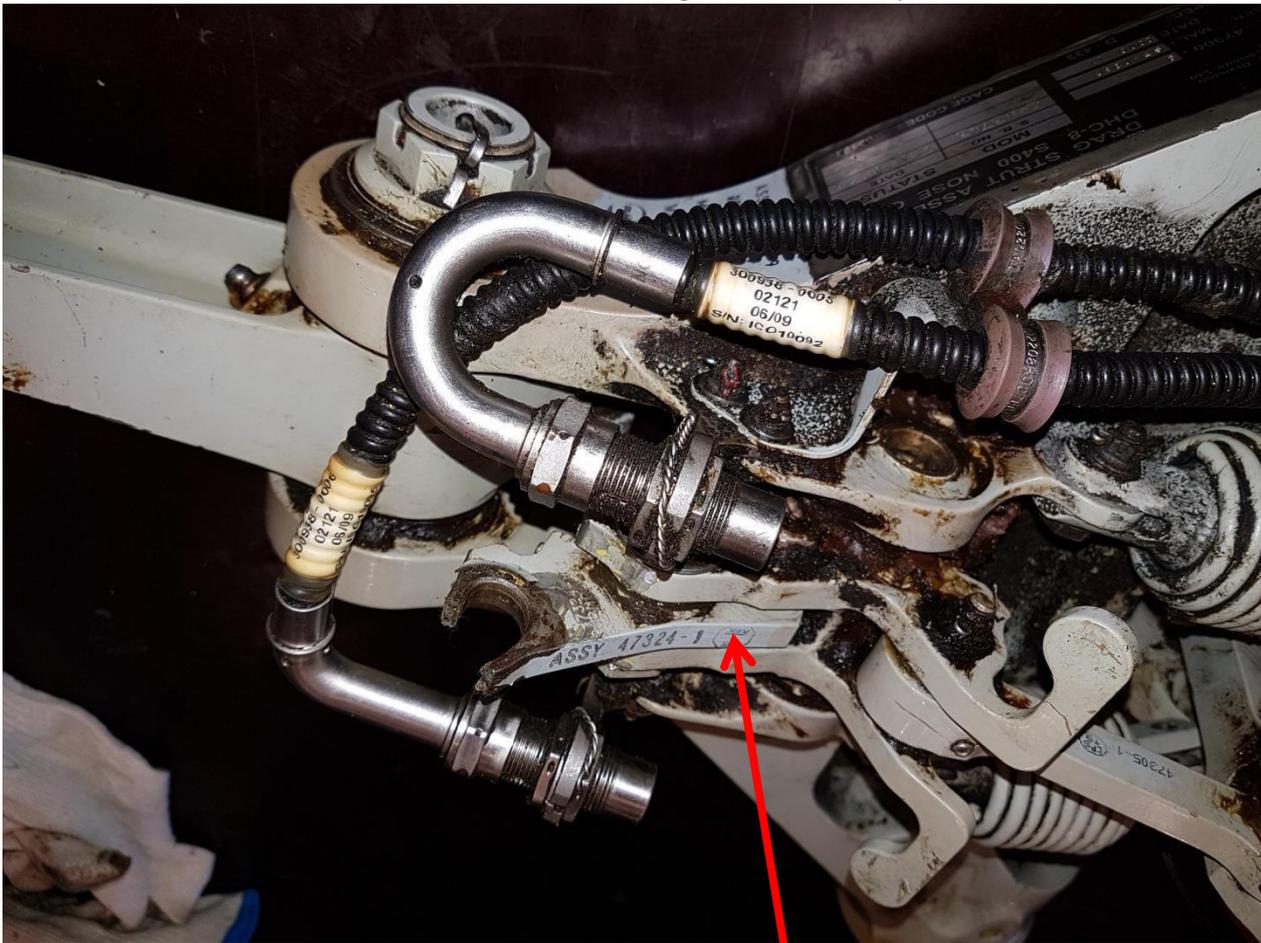
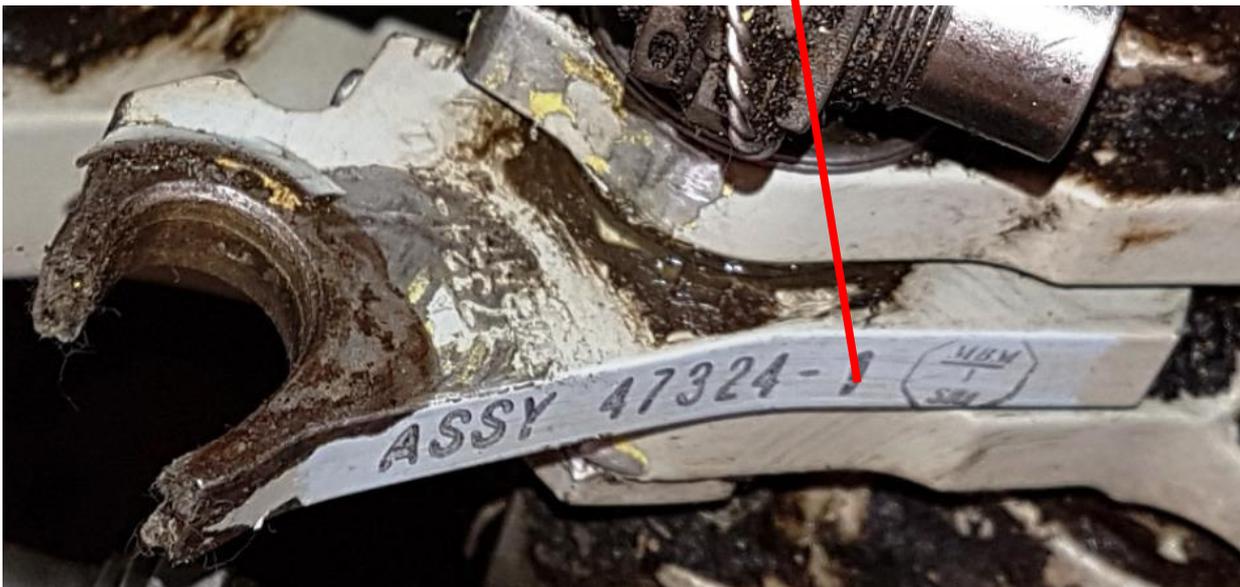
Picture 27 Lower Lock Link

By visual inspection it was stated that the Lower Lock Link ASSY P/N 47324-1 is damaged at the place of hole/lug where it is connected to the Lower Drug Strut P/N 47313 -1.

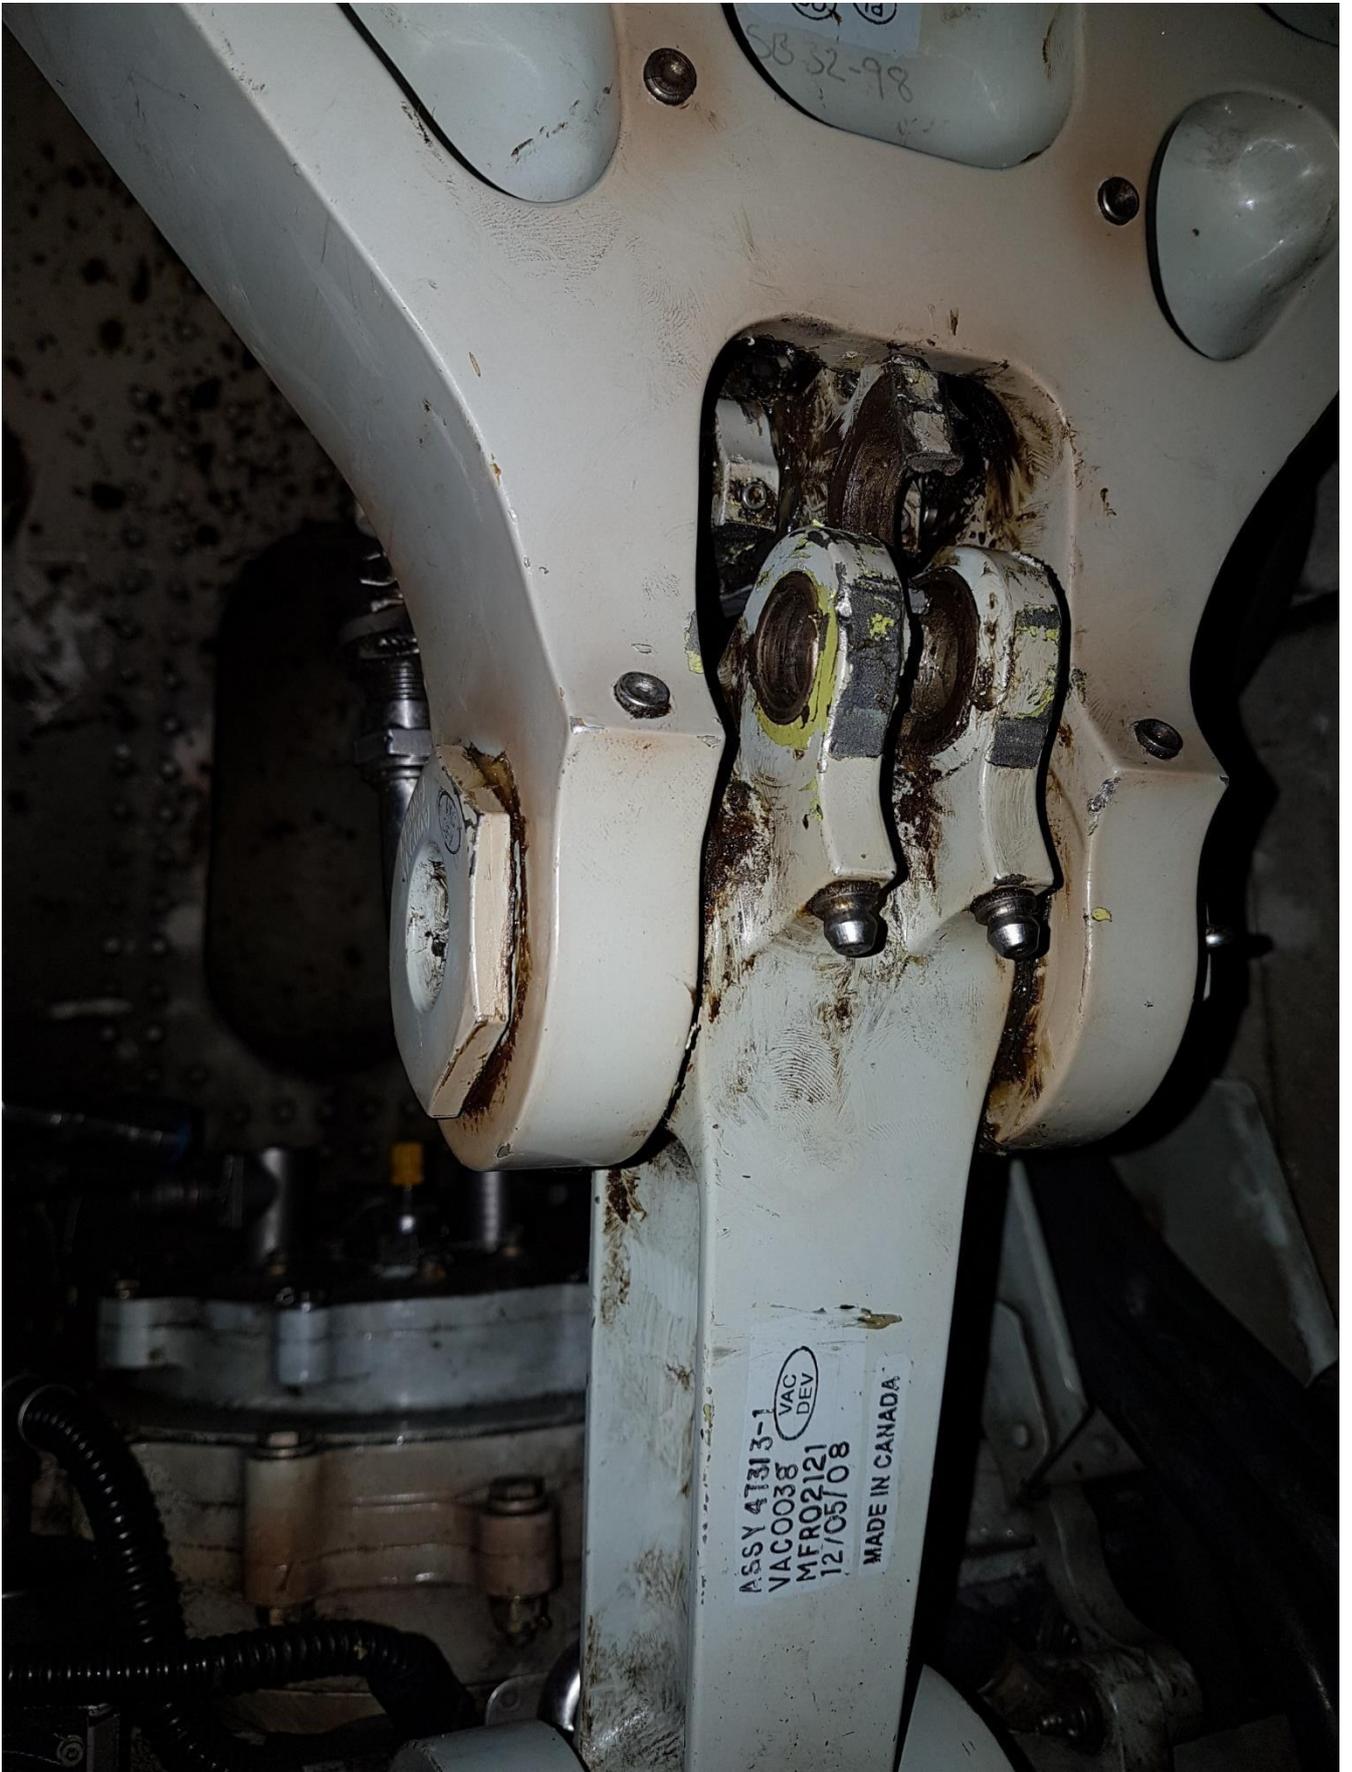
Picture 28 Lower Drag Strut

After removing from aircraft it was stated that the lugs of the Lower Drag Strut for the Lower Lock Link was damaged.

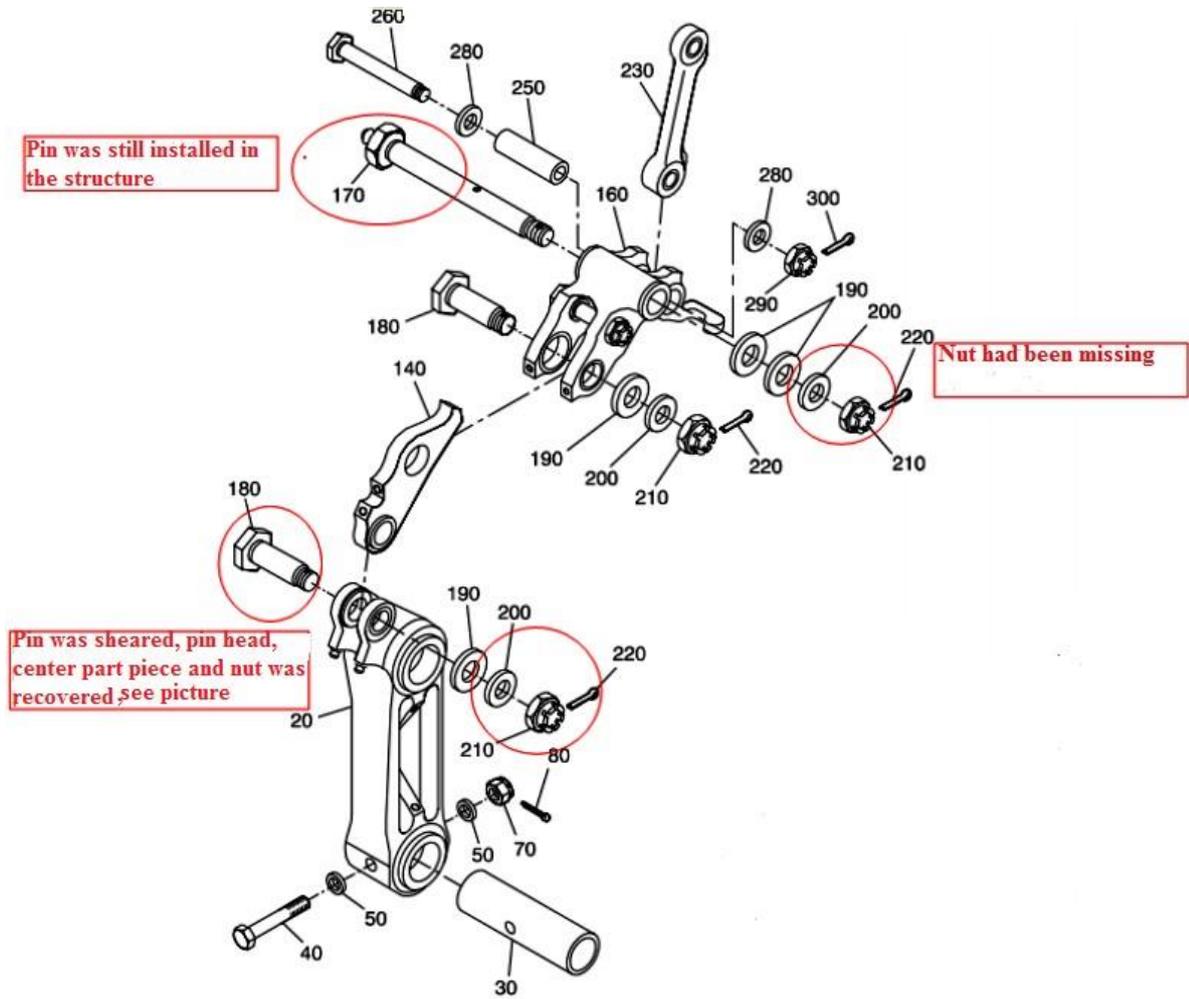
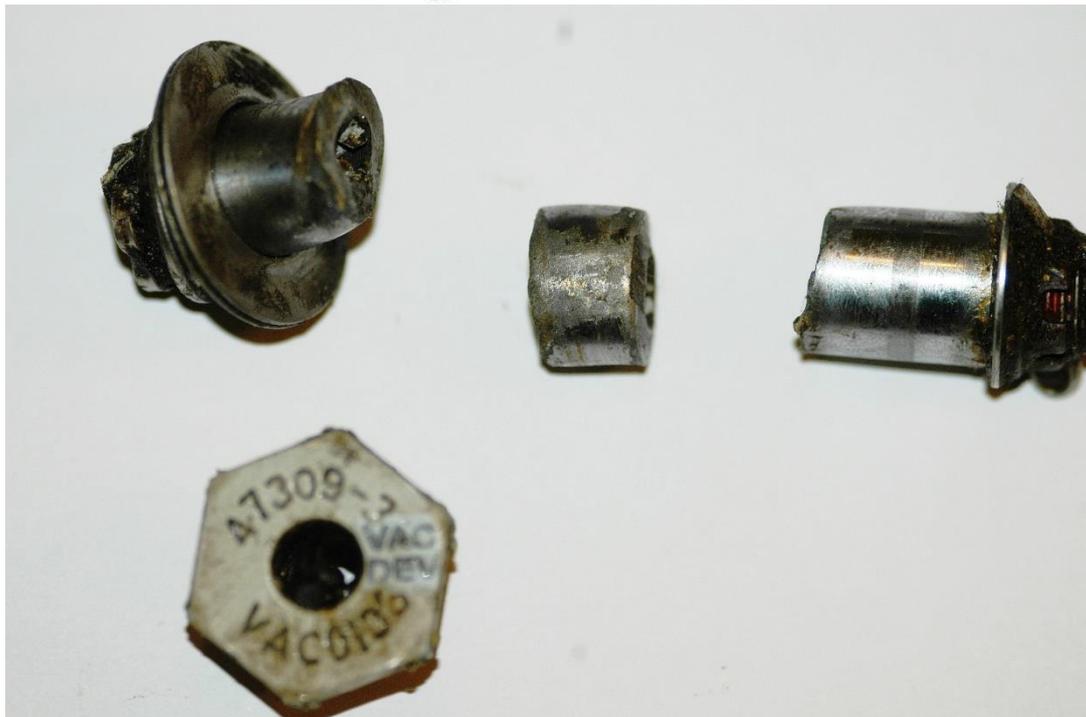
Picture 29 Lower Lock Pin, P/N47309-3

Lower Lock Pin (Illustrated Parts Catalog, 180) was sheared. Pin (Illustrated Parts Catalog, 170) was still installed in the structure.

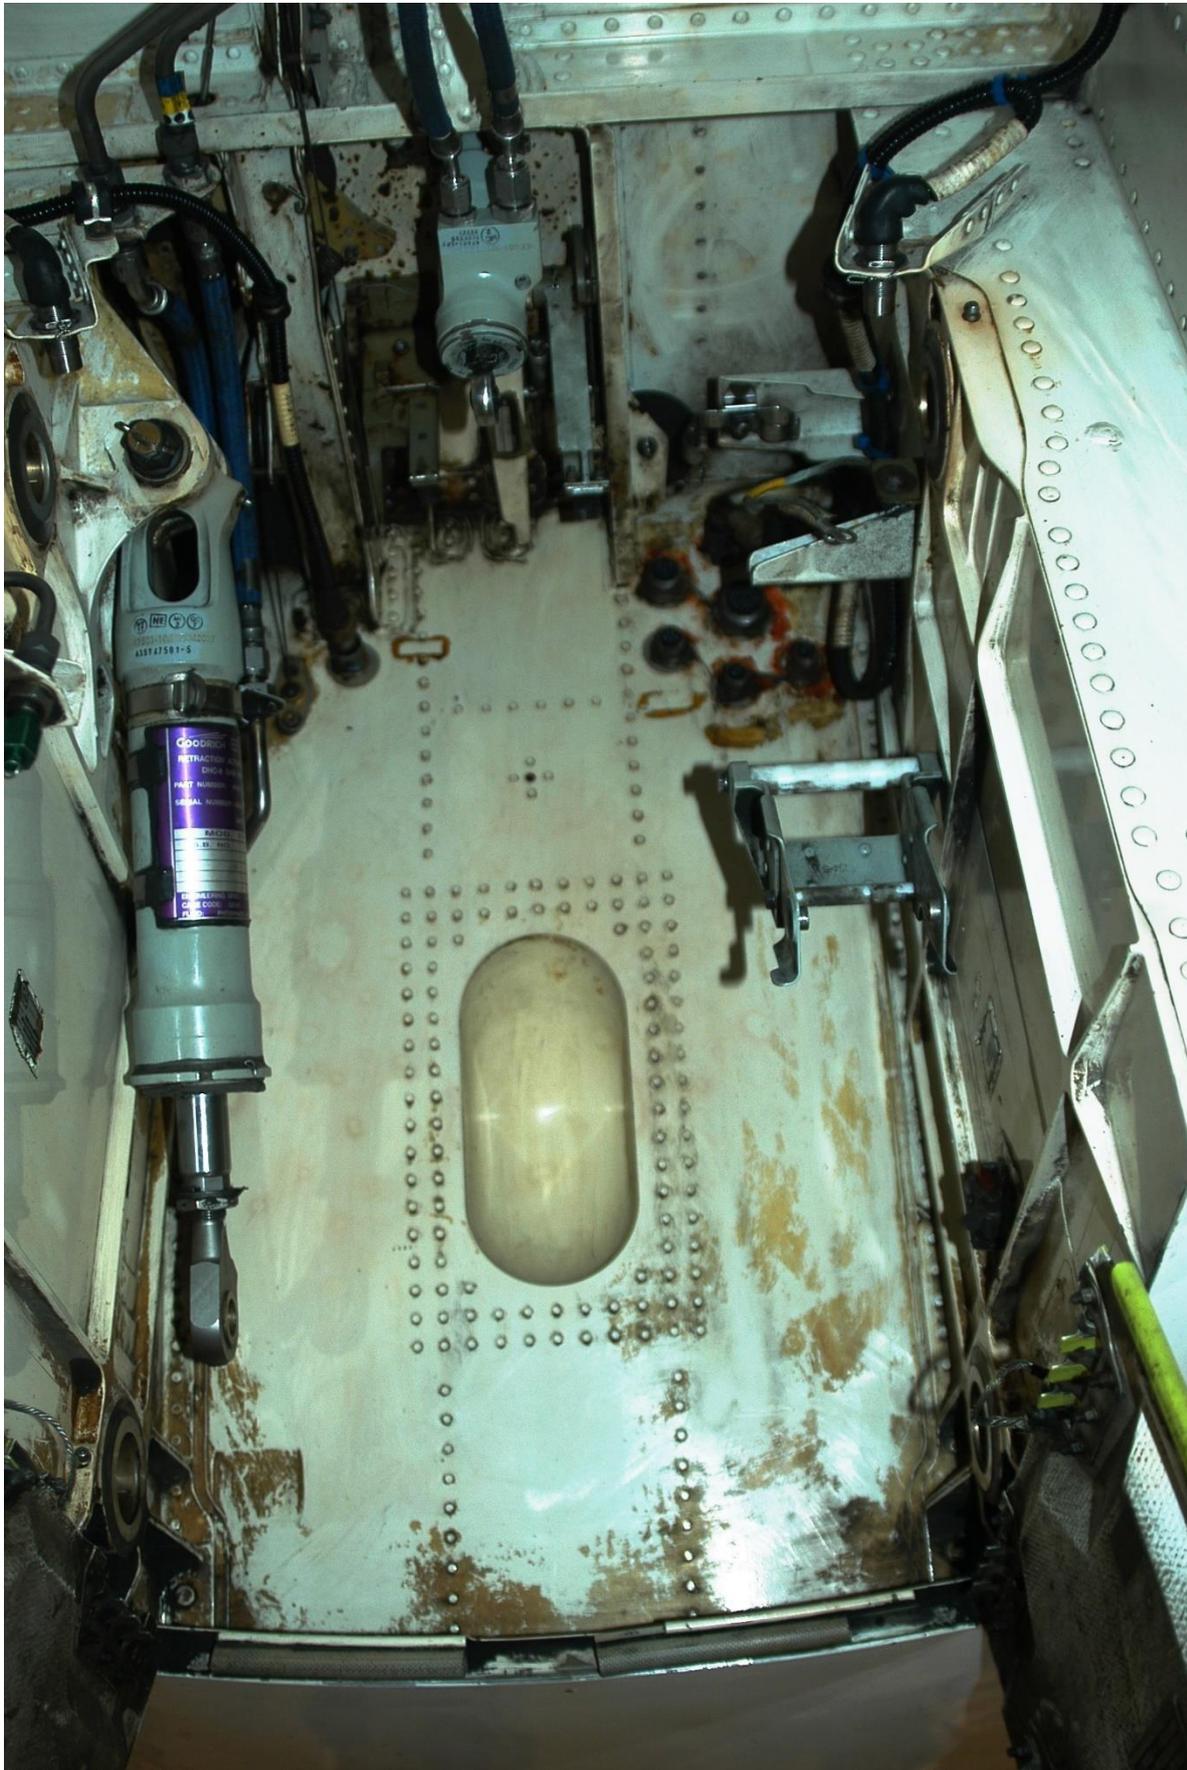
Picture 30 NLG compartment after components removing.

There were found fragments of broken details from not identified material, probably pieces of washers or bushings at the place of joint Lower Lock Link (Illustrated Parts Catalog, 140).

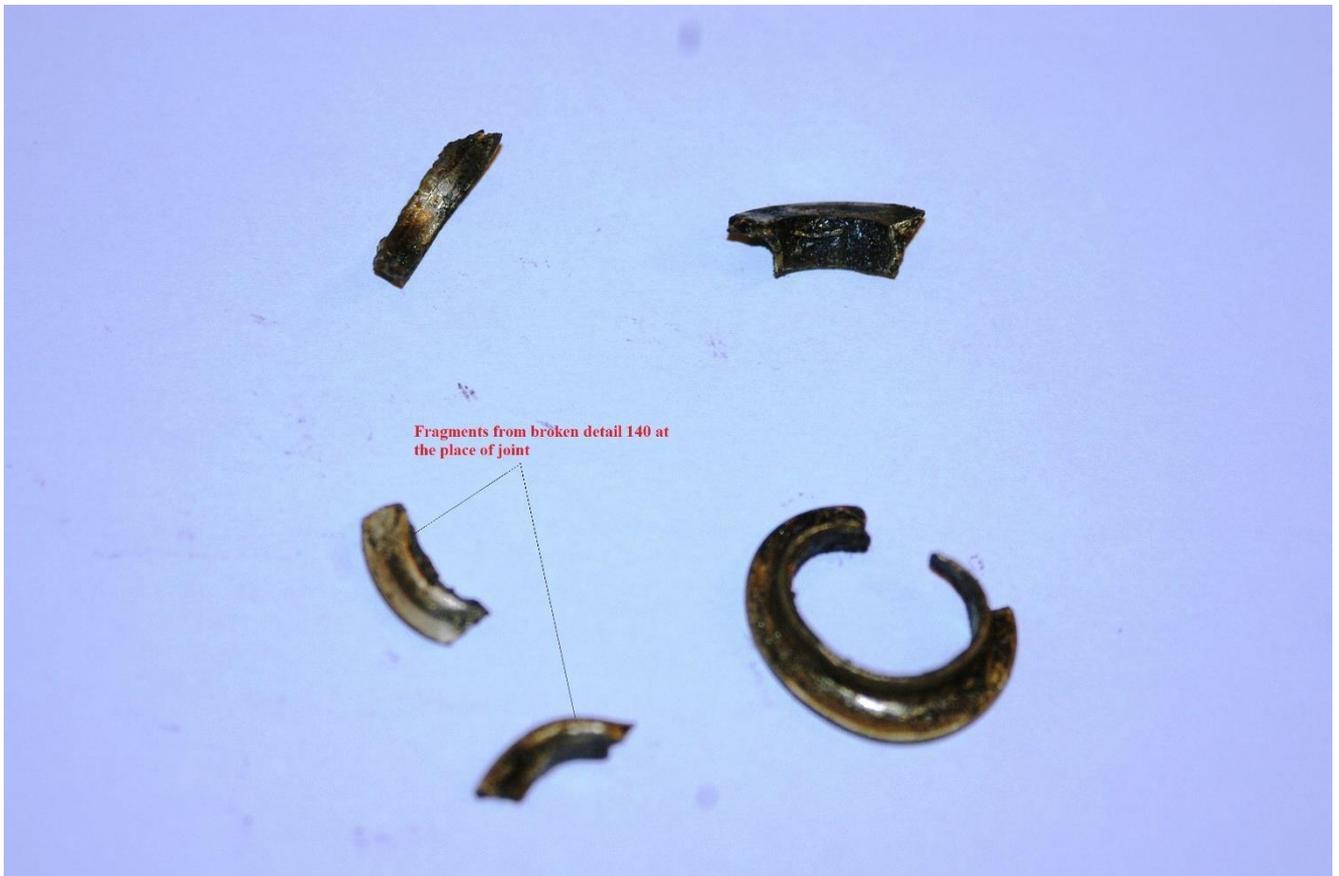
Picture 31 Fragments of broken details from not identified material

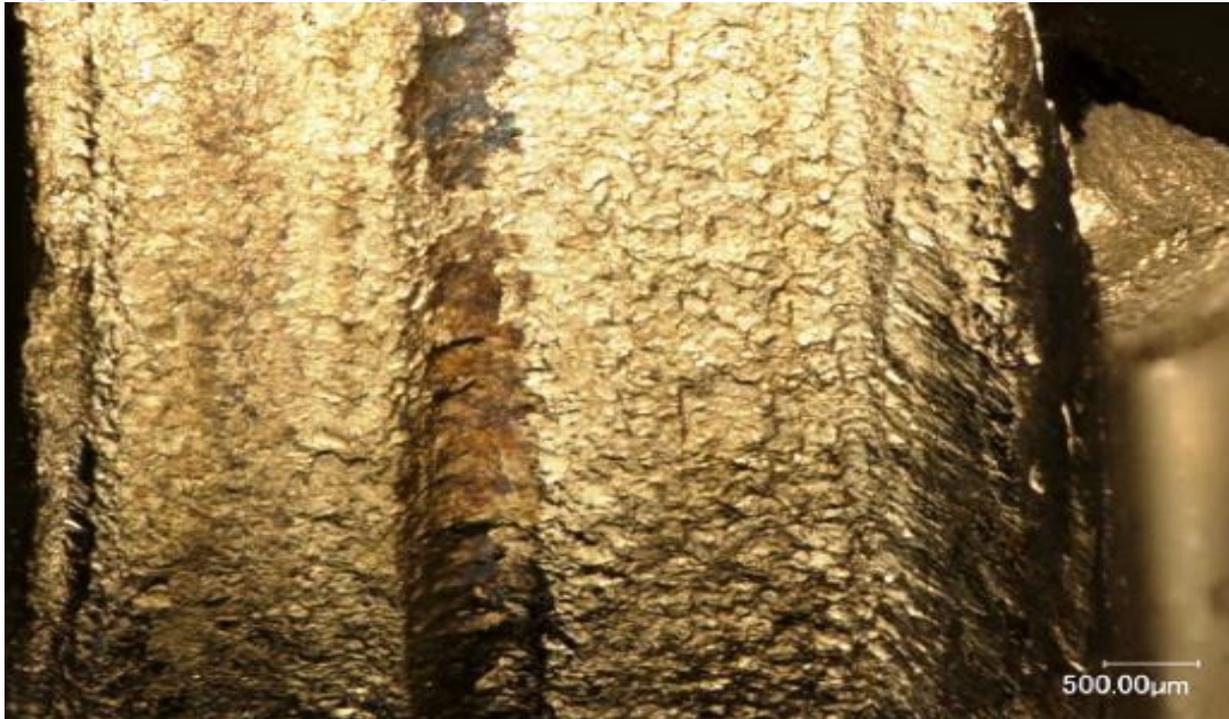
The small engaged length of this particular bushing was also a factor in addition to the low radial interference. The radial interference sets the interference pressure, and the relationship between this interference pressure and the load reaction capability of the interface is determined, in part, by the engaged length of the bushing.

Picture 81 Optical microscopy image of the mating surface of the bushing with the inside of the LLL pin hole

Corrosion of LLL hole and wear of bushing OD led to excessive clearance in the mechanism and allow for jamming of the NLG. Landing loads damaged the locking mechanism.
