LATVIJAS REPUBLIKA  
**TRANSPORTA NELAIMES GADĪJUMU UN INCIDENTU  
IZMEKLĒŠANAS BIROJS**

REPUBLIC OF LATVIA  
**TRANSPORT ACCIDENT AND INCIDENT INVESTIGATION BUREAU**  
58 Brivibas Street, Riga, Latvia, LV-1011 Phone: +371-67288140 Mob. ph.: +371-26520082 Fax: +371-67283339  
E-mail: taiib@taiib.gov.lv www.taiib.gov.lv

**FINAL REPORT Nr.4-02/3-12(3-2013)**  
**OF THE AIRCRAFT SERIOUS INCIDENT**

**LOSS OF SEPARATION BETWEEN THE AEROFLOT AIRCRAFT A320,  
REGISTRATION VP-BZS, flight AFL2100 and AirBaltic AIRCRAFT Boeing 735,  
REGISTRATION YL-BBN, FLIGHT BTI60K, ON MAY 19, 2012**

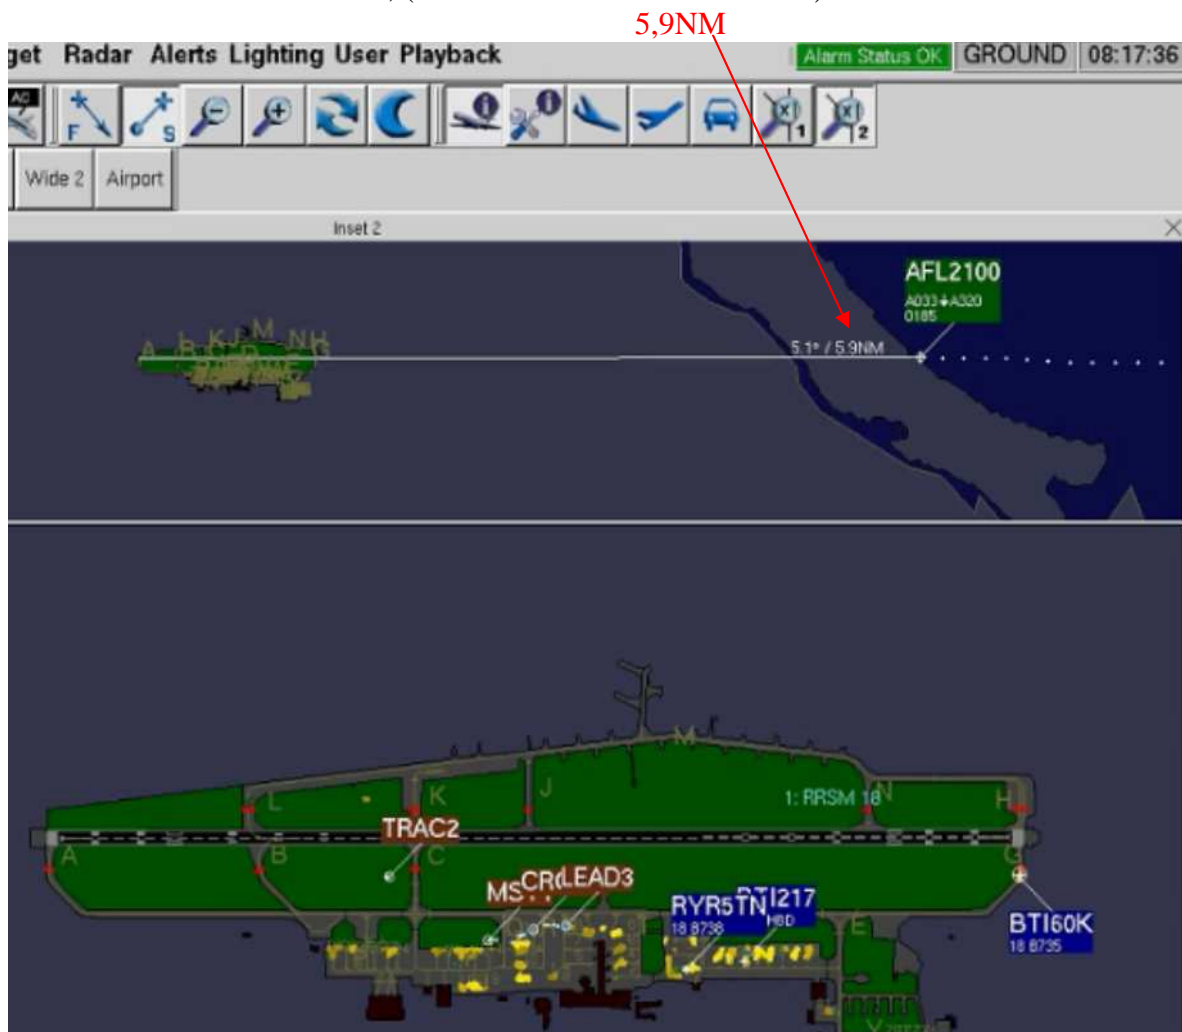
Picture 3, at 08:17:36, Air Baltic 60K cleared for immediate take-off

At **08:17: 36** the crew of air Baltic Boeing 735 (flight BTI-60K) contacted TWR controller and declared: “Good morning, Air Baltic 60K, rolling 18, ready for departure.”

TWR controller answered: “Good morning Air Baltic 60K, landing traffic 5NM, are you ready for immediate?”

After that TWR controller gave clearance for Air Baltic 60K: “Air Baltic 60K, wind 140 degrees, 7 knots, RWY 18, cleared for immediate take-off”. The crew of Air Baltic 60K read back controller’s clearance.

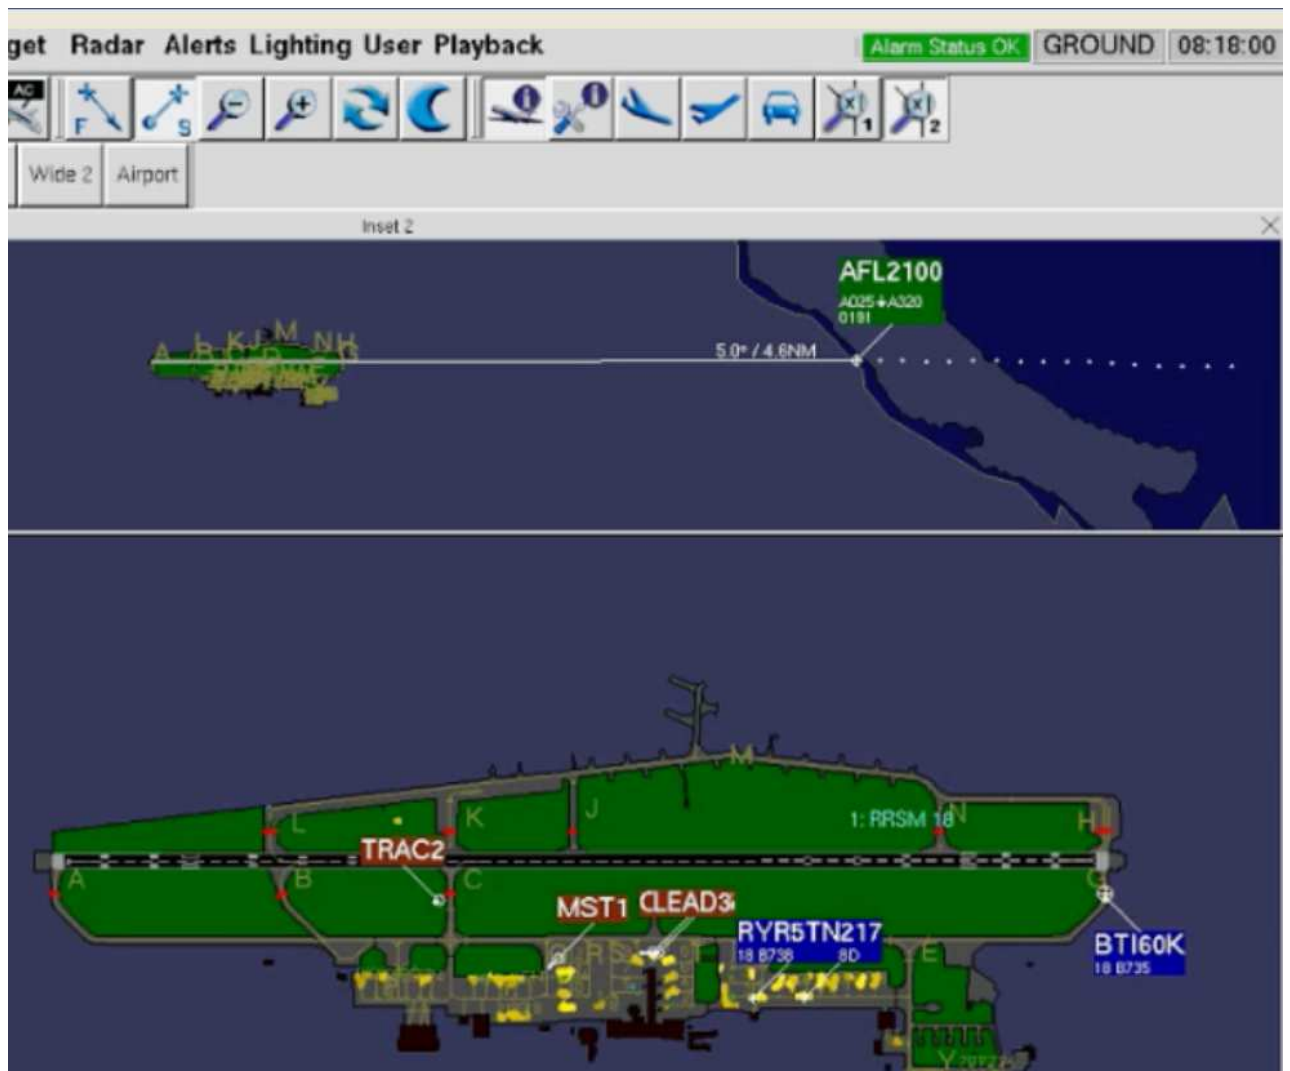
At **08:18:00** A-320 (flight No AFL 2100) on track 186 degrees, with ground speed 190KN at 2500FT on descent, (4.6NM from threshold RWY18).

**A-SMGSM Radar:** BTI60K crossed holding point to take-off position.

*Picture 4, at 08:18:00, BTI60K crossed holding point to take-off position*

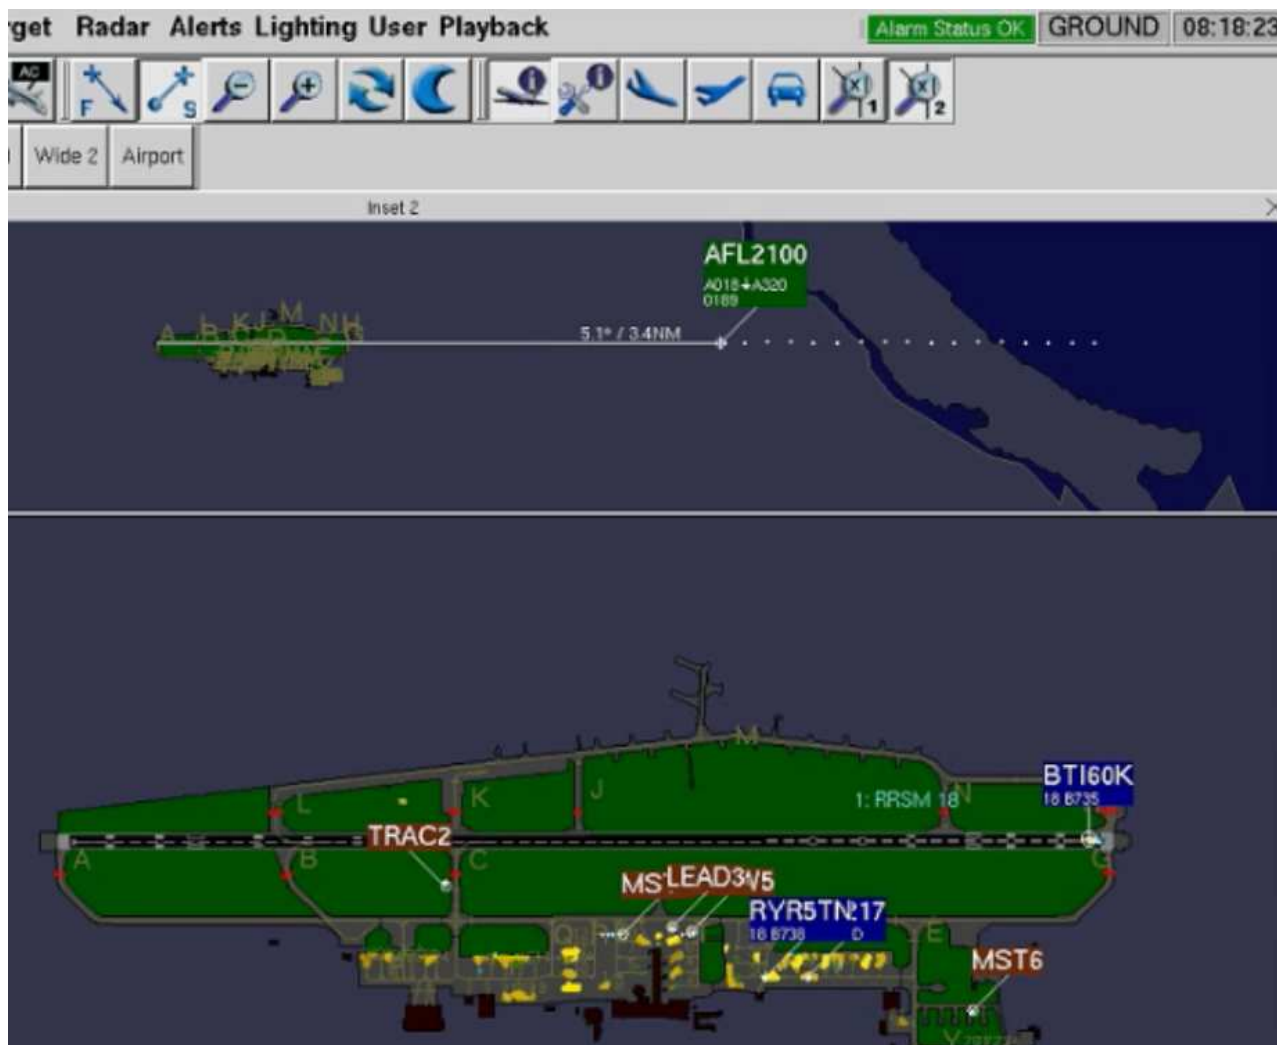
At **08:18:23 A-SMGSM Radar:** BTI-60K started take-off roll.

AFL2100 was 3,3NM from RWY threshold.

Picture 5, at 08:18:23, BTI-60K started take-off roll.

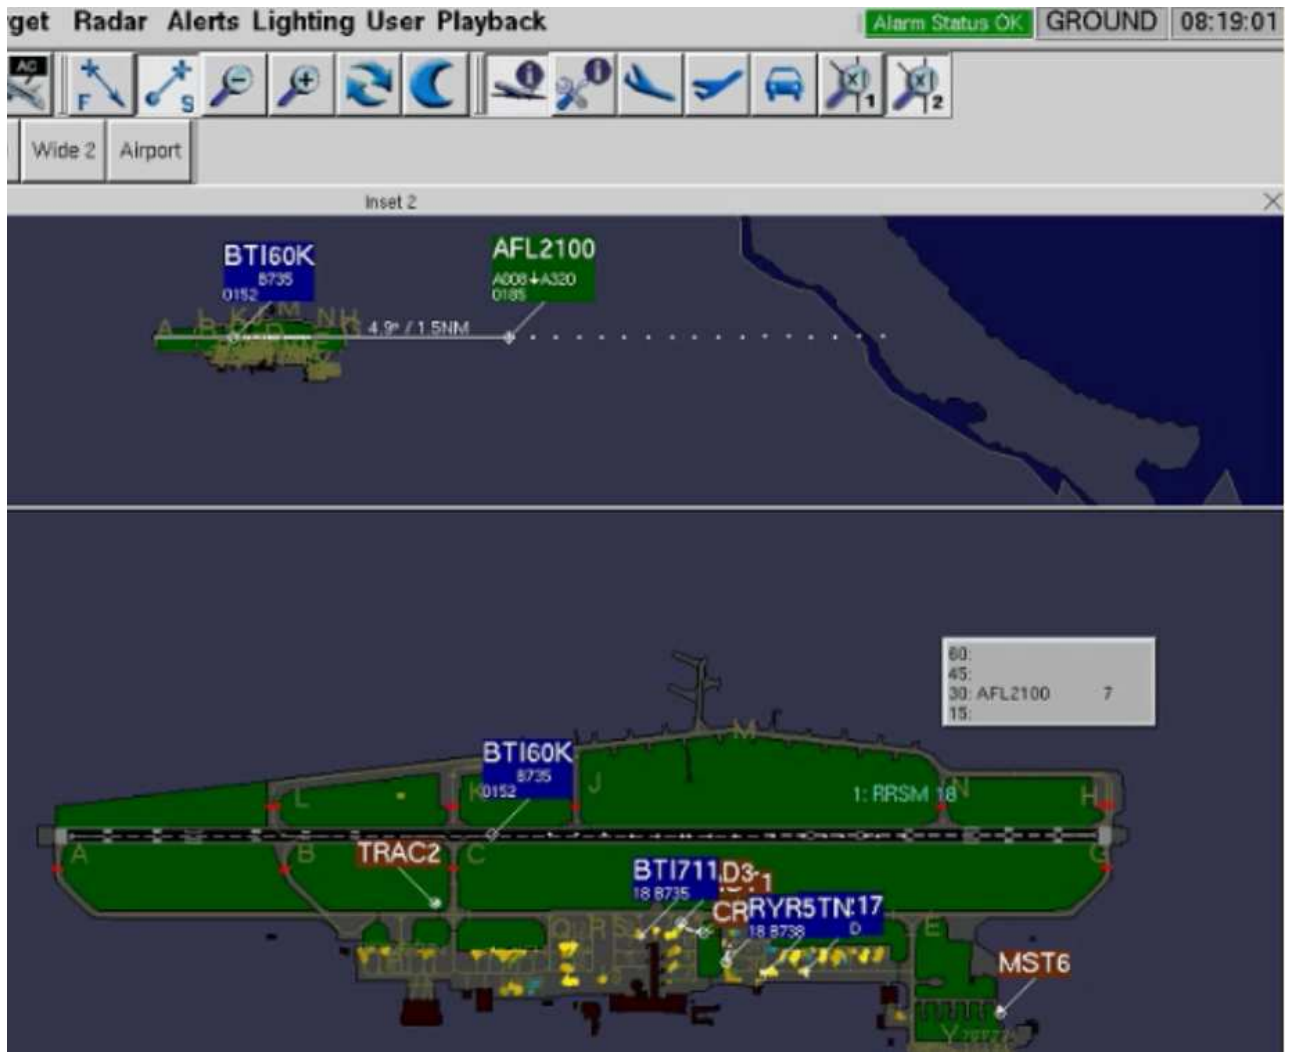
At 08:19:01 the crew of A-320 (flight No AFL 2100) received following clearance from TWR controller: “Aeroflot 2100 RWY 18, cleared to land”. The crew of A-320 (flight No AFL 2100) declared:” Aeroflot 2100 go around, are not stabilized”.

Aircraft A-320 (flight No AFL 2100) was on heading 185 degrees, with ground speed 188KN at 800FT, 1,5NM from threshold RWY18. Separation between traffic was 3NM.

Picture 6, at 08:19:01, Aeroflot 2100 go around, are not stabilized

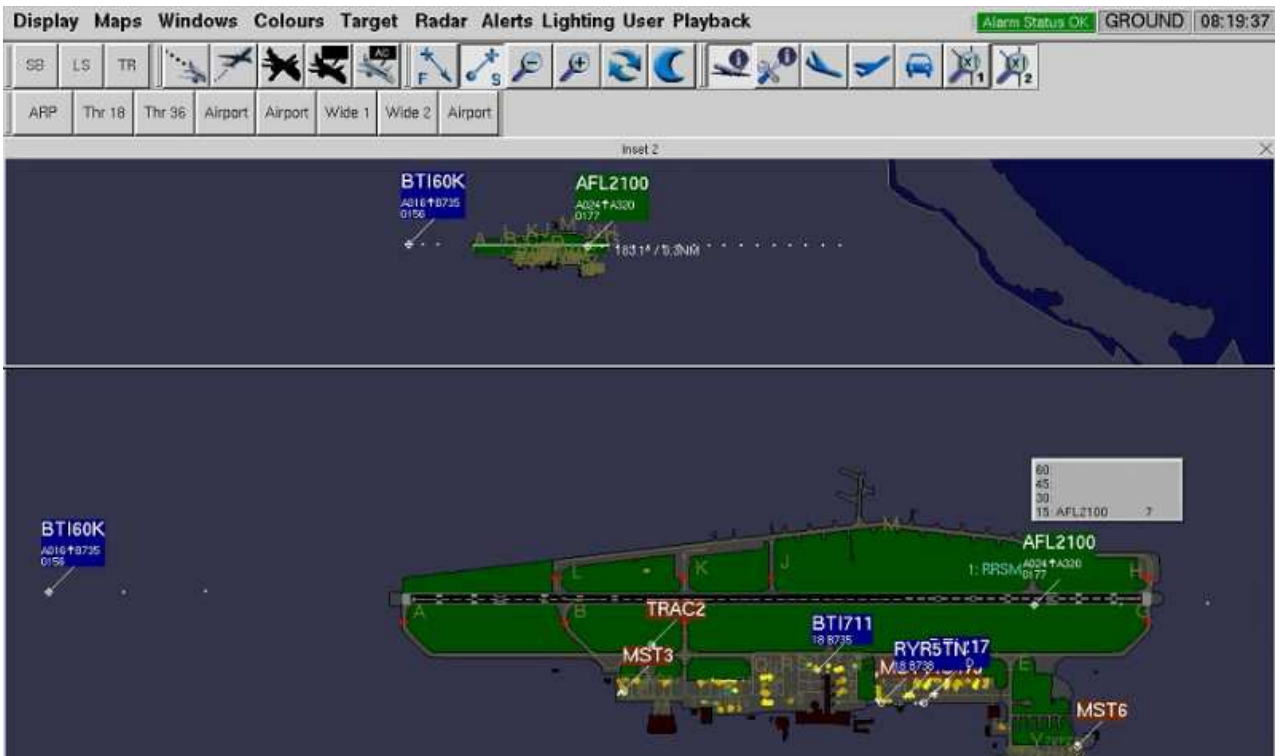
At 08:19:37 the crew of A-320 (flight No AFL 2100) reported missed approach to APP controller and received instruction to turn left on heading 90°.

Picture 7, at 08:19:37, APP controller issued instruction for AFL2100 to turn left on heading 90°.

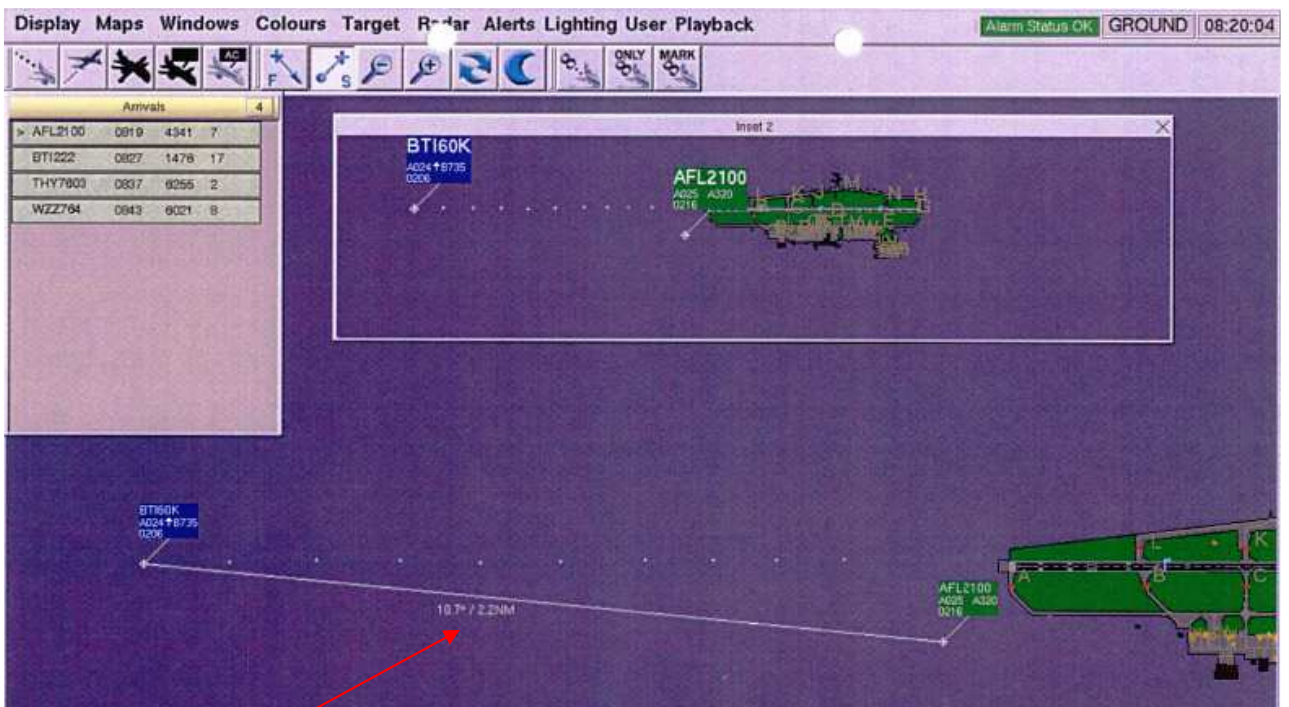
At 08:20:04 Aircraft A-320 (flight No AFL 2100) was on track 172° with ground speed 216KN at 2500FT.

AirBaltic Boeing 735 (flight BTI-60K) was on track 185° with ground speed 211KN at 2200FT.

Horizontal separation between aircraft was 2,2NM

2.2NM Picture 8, at 08:20:04, minima separation between aircraft 2,2NM

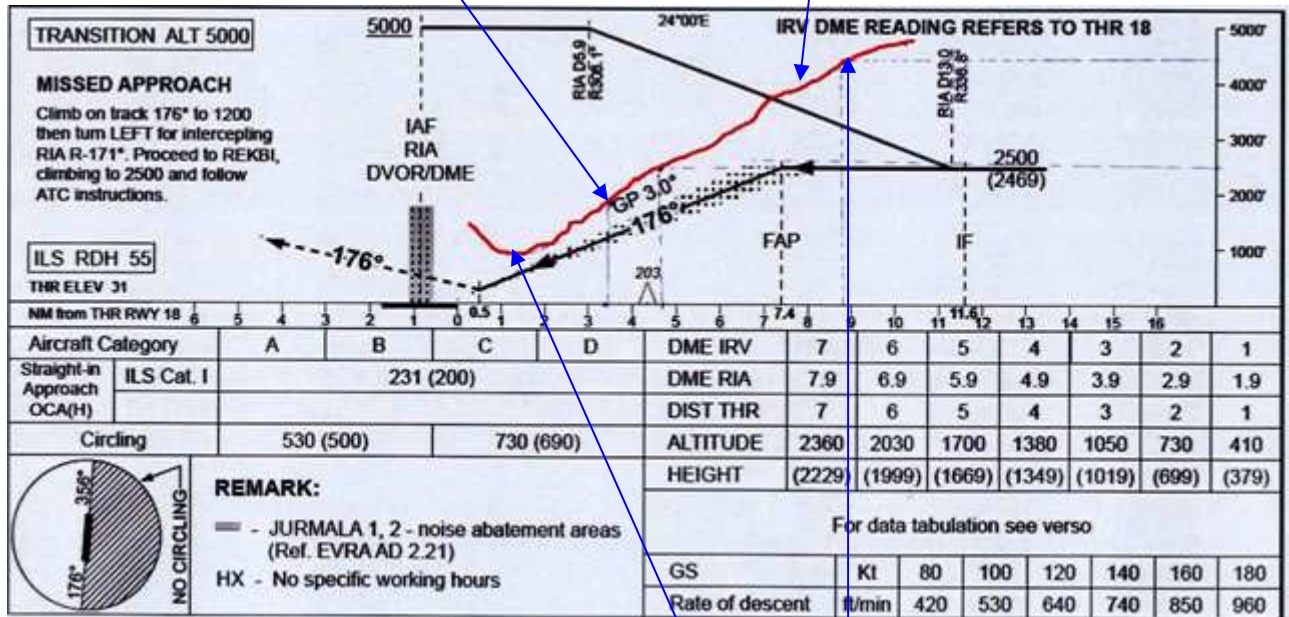
AFL2100 3,3NM from THR RWY 18  
B735 started take-off roll

AFL2100 descending profile  
according to radar data

AFL2100 transferred to TWR
