Transporta nelaimės
gadījumū un incidentu
izmeklēšanas birojs

Simplified report Nr. 2-2024

**Serious injury of crew member on board of Lithuanian
flagged fishing vessel TOVE on 19 May 2024 in Baltic Sea**

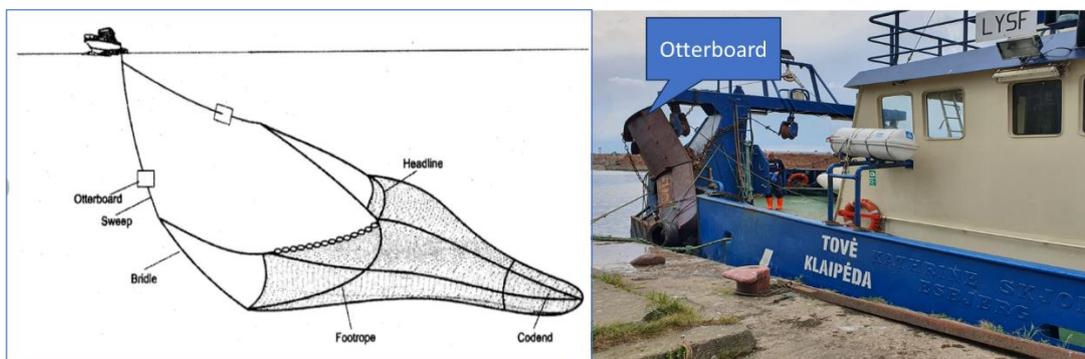
Image 2. Pelagic trawl in action (schematic visualisation) as used onboard of TOVE with otter board fastened in sailing position

A. Whether the port-side turn of the vessel, with the gear attached to the starboard side, was operationally justified? (see Image 2)

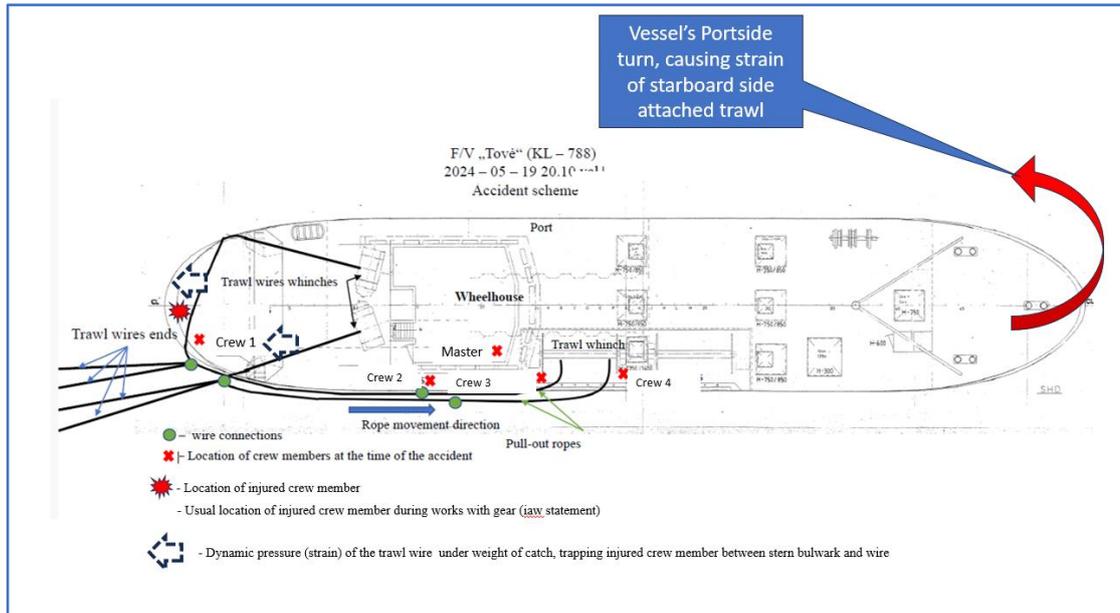
Image 3. Location of crew members on TOVE deck during operations with trawl

B. Whether the location of the injured crew member on deck, between the bulwark and the wire (see Image 3), was a normal working location during normal fishing gear operations?

C. Location and duties of the injured crew member: At the time of the accident, the injured crew member was positioned on the stern deck on the port side, performing tasks related to disconnecting and connecting trawl gear components, including monitoring and regulating the direction and tension of the wire. This position was located within a hazardous zone between a moving wire under load and fixed ship structures.

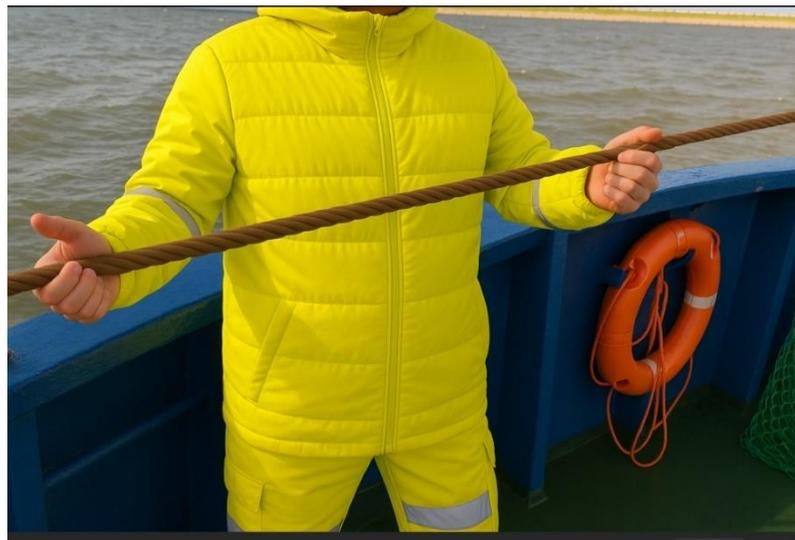
The injured crew member was standing between the wire and the stern bulwark, with the task to control the wire tension and direction during the hauling process. After the vessel's port-side turn, the wire became taut under the weight of the catch and pressed the crew member between the wire and the bulwark, causing severe chest injuries. Deck works were immediately suspended, and first aid was provided on scene at 20:15 (LT). The accident was reported to MRCC Riga by VHF radio (Channel 16) at 21:00 (LT). The Latvian Coast Guard ship P-07 VIESITE arrived alongside TOVE at 21:45 (LT), and a paramedic provided further medical assistance. After assessment of the seriousness of the injuries, a decision was made to call a Lithuanian SAR helicopter, which carried out the medical evacuation of the injured deckhand to Ventspils Hospital.

Image 4. App location of injured crew member onboard of TOVE at the time of accident (illustrative photo)

B. Accident: During the trawl hauling operation, while the vessel was executing a port-side turn, significant dynamic tension developed in the trawl wire due to the weight of the catch. As a result, the movement of the wire pressed a deckhand between the trawl wire and the vessel's stern bulwark.

- 1. Enhance the Safety Management System (SMS):** Develop and implement comprehensive, ship-specific working instructions for all phases of fishing gear operations, including launching, winching, and catch retrieval.
- 2. Conduct targeted risk assessments:** Establish formal risk assessments that specifically address the “danger zones” on deck, such as areas between moving wires under dynamic pressure and the vessel's bulwark.
- 3. Improve operational communication:** Formalize communication protocols between the Master (operating winches from the bridge) and deckhands to ensure situational awareness during vessel manoeuvres that increase wire tension.
- 4. Standardize documentation language:** Ensure that all safety manuals and critical working instructions are provided in a language fully understood by the crew to eliminate ambiguity during high-risk operations.
