Transporta nelaimes  
gadījumu un incidentu  
izmeklēšanas birojs

## Final report Nr.1/2008

## Final report No.1/2008 of the aircraft serious incident

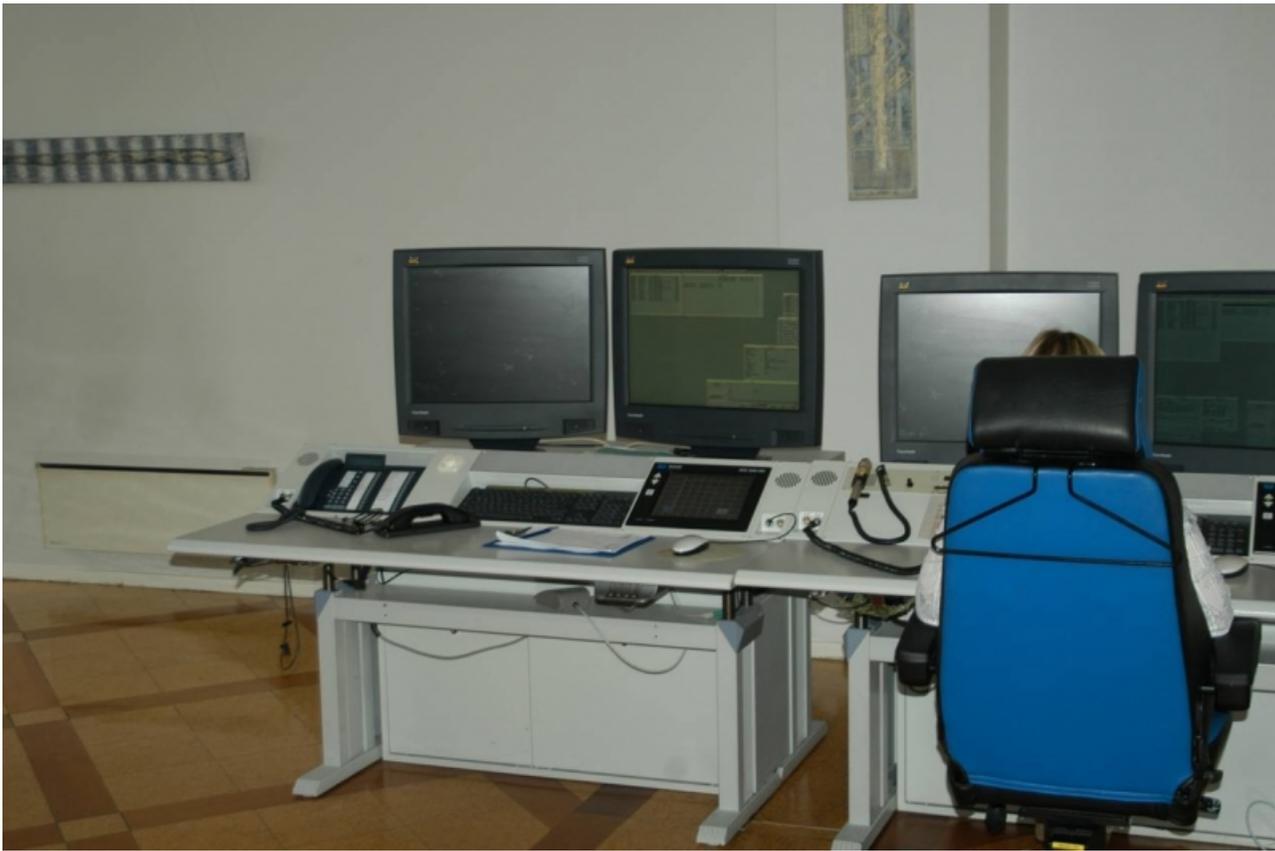
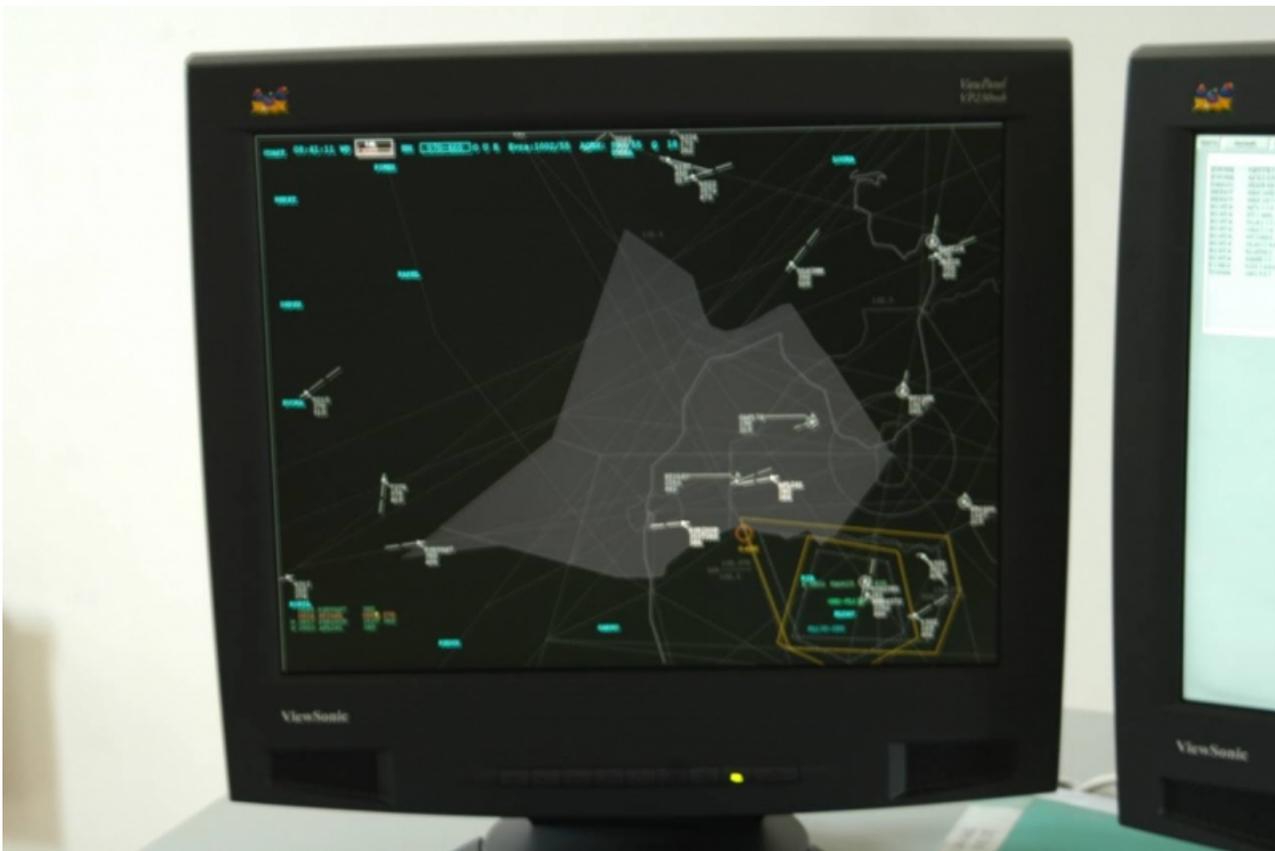
According to radar records, the closest distance between RYR26UP and ABW226A was 2.4 NM, and vertical separation between the aircrafts was 400 FT at the same time. At that moment RYR26UP was at flight level of 38300 feet and ABW226A was climbing with rate of climb 1400ft/m passing through the altitude of 37900 feet.
