**FINAL REPORT No 4-02/3-10/-2/2011**

**OF THE AIRCRAFT SERIOUS INCIDENT**

**INFRINGEMENT OF SEPARATION STANDARDS BETWEEN THE WizzAir  
AIRCRAFT AIRBUS A-320, REGISTRATION HA-LPV, FLIGHT WZZ125H AND  
KLM AIRCRAFT AIRBUS A-332, REGISTRATION PH-AOA, FLIGHT KLM 409 ON  
JULY 17, 2010**

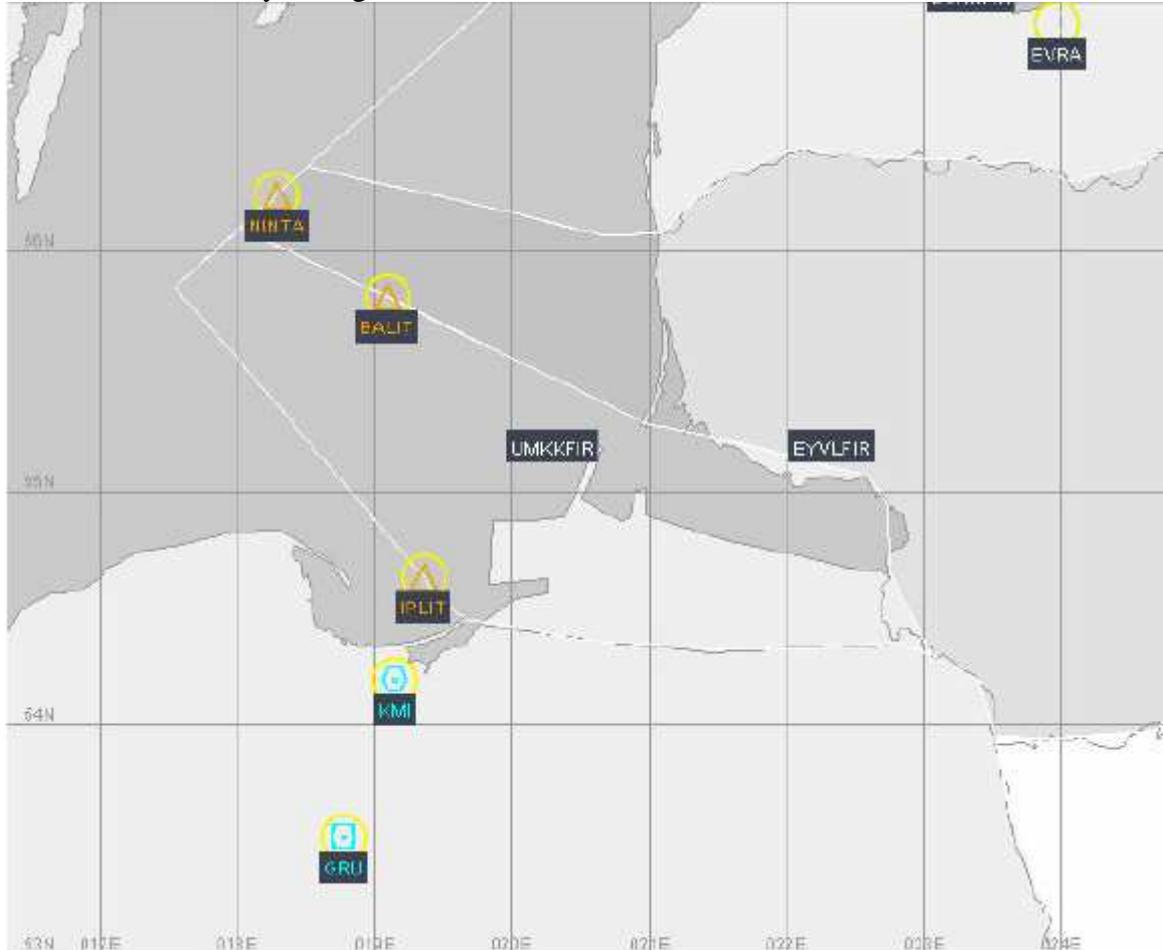
The other aircraft involved in incident was Hungarian Airbus A320 registration HA-LPV, flight WZZ125H diverged from its initially planned route via Warsaw and Kaliningrad FIR probably due to adverse weather conditions enroute. WZZ125H entered Vilnius FIR approximately 10 NM northwest of point BALIT from Kaliningrad FIR, then maintained track 345 degrees and crossed the boundary of Riga FIR at FL 380 without communication.

The aircraft (later known as Hungarian A320, flight WZZ125H) diverged from its initially planned route via Warsaw and Kaliningrad FIR due to adverse meteorological conditions enroute. WZZ125H entered Vilnius FIR approximately 10NM northwest reporting point BALIT from Kaliningrad FIR, then maintained track 345 and entered Riga FIR at FL 380 without communication.

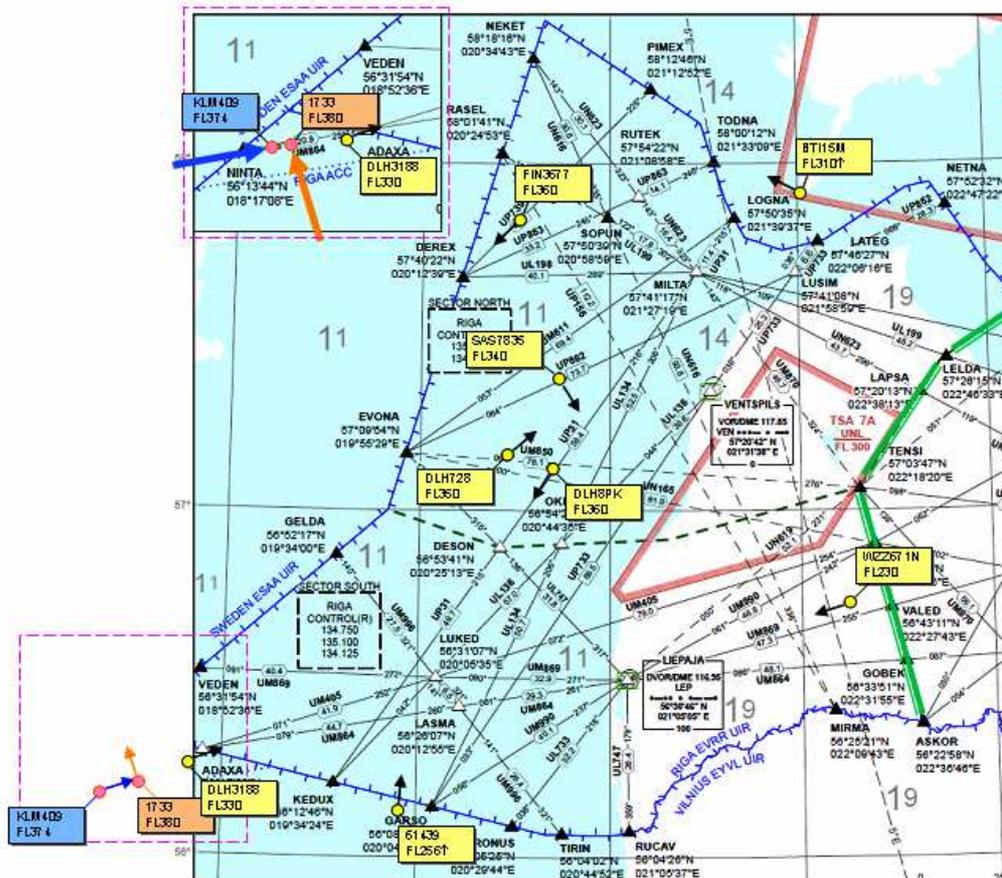
Picture 4, Traffic situation at 17:14:06 UTC

**AREA OF RESPONSIBILITY**

NUMBER OF TRAFFIC – 10

DLH3188	FL330	– EASTBOUND	
61439	FL256	– EASTBOUND	
WZZ671N	FL230	– WESTBOUND	
DLH728	FL350	– EASTBOUND	
DLH8PK	FL360	– WESTBOUND	
SAS7835	FL340	– EASTBOUND	
FIN3677	FL360	– WESTBOUND	
BTI15M	FL310	– WESTBOUND	
<b>KLM409</b>	<b>FL372</b>	<b>– EASTBOUND</b>	<b>SEPARATION – 4,5 NM</b>
<b>1733</b>	<b>FL380</b>	<b>– WESTBOUND</b>

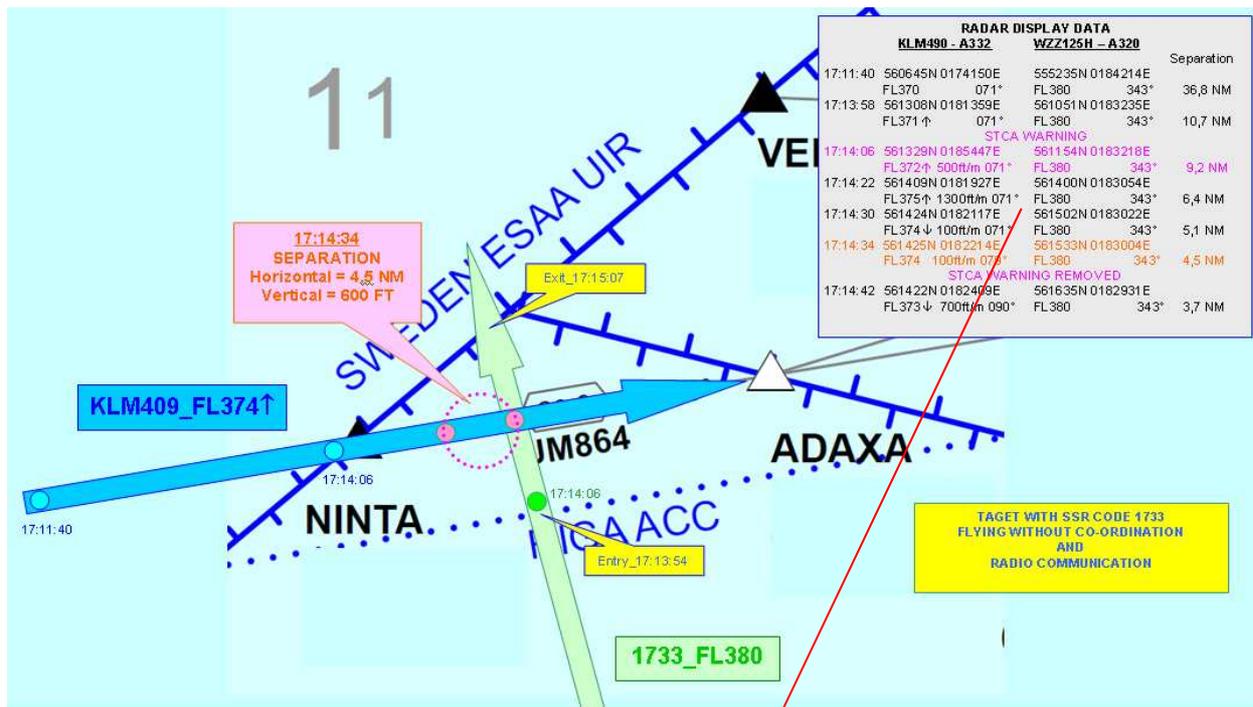
Picture 5, Conflict situation KLM 409 & WZZ125H

KLM490 - A332		WZZ125H - A320		Separation
17:11:40	560645N 0174150E	555235N 0184214E		
	FL370 071°	FL380 343°		36,8 NM
17:13:58	561308N 0181359E	561051N 0183235E		
	FL371 ↑ 071°	FL380 343°		10,7 NM
STCA WARNING				
17:14:06	561329N 0185447E	561154N 0183218E		
	FL372 ↑ 500ft/m 071°	FL380 343°		9,2 NM
17:14:22	561409N 0181927E	561400N 0183054E		
	FL375 ↑ 1300ft/m 071°	FL380 343°		6,4 NM
17:14:30	561424N 0182117E	561502N 0183022E		
	FL374 ↓ 100ft/m 071°	FL380 343°		5,1 NM
17:14:34	561425N 0182214E	561533N 0183004E		
	FL374 100ft/m 079°	FL380 343°		4,5 NM
STCA WARNING REMOVED				
17:14:42	561422N 0182409E	561635N 0182931E		
	FL373 ↓ 700ft/m 090°	FL380 343°		3,7 NM

Both aircraft had approximately equal flight level, when KLM 409 was crossing FL374 there was WZZ125H at FL 380. Two aircraft passed each other and the separation standard between the two aircraft was infringement. Minimal distance between aircraft was 4,5NM.

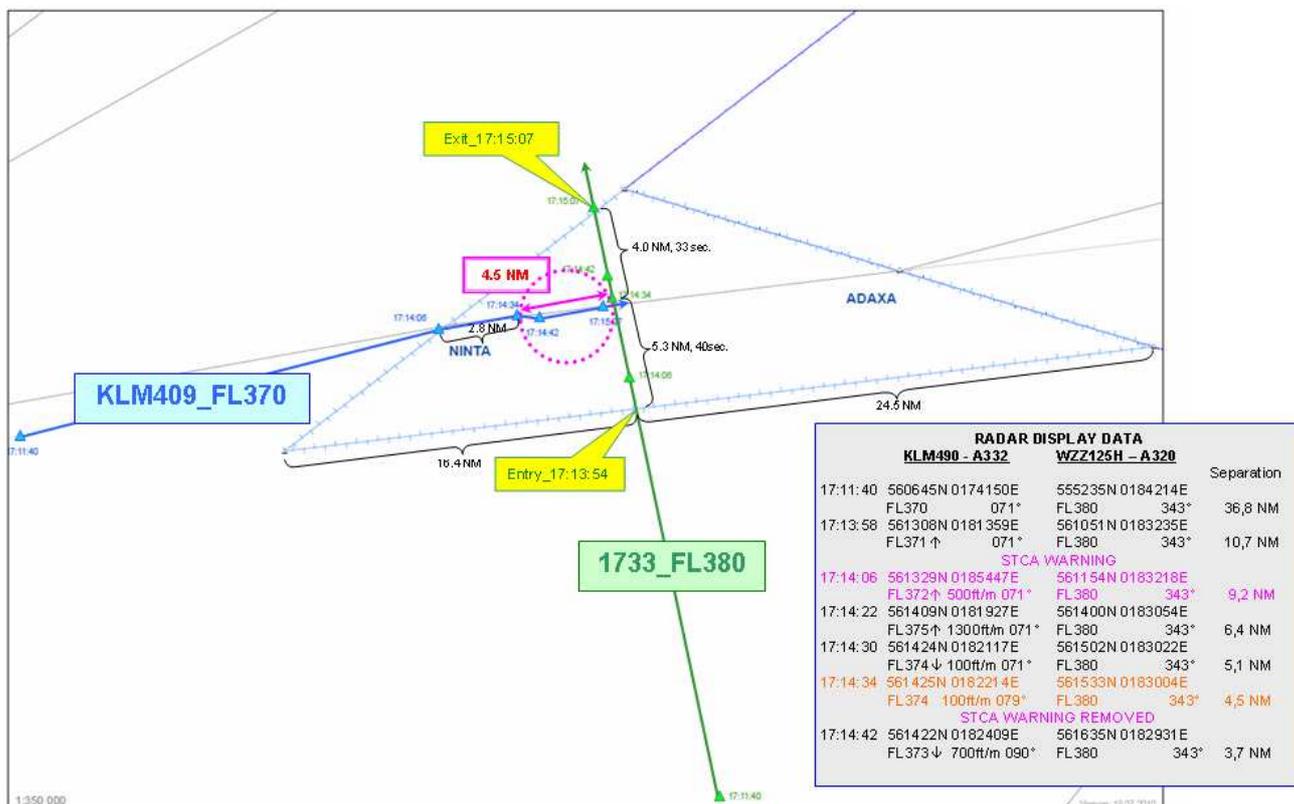
Picture 6

1733 entered in Latvia ATCC area of responsibility at 17:13:54 at FL380, intersected Sector WEST between points NINTA and ADAXA and left Latvia ATCC area of responsibility at 17:15:07.

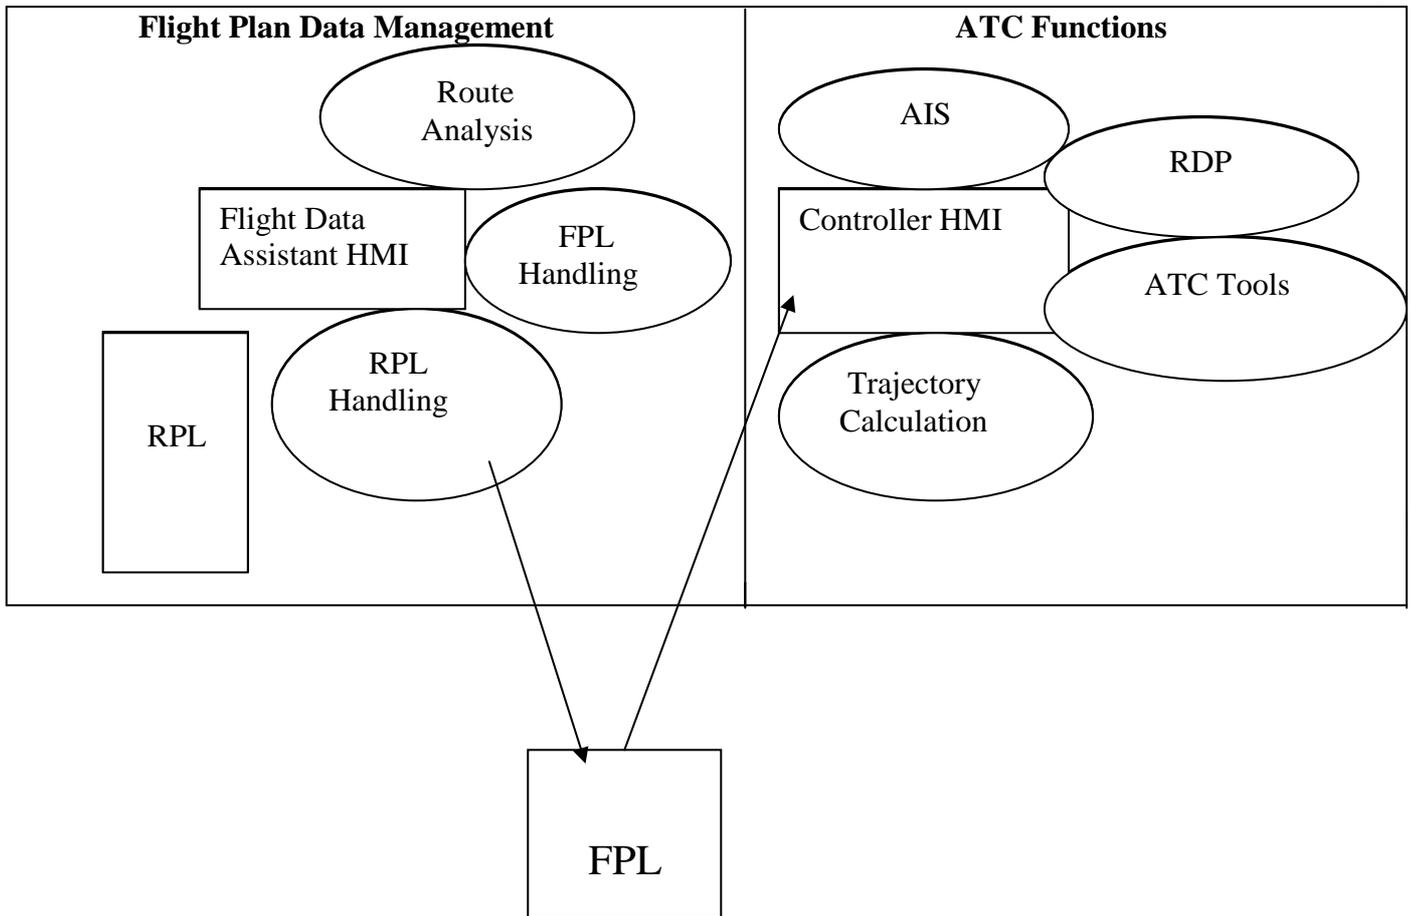
Picture 7

Four main functional blocks are defined:

- The Flight Plan Data Management block
- The ATC Functions
- The Support Functional block and the ATC-Simulator

The distinct border is between the Flight Plan Data Management block and the ATC Functional block.

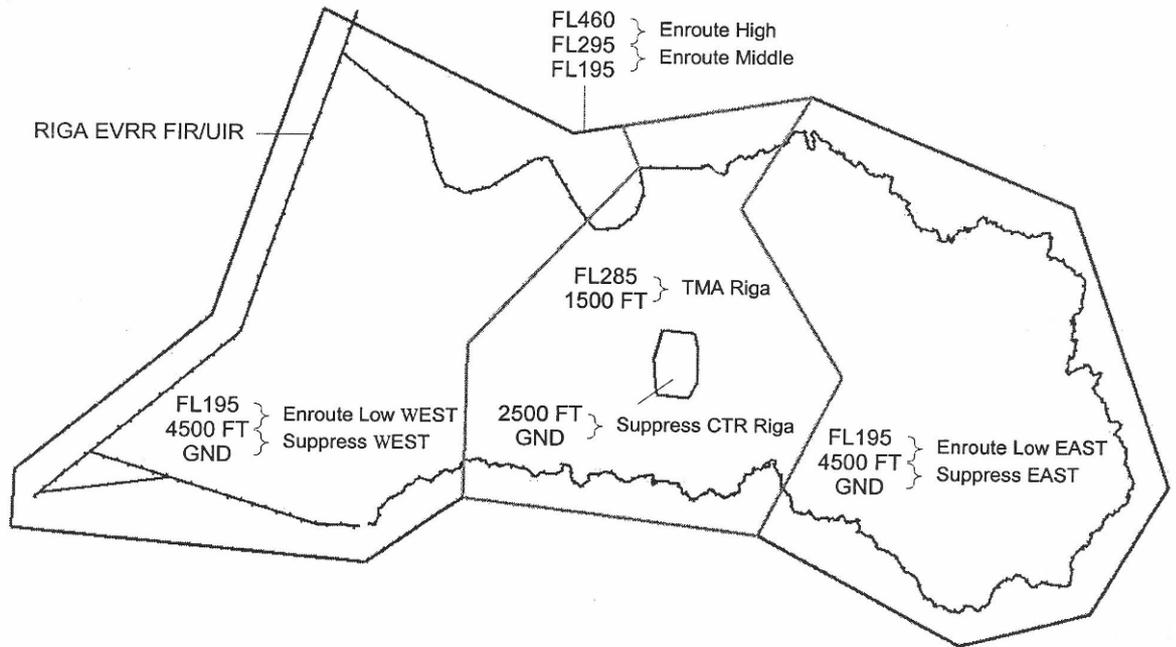
The generation of Short Term Conflict Alerts is a function of an ATC radar data processing system. If the distance between the three-dimensional positions of two aircraft is predicted to be reduced to less than the defined applicable separation minima within a specified time period, the visual alert will be generated to the radar controller within whose jurisdiction area the aircraft is operating. All types of flight transponder-equipped aircraft with Mode C are eligible for generation of STCA.

STCA WORK AREAS

The parameters for generation of STCA alert and alert warning time:

Item Area	Look Ahead Time <sup>1</sup>	Hsep <sup>2</sup> (NM)	Vsep <sup>3</sup> (feet)	Hsep <sup>4</sup> ATC (NM)	Vsep <sup>5</sup> ATC (feet)
Enroute High Above FL295	120 sec	4,2	870	5,0	1000
Enroute Middle FL195-FL295	120 sec	4,0	800	5,0	1000
Enroute Low East 4500FT-FL195 GND - 4500 FT (suppress)	90 sec	4,0	800	5,0	1000
Enroute Low West 4500FT-FL195 GND - 4500 FT (suppress)	90 sec	4,0	800	5,0	1000
Tma Riga 1500FT-FL255 GND - 1500 FT (suppress)	90 sec	4,0	700	5,0	1000
Ctl Riga GND - 2500 FT (suppress)	-	-	-	-	-
