**REPUBLIC OF CYPRUS
MARINE ACCIDENT AND INCIDENT
INVESTIGATION COMMITTEE**

Investigation Report No: 56E/2016

Very Serious Marine Casualty

**Death of a crew member of the M/V “VASTERBOTTEN” on
14/04/2016 while plying the Baltic Sea**

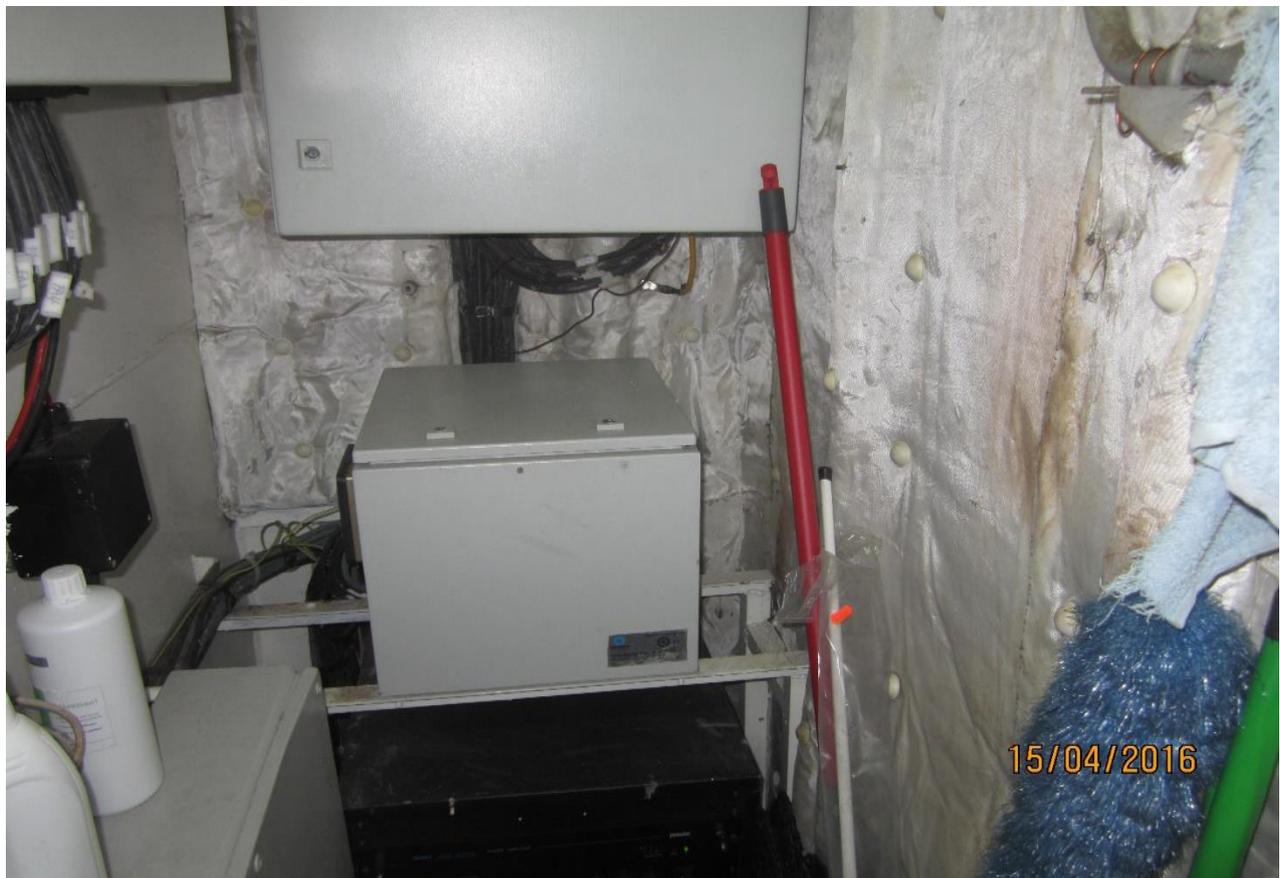
Figure 6: VDR cabinet

Type: VDR-100 G2S S-VDR (Simplified Voyage Data Recorder)-Serial no: 20107121737. After the fatal accident, the decoded data from the S-VDR was requested. Records have been saved, but decoding was not possible on board. A specialist went on board, and downloaded on CD-ROM the last 48 hours.
