**FINAL REPORT Nr.1/2010
OF THE AIRCRAFT SERIOUS INCIDENT**

**INFRINGEMENT OF SEPARATION STANDARDS BETWEEN THE AIRBALTIC
AIRCRAFT BOEING 733, REGISTRATION YL-BBJ, FLIGHT BTI16C AND JAPAN
AIRLINES AIRCRAFT BOEING 777, REGISTRATION JA-733J, FLIGHT JAL 407
IN THE VICINITY OF THE POINT RUTEK ON AUGUST 31, 2009**

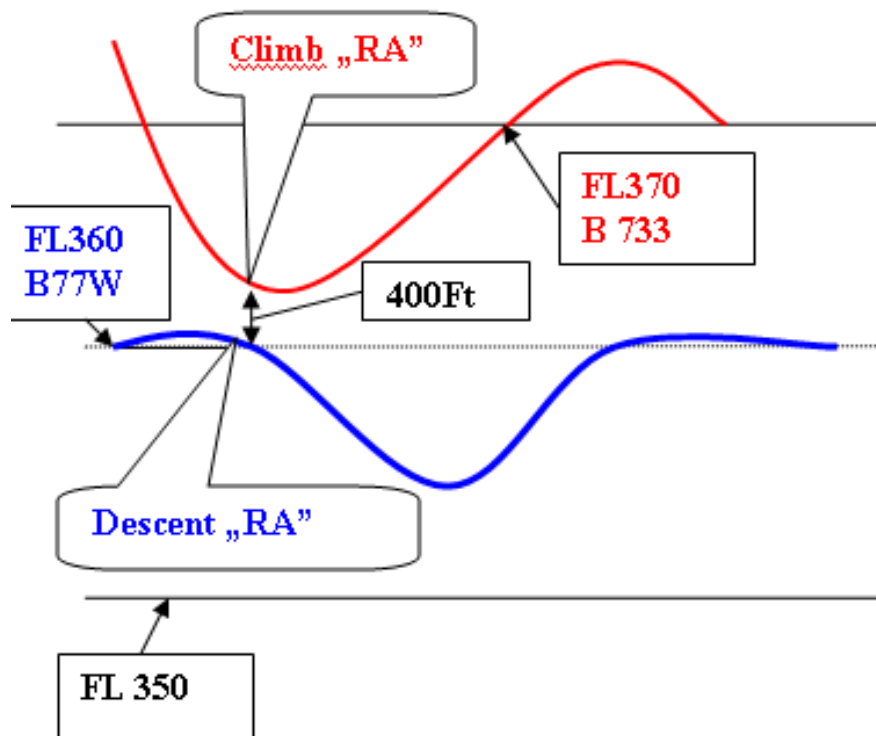
Picture 4 Aircraft reaction to commands of TCAS

Unless informed by the pilot, ATC does not know when ACAS issues RAs. It is possible for ATC to issue instructions that are unknowingly contrary to ACAS RA indications. Therefore, it is important that ATC be notified when an ATC instruction or clearance is not being followed because it conflicts with an RA.

- promptly return to the terms of the ATC instruction or clearance when the conflict is resolved; and notify ATC when returning to the current clearance.

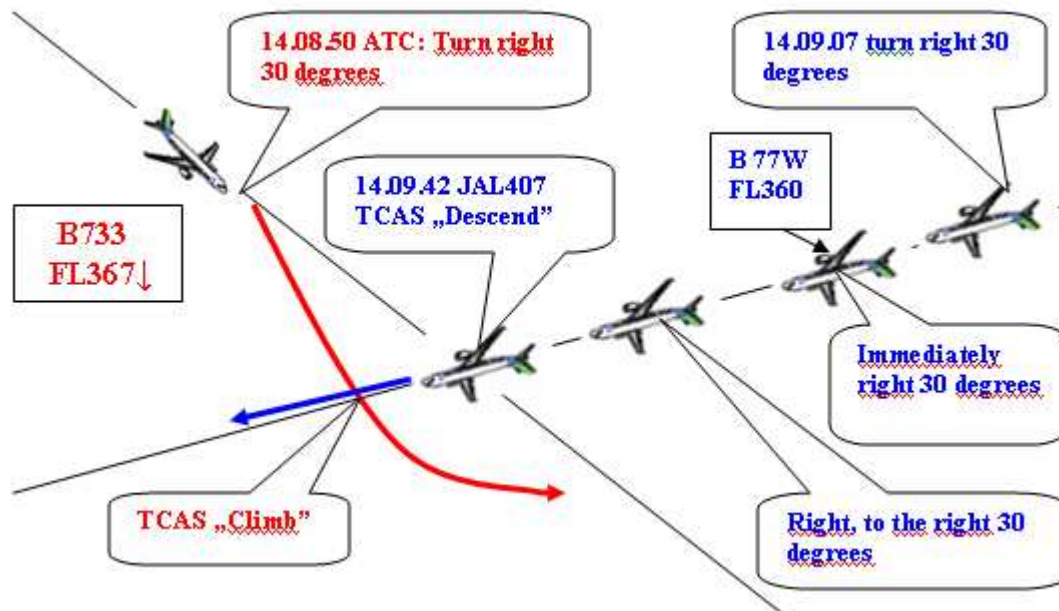
Picture 5

The crew flew at FL 360 to the point DEREK (574022N 0201239E) subsequently it received the instruction to change the heading by 30 degrees to the right. There occurred failure to understand controller’s instructions by crew. To controller’s first instruction to turn right the crew asked for repeating instruction. To controller’s reiterative instruction to turn right the crew understood as instruction to turn 30 degrees left although quality of communication was good and instruction was given according to requirements of PANS ATM, ICAO Doc 4444 Chapter 12 ATC Phraseologies. Only after repeating by controller instruction third time the crew affirmed it adequately: „Right to 30 degrees, Japan Air 407” (See Picture 5). After a while when TCAS triggered and generated RA “Descend” the crew reacted properly and followed TCAS instruction to descend as well as notified controller ATC1.
