FINAL REPORT No. 4-02/3-20(1-21)

ON AVIATION SERIOUS INCIDENT INVOLVING AIRCRAFT TECNAM P2008 JC OF ERIVA LTD., REGISTRATION No. YL-EVA AT AERODROME ĀDAŽI ON 1 SEPTEMBER 2020

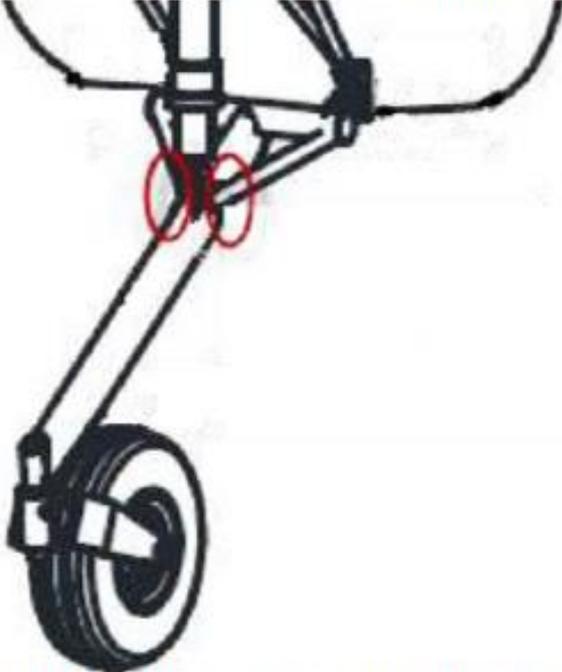
N	Accomplishment Instructions
1	Parking the airplane in safe area;
2	Master Switch OFF and Parking brake ON;
3	Remove the cowling according to the instruction included in the AMM;
4	<p>Perform the visual inspection on NLG, with particular attention of the welded points highlighted in the picture below where is needed to remove the paint in order to identify better eventually cracks and deformation and use a torch light and/or mirrors, if needed;</p>

5	<p>If a crack is found, no further flight is allowed, please contact Tecnam Technical Support for corrective action and fill the occurrence report (included in the AMM) and send it to Tecnam. Otherwise reinstall the engine cowling.</p>
