Transporta nelaimes gadījumu un incidentu izmeklēšanas birojs

## **FINAL REPORT 4-02/2-21(2-22)**

### **on accident, collision with ground shortly after take-off at the Cēsis airfield on August 8, 2021 with the amateur built aircraft ANBO-II (replica), registered LY-BDJ (Lithuania)**

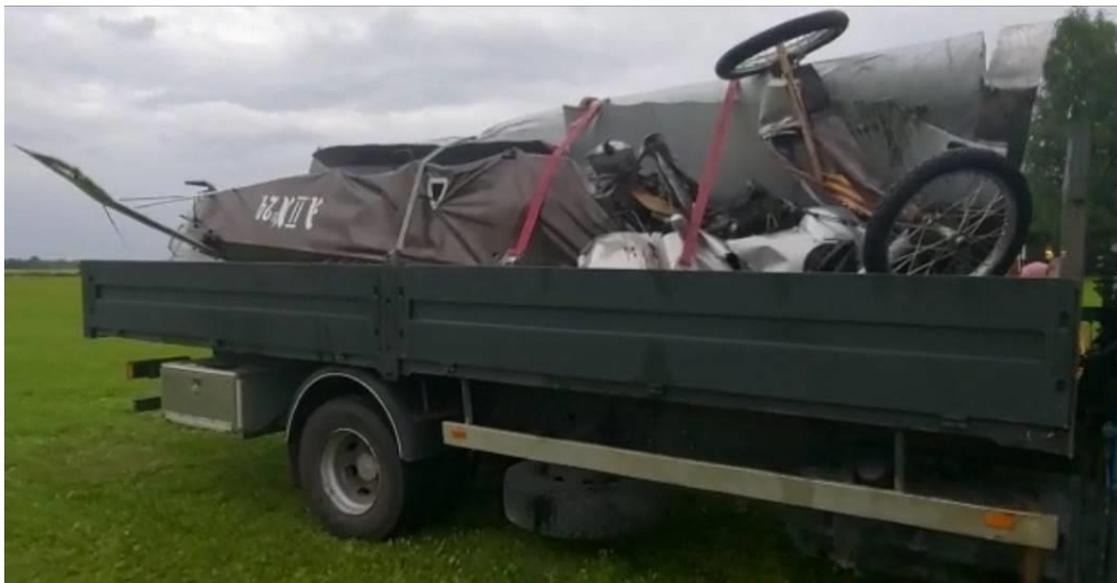
Picture 3: Transportation of the aircraft wreckages

The TAIIB initiated the collection of data from the institutions involved in this accident. The wreckage was placed in the TAIIB hangar for the further technical investigation (see picture 3).

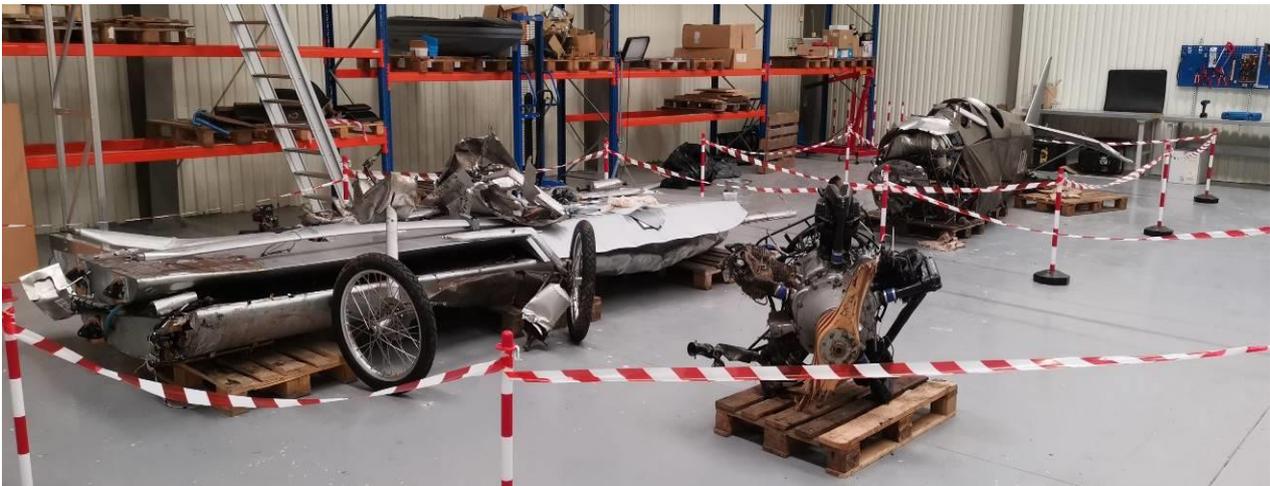
Picture 15: Dismounted engine

In the hangar the engine was dismantled from the aircraft and prepared for a detailed inspection (see picture 15).

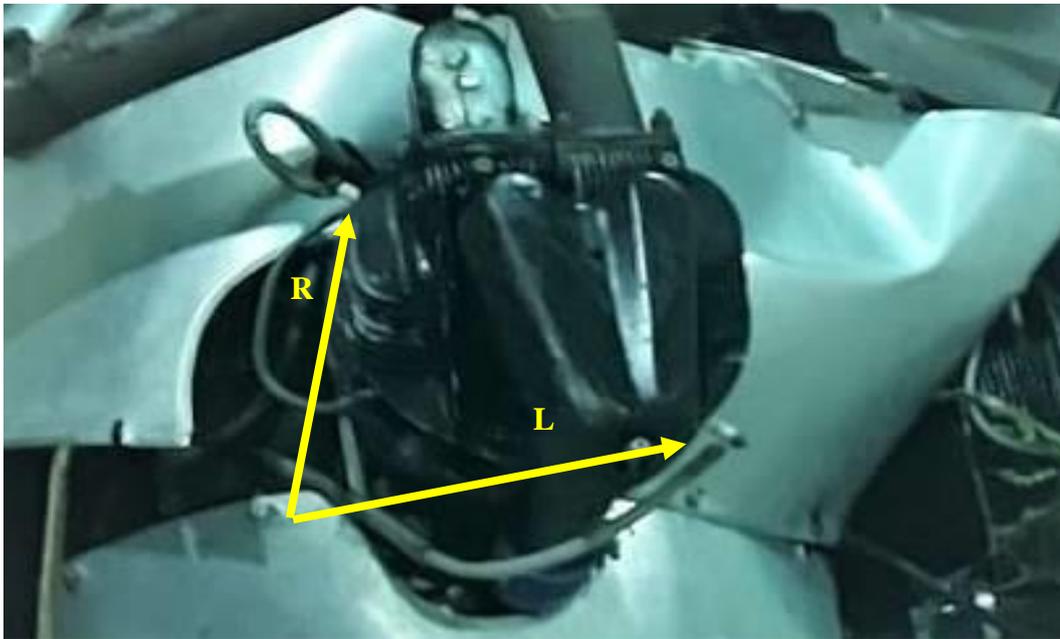
Picture 18: The location of the spark plugs on the engine cylinders

The engine M-11FR of the aircraft ANBO II was equipped with 10 moderns [non-standard] BRISK Platin MR15LP spark plugs, two for each cylinder (see picture 18).

The fact that the 3rd cylinder spark plugs were covered with black oily soot and the 5th cylinder right spark plug was wet with oil lets to suppose that the spark plugs probably did not work during the aircraft take-off. Based on the results of a visual inspection of the spark plugs, it can be assumed that the 3rd and 5th cylinders of the engine could be a contributing cause of the unstable engine running.
