Transporta nelaimes gadījumu un incidentu izmeklēšanas birojs

FINAL REPORT No. 4-02/2-17(3-2018)

AVIATION ACCIDENT WITH HELICOPTER R44, REGISTRATION NO. YL-HBH, ON OCTOBER 8, 2017, IN PRIEKULE MUNICIPALITY, GRAMZDA RURAL TERRITORY, IN LOCALITY OF GRAMZDA PIT

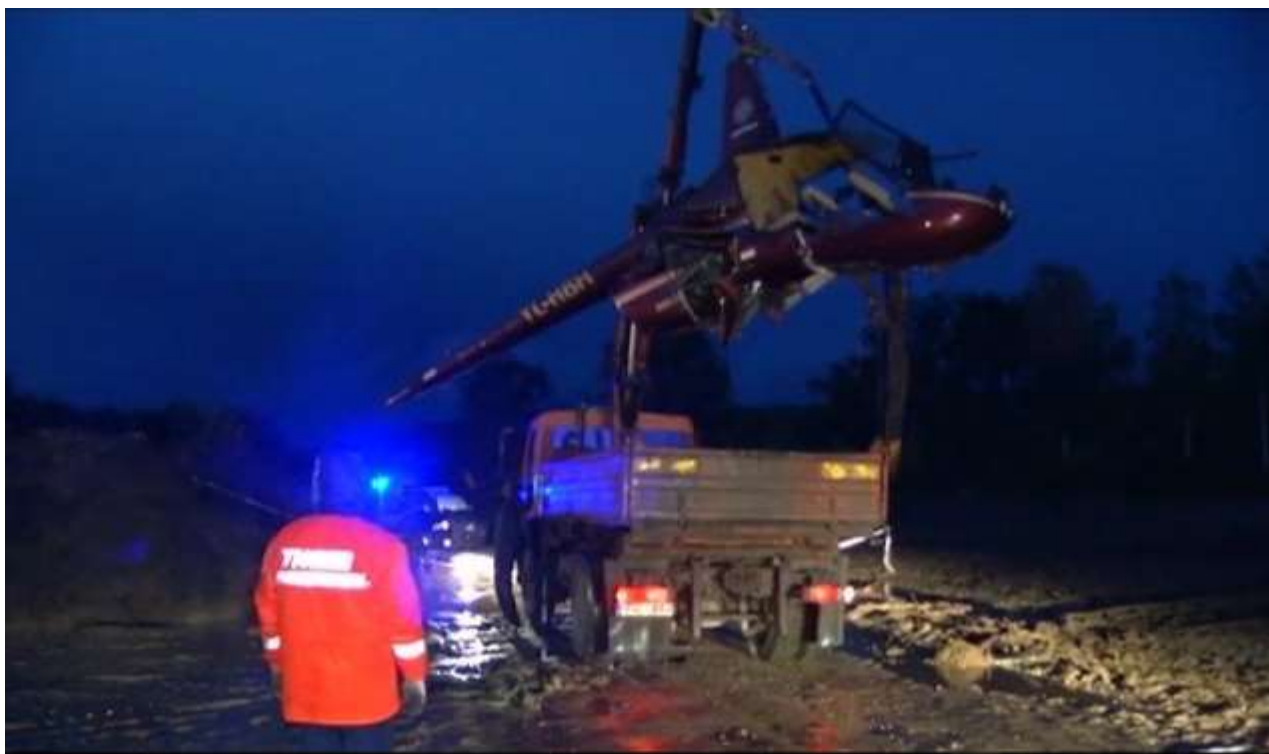
Picture 2. Process of loading of helicopter wreckage

After the above mentioned procedures were conducted the wreckage of helicopter was collected and transported from the accident site to the TAIIB hangar for storage and further investigation. (Pic. 2). Aircraft's technical documentation and flight documentation and GPS device were seized.

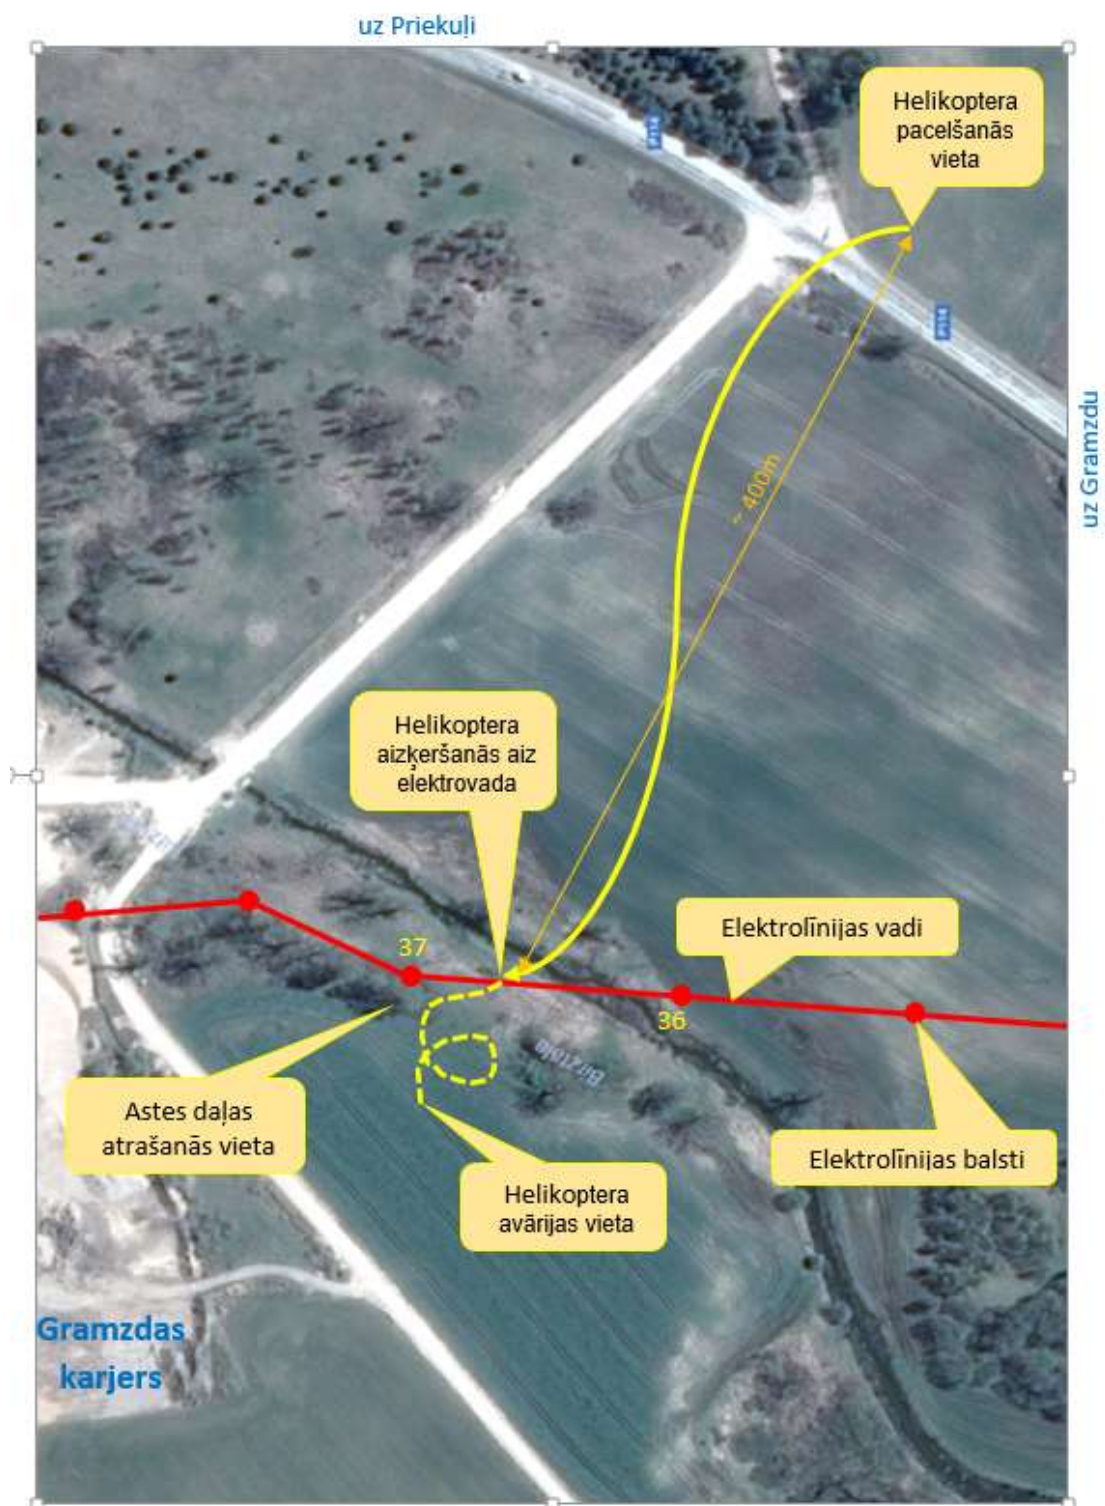
Pic. 3 Flight scheme

On October 8, 2017, at 13:14 in Priekule municipality, Gramzda rural territory, during the rally competition "Rally Liepāja" approximately 400m from take-off place helicopter R44 with the tail rotor touched the upper wire of electric powerline between the poles No. 36 and No. 37, as a result helicopter crashed (Pic.3).

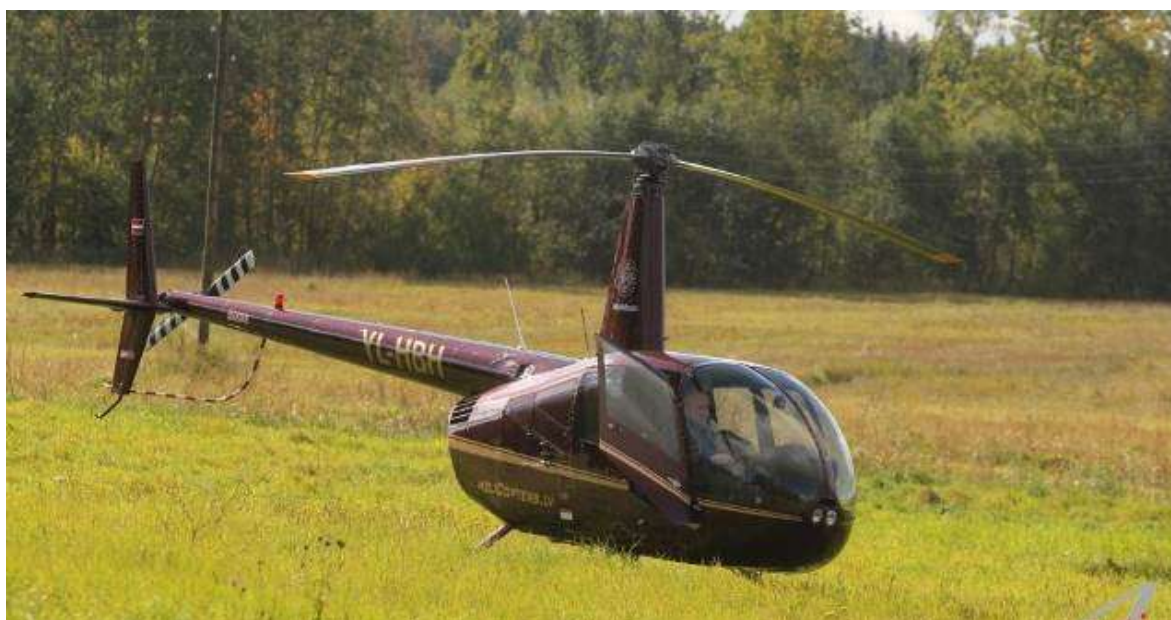
Picture 17. Helicopter R44, r/n YL-HBH

Crashed helicopter is four-seated light helicopter «Robinson R44», manufactured in 2006 in USA and registered in Latvia on February 7, 2014, national registration YL-HBH.
