Transporta nelaimes  
gadījumu un incidentu  
izmeklēšanas birojs

**Simplified report Nr. 2-2026**

**Occupational accident (leg trauma) onboard of Latvian flagged vessel  
CAPELLA in port of Vasteras (Sweden) on 21th January 2026**

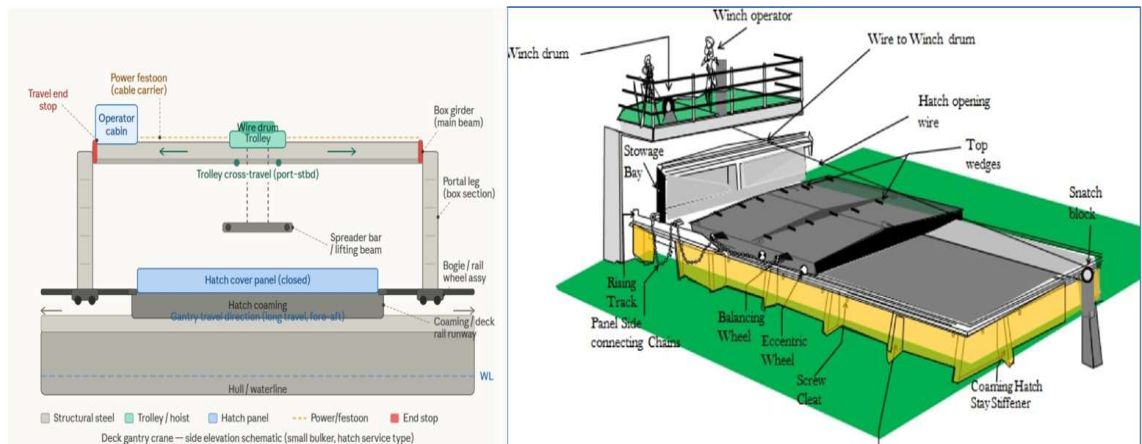
Image 2. Generic parts and elements of vessel's gantry crane and cargo hold hatch

The vessel is equipped with the mounted gantry crane, named Hatch Crane 15kw, fitted specifically to open and close the folding hatch covers without shore assistance or port crane dependency. The crane does not normally handle cargo — its primary function is hatching panel handling only (see Image 2.).
