**FINAL REPORT No.4-02/8-12/5-13
ON THE AIRCRAFT SERIOUS INCIDENT**

**LOSS OF SEPARATION STANDARD BETWEEN THE KLM AIRCRAFT B737-800,
flight KLM903, REGISTRATION PH-BXN and FINAIR AIRCRAFT E190, flight
FIN746L, REGISTRATION OH-LKH IN THE VICINITY OF THE POINT ATRAK
ON OCTOBER 20, 2012**

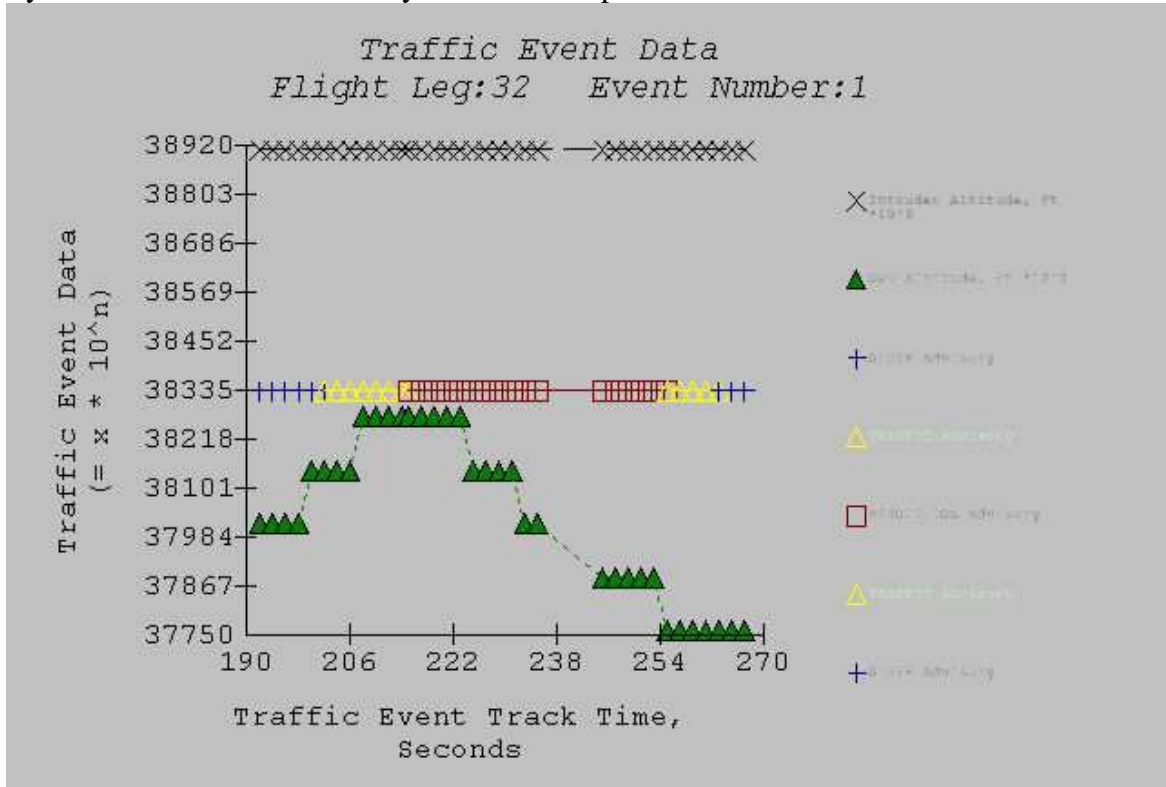
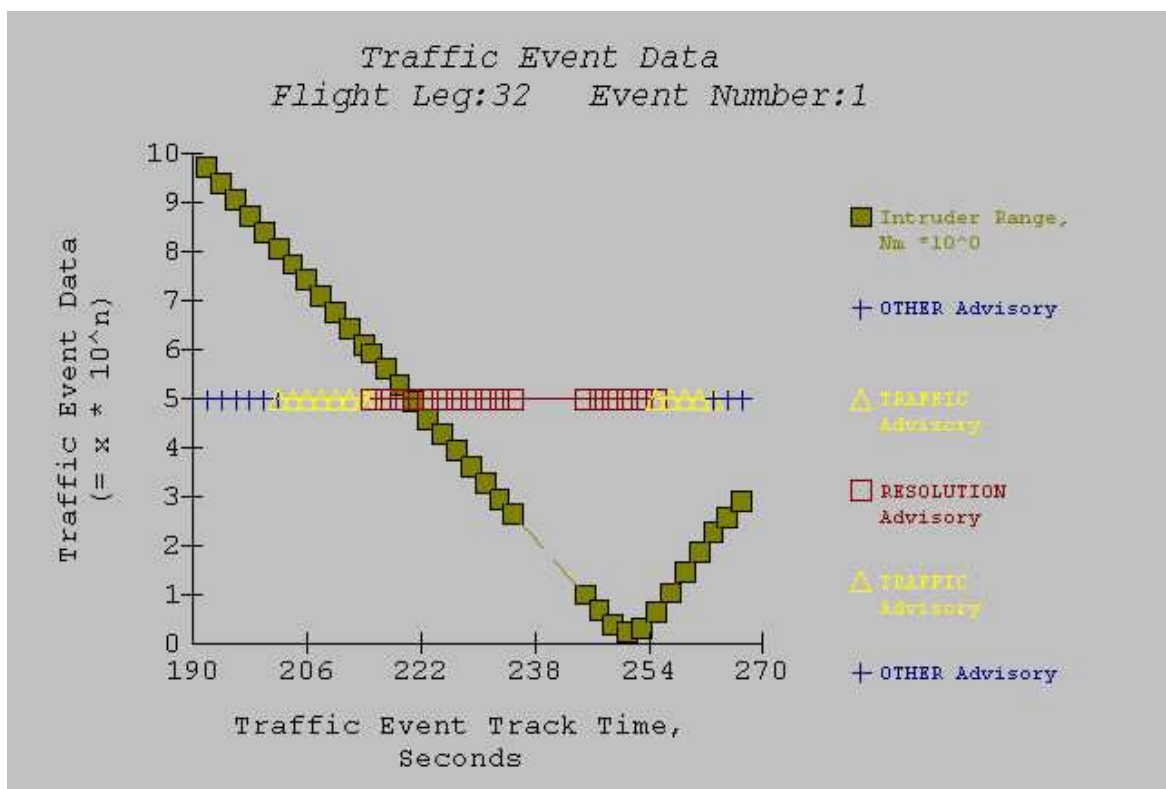
According to the statement of crew members their actions were based on the static nature of the flight phase and altitude of the flight. They had been on cruise at FL390 when received the traffic advisory, eventually the TCAS RA and there was no command to change the flight path. TCAS advised to maintain current vertical speed. Conflicting flight descended to lower altitude. When they first received traffic advisory the vertical separation was 600ft.

To PF observation other traffic was climbing to same altitude or above. When they received TCAS RA and opposite traffic started descending according to the RA so that when it passed below the altitude separation was about 1000FT. The crew of FIN746L did not have visual contact of the other traffic.
