FINAL REPORT No.4-02-9/2012(4-2014)

on THE ACCIDENT

of AIRCRAFT TECNAM P2006T, REGISTRATION YL-SVN ON NOVEMBER 13, 2012, GARKALNE MUNICIPALITY, IN THE LOCALITY OF BUKULTU VILLAGE

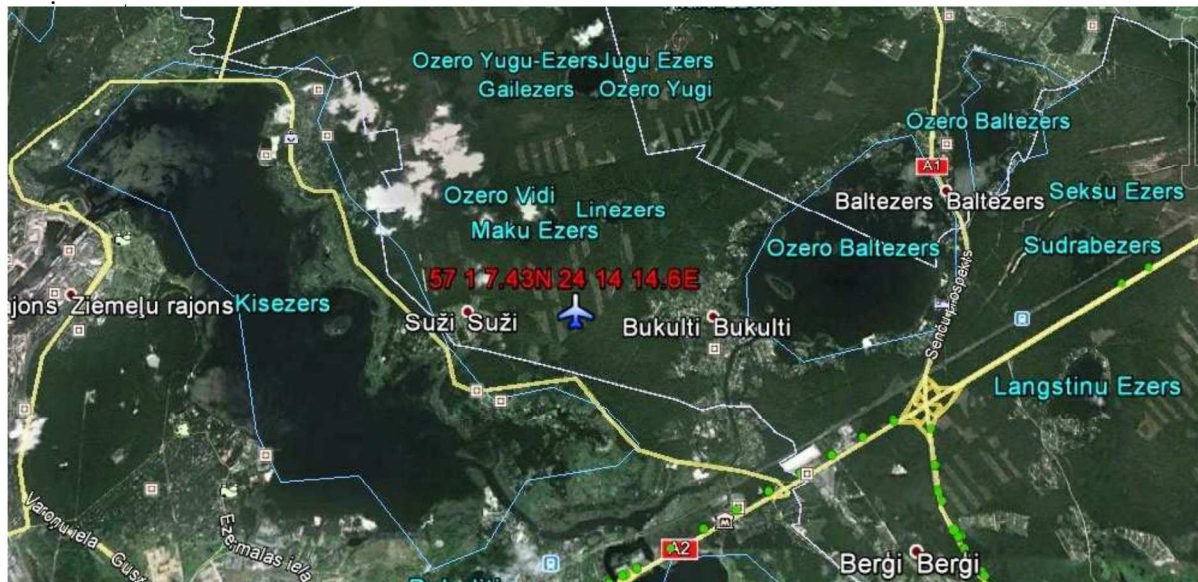
Aircraft flew at altitude 1500 FT with ground speed within 100 -110 kt. Continuing the flight at altitude of about 1500 feet over the wood between the populated areas of Suži and Bukulti, at about the same distance from lake Kīšezers and lake Baltezers, the aircraft ground speed within 43 seconds sharply decreases from 100kt to 8kt, altitude decreases to 500FT and at **13:20:37** aircraft disappeared from the radar screen. At that time aircraft collided with earth surface. Approximately at the same time at 13:18 was transmitted distress signal from aircraft Emergency Locator Transmitter (ELT, country of beacon registration 275/Latvia, user class aviation/identification YL-SVN) on frequency 406.037 MHz and had received by MRCC Riga. Some difference in time appears due to lack of synchronization with ATC

Image 5. Place of collision on a map

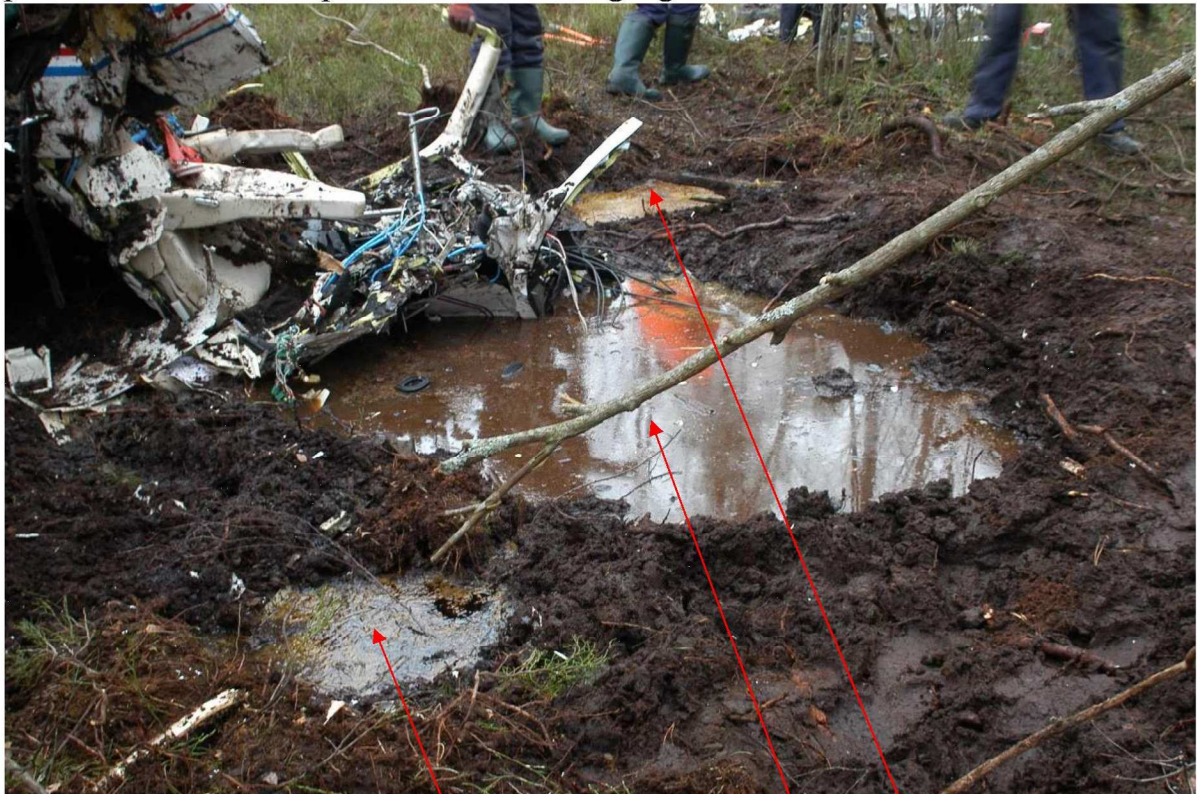
Image11.

Collision place of the left side engine

Collision place of the right side engine

Collision place of ACFT fuselage forepart

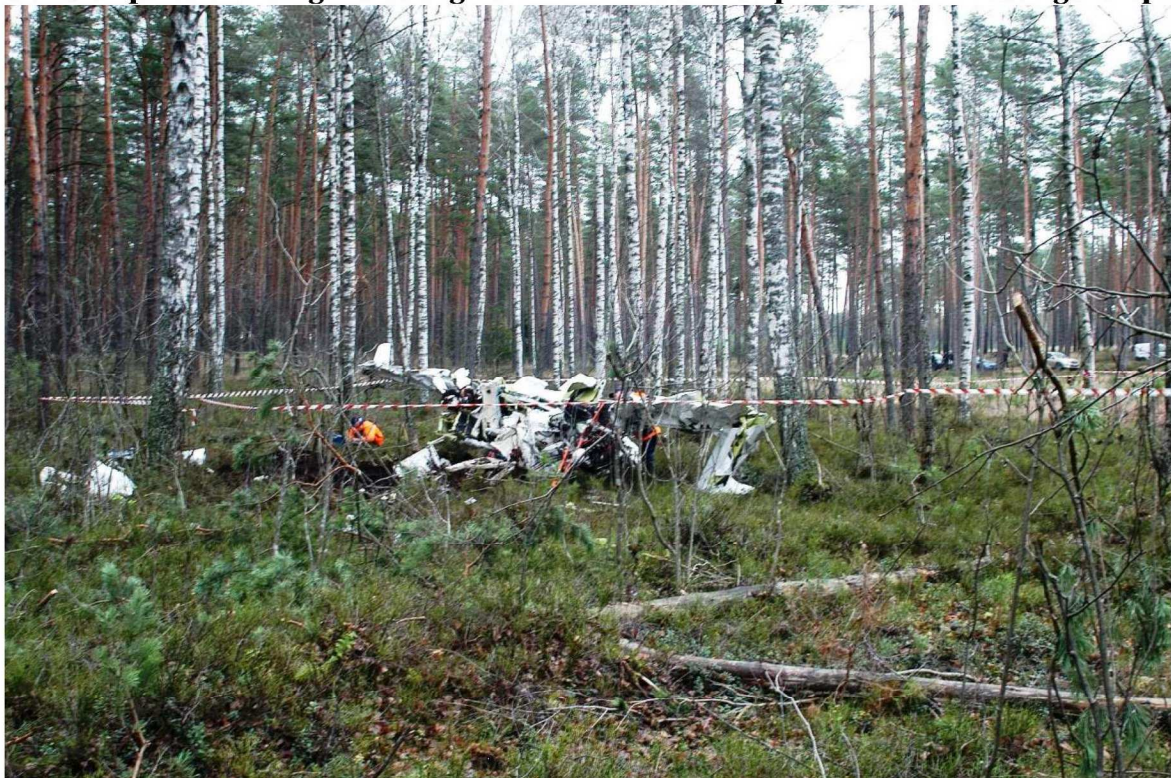
Image 12. Collision place

According to the testimonies of witnesses, who were few kilometers from the collision place, the aircraft was flying over the wood with nose down in about 45° angle. Coming closer to the ground the aircraft continued to incline with nose downwards and almost in vertically straight angle fell into the wood. Around the collision place there were large trees and inspecting their leafages there was not found any traces of breaches of tip of the trees and branches, as well fresh broken branches on the ground. Any traces of sliding on the ground were not visible, the forepart and engines of the aircraft were deeply submerged into the ground, it approves that collision angle with the ground was extremely steep.

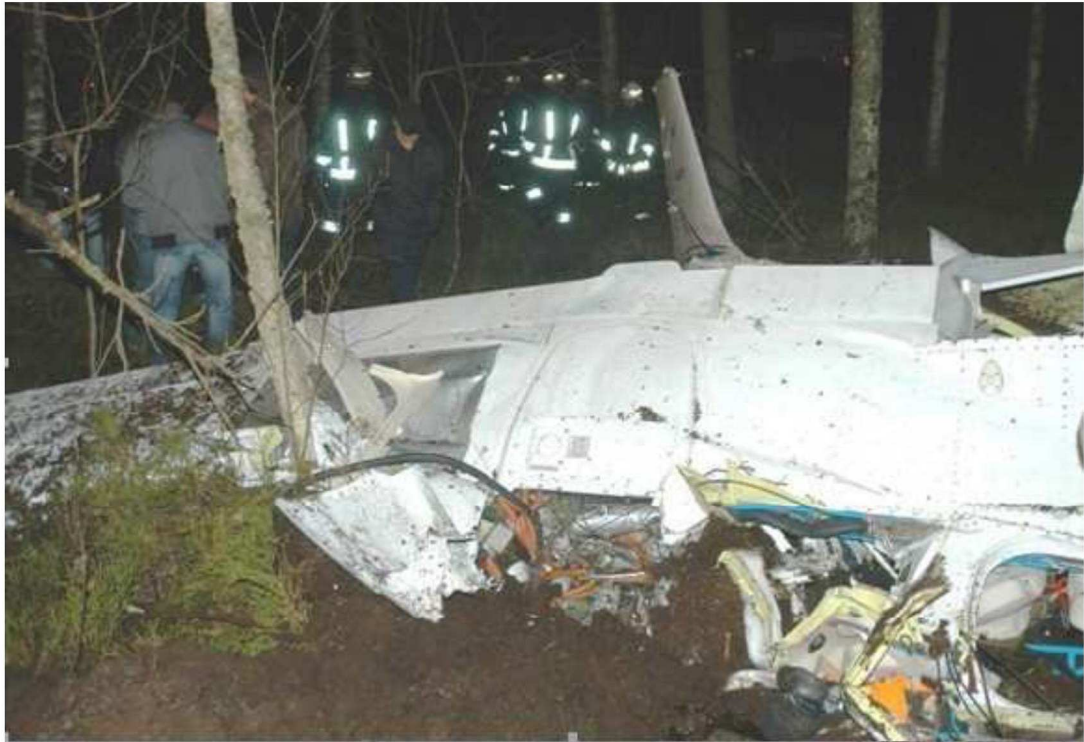
Image 13. Trees behind the aircraft in the flight direction are not affected

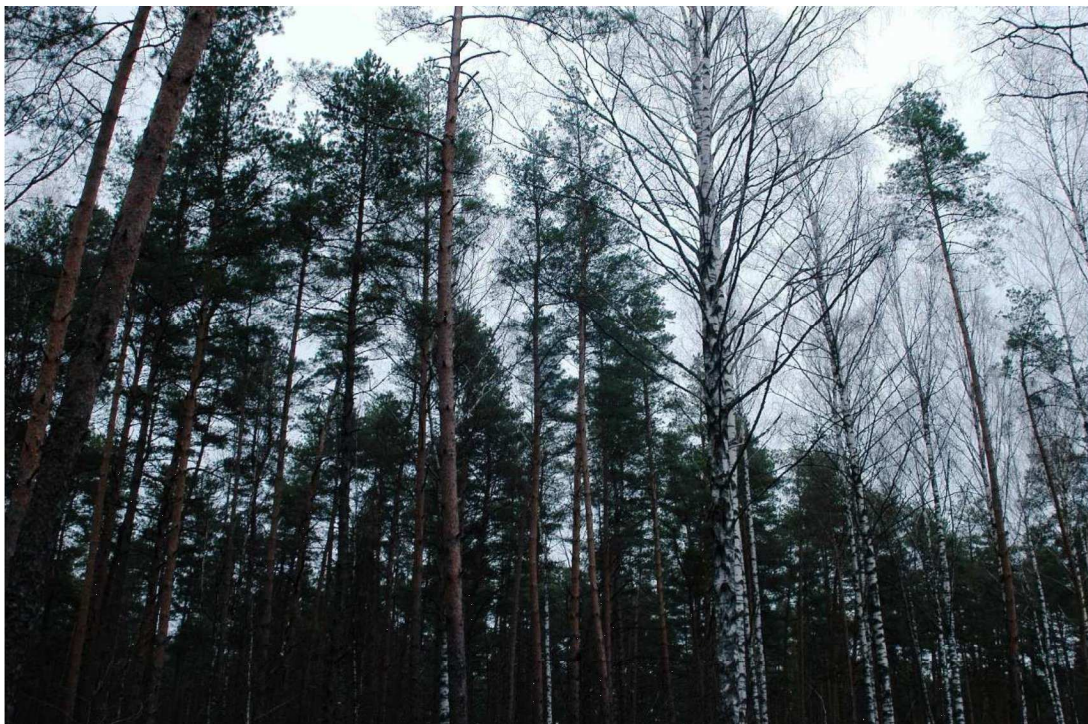
Image 14. Tips of the trees and leafages around the place of collision are not touched

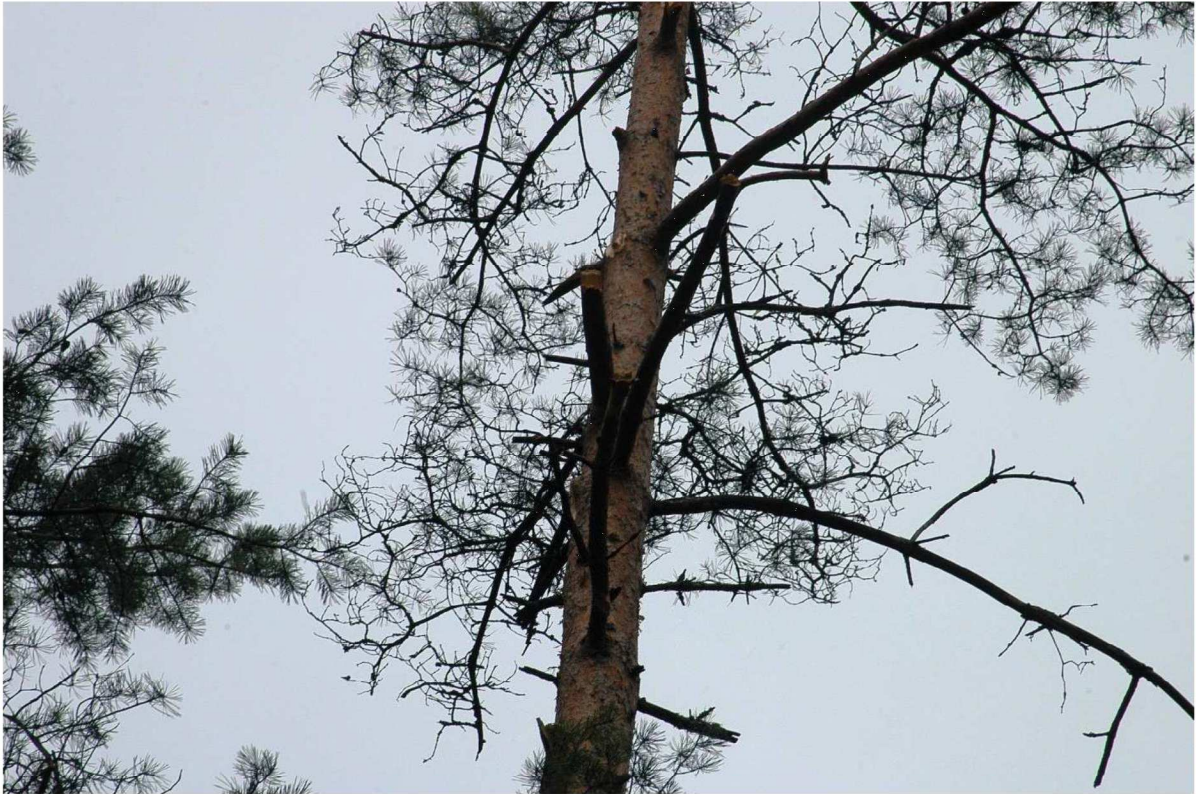
Image 15. Tips of the trees and leafages around the aircraft collision place are not touched

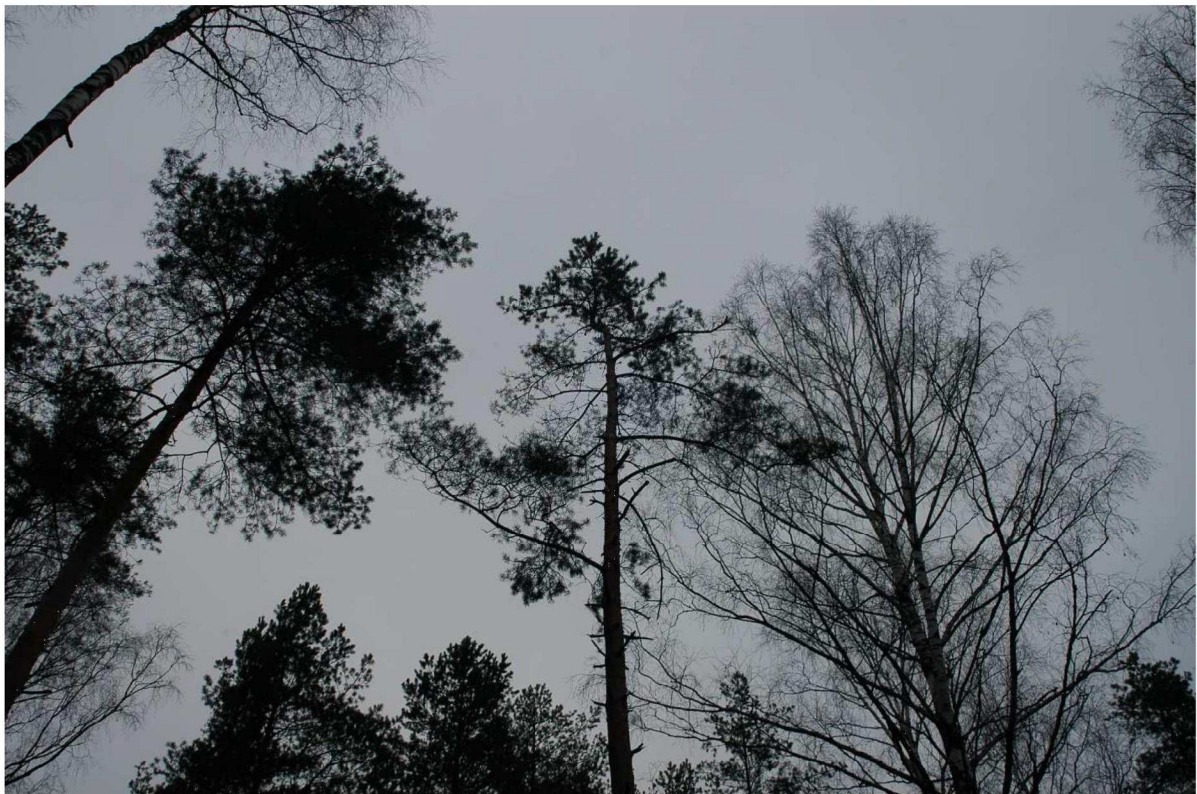
Image16. Tips of the trees and leafages around the aircraft collision place are not touched

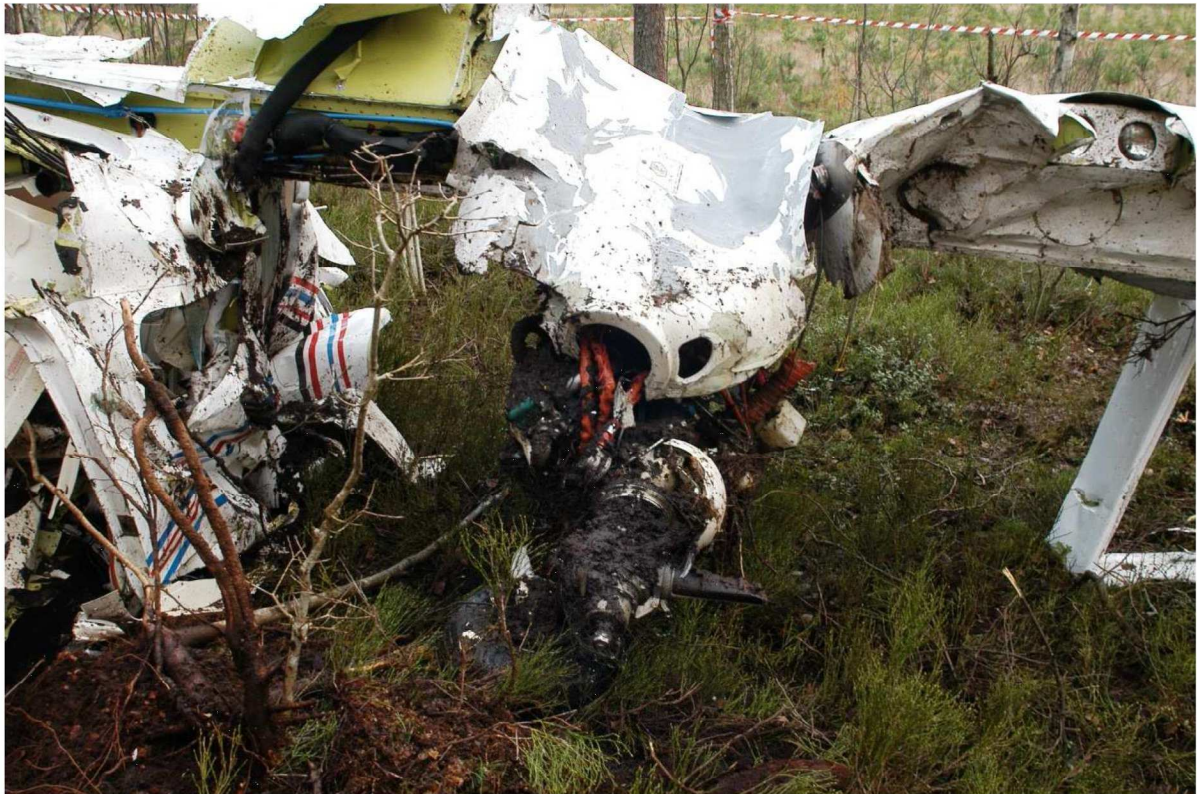
Image19. Left side engine after pulling out of the ground

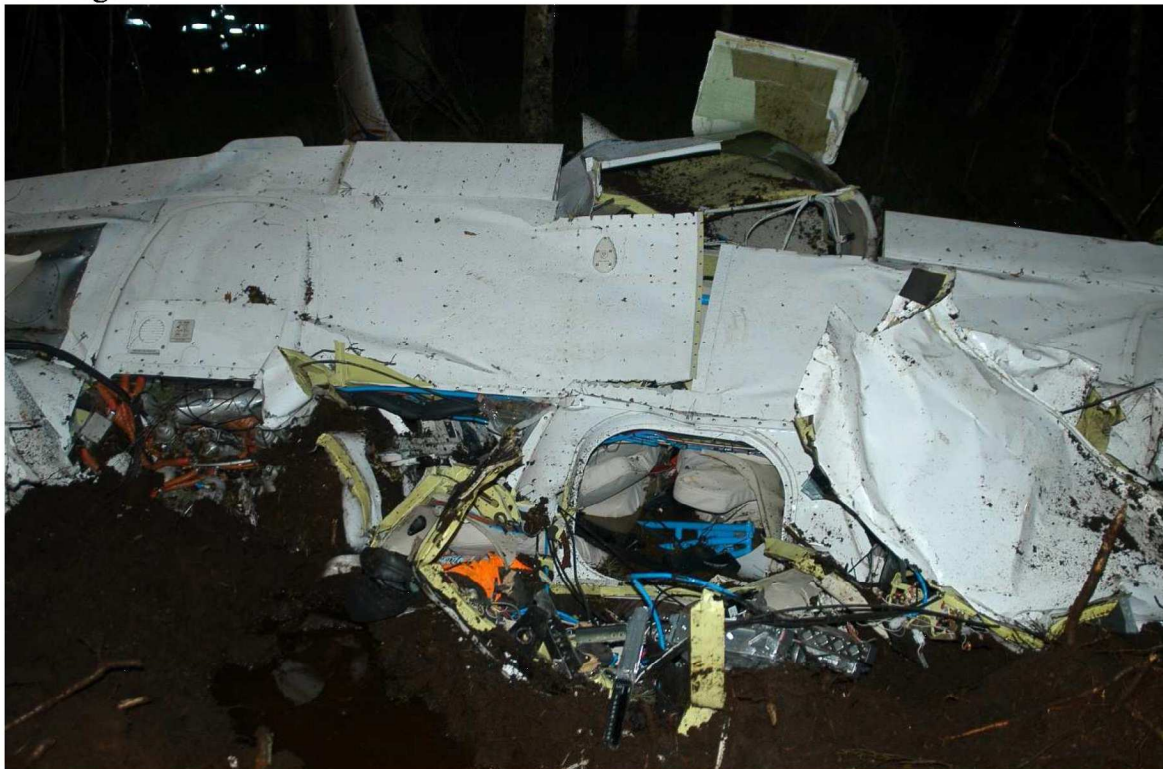
Due to the strong impact the aircraft pilot and examiner-instructor got fatal body injuries. In the place of accident the pilot and examiner was found under the front part of the aircraft fuselage wreckage forced in the ground and practically were not visible till the moment of removal of the wreckage.

Image 20. Pilot and examiner under the wreckage of aircraft

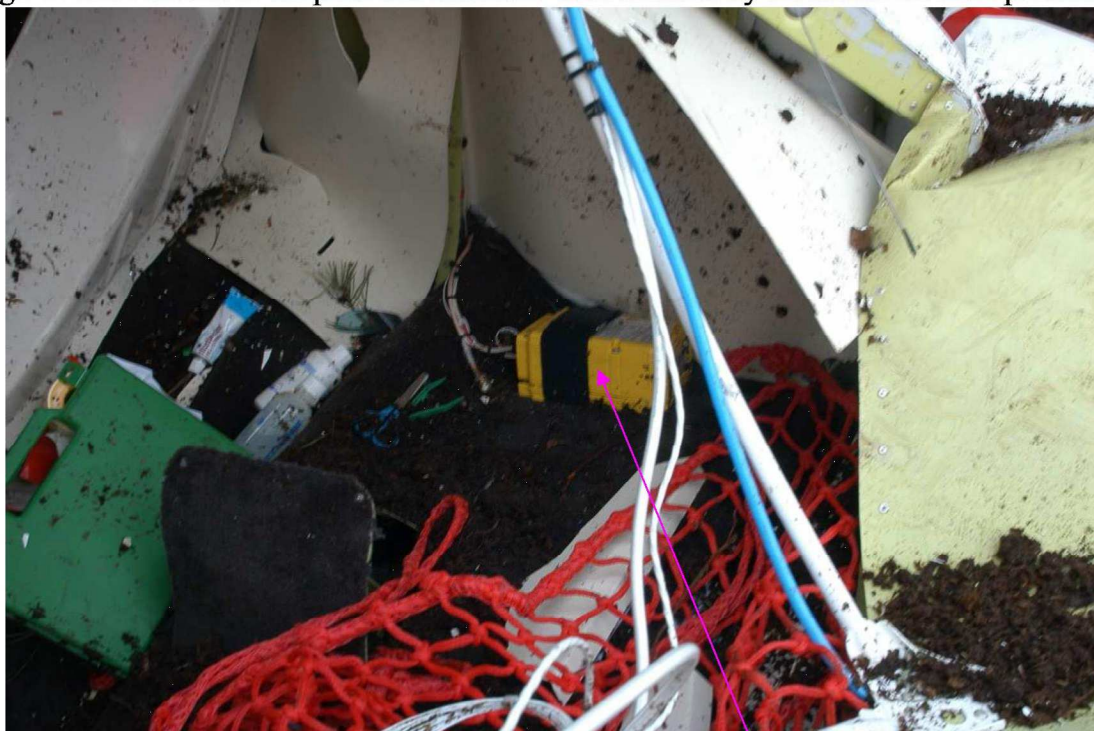
Image 22. ELT (Emergency Locator Transmitter)

The aircraft was equipped with ELT (Emergency Locator Transmitter) ME406, series No.197-05953. ELT is equipped with gravitation switch „G switch”, which automatically turns on ELT when the aircraft suffers in accident. ELT transmits signal with frequency 121,5 MHz for local use and with frequency 406 MHz to satellite from which the signal is being transmitted to MRCC. MRCC transmits information to LGS ARCC. In the place of accident ELT found on the board of aircraft was turned on and transmitted the signals.

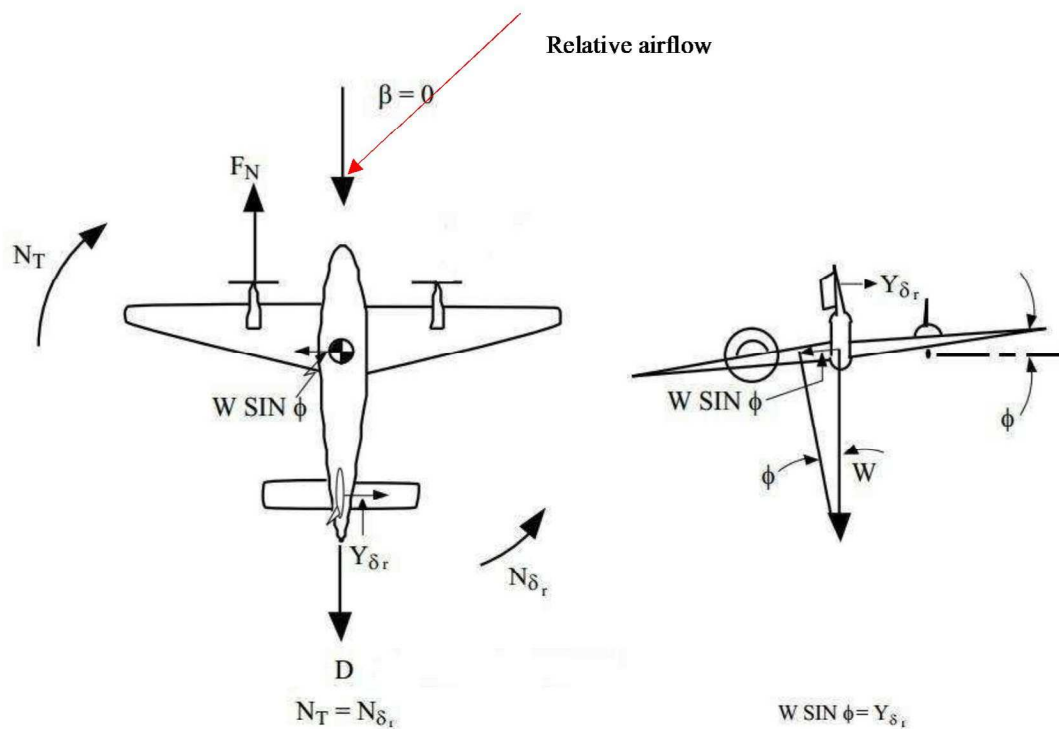
Image 37. Equilibrium Asymmetric Power Condition with Zero Sideslip with small bank angle on the side of operating engine

Rudder and ailerons used together in the proper combination will result in a small bank towards the operative engine. If a asymmetric yawing moment N_T is positive (the right side engine inoperative) the trailing edge left (positive) rudder deflection is required, therefore a negative (left) bank angle Φ is necessary to maintain equilibrium flight (Image 30).

In most cases, the bank angle requirement is fairly small (approximately 5 degrees). In this case bank on the side of operating engine, smaller drag (D) due to zero sideslip ($\beta=0$), a maximum climb performance and smaller required deflection of control element surfaces. **Maximal** speed V_{MC} under these circumstances can be higher as it is published.

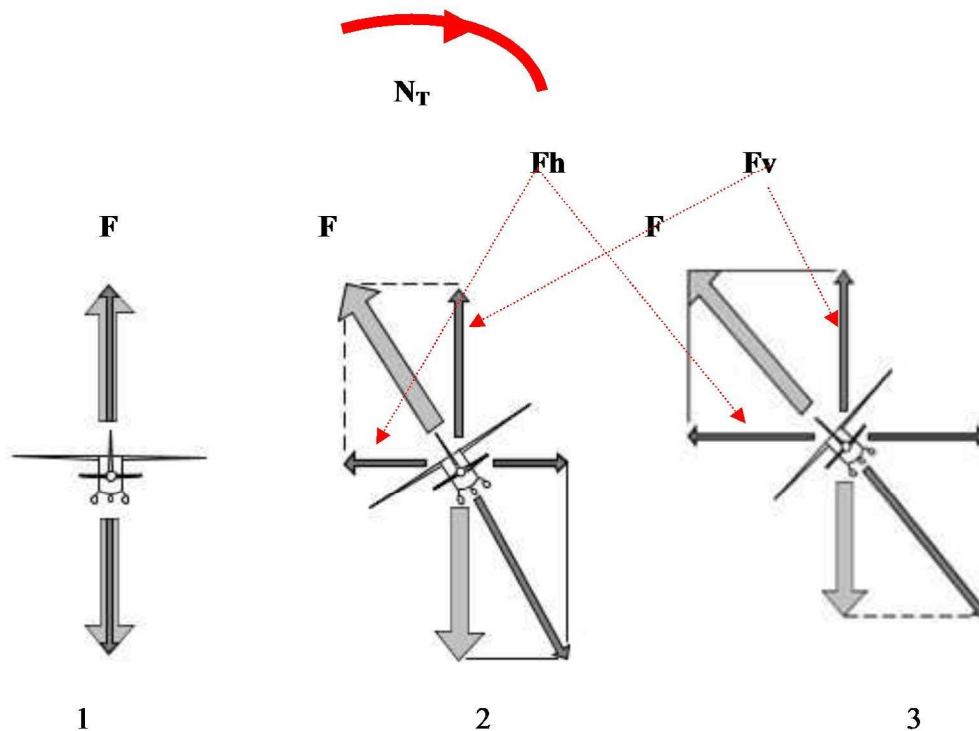
Image38 Schematic interpretation of lift vectors when aircraft banked

If we bank an aircraft, the lift (F) produced by the wing banks or tilts, too. We can break up the tilted lift into two parts, the vertical and the horizontal. After an engine fails, and we bank towards the operative engine, the horizontal component (F_h) of the tilted lift opposes the yawing moment (N_T) into the dead engine. If we increase our bank into the good engine, sure, we increase the

horizontal component of lift, and we don't need as much rudder. From one side if a little bank is good, then more must be better, but from other side as you bank the aircraft, the vertical component of lift (F_v) decreases, and the aircraft starts to descend. The manufacturer Aircraft Flight Manual for improving directional control defines that it is advisable to bank the aircraft of about 5° to the side of the operating engine. The 5 degrees of bank chosen for the V_{mc} demonstration is entirely arbitrary, and has nothing to do with achieving maximum performance at the higher single engine best rate of climb speed, known as V_{yse} , which is painted on the ASI as a blue line.

Excessive bank at V_{yse} , which is nice but not needed for control, really hurts climb performance, which is usually already hurting, factors which are beneficial for minimal speed V_{mc} or yawing control by all means are not beneficial for performance. In the case of one engine failure the best rate of climb speed V_{yse} shall be set, as it will provide the best climb performance, but at particular conditions this best climb performance can be only decreasing of altitude. For lightweight multi-engine aircrafts climb is not always guaranteed.

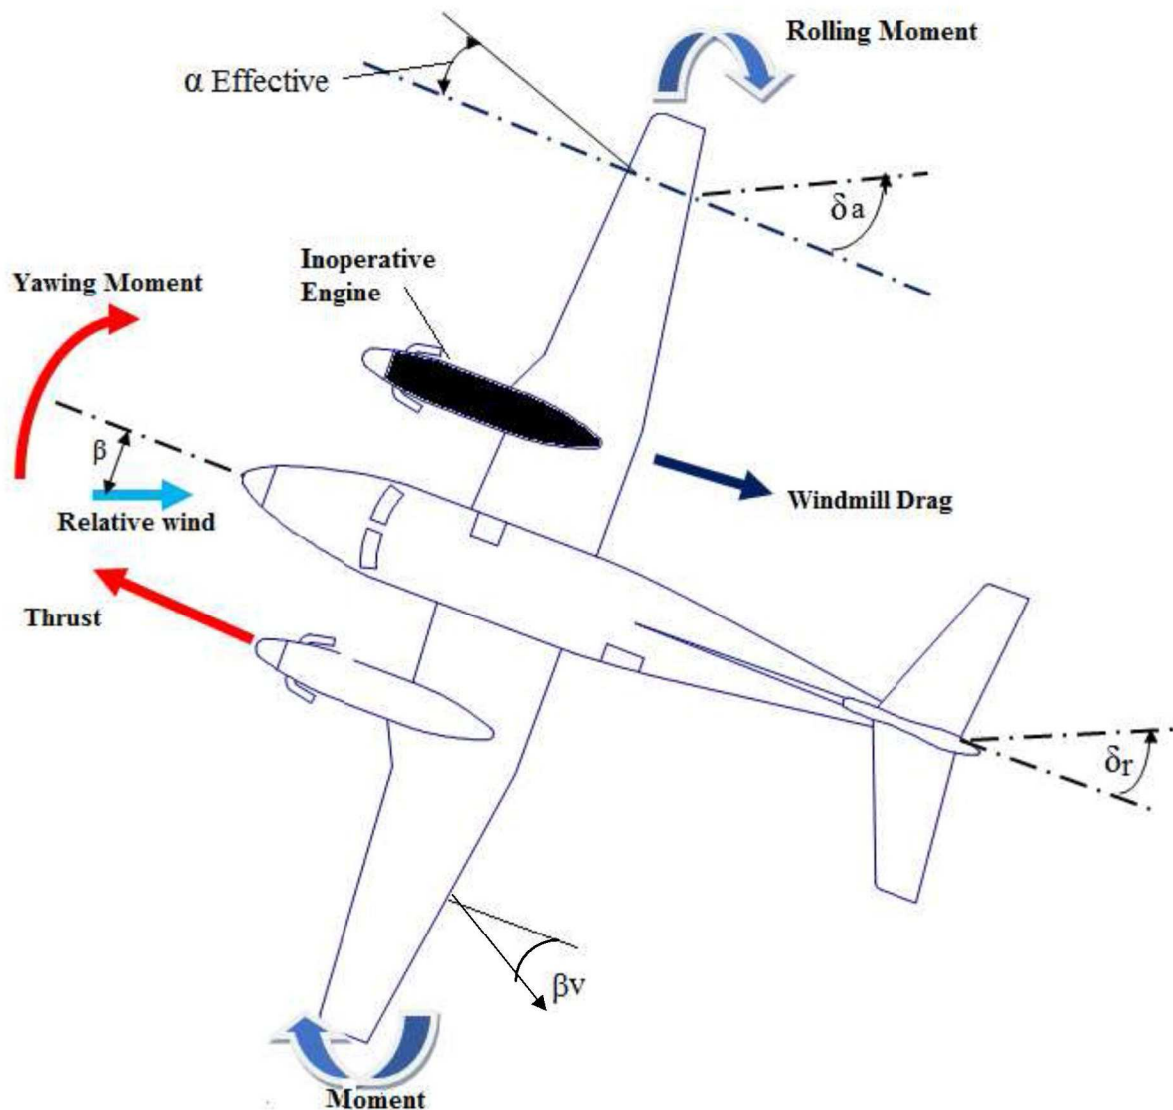
Image39 Flight Conditions Right Engine Failed

1. Assume the aircraft is in flight and one engine failed.

2. For example the pilot experienced a sudden power failure on the right engine. Because of the surprise factor, the pilot does not immediately react to the situation. The large yawing moment generated by the asymmetric power causes a large sideslip angle to develop from the operative engine side. If the sideslip angle reaches large enough proportions, the vertical tail may stall. An increase in drag accompanies the increase in sideslip, compounding an already (possibly) serious performance deficiency.

3. A rolling moment toward the inoperative engine will probably be generated by the yaw rate. This rolling moment will be increased if the airplane exhibits positive dihedral effect. Propeller-driven airplanes may rapidly diverge in roll due to slipstream effects, particularly if the wings are completely immersed in slipstream prior to the engine failure.

4. The pilot will likely apply large rudder and lateral control inputs to attempt to arrest the yawing and rolling motion. The large rudder input increases the tendency for the vertical tail to stall and may result in "rudder lock" if the control system is reversible. The lateral control input may generate an adverse yawing moment which increases the yawing moment toward the inoperative engine side. The large lateral control deflection, coupled with the rolling velocity, may cause the down-going wing to exceed stall angle of attack

5. If the pilot is **unable to achieve equilibrium flight with full lateral and directional control inputs, a power reduction on the operative engine side and/or an increase in airspeed will be required to prevent catastrophic consequences.** Obviously, these measures may not be possible **in a low altitude**, marginal performance flight condition.

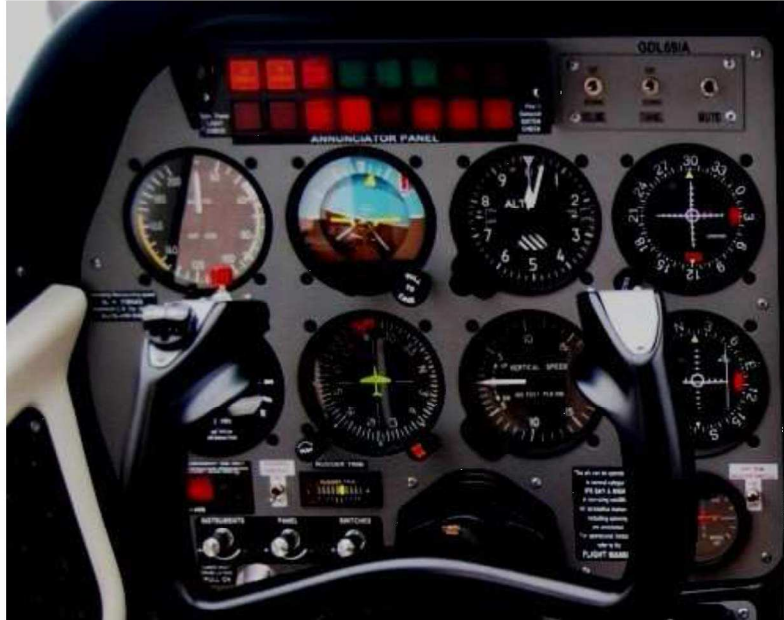
Image 40. Tecnam T2006P left side instrument panel

Total decrease of the aircraft thrust and extended deflection of control element surfaces led to decrease of the aircraft performance. In compliance with the paragraph 7.2., Section 3 „Characteristic airspeeds with one engine inoperative” of the “Flight manual P2006T” minimal aircraft control speed with one engine inoperative - V_{mc} is 62kt. The aircraft speed V_{mc} could never be less than it is provided in the manual and painted with the red thick line on the speed indicator, as if the speed is higher, the efficiency of the aircraft side and direction control elements is higher as well.

Probably, when the operating engine power was reduced to decrease the yaw towards the failed engine and taking into account that the speed has been reduced close to critical limits, the pilot (or pilots) tried to lower the nose of aircraft, to increase the speed. As well it is recommended by the instructions of flight manual. As the aircraft was flying only about at 1500 feet altitude, there was not enough time and enough efficiency of control inputs, at low speed to get back the control over the aircraft and regardless the fact that one engine was working, aircraft was losing the altitude and at steep angle collided with ground. The theory of flying with multi-engine aircrafts does not recommend to perform these procedures during the takeoff and in low altitude.

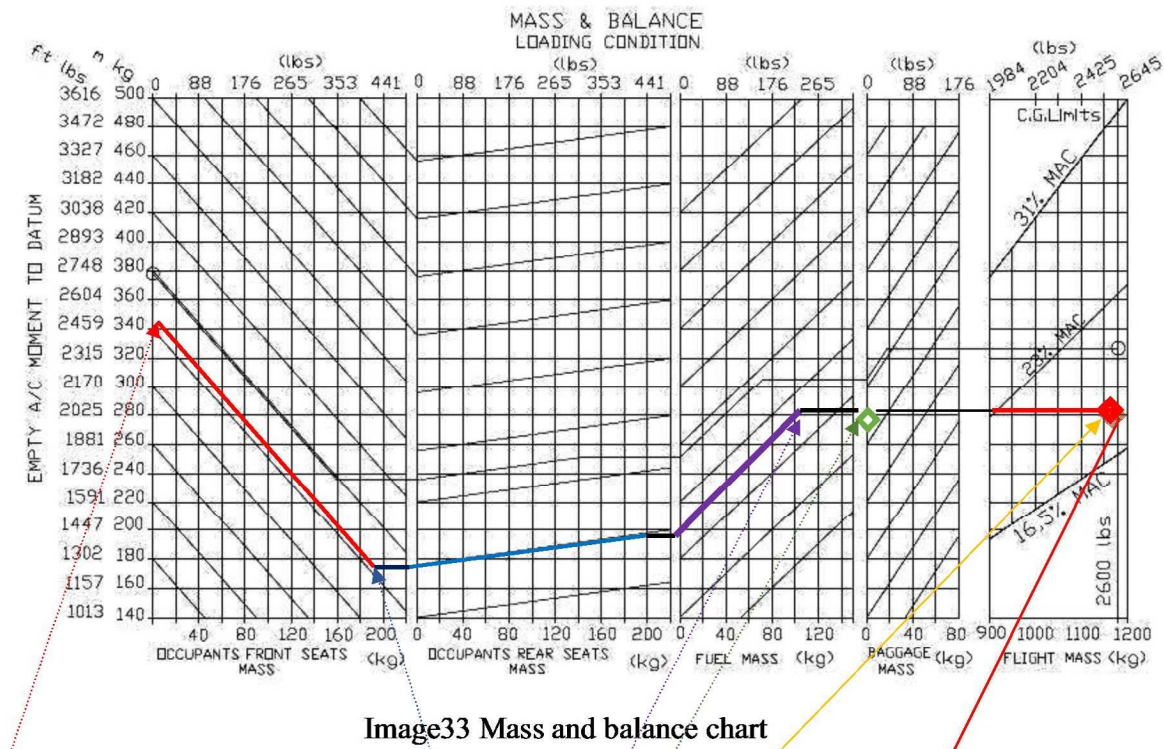
Image33 Mass and balance chart

Using recorded data was defined CG position by means of the manufacturers chart from Aircraft Flight Manual.

Empty weight moment $M = (D \times W_E) = 0.41037\text{m} \times 837.0\text{kG} = 343.48(\text{m kG})$

A more serious problem caused by the CG being too far forward is **the lack of sufficient elevator authority**. At slow speeds, the elevator might not produce **enough nose-up force**.

It is not possible to exclude that at situation developed during one engine failure or intentionally shut down by examiner or pilot by mistake (when suddenly asymmetric flight occurred), with moved CG far forward, the elevator might not produced enough nose up force due to the lack of sufficient elevator authority, especially at slower air speed, that could made strong affect to he flight when aircraft with nosedz down at steep angle collided with ground.
