FINAL REPORT No 4-02/3-21(1-23)

on the serious incident to the aircraft Airbus A220-300 (CS300) registered YL-CSE operated by airBaltic runway excursion at the Riga International Airport (RIX), on December 3, 2021

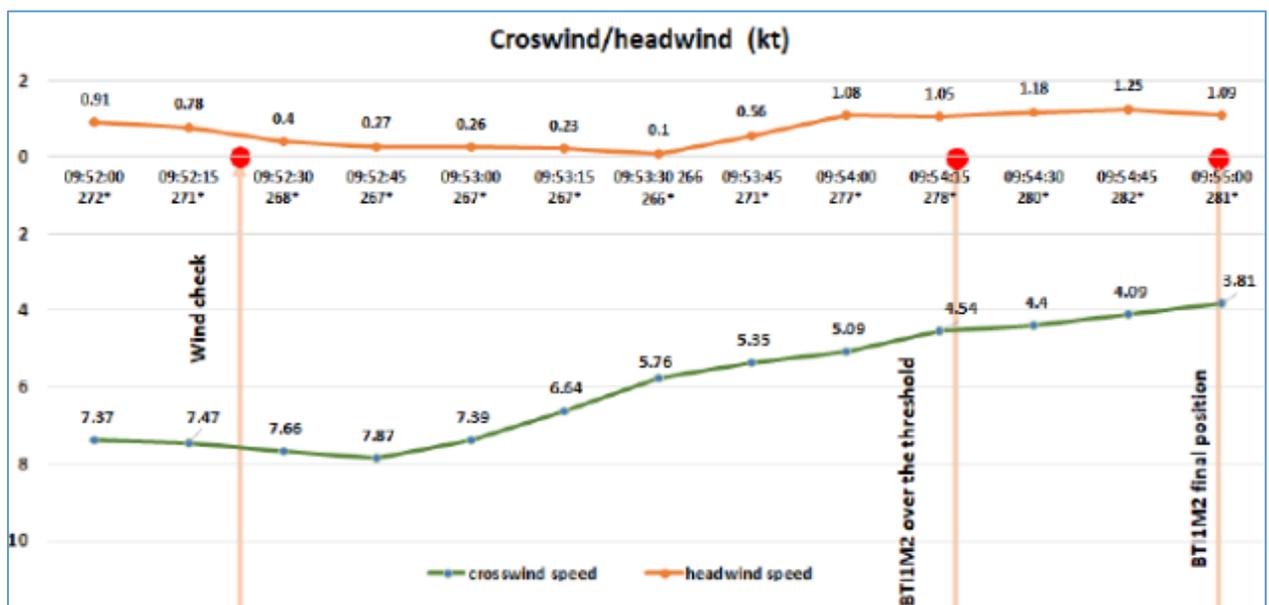
Picture 4: Crosswind/headwind during landing of the RIX

At 09.52.28 TOWER ATC issued wind check to the flight BTI1M2: “270 degrees 8 kt” (3.8 NM out from RWY36). Until landing the surface wind for RWY36 did not change significantly and ATC did not give wind check any more (see picture 4).

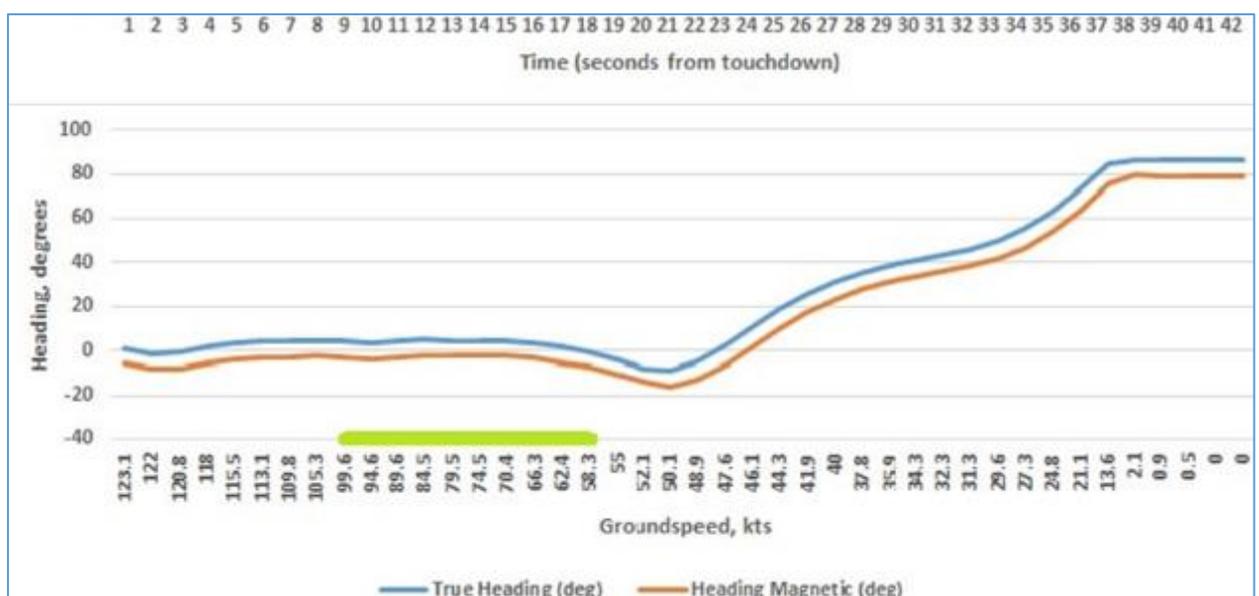
Picture 5: Aircraft deviation after touchdown on the RWY36 (Fragment from FDR data plots)

At **09.54.58** the aircraft stopped; The longitudinal deceleration was -0.83g and the lateral deceleration was 0.45g (ground speed **0 kt**), (see picture 5).

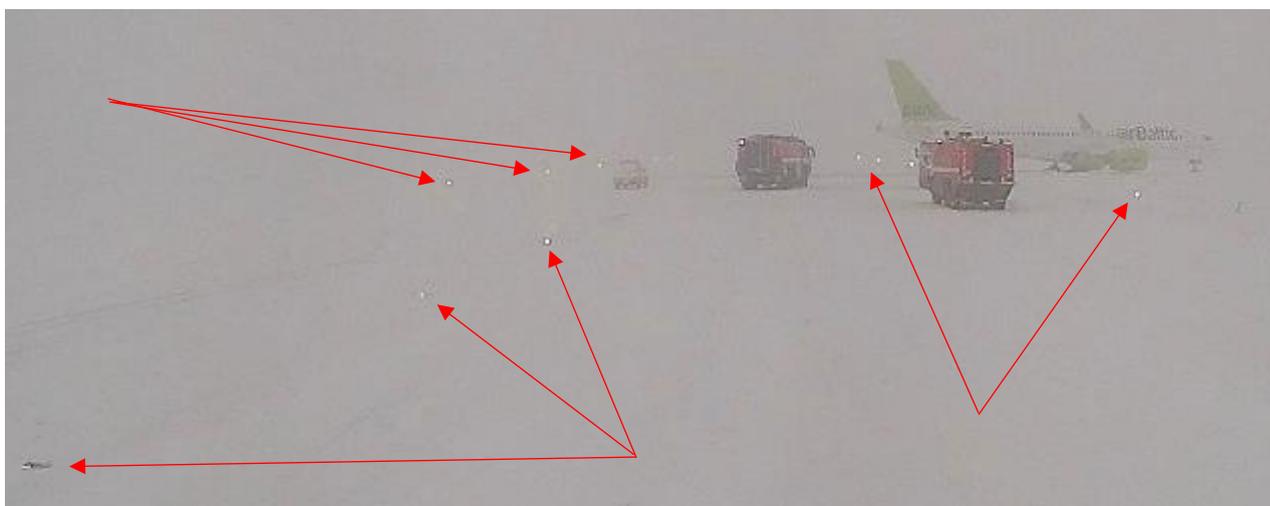
Picture 9: Screenshot of the video recording from the RFFS vehicle

The AGL (Aerodrome ground lighting) system was fully operational and operated for 100% of its brightness power according to AERODROME MANUAL – PART E11.1 – Operating Instructions for aerodrome lighting system. The AGL was working at the time of the occurrence, the side lights of the runway and centerline lights were not covered with snow, what can be seen in the video from RFFS vehicles approaching the aircraft approximately 4 minutes after the serious incident (see picture 9).

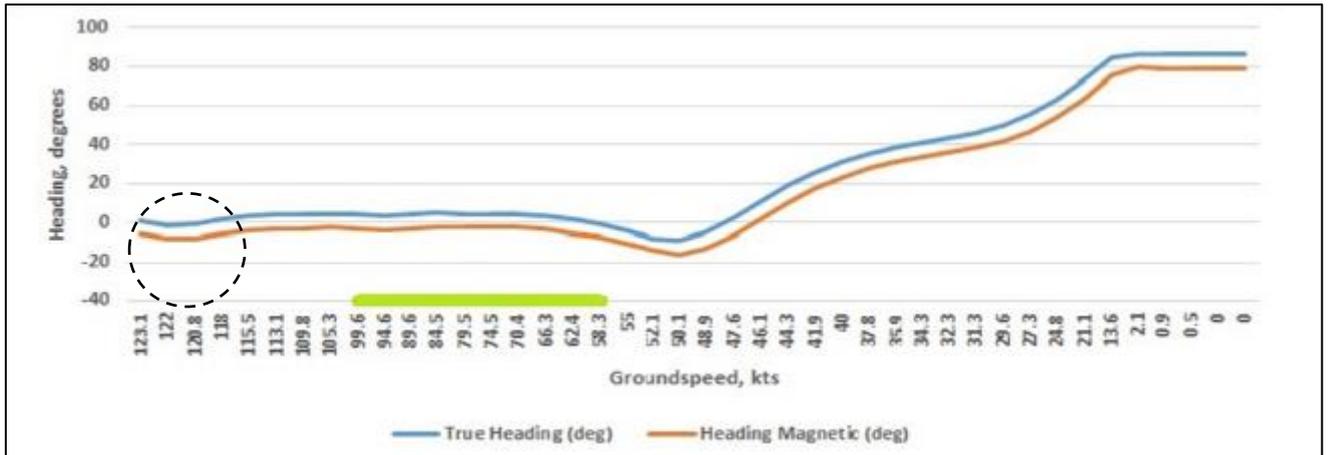
Picture 10: Fragment from FDR data plots of the aircraft heading

The aircraft touchdown executed within the touchdown zone with vertical acceleration is recorded at max 1.7G. The nose wheel on the ground is recorded 1 sec after the main wheels contact with 122kts groundspeed on the centerline of the runway. Initially, during the landing roll, the aircraft deviated slightly right from the centerline.

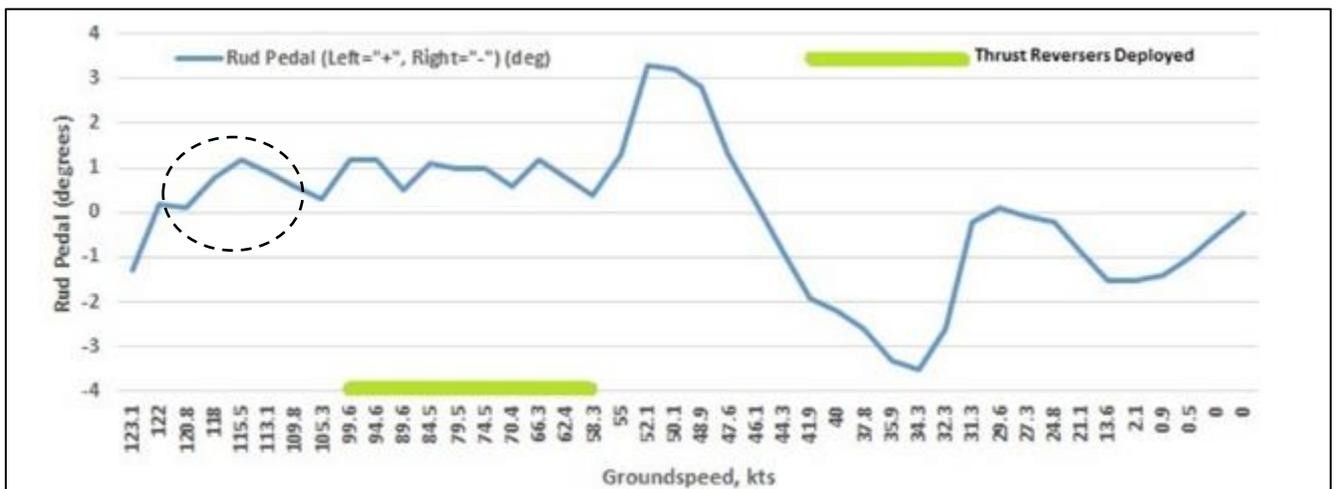
Picture 11: Fragment from FDR data plots of rudder pedal

Initially the aircraft slight right deviation from the centerline was compensated by using of the left rudder inputs. The aircraft returned to the centerline.

The left rudder input was kept within approx. 0,2 - 1,5 degrees until the aircraft deviated noticeably to the left, reaching a maximum distance of 15 meters to the left from the centerline.

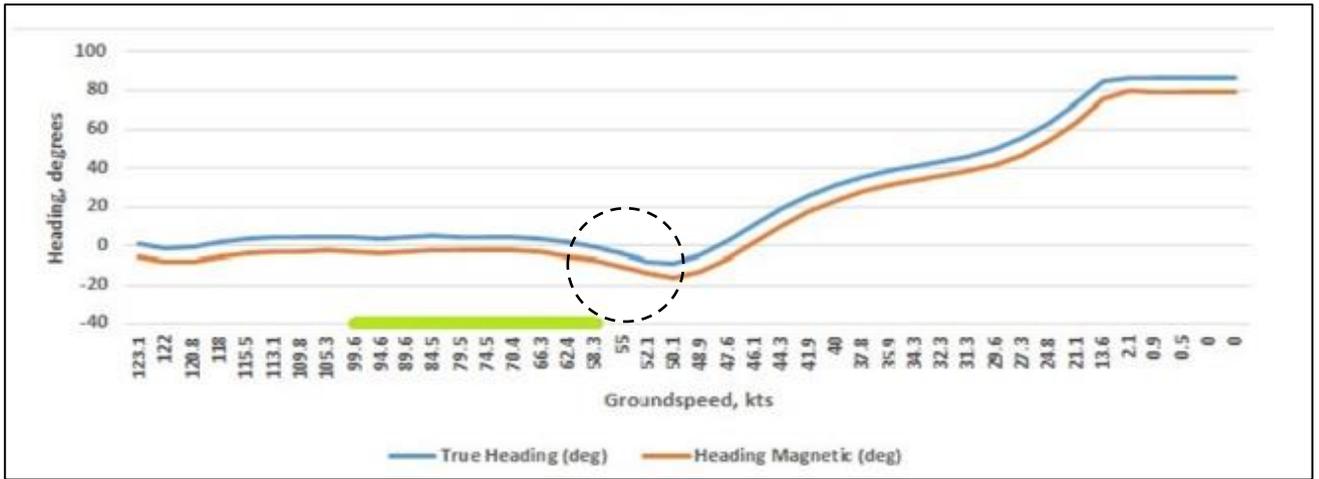
Picture 12: Fragment from FDR data plots of the aircraft heading

While the autobrakes were still in use at ~66kts groundspeed the heading changed to the 13 degrees to the left. In the FDR the aircraft heading is recorded at 344 degrees while the autobrakes turned off at a groundspeed of 50kts.

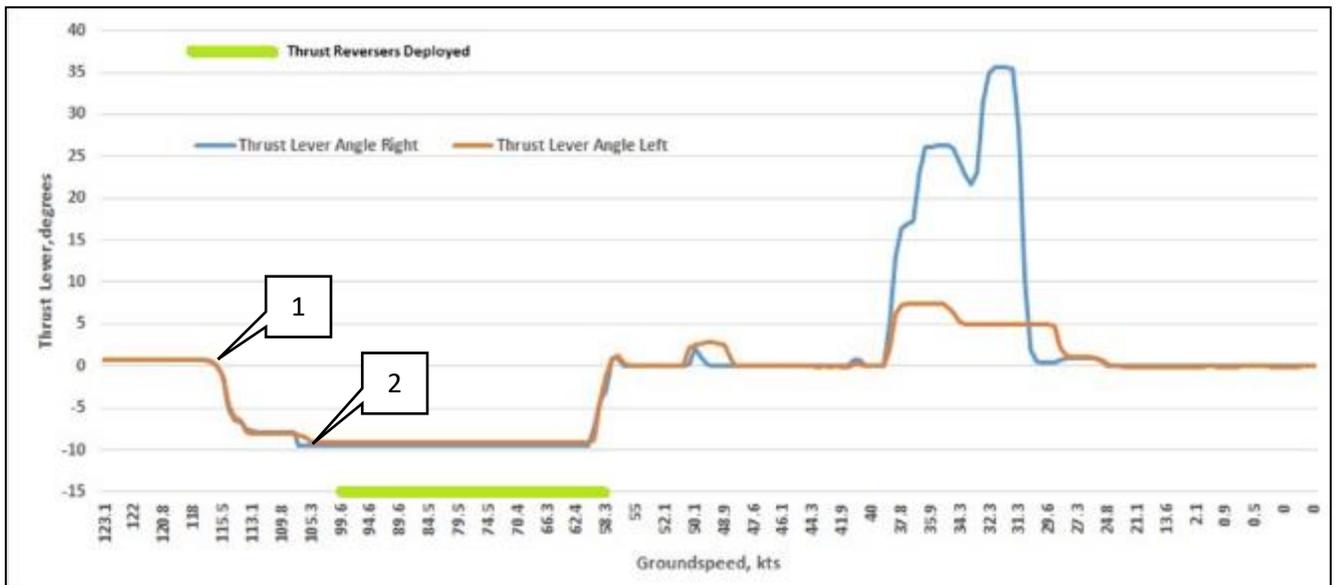
Picture 13: Fragment from FDR data plots of thrust levers

The Autothrottle was disconnected 3 sec after the touchdown at the 118kts groundspeed (see picture 13: 1). The thrust reversers [TR] were deployed at 105kts groundspeed 7 sec after the touching of the landing gears on the runway (see picture 13: 2).

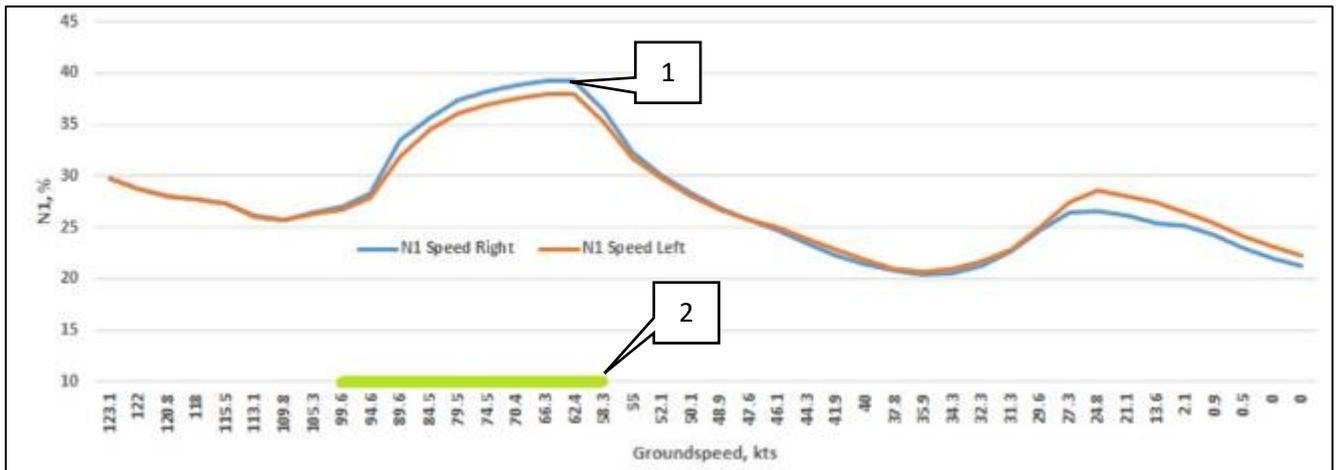
Picture 14: Fragment from FDR data plots of N₁

The N_1 torque of engines increased to 39% recorded during TRs deployment (see picture 14: 1). The TRs were in use for 9 seconds and stowed at 58.3kts groundspeed together with the autobrake setting deactivation (see picture 14: 2).

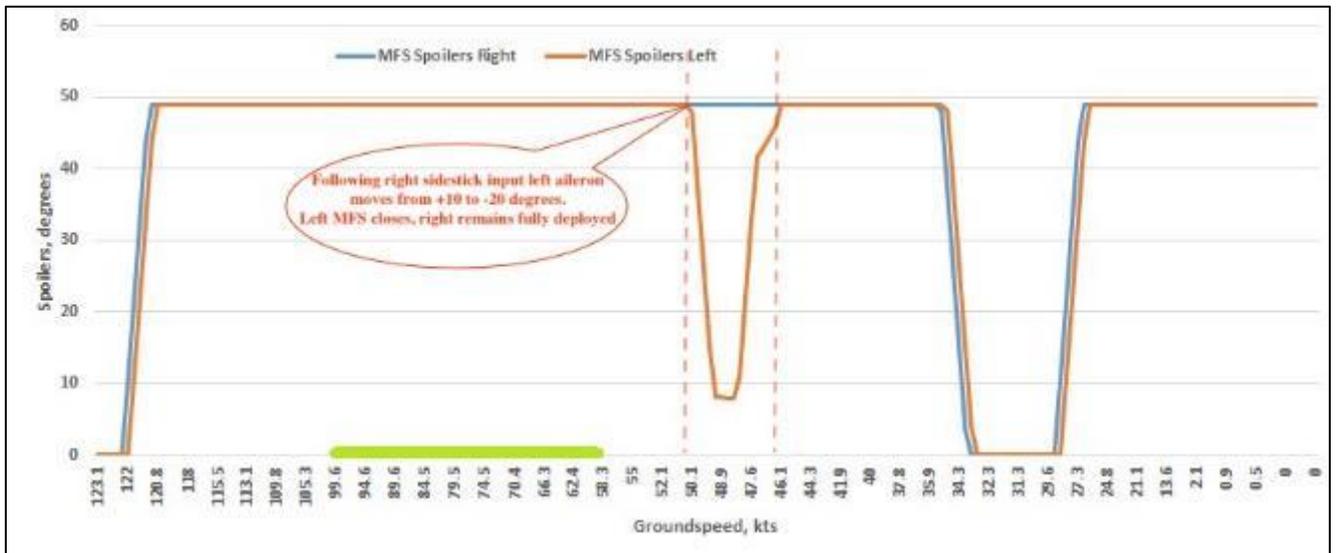
Picture 15: Fragment from FDR data plots of spoilers

Simultaneously with the left rudder and the right brake application the right sidestick input was detected, which commanded the left MFS spoiler to retract where the right MFS spoiler remained fully deployed.

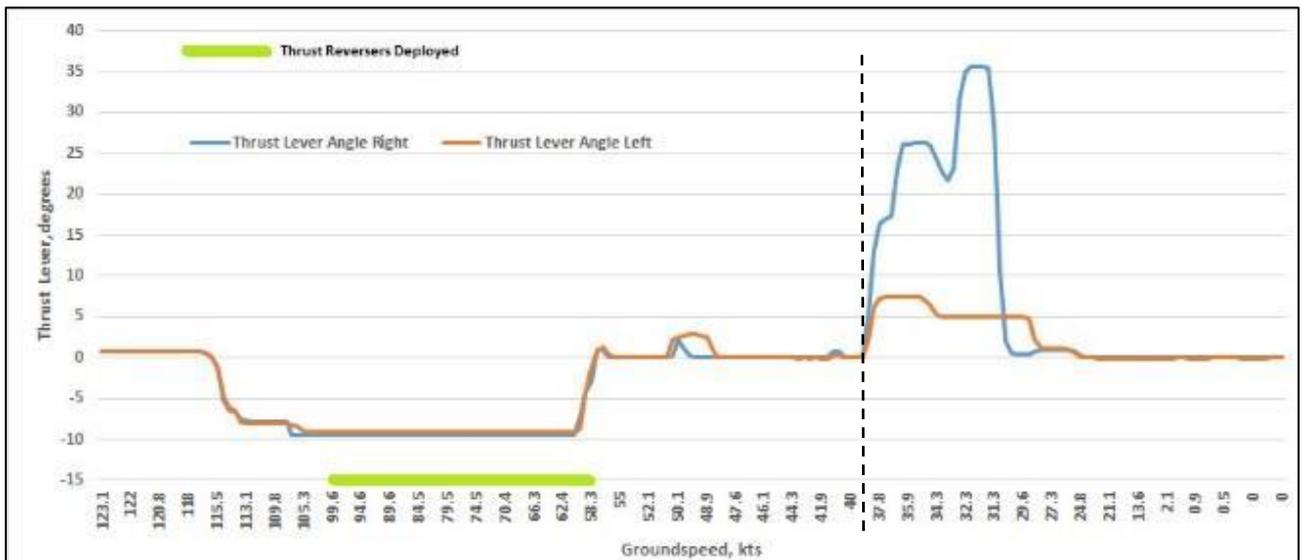
Picture 17: Fragment from FDR data plots of thrust levers

At a groundspeed of 39kts and the aircraft heading ~30 degrees right from the RWY centerline the pilot attempted to use the thrust levers to prevent the aircraft drifting to the right and skidding off from the RWY by increasing power on both the left (7.5 degrees) and the right (35.7 degrees) engines; as a result, the spoilers were retracted.

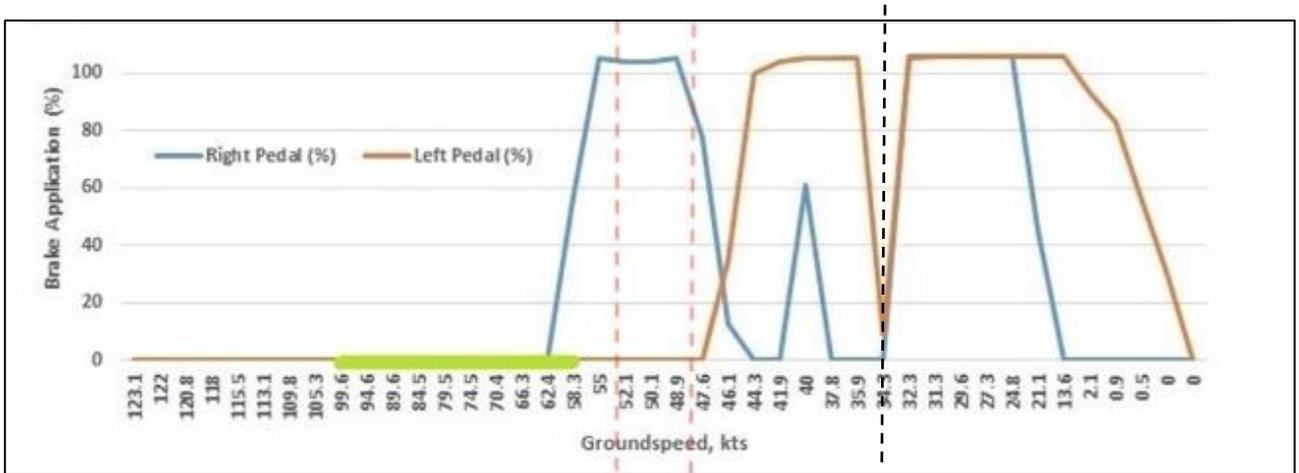
Picture 18: Fragment from FDR data plots of brake application

At a groundspeed of 34kts a symmetric brakes application was recorded while the aircraft continued to skid to the right and left the RWY at a groundspeed of ~30kts with rapid spikes in the lateral and longitudinal acceleration at ~0.71G and ~0.79G. The aircraft stopped finally on a heading 79 degrees.

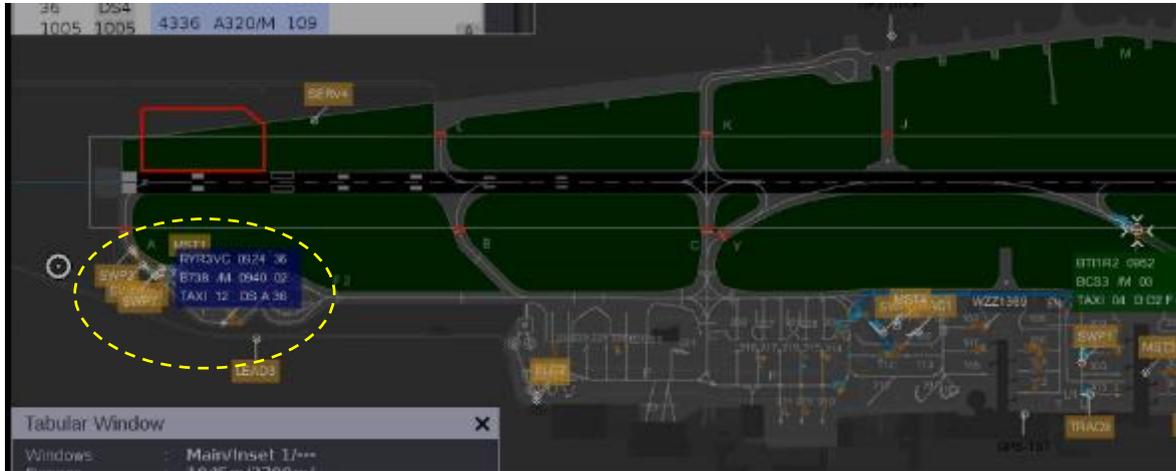
Picture 24: Screenshot of the A-SMGCS TWR

At **9.49.54** the snow cleaning vehicles arrived at the taxiway "A" turn to clean the sections 3 and 2 of the RWY36; the vehicles stopped and waited for the landing of the flight BTI1M2 (see picture 24).
