DRAFT FINAL REPORT No 4-02/3-21

on the serious incident to the aircraft Airbus A220-300 (CS300) registered YL-CSE operated by airBaltic runway excursion at the Riga International Airport (RIX), on December 3, 2021

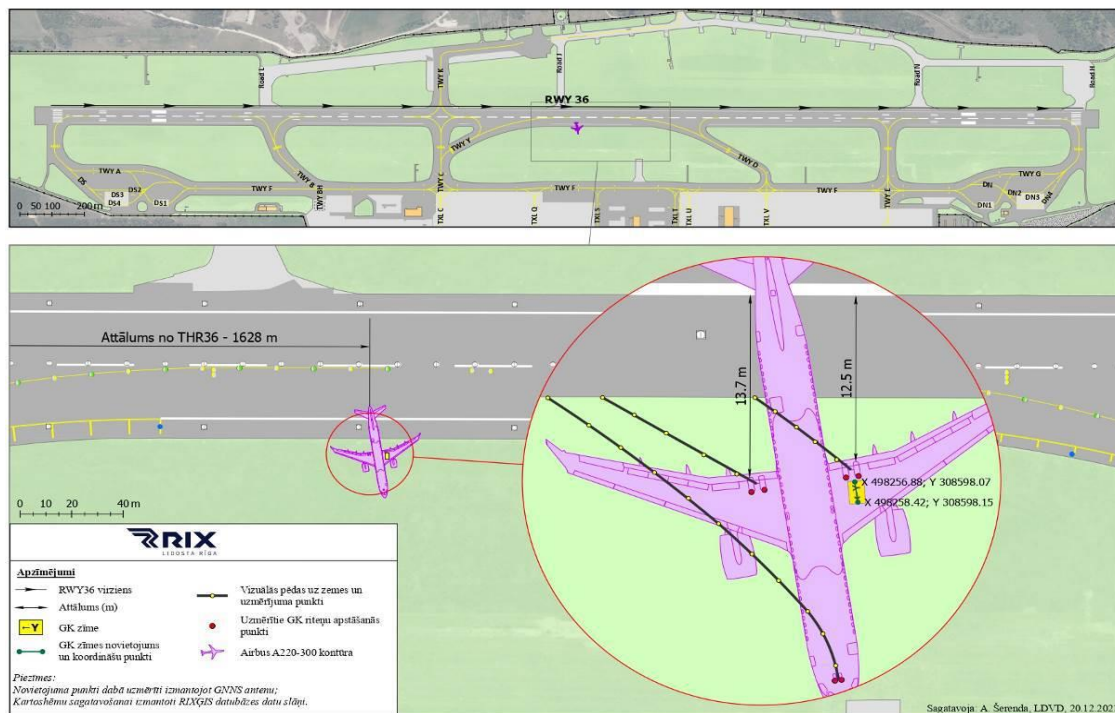
Picture 2: Location of the aircraft after the occurrence (source RIX report DP 8203F)

At **9:55** a.m. the flight BTI1M2 of the AirBaltic airline aircraft suffered a runway excursion after landing on the RWY 36 in the Riga International Airport (RIX). In adverse weather conditions (heavy snowfall) and reduced visibility conditions the aircraft lost directional control, skidded to the right side of the runway, broke the runway exit sign “Y” of the TWY with the LH engine inlet cowl and stopped in snow (see picture 1). The passengers of the aircraft were disembarked safely.

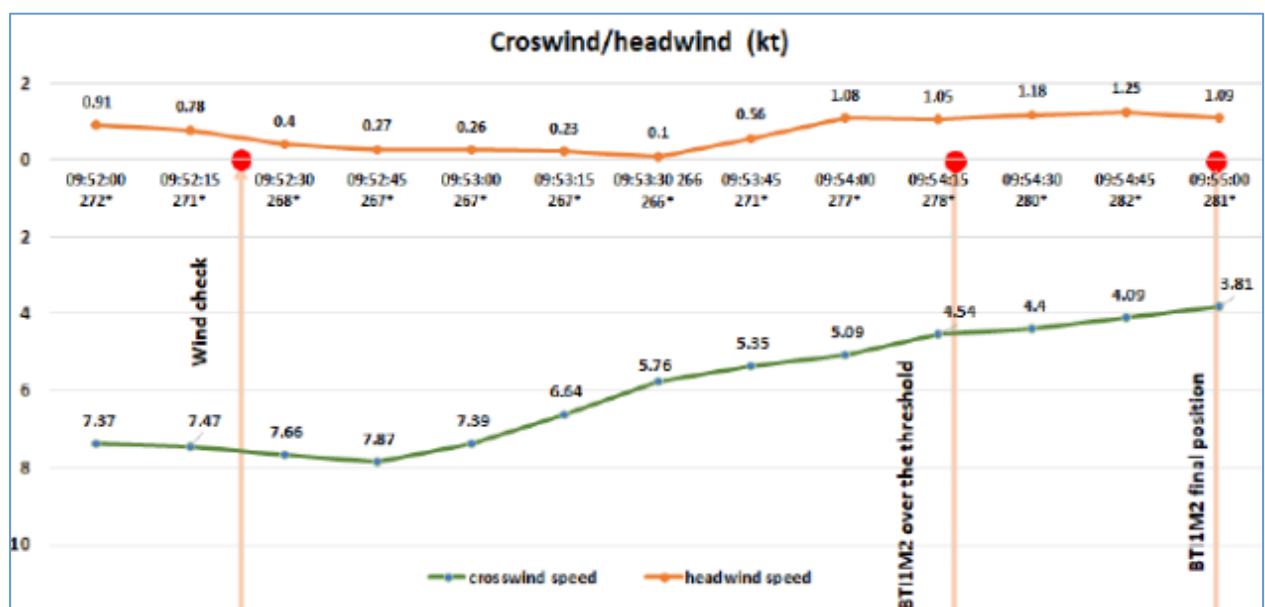
Picture 4: Crosswind/headwind during landing of the RIX

At **09.52.28** TOWER ATC issued wind check to the flight BTI1M2: “270 degrees 8 kt” (3.8 NM out from RWY36). Until landing the surface wind for RWY36 did not change significantly and ATC did not give wind check any more (see picture 4).

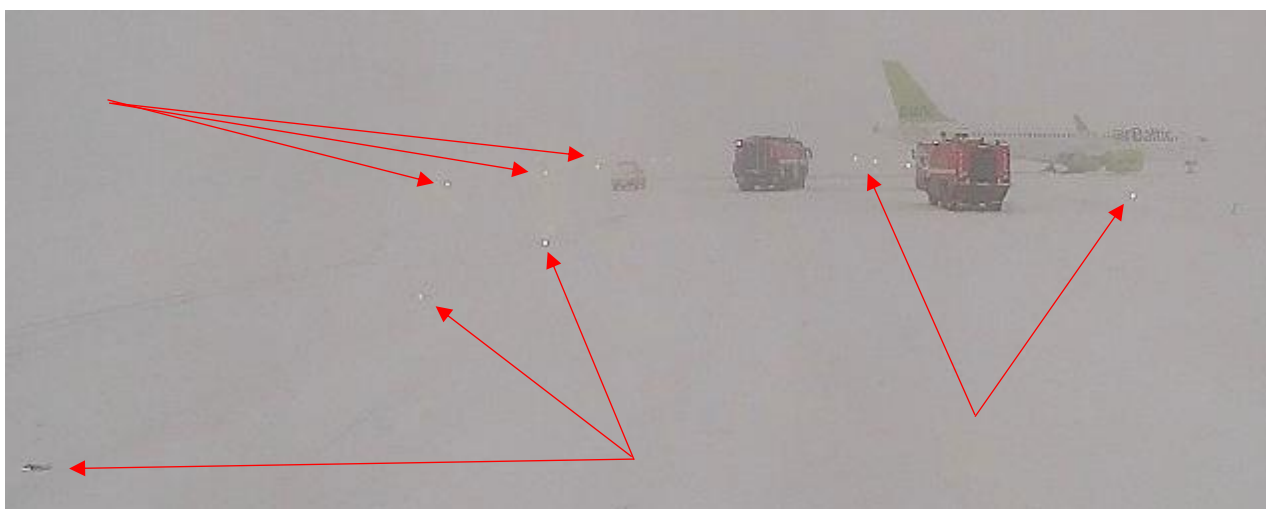
Picture 9: Screenshot of the video recording from the RFFS vehicle

The AGL (Aerodrome ground lighting) system was fully operational and operated for 100% of its brightness power according to AERODROME MANUAL – PART E11.1 – Operating Instructions for aerodrome lighting system. The AGL was working at the time of the occurrence, the side lights of the runway and centerline lights were not covered with snow, what can be seen in the video from RFFS vehicles approaching the aircraft approximately 4 minutes after the serious incident (see picture 9).

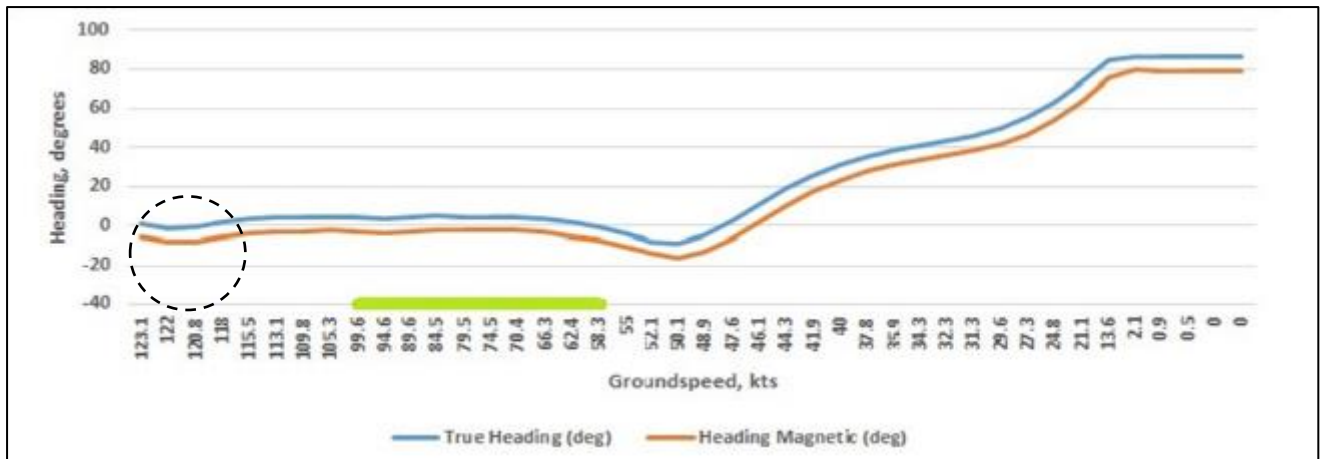
Picture 10: Fragment from FDR data plots of the aircraft heading

The aircraft touchdown executed within the touchdown zone with vertical acceleration is recorded at max 1.7G. The nose wheel on the ground is recorded 1 sec after the main wheels contact with 122kts groundspeed on the centerline of the runway. Initially, during the landing roll, the aircraft deviated slightly right from the centerline.

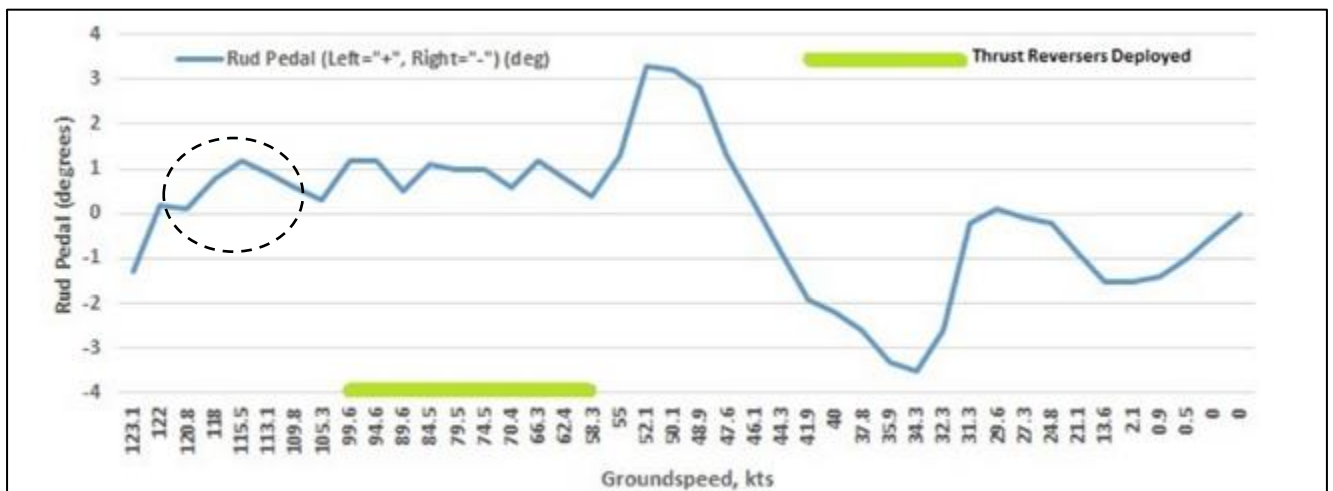
Picture 11: Fragment from FDR data plots of rudder pedal

Initially the aircraft slight right deviation from the centerline was compensated by using of the left rudder inputs. The aircraft returned to the centerline.

The left rudder input was kept within approx. 0,2 - 1,5 degrees until the aircraft deviated noticeably to the left, reaching a maximum distance of 15 meters to the left from the centerline.

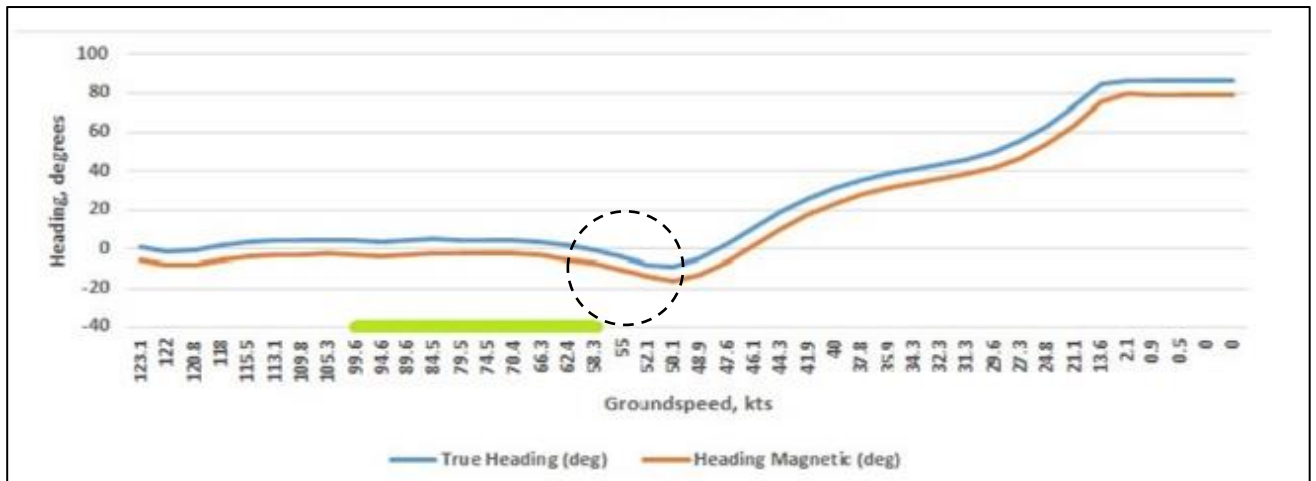
Picture 12: Fragment from FDR data plots of the aircraft heading

While the autobrakes were still in use at ~66kts groundspeed the heading changed to the 13 degrees to the left. In the FDR the aircraft heading is recorded at 344 degrees while the autobrakes turned off at a groundspeed of 50kts.

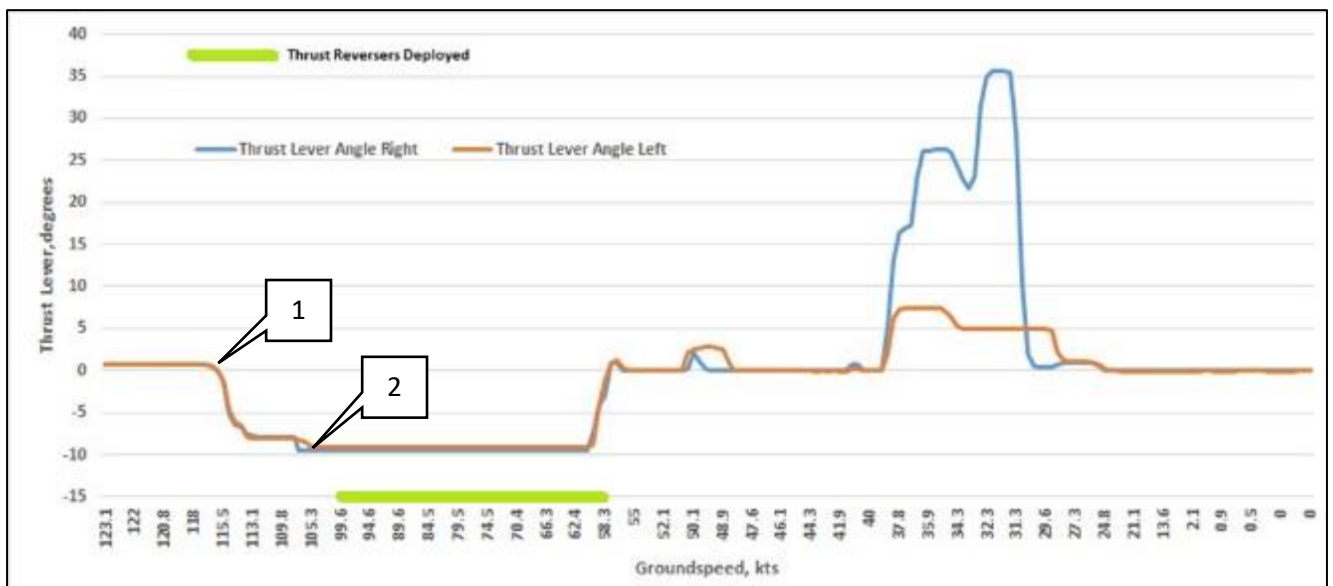
Picture 13: Fragment from FDR data plots of thrust levers

The Autothrottle was disconnected 3 sec after the touchdown at the 118kts groundspeed (see picture 13: 1). The thrust reversers [TR] were deployed at 105kts groundspeed 7 sec after the touching of the landing gears on the runway (see picture 13: 2).

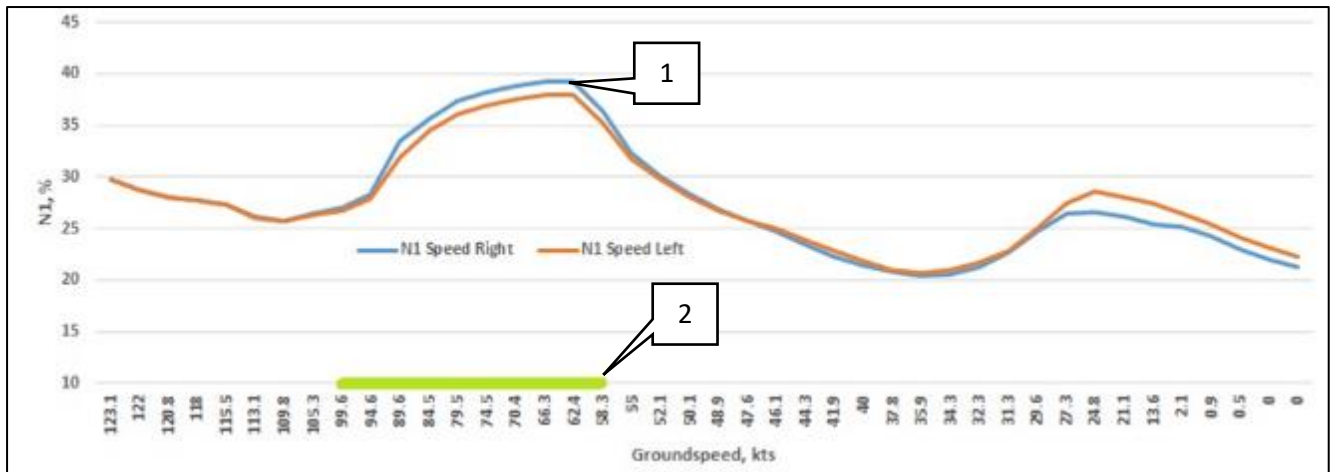
Picture 14: Fragment from FDR data plots of N₁

The N_1 torque of engines increased to 39% recorded during TRs deployment (see picture 14: 1). The TRs were in use for 9 seconds and stowed at 58.3kts groundspeed together with the autobrake setting deactivation (see picture 14: 2).

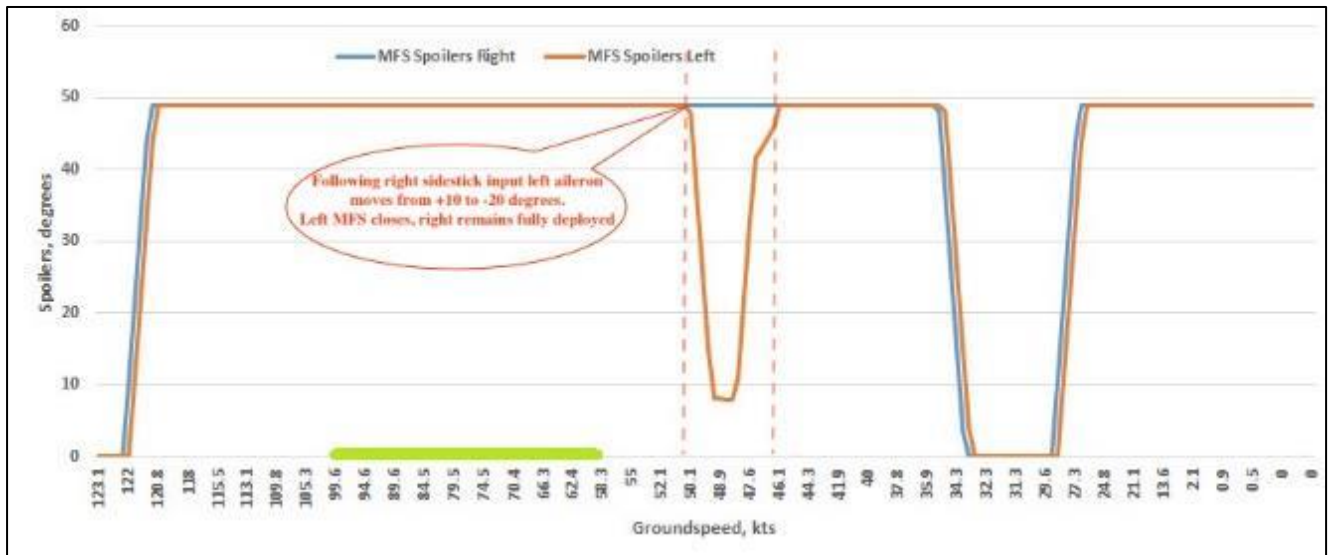
Picture 15: Fragment from FDR data plots of spoilers

Before the TR's disconnection at 62.4.3kts groundspeed the right brake pedal was rapidly applied up to 100% (that caused an autobrake disconnection) where the left brake pedal recorded at 0% brake application and after ~7 sec the right brake pedal was released. Simultaneously with the right brake pedal application the left rudder pedal was applied from 0.5 degrees to 3.5 degrees.

This pilot's actions possibly caused that the aircraft started to rapidly veer to the right at the groundspeed of approx. 50kts.

Simultaneously with the left rudder and the right brake application the right sidestick input was detected, which commanded the left MFS spoiler to retract where the right MFS spoiler remained fully deployed.

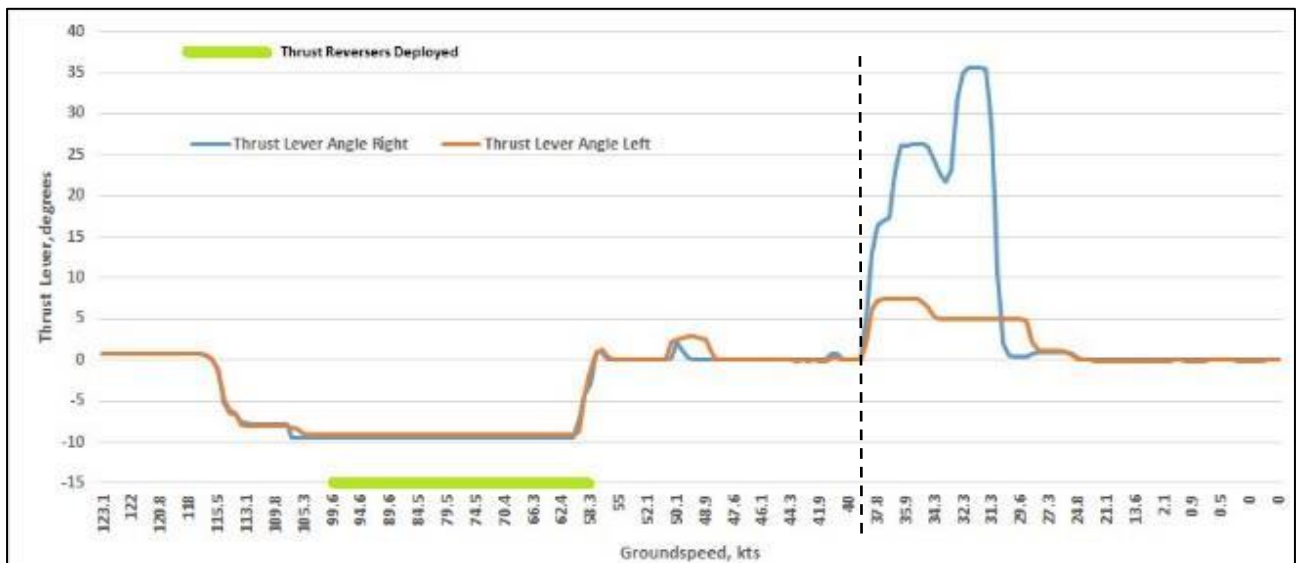
Picture 17: Fragment from FDR data plots of thrust levers

At a groundspeed of 39kts and the aircraft heading ~30 degrees right from the RWY centerline the pilot attempted to use the thrust levers to prevent the aircraft drifting to the right and skidding off from the RWY by increasing power on both the left (7.5 degrees) and the right (35.7 degrees) engines; as a result, the spoilers were retracted.

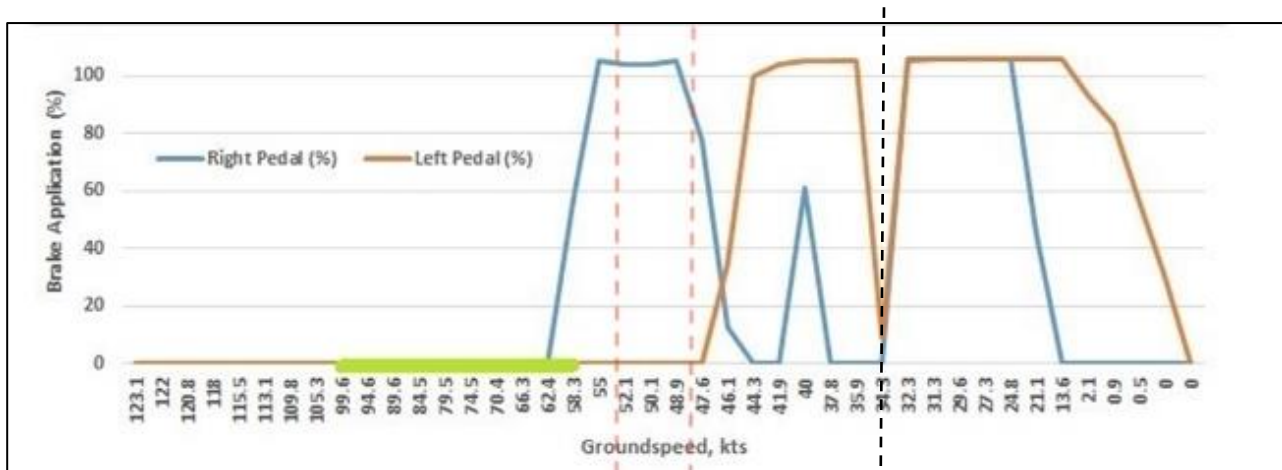
Picture 18: Fragment from FDR data plots of brake application

At a groundspeed of 34kts a symmetric brakes application was recorded while the aircraft continued to skid to the right and left the RWY at a groundspeed of ~30kts with rapid spikes in the lateral and longitudinal acceleration at ~0.71G and ~0.79G. The aircraft stopped finally on a heading 79 degrees.

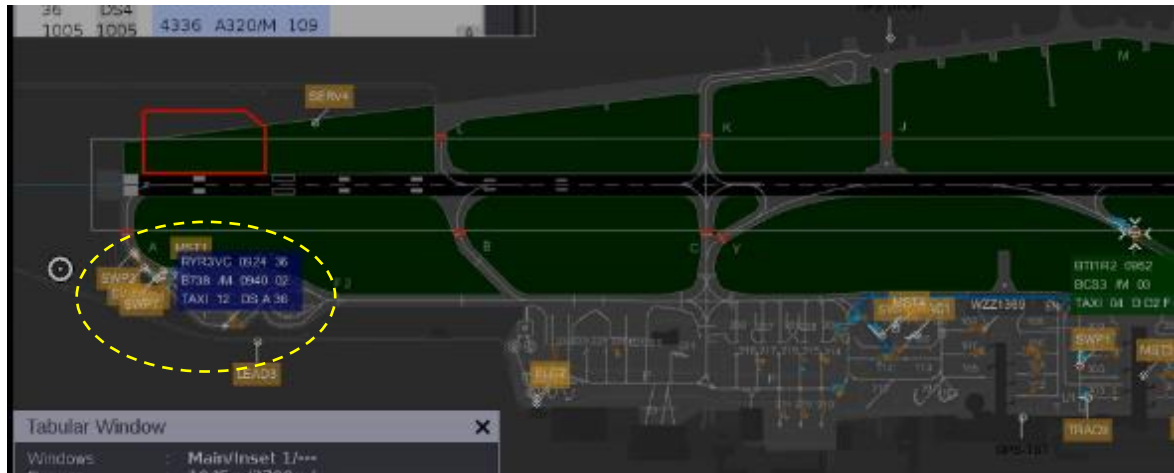
Picture 24: Screenshot of the A-SMGCS TWR

At **9.49.54** the snow cleaning vehicles arrived at the taxiway "A" turn to clean the sections 3 and 2 of the RWY36; the vehicles stopped and waited for the landing of the flight BT11M2 (see picture 24).
