**FINAL REPORT No. 4-02/1-17(2-2018) on
THE AIRCRAFT SERIOUS INCIDENT**

**RUNWAY EXCURSION RIGA INTERNATIONAL AIRPORT (RIX), ON 17
FEBRUARY 2017
AIRCRAFT BOEING 737-524, VP-BVS**

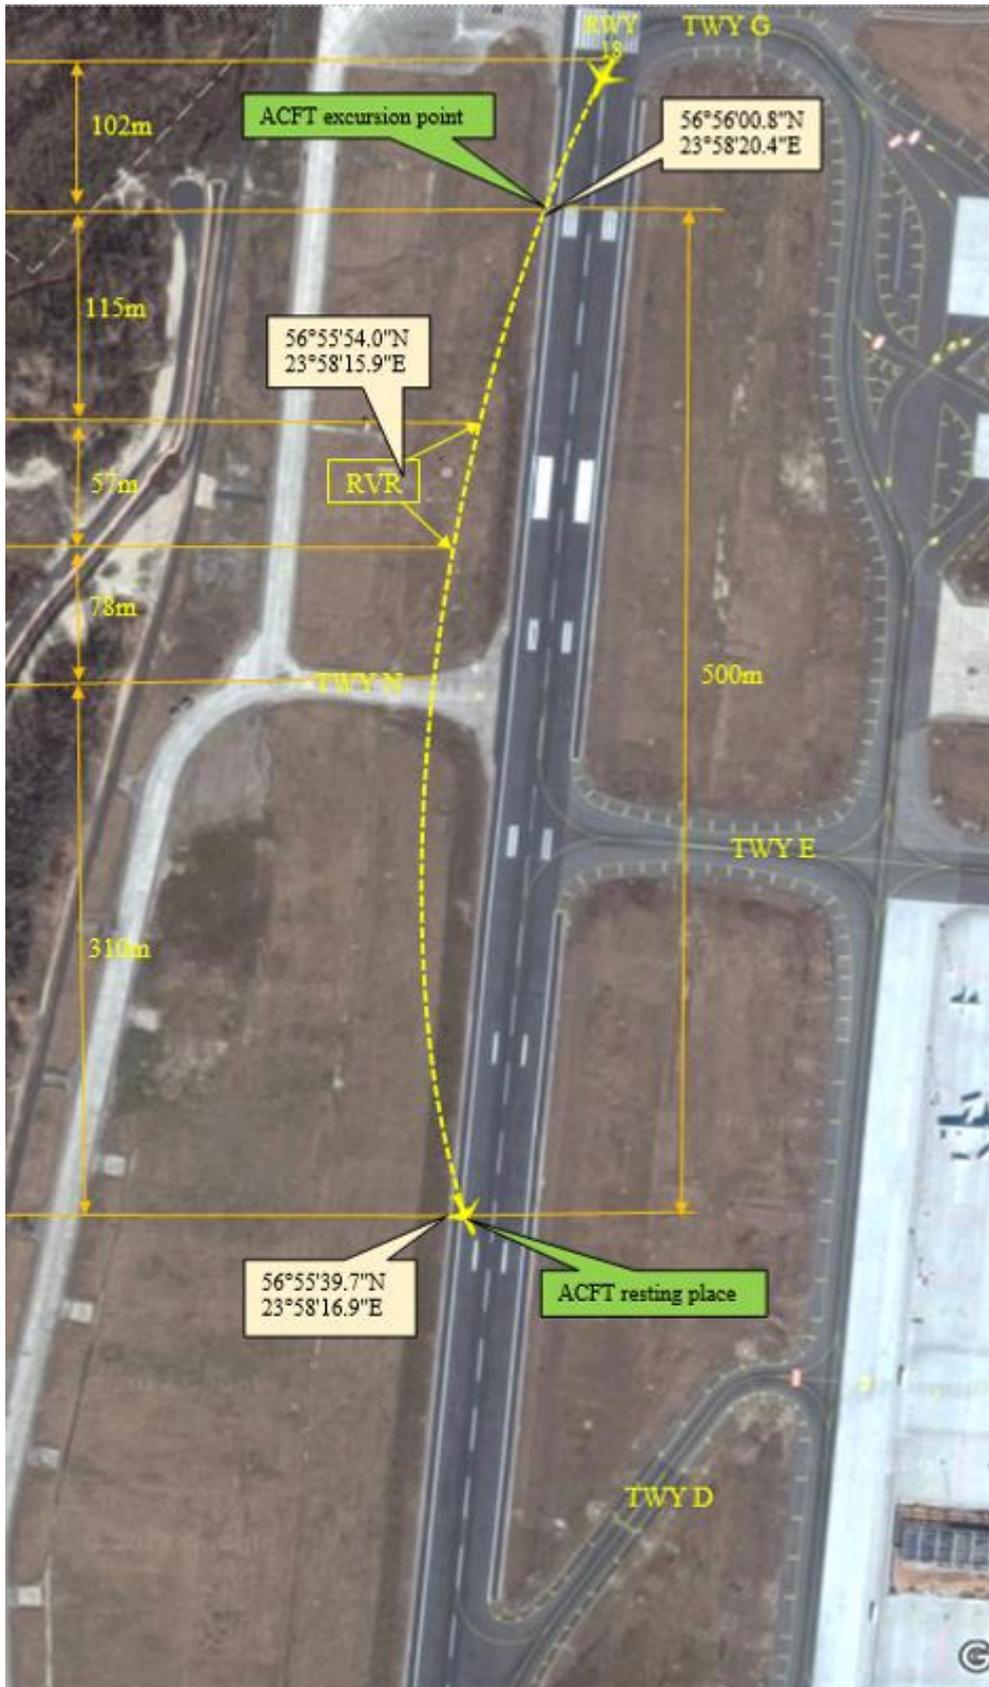
Scheme 1 the aircraft Boeing 737-524, VP-BVS movement's scheme on the RWY 18

The charts of FDR data after decoding show following: shortly after the takeoff was initiated, the aircraft began a slight left turn followed by a sharp right turn.

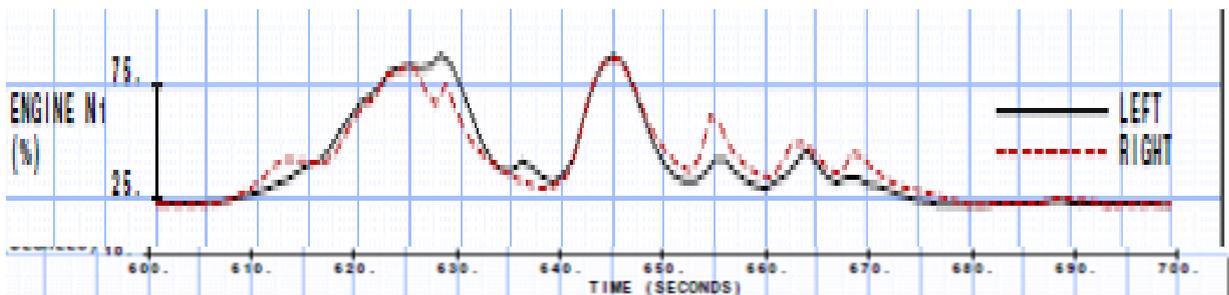
Fragment 1 from FDR data plots of 10.03.2017

LH engine N1 was about 87% while RH engine N1 was about 66% therefore the difference was about 21%. The left engine N1 spooled up faster than the right engine which caused aircraft to deviate slightly right of centerline. Small amounts of left rudder were commanded to correct the heading.

The crew returned the rudder to neutral position shortly before time 640 seconds. Simultaneously, reverse thrust was commanded on only to the left engine which caused the airplane to continue turning left.

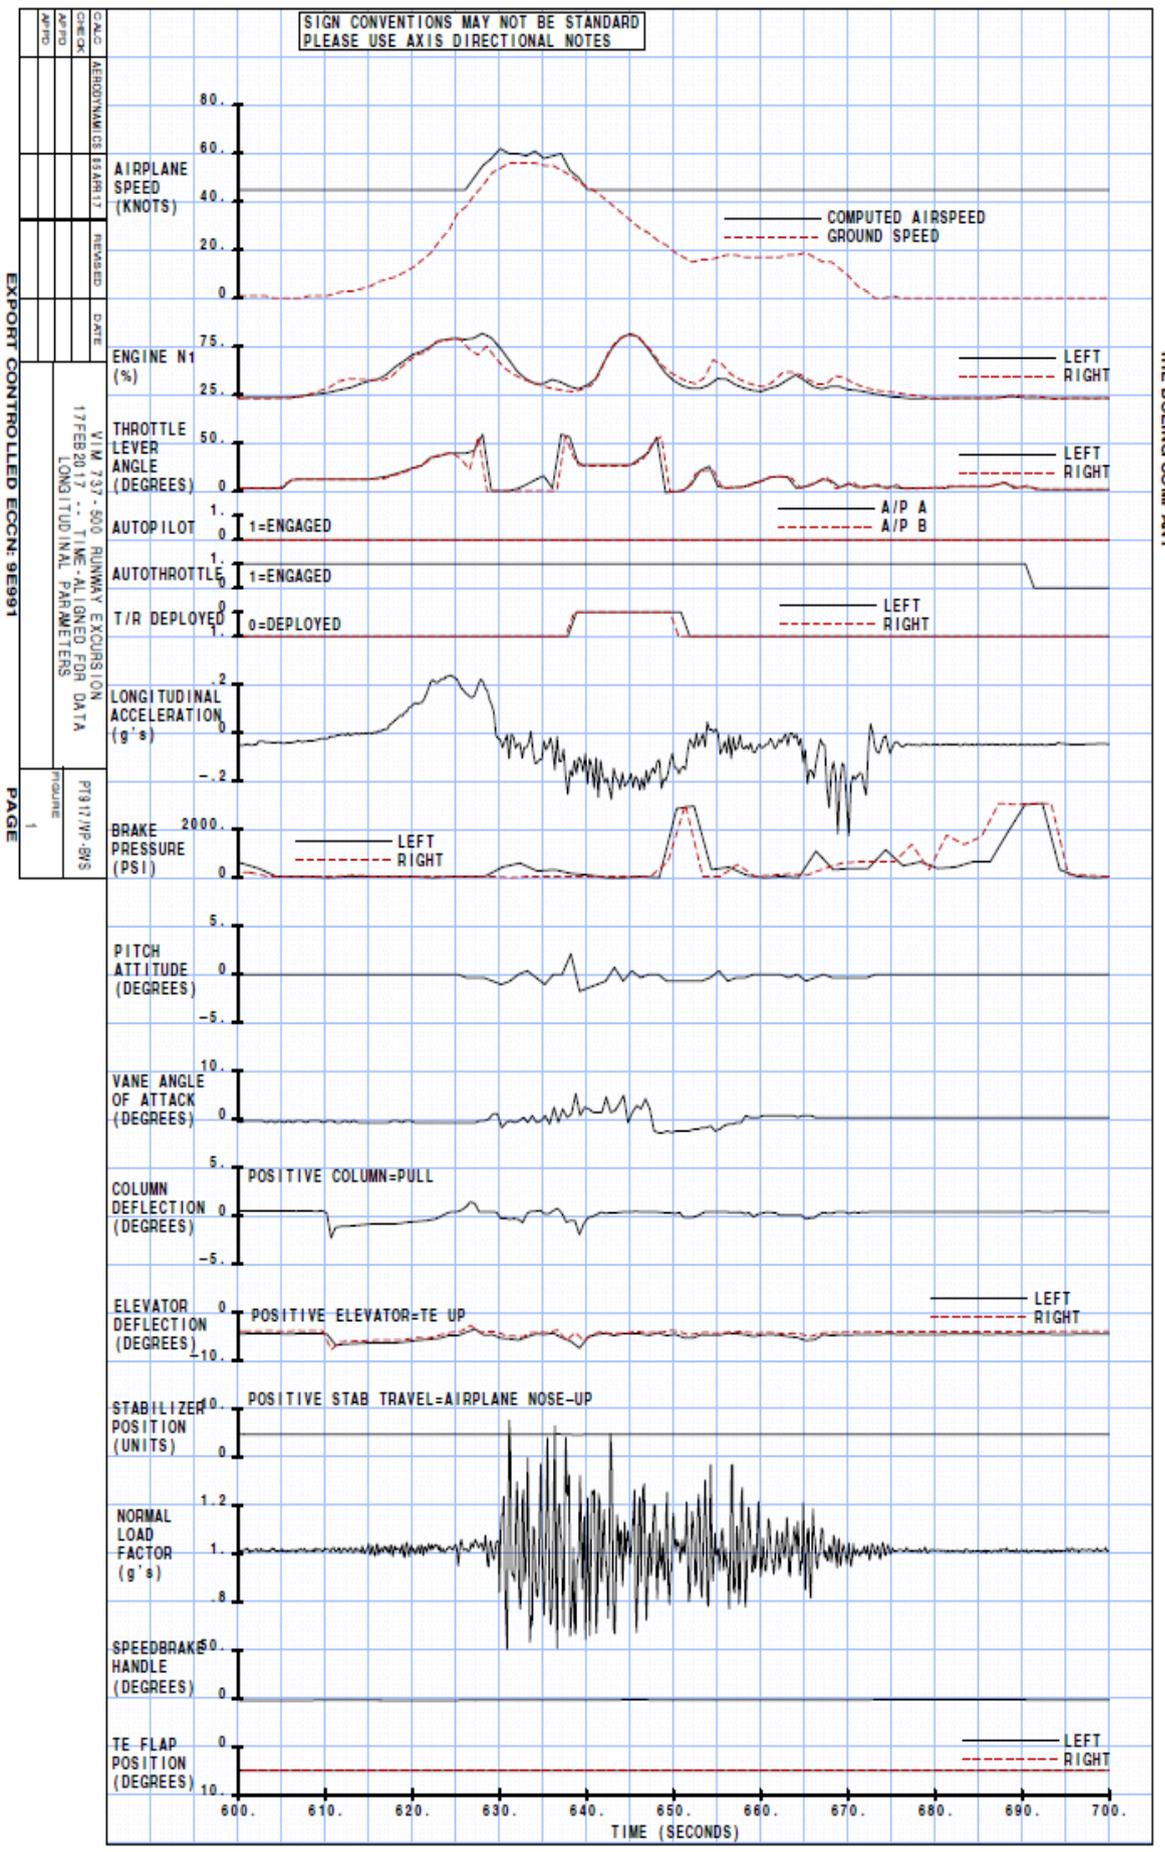
Plots 1

The FDR data show a flaps 5 takeoff was initiated from Riga's Runway 18 (based on recorded heading data) [Plots 1]. Throttles were initially advanced to 15 degrees at time 605 seconds. Once the engines began spooling up for takeoff, the crew advanced the throttles to command takeoff thrust. At time 611 seconds, the crew applied a right pedal input of 3 degrees, presumably to maintain runway heading (Plots 2). Beyond time 620 seconds, heading began to deviate to the right of runway heading more rapidly. Simultaneously, the crew began to input full left pedal to arrest the yaw rate to the right. The rejected takeoff (RTO) was initiated at 58 knots computed airspeed (time 629 seconds) with a reduction in the throttles to idle. The auto speedbrakes did not deploy because wheel speed was below the 60-knot threshold required for deployment. Fluctuations in normal load factor increased beyond time 630 seconds, indicating the likely time the airplane departed the runway. Heading continued increasing to the right – despite a full left rudder input – until heading reached 212 degrees at time 631 seconds. The airplane began turning to the left at time 632.5 seconds. Shortly thereafter, reverse thrust was commanded. The left pedal input was removed at time 637.5 seconds, as heading approached the runway heading. Right pedal was briefly commanded at time 642 seconds, which temporarily arrested the heading change to the left. Thrust reversers were stowed at time 652 seconds when ground speed was 15 knots. Three degrees of left pedal was commanded at time 652 seconds, which caused the airplane to turn left to 134 degrees. Twelve degrees of right pedal was commanded at time 657.5 seconds, which caused a heading change to the right. An increase in brake pressure at time 665 seconds brought the airplane to a complete stop (Plots 2).

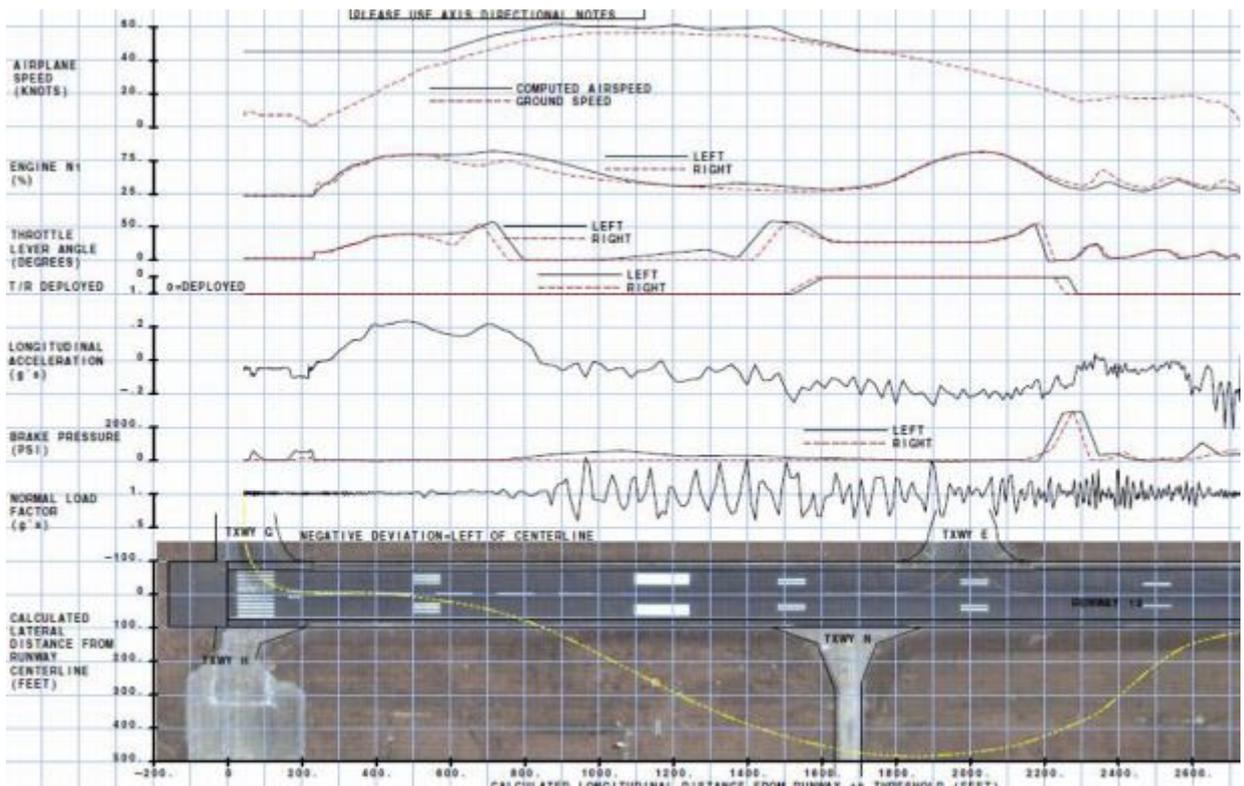
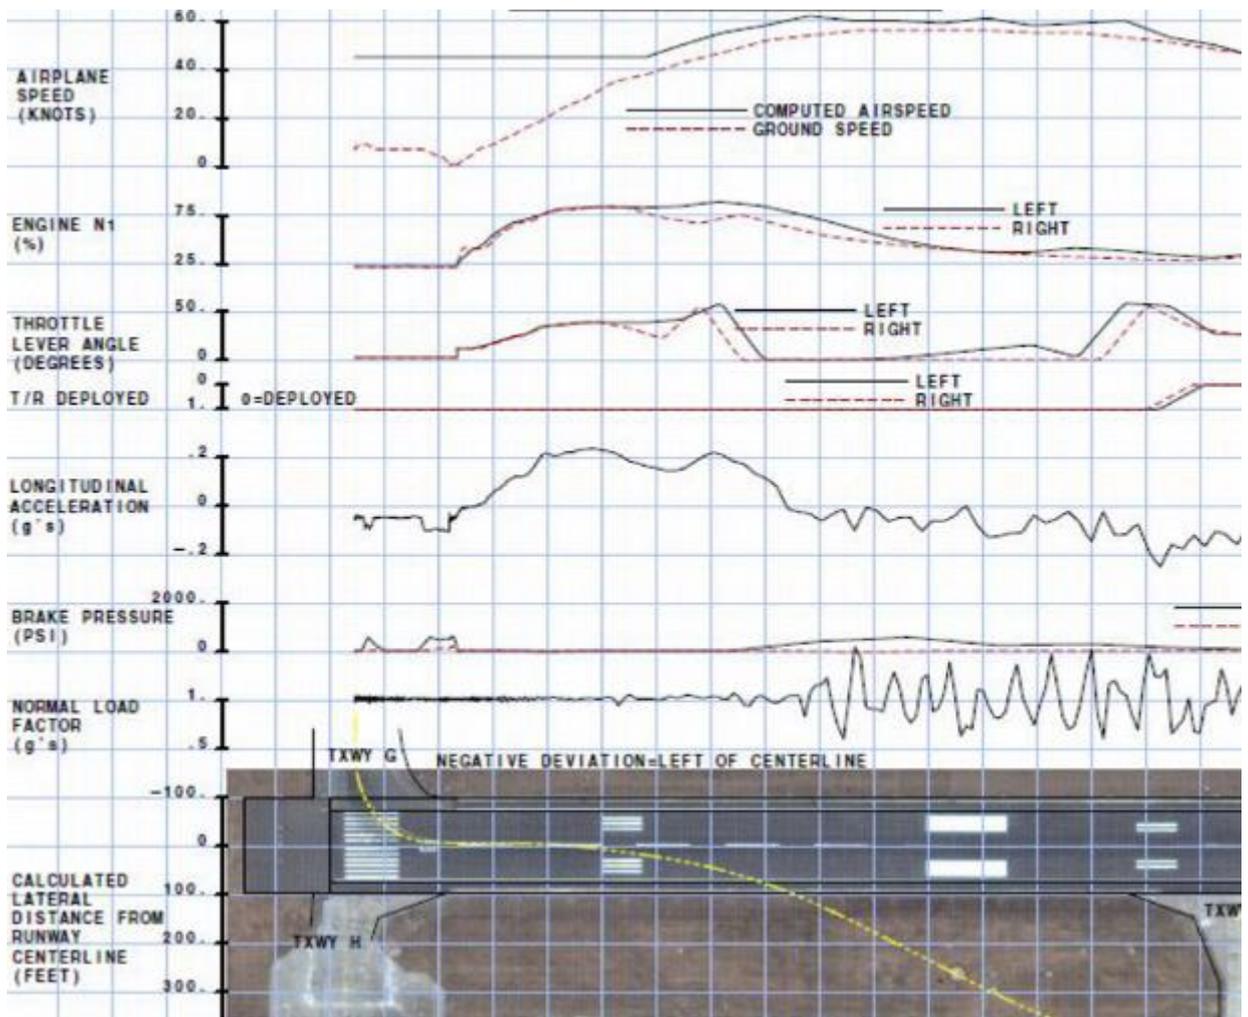
Plots 3

The ground track analysis results indicate the takeoff roll was initiated from the start of Runway 18 at taxiway G (Plots 3 and 4). At 400 feet beyond the threshold, the airplane began deviating right of centerline. Simultaneously, full left rudder was commanded (Plots 4). The RTO was initiated 750 feet beyond the threshold once the airplane deviated 60 feet to the right of centerline. The airplane departed the right edge of the runway surface 850 feet beyond the threshold at a computed airspeed of 60 knots. Heading continued increasing to the right after departing the runway surface. Once heading reached 210 degrees, at 1100 feet beyond the threshold, the airplane began yawing to the left. The left rudder pedal input was relaxed once the lateral deviation reached 470 feet to the right of centerline. Reverse thrust was simultaneously commanded. Upon crossing taxiway N, heading was close to the runway heading. Nearly 200 feet after crossing taxiway N, the airplane began returning towards the runway. The thrust reversers were stowed 2250 feet beyond the threshold at about 400 feet to the right of centerline. At the same time, maximum brake pressure was briefly commanded. The analysis indicates that the airplane center of gravity (c.g.) came to a complete stop 2730 feet beyond the threshold and 110 feet to the right of centerline.

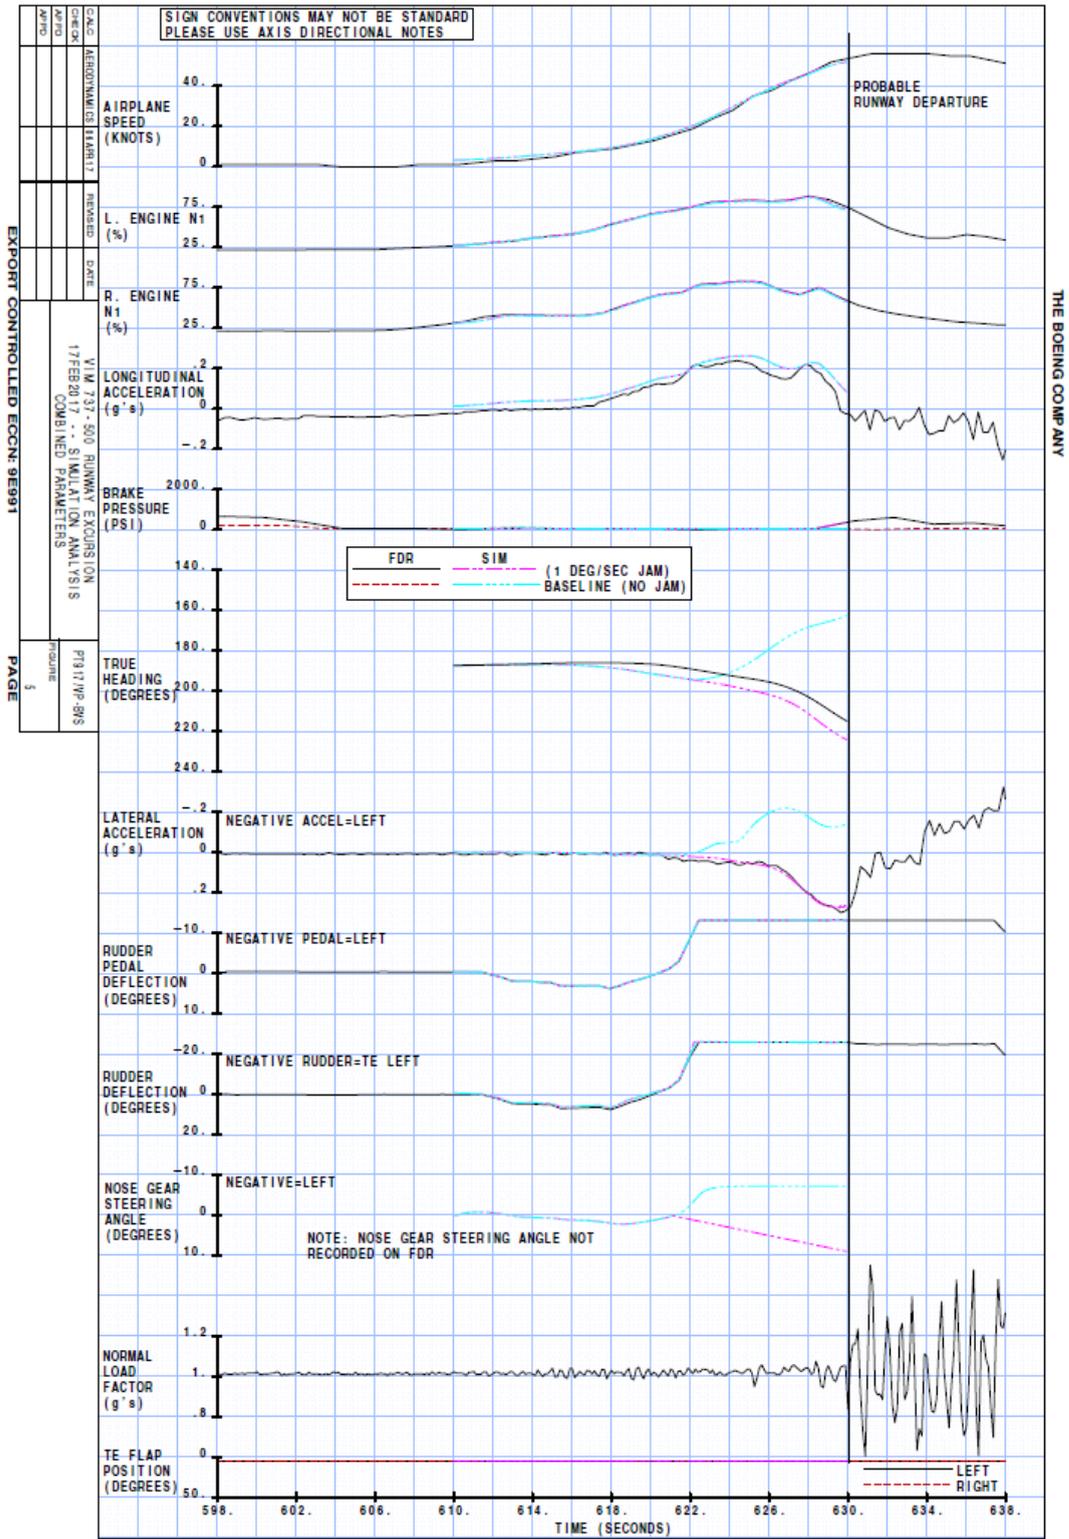
Plots 5

A nose gear steering rate jam of 1 degree/second was evaluated (Plots 5). There have been previous 737 suspected nose gear steering rate jams that left no evidence of why they occurred. In most cases, it is theorized that a piece of debris, internal or external to steering metering valve, caused the nose gear steering metering valve to jam in an off-null position, forcing it to stay open. This led to a continuously increasing (at a constant rate) nose gear steering angle. It is also theorized

that a subsequent large rudder pedal input freed the jam, and the nose gear returned to normal functioning. In one case, the improper installation of a nose wheel steering system pulley bolt resulted in an interference condition between the pulley bolt and nose wheel steering system cover, which caused an interruption in the normal steering system feedback, refer Boeing Service Letter 737-SL-32-070. This also led to the nose gear steering metering valve to jam in an off-null position. The rate jam was introduced at time 621 seconds - immediately after the crew used a small amount of right pedal. Initially, heading data matched the baseline case (without jam); however, beyond time 622 seconds, the airplane continued turning to the right as in the FDR data. The lateral acceleration in the simulation matched the FDR well throughout the simulation run. The simulation was stopped at time 630 seconds where the airplane presumably departed the paved surface.

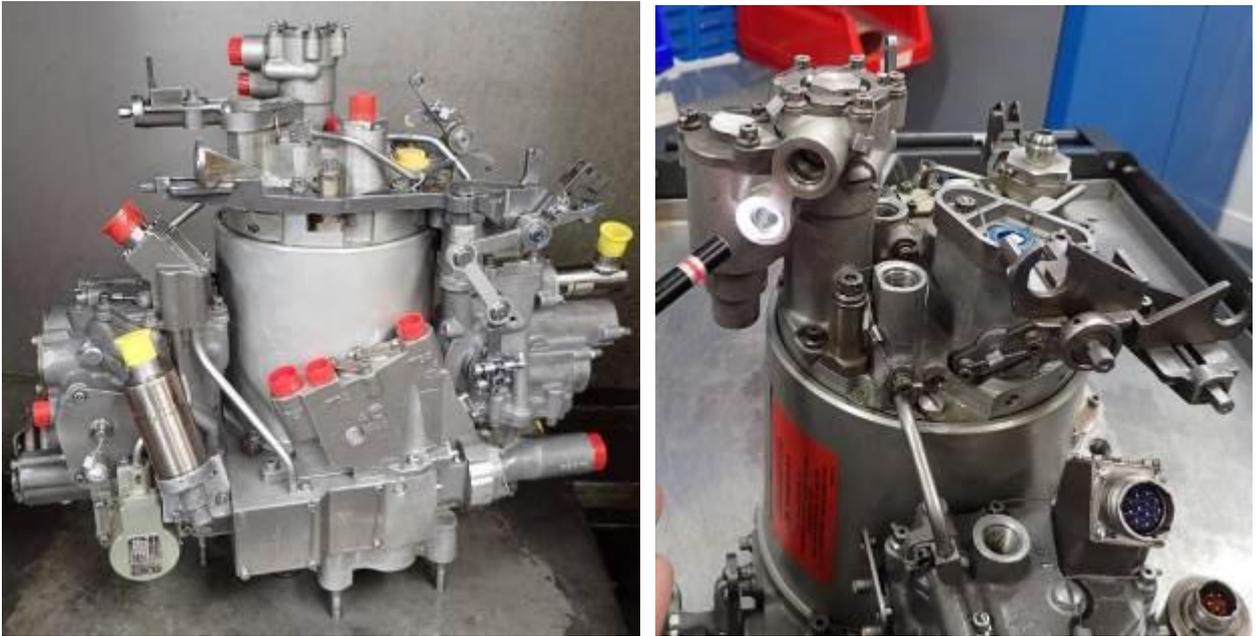
As-received inspection of the MEC revealed all external linkages to move normally. Similarly, the input drive gear was noted to rotate normally. No anomalies were observed during completion of as-received inspection.

Photo 22a/b: The MEC equipment visual check

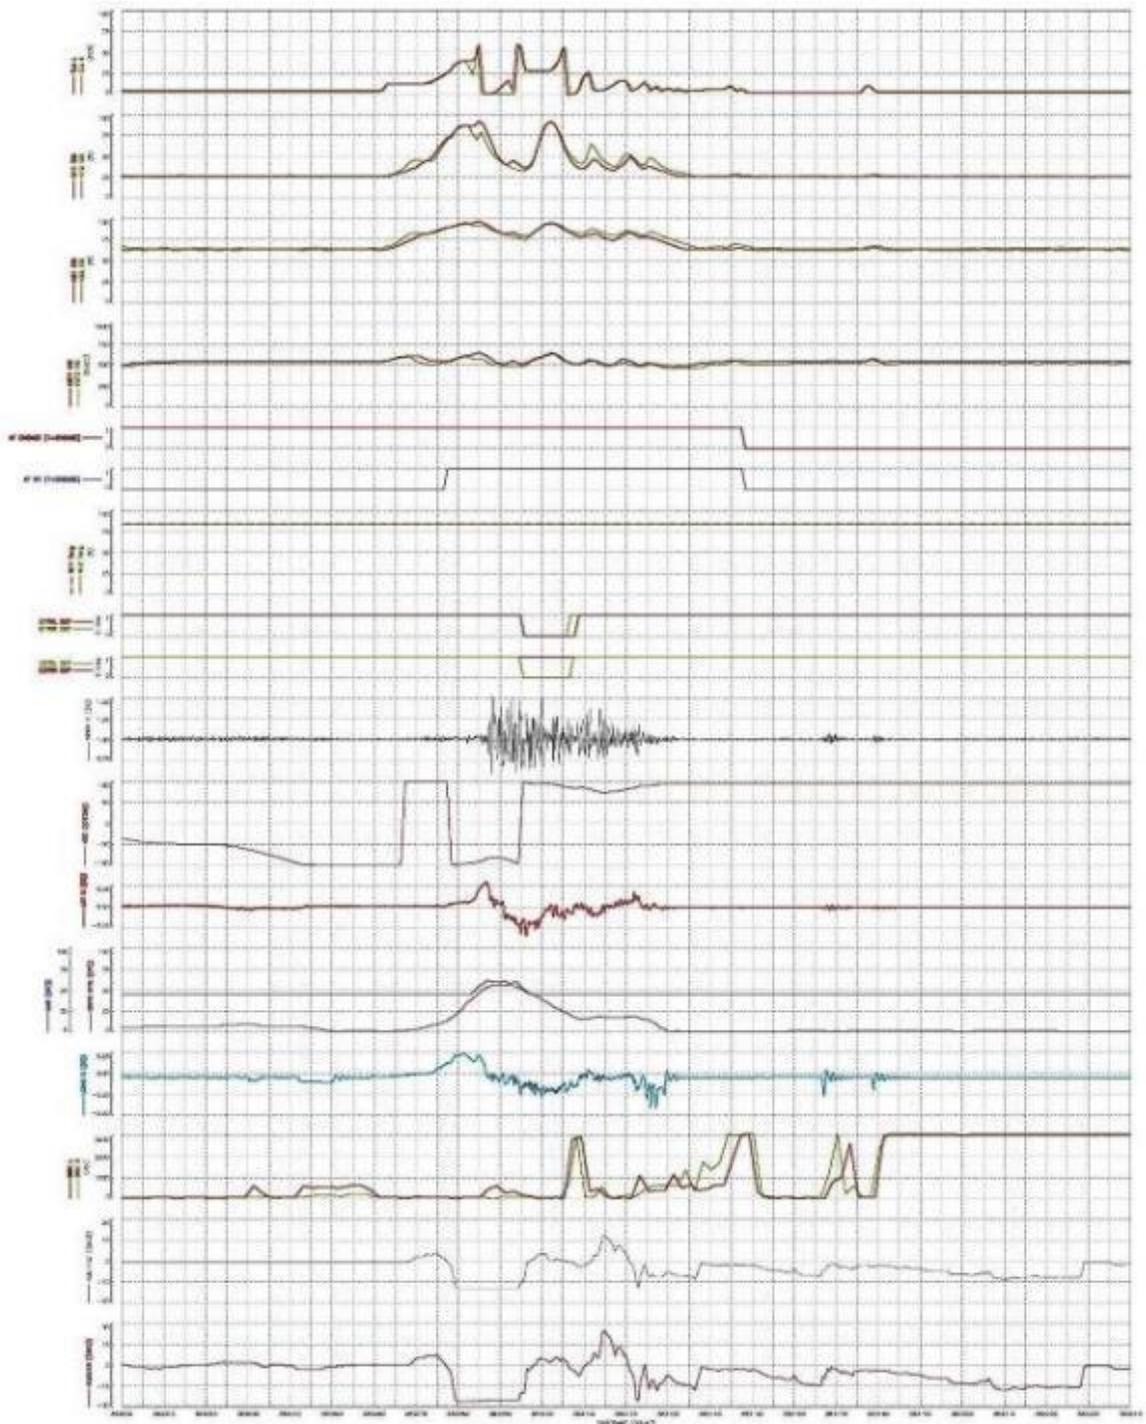
VBV schedules were within tolerances except for one point which will be rerun. Even if the point is found to be out of tolerance when it is rerun, it would only open the bleed doors slightly. This would cause a slight increase in EGT. No discernible effect on thrust would have taken place. The

accel and decel schedules were found up to 15% higher to nominal but 10-12% in the takeoff region. This has been noted in past field experience on engines as cycles and time accumulate which is within acceptable operating parameters as long as acceleration requirements defined in AMM 71-00-00, Test number 8 are met.

Photo 25: MEC data testing plots

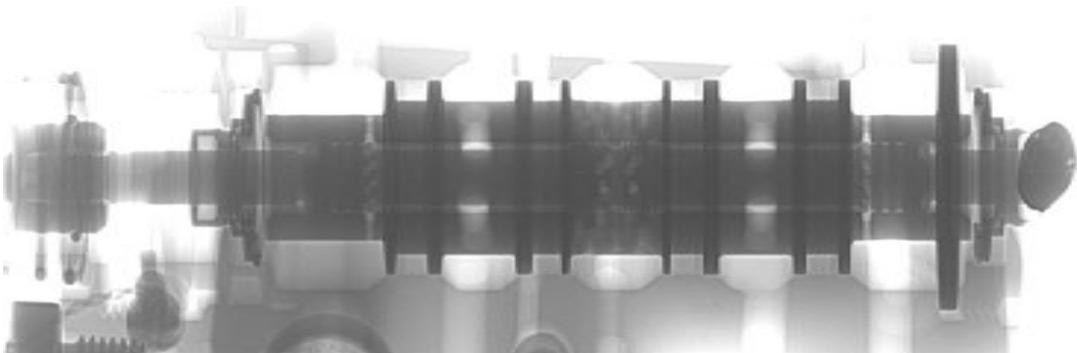
The steering metering valve was examined using digital radiography (DR), with the focus of the DR examination being placed on the spool, sleeve and return spring; see Photo 33 and Photo 34. The spool appeared to be centered in the sleeve, and the centering spring was intact.

Photo 33: DR image of the spool and sleeve

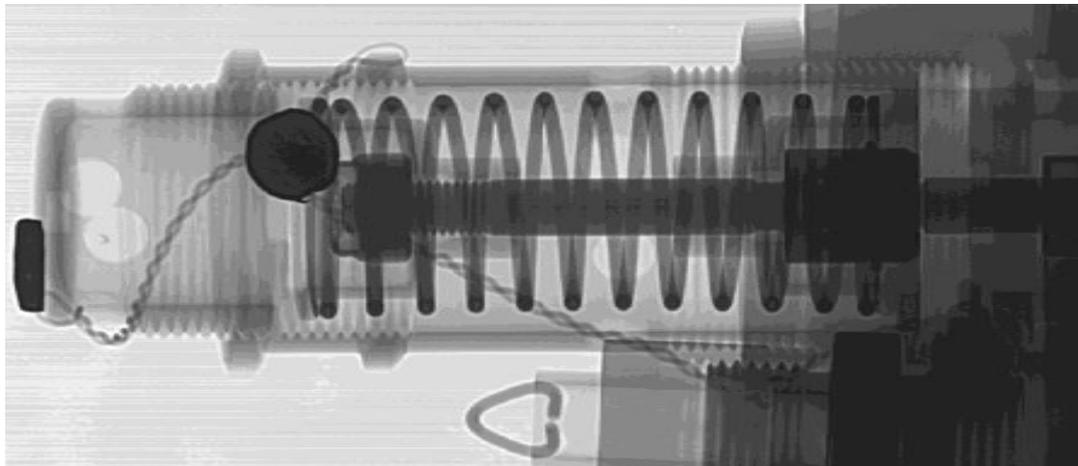
Photo 34: DR image of the return spring

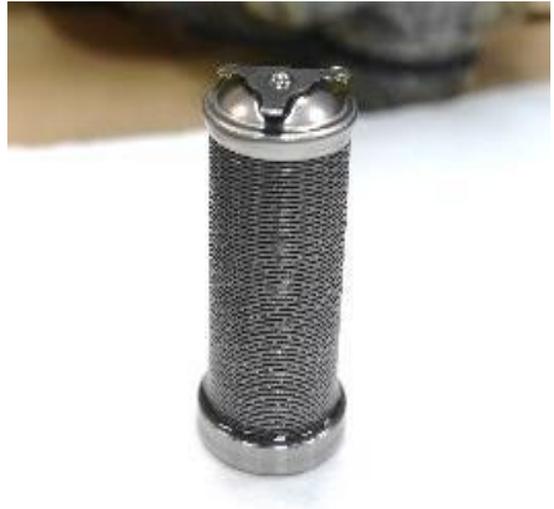
Photo 36: Filter removed from steering metering valve

The filter appeared to be clean and free of debris.

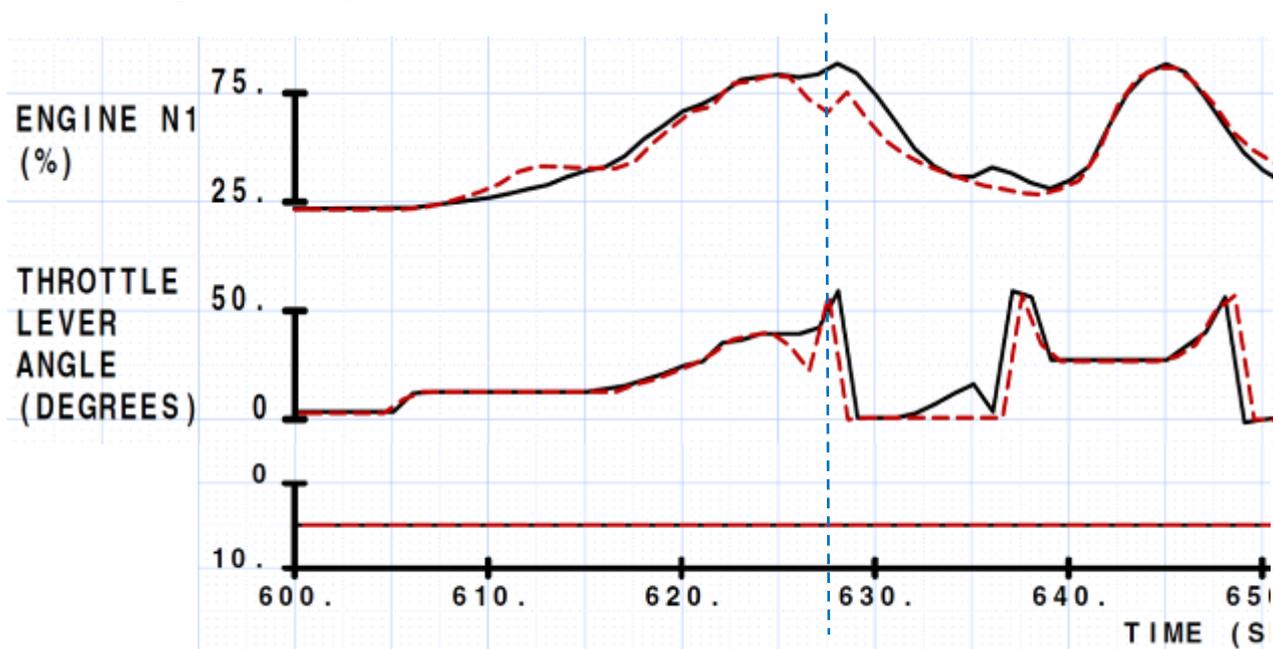
Fragment 3 from FDR data plots of 28.02.2017

Aircraft Boeing 737-524, VP-BVS, after TO/GA button press at the take-off roll position the difference of thrust on both engines were reached max approximately 21%, for left engine N1 was 87% and 66% for right engine thrust, which can also be seen from the FDR data plots respective depicted in Fragment 3.

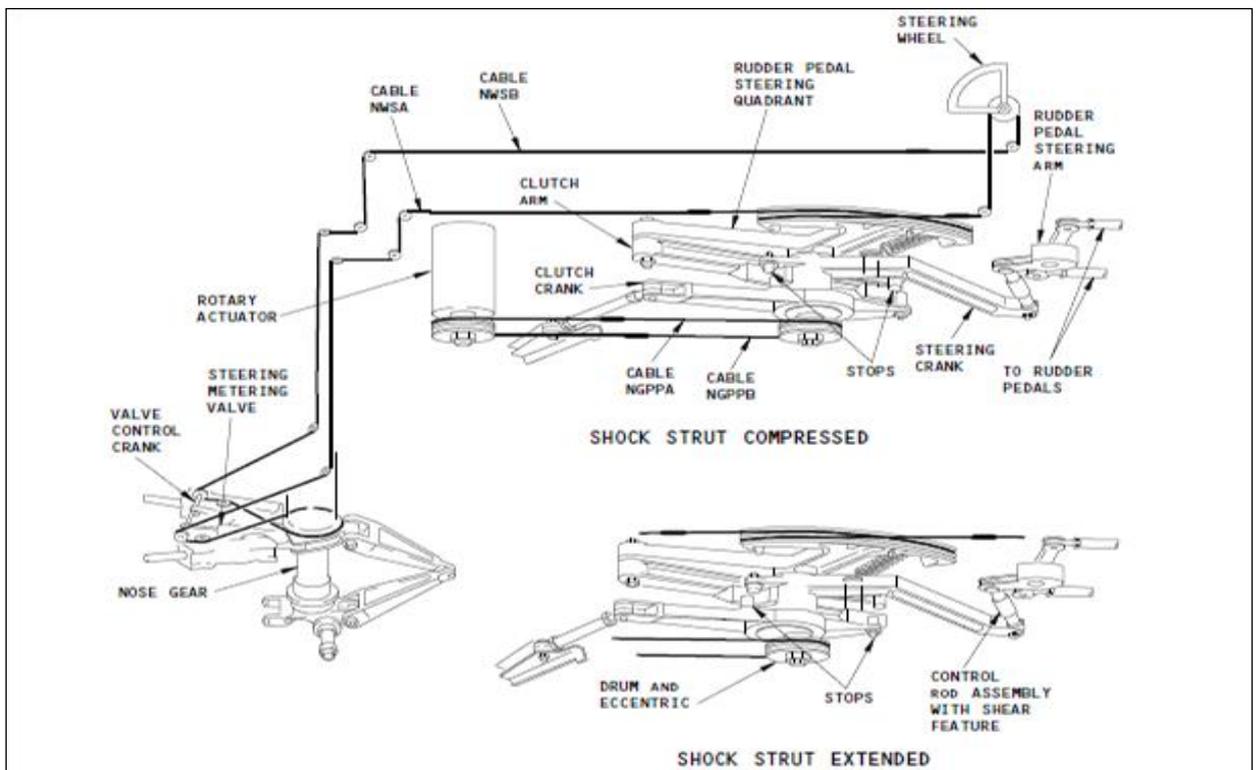
Scheme 2: Nose wheel steering Schematic

The insignificant nose wheel deflection (up to 7 degrees) and the low speed on takeoff didn't compensate the aircraft turn to the right through the use of the nose wheel steering pedal. Due to the asymmetric thrust from the engines the moving of the aircraft led to the nose wheel skidding and to the loss of the directional control of the aircraft.

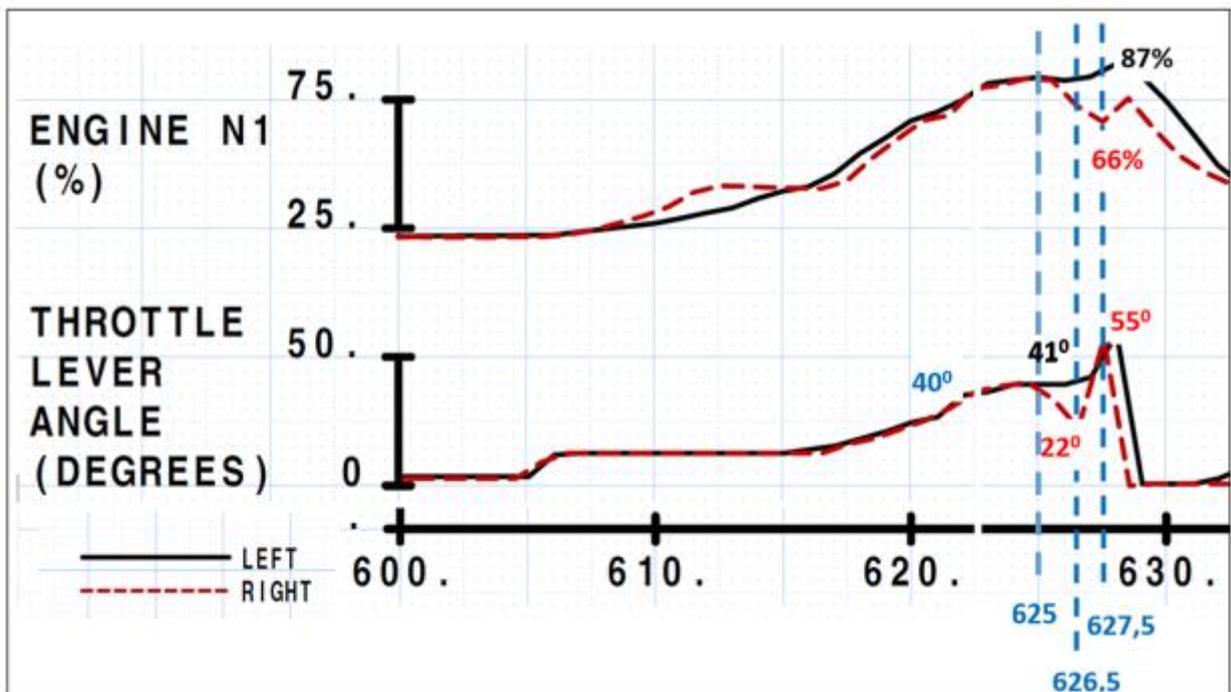
Excerpt 4 from FDR data plots of 24.04.2017

The aircraft FDR data show possible unsynchronic movement of the aircraft thrust levers that appeared after the TO/GA button was pressed. Until 625 seconds both thrust levers (TLA) had moved equally, but suddenly the thrust control of the right and left engines developed unsynchronic movement (Excerpt 4 from FDR data plots of 24.04.2017). At 626.5 seconds the thrust levers position difference became 19 degrees, the left - 41° and the right - 22° accordingly. At 627.5 seconds the thrust levers sync had reverted.

The max difference of the engines N₁ thrust (Excerpt 4 from FDR data plots of 24.04.2017) happened 1 second later after TLA failure that depends on the thrust control system inertly. The indication of the retarded operation of the thrust N₁ control system of the right engine is explained in 737-345 AWW AMM 76-11-00: "B. The forward thrust control system consists of a thrust lever
