FINAL REPORT No. 4-02/4-16 (1-2018) on

THE SERIOUS INCIDENT of AIRCRAFT BOMBARDIER- DHC-8-402, REGISTRATION YL-BAI

ON SEPTEMBER 17, 2016 AT RIGA INTERNATIONAL AIRPORT

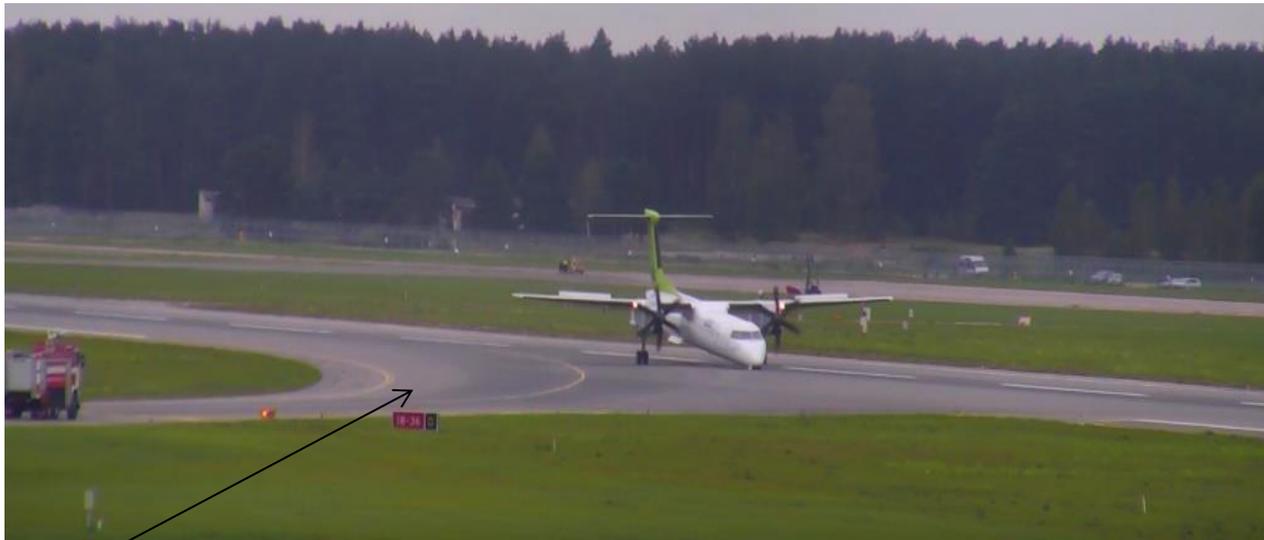
Picture 1 Aircraft stopping after landing

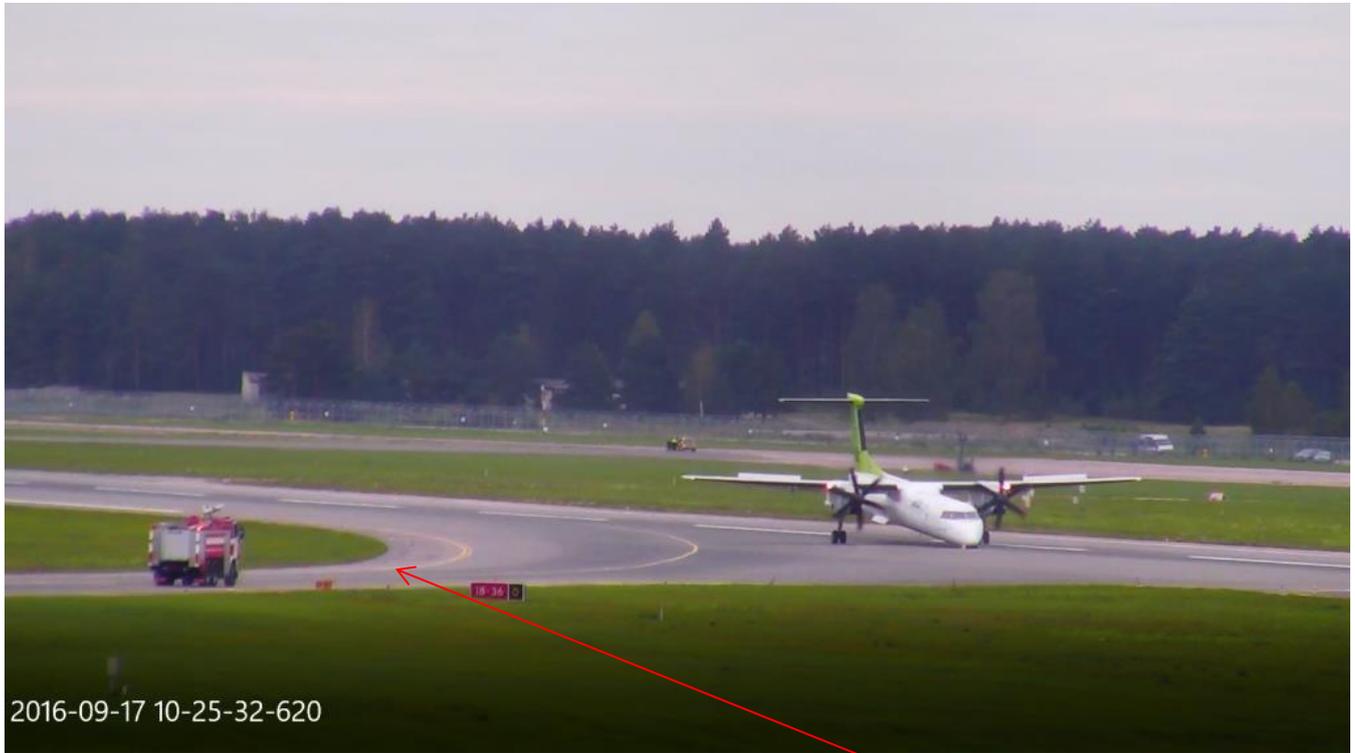
Picture 12 Aircraft stop on RWY opposite of TWY D

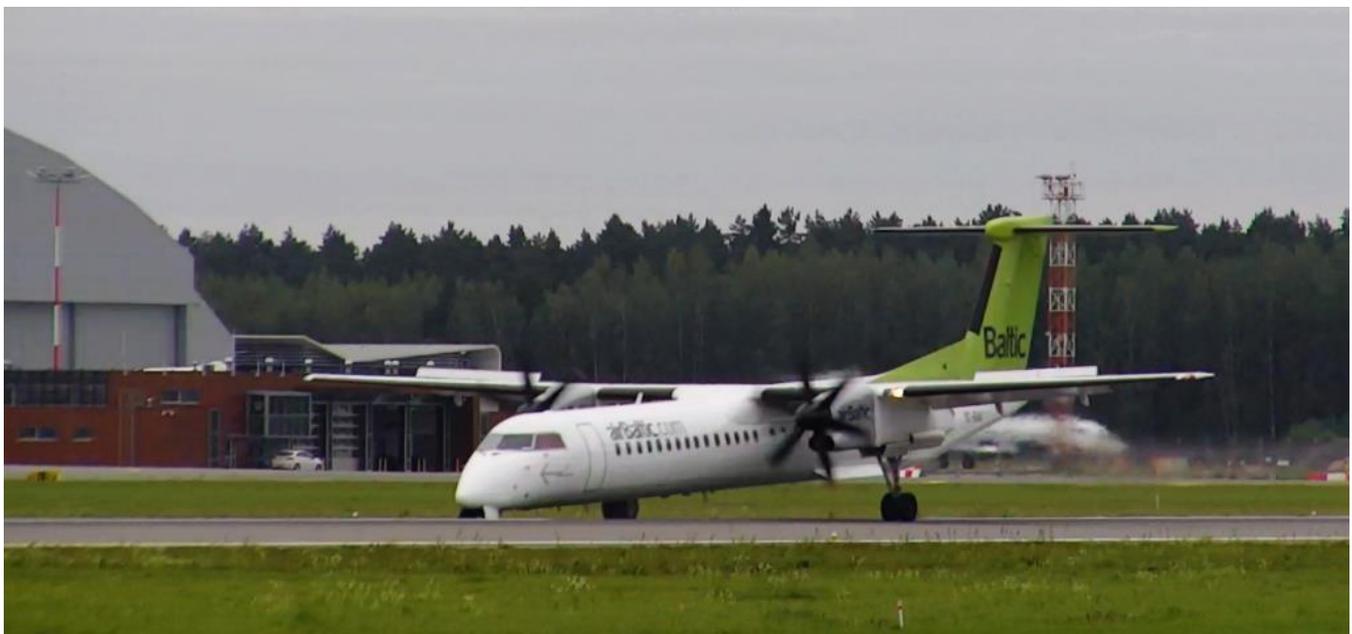
Picture 15 After landing the NLG collapsed but not abruptly but progressively, because NLG doors didn't touch RWY surface right away after touching.

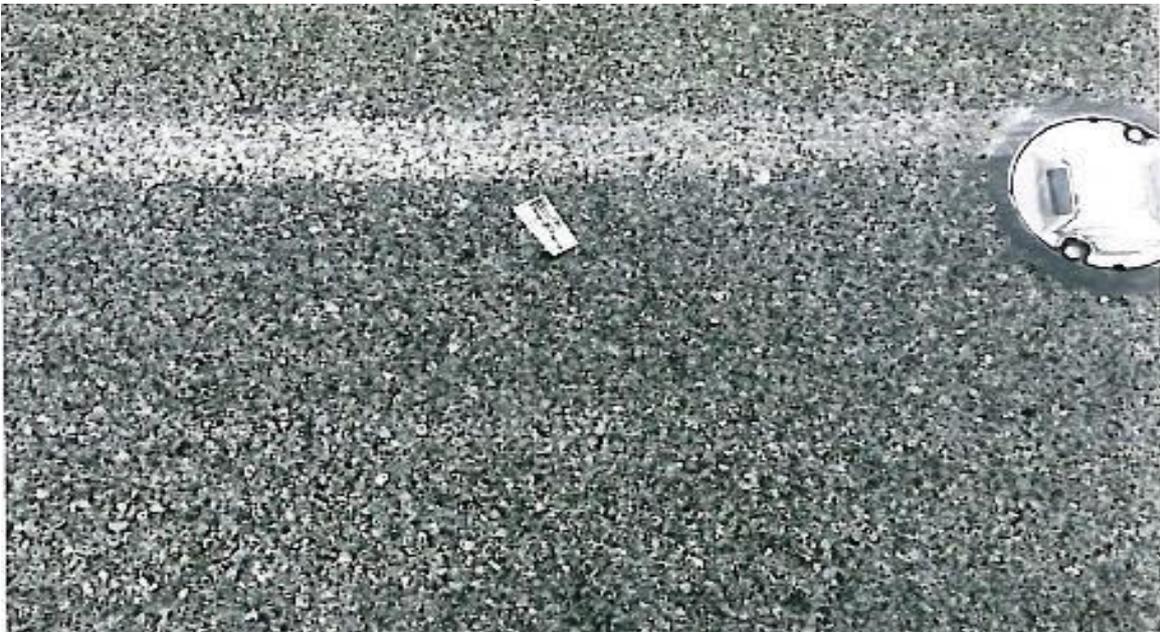
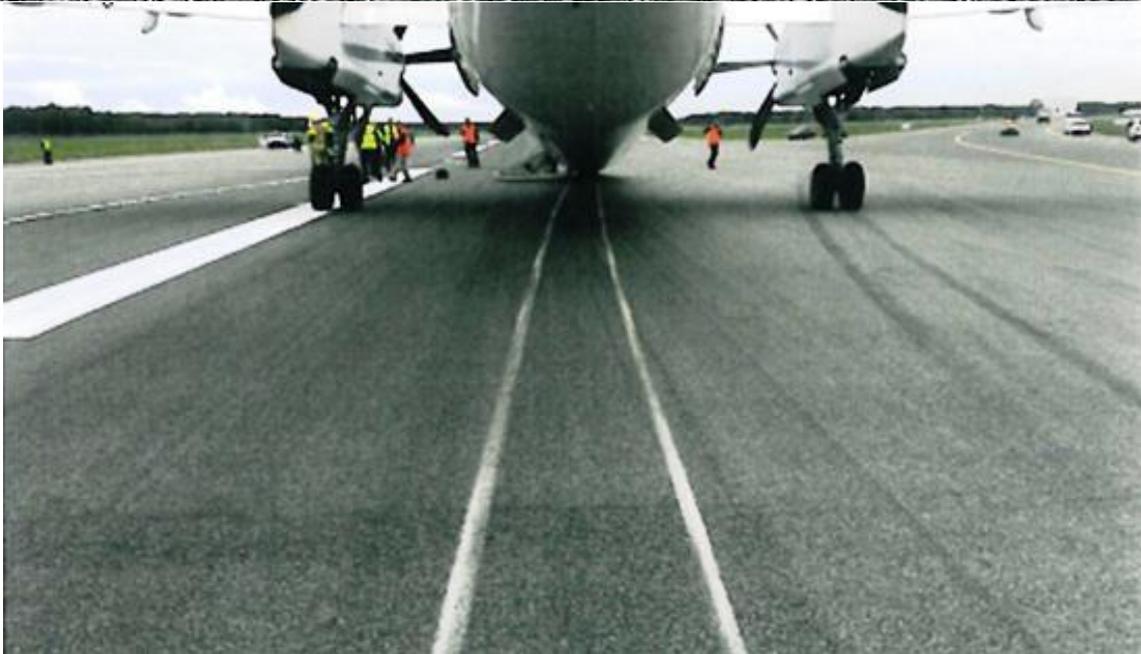
Picture 19 traces of braking 1. 5. Personnel information

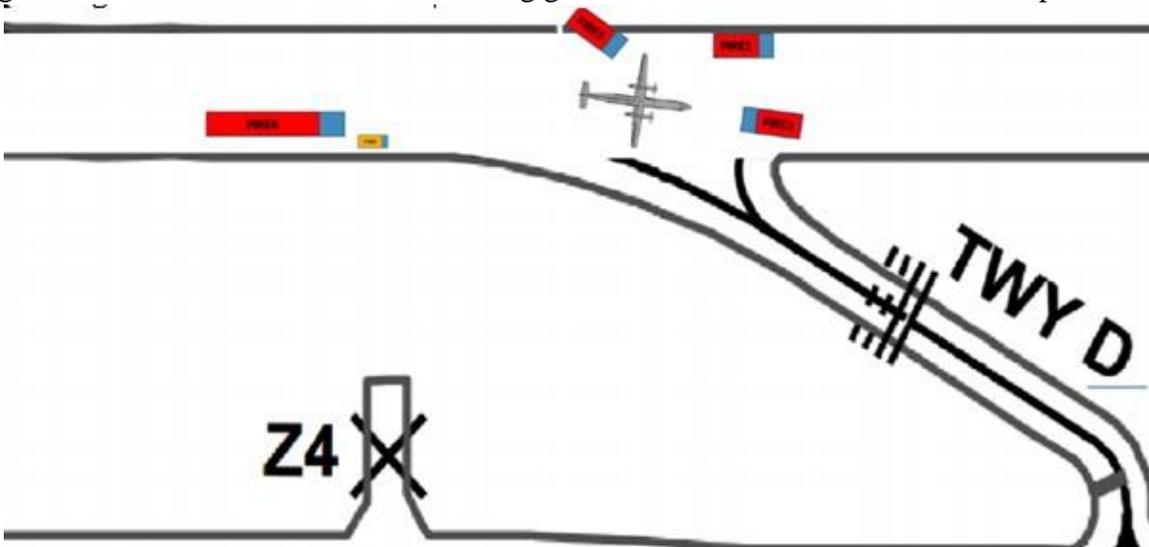
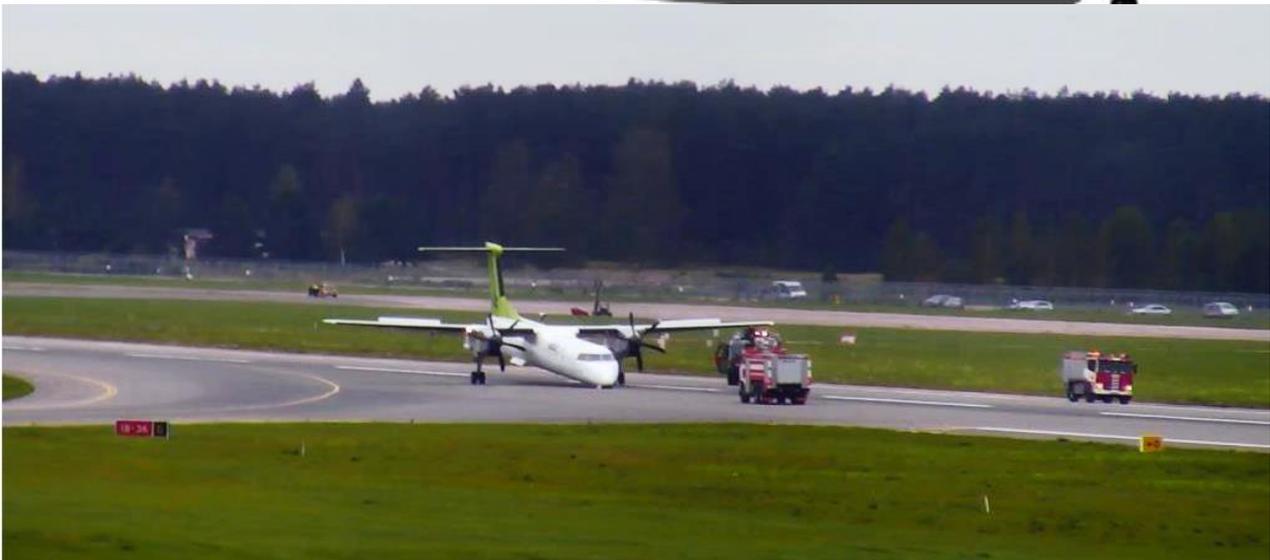
When arriving at ACFT, Fire-1 => 10, Fire-2 => 12, Fire-5 => 8 and Fire-6 => 5 were placed. While ACFT engines worked, the fire fighter shift chief (R40- Crisis Coordination Team Manager) performed the observation and found that the rear exit door was not open and were more than 2m in height due to the fracture of the nose landing gear and the ACFT nose was on the asphalt.

Picture 22 Airport Fire fighter team's (UK) car disposition at ACFT

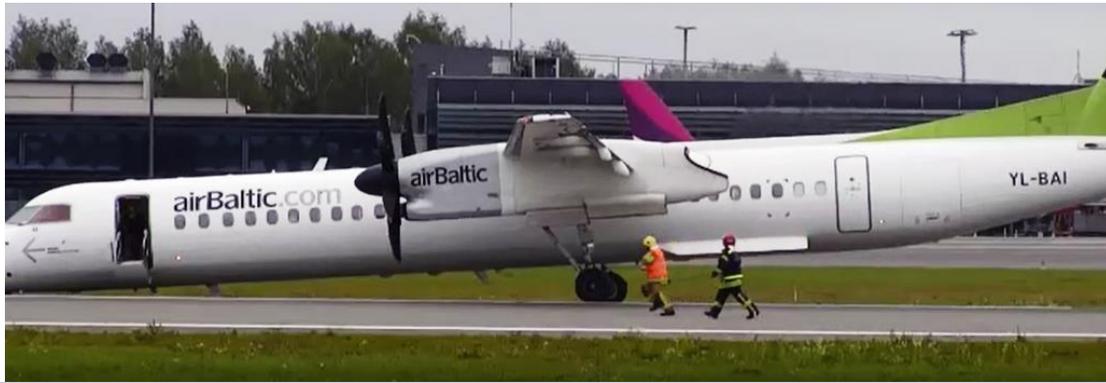
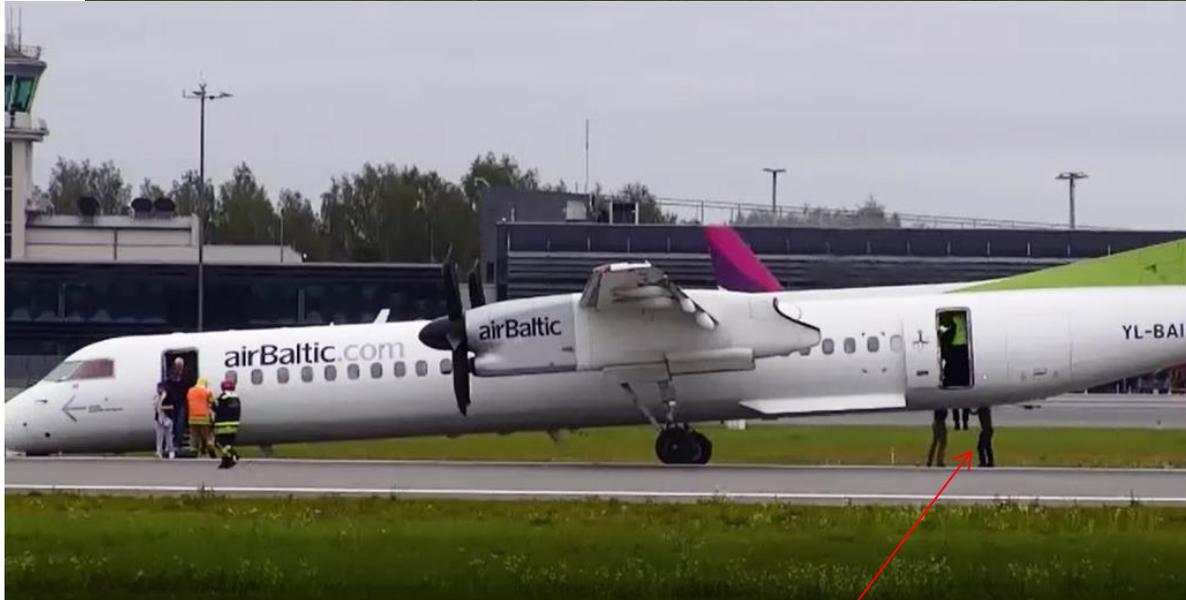
Passengers started to leave the ACFT by the rear door unattended

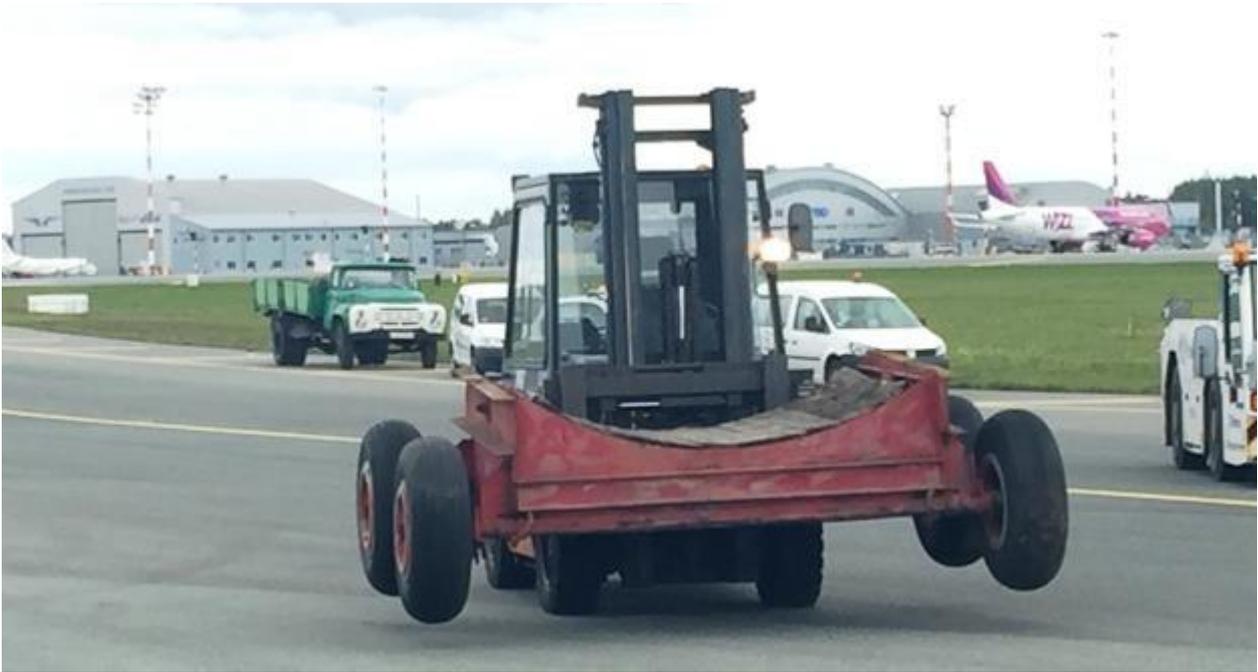
Picture 25

Offered facility (picture 25) by Riga International Airport for Removal commercial aircraft that is **unable to move under its own power or through the normal use of an appropriate tow tractor and tow bar** was only self-made equipment that was not suitable for the commercial aircraft with which will cause the aircraft to be more susceptible to secondary damage.

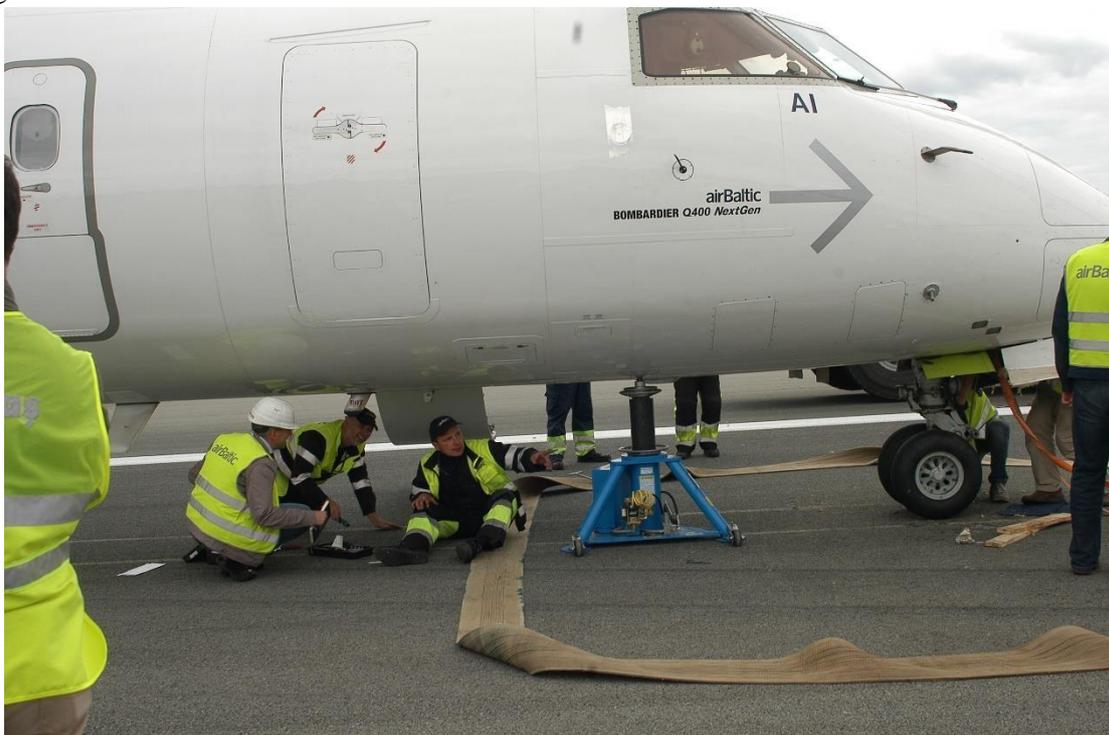
Picture 26 Preparation of aircraft lifting

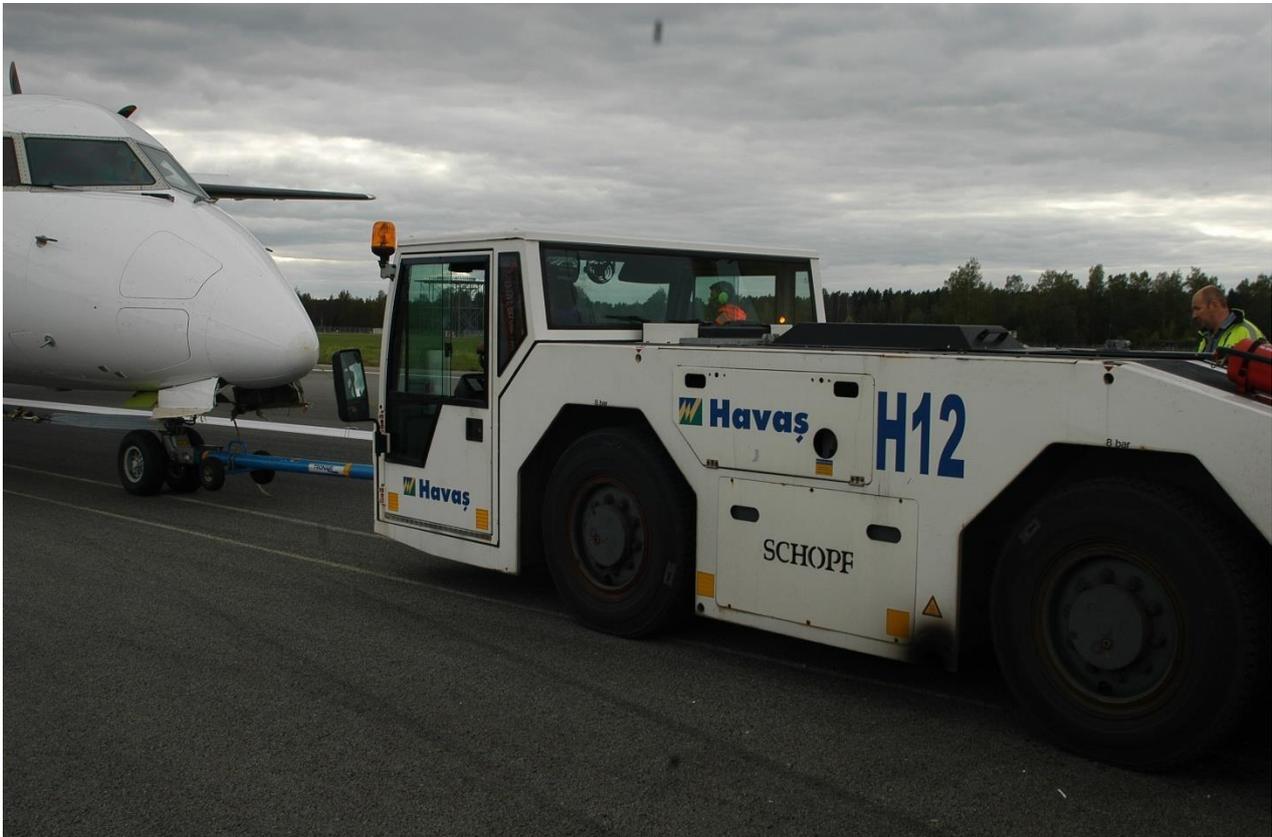
Picture 28 Removing aircraft from RWY procedure

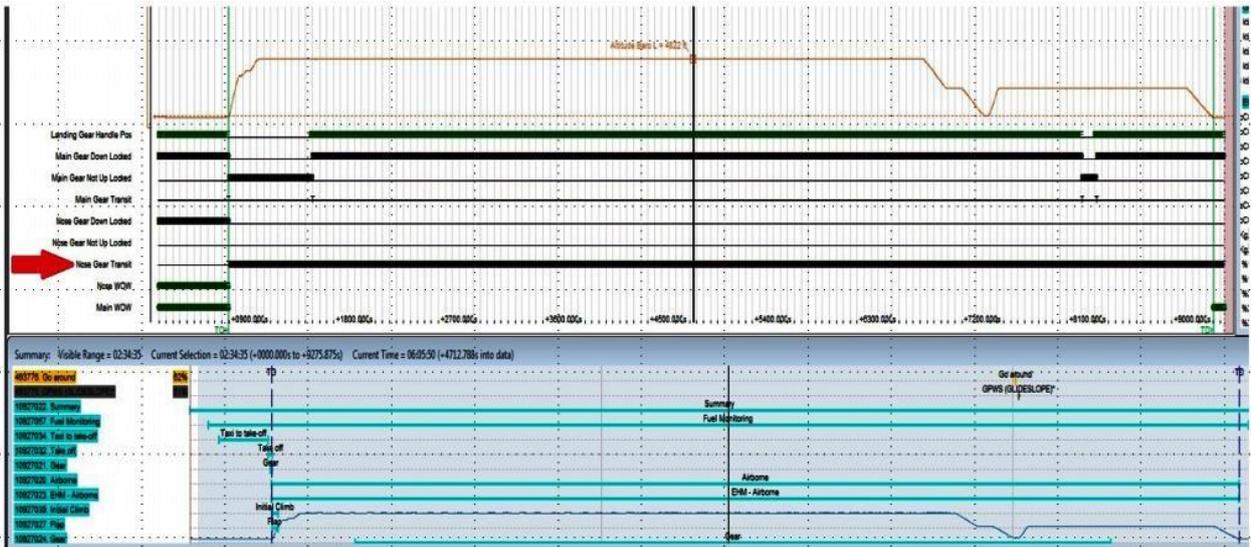
Nose Gear indication recorded IN TRANSIT from the moment of unstick to the end of recording.

BT641 FDM Gear Position Indication (Full Flight)

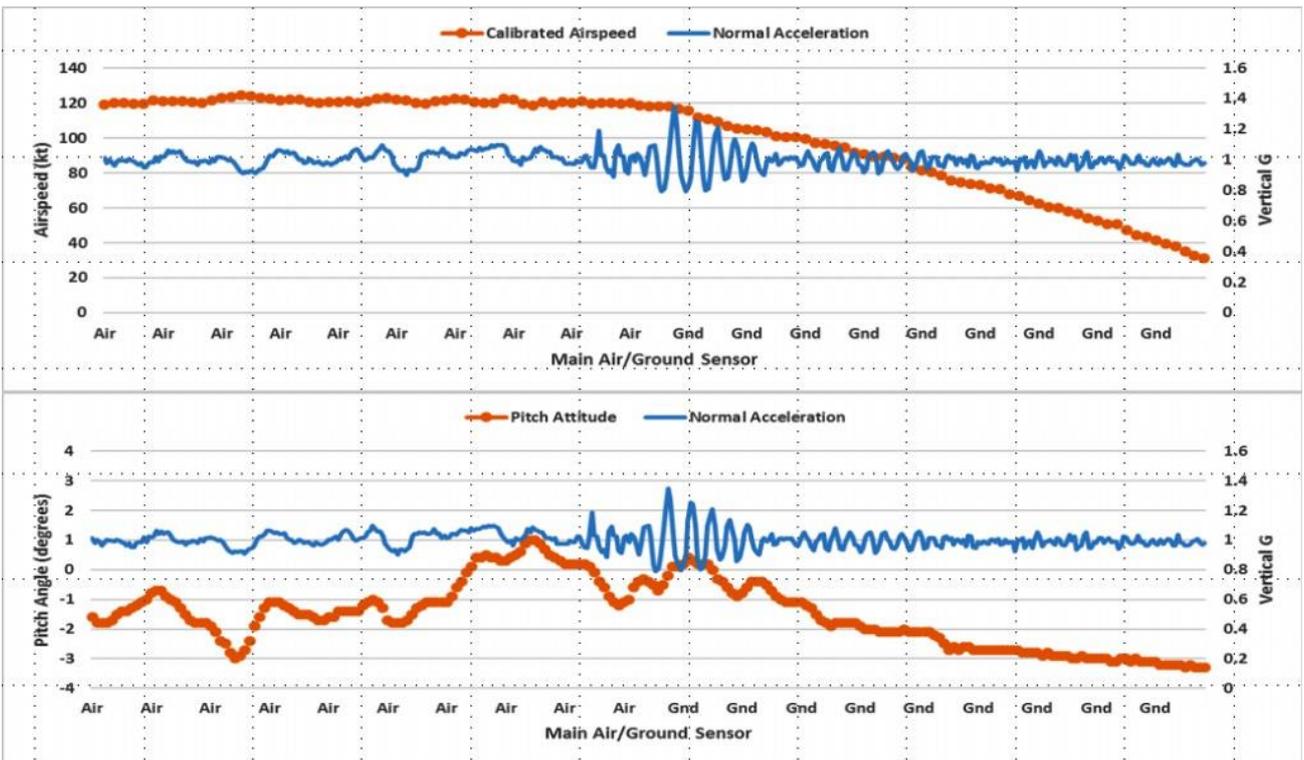
Final Approach and Landing from 250FT to airspeed inactive (30 KT airspeed) displayed.

Corresponding vertical acceleration values (max 1.35G) pitch angle and airspeed values shown **BT641 Landing FDM Data**

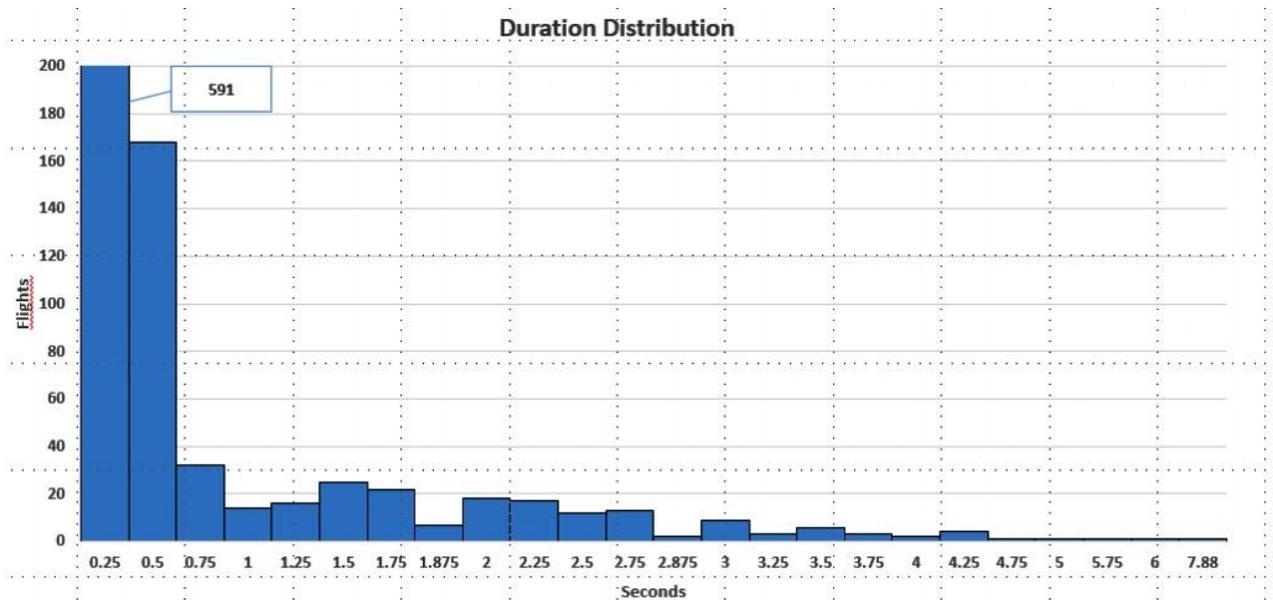
On YL-BAI maximum duration from Nose WOW sensor activation to Main WOW sensor activation was 3.75 seconds with corresponding 1.15G landing acceleration value (October 2015).

Duration of Nose WOW before Main WOW Q400

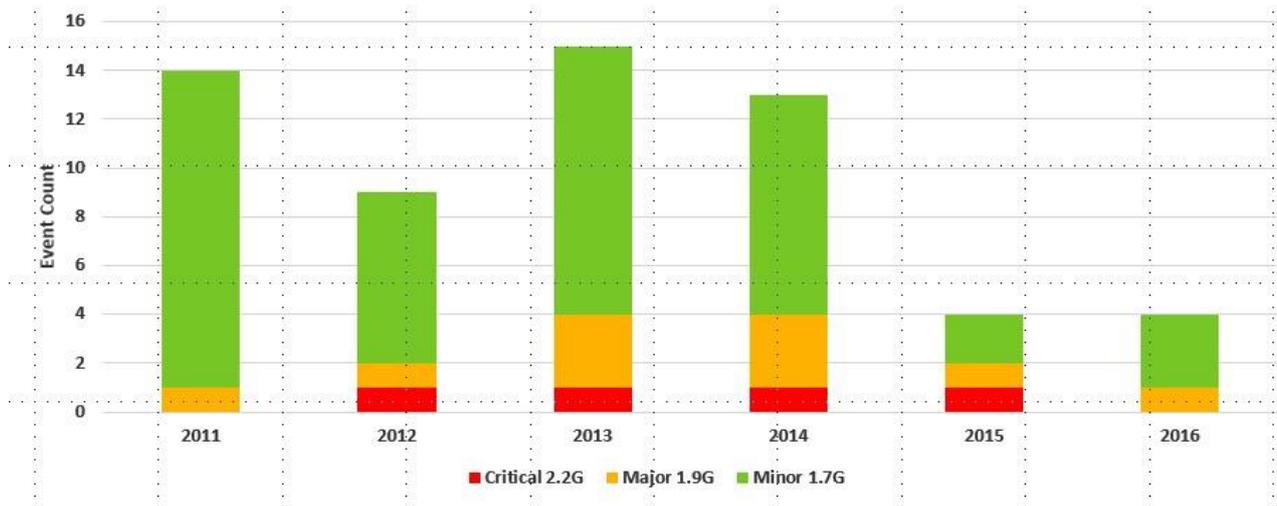
YL-BAI High Acceleration Landings FDM Data

1. 0.5% of YL-BAI landings have maximum Vertical G value equal to or exceeding 1.7G – minimum threshold to consider landing G as value of interest;
2. Since Year 2011 in FDM have been recorded 4 hard landings with Vertical G value equal to or exceeding 2.2G – threshold to carry out hard landing maintenance actions.

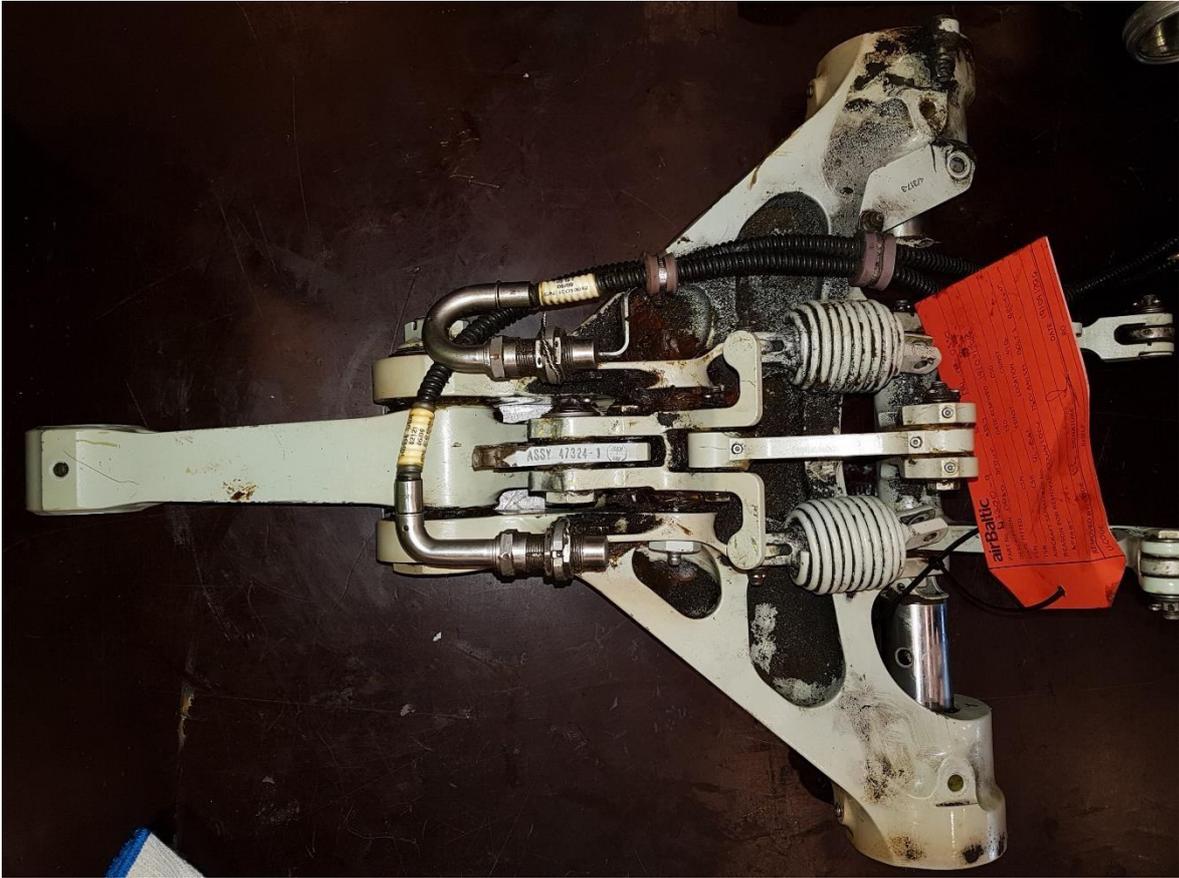
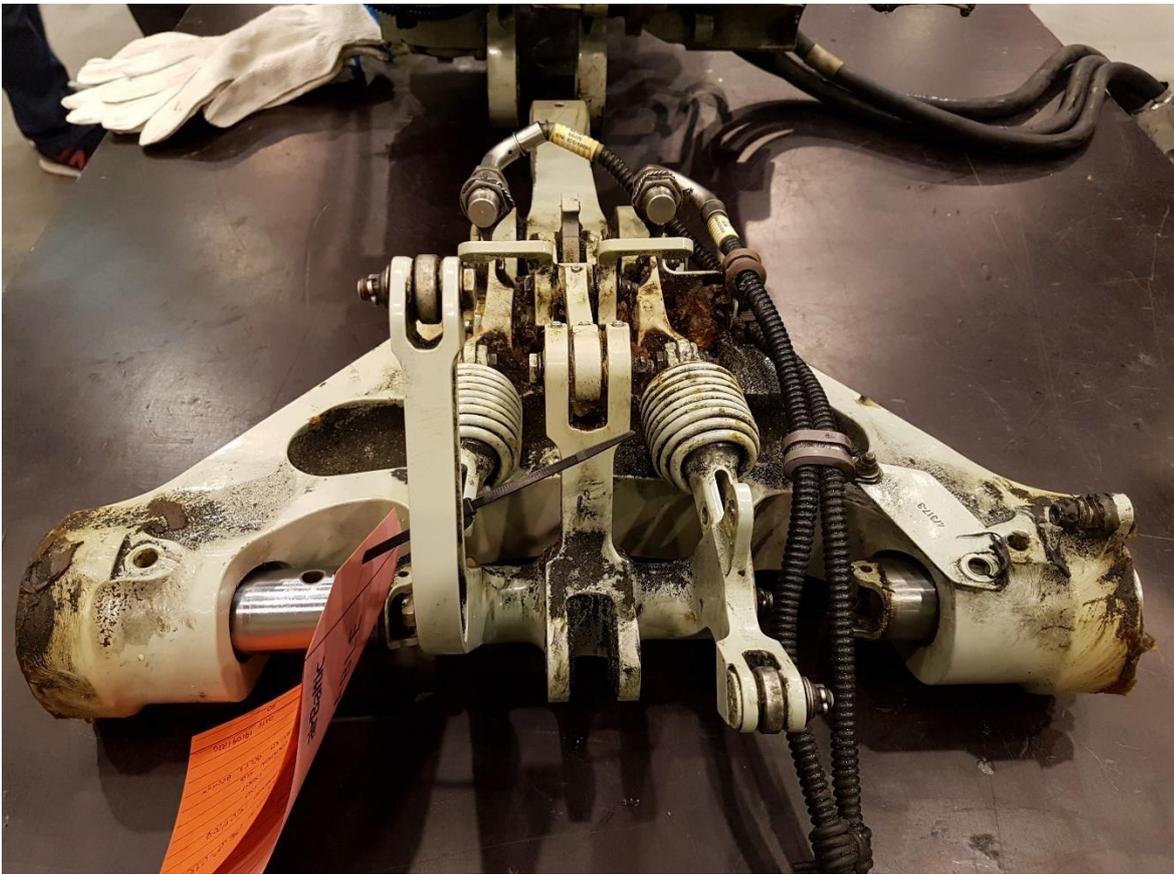
Picture 26 NLG Drag Strut Assembly

Picture 25 NLG Drag Strut Assembly, Illustrated Parts Catalog (IPC) During the first inspection was found that nut 210 of pin 170 of upper lock drag strut and part of pin was detached. NLG Drag Strut Assembly was removed from aircraft for inspection.

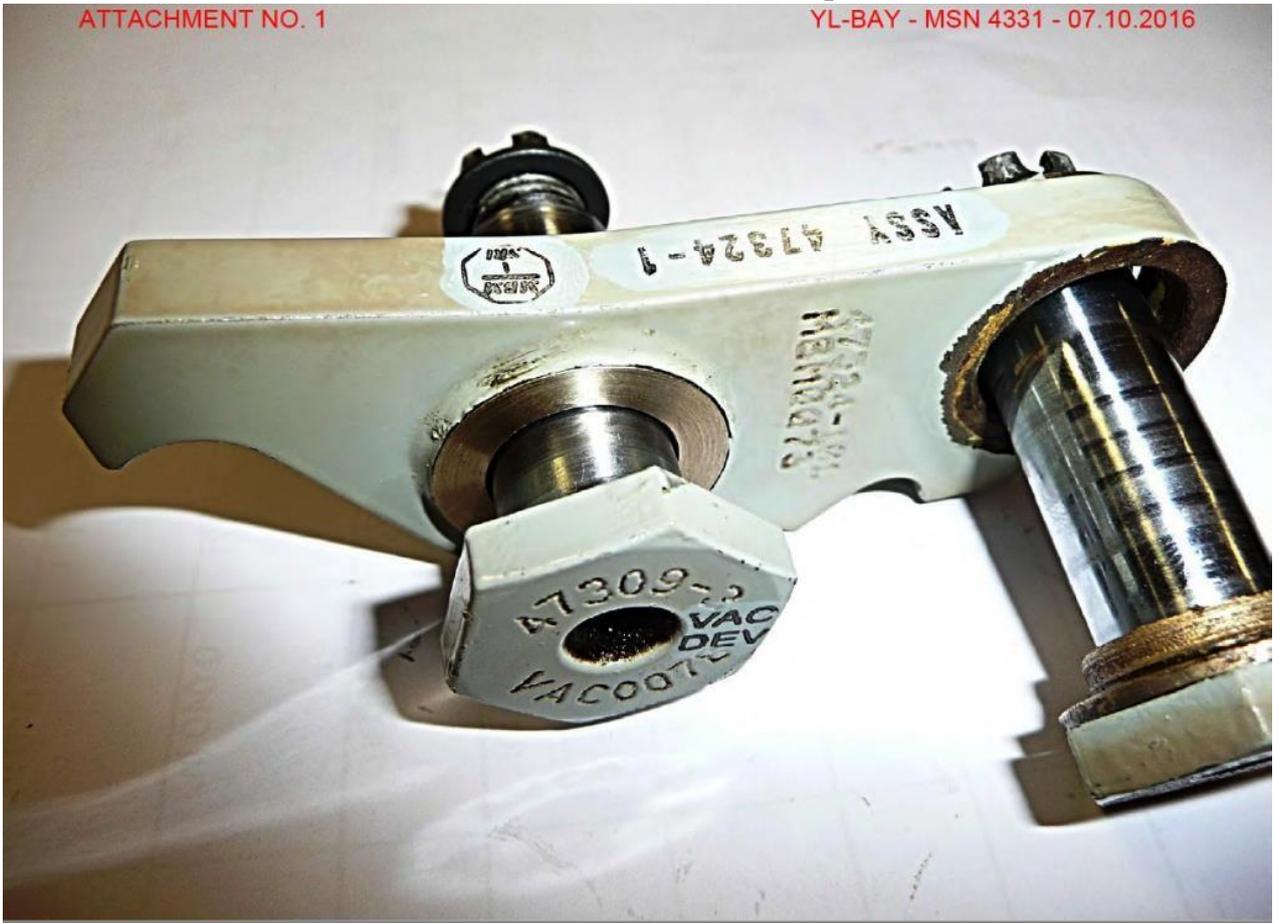
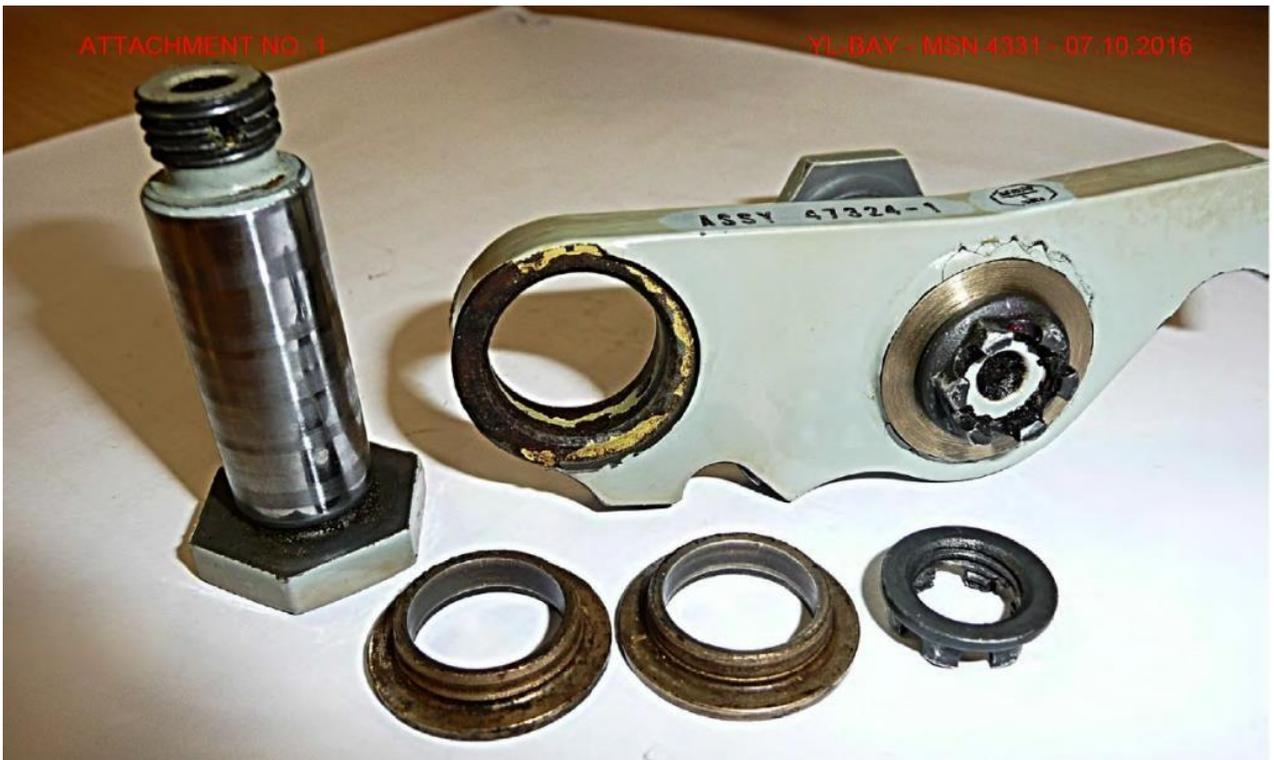
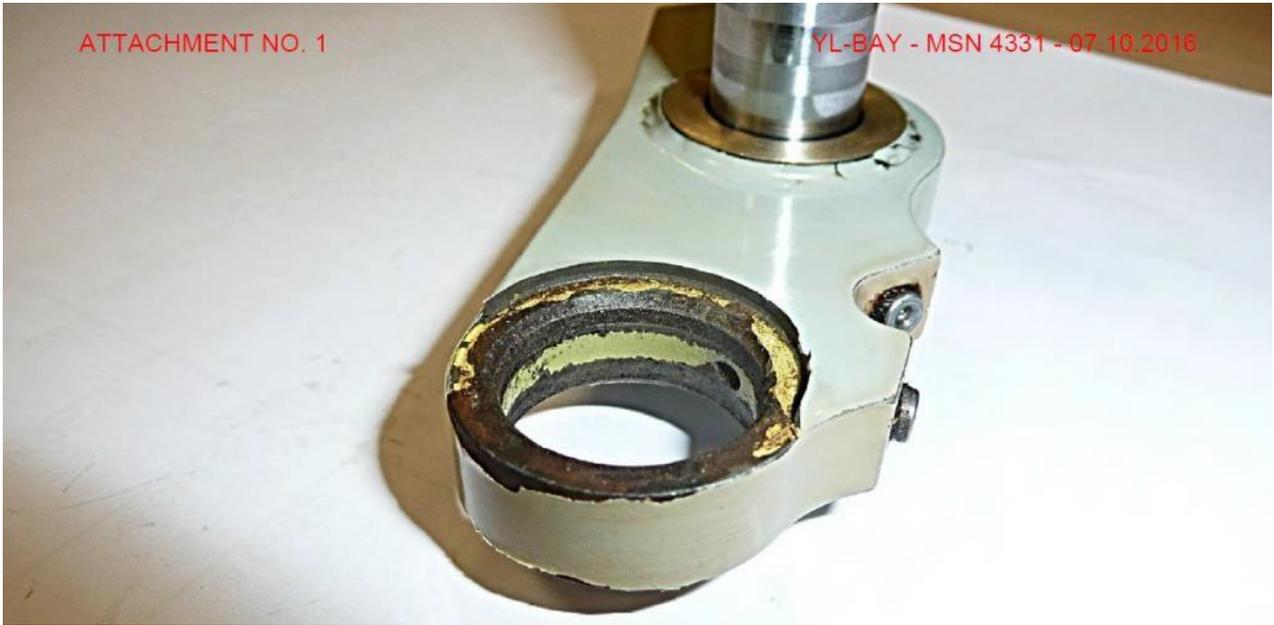
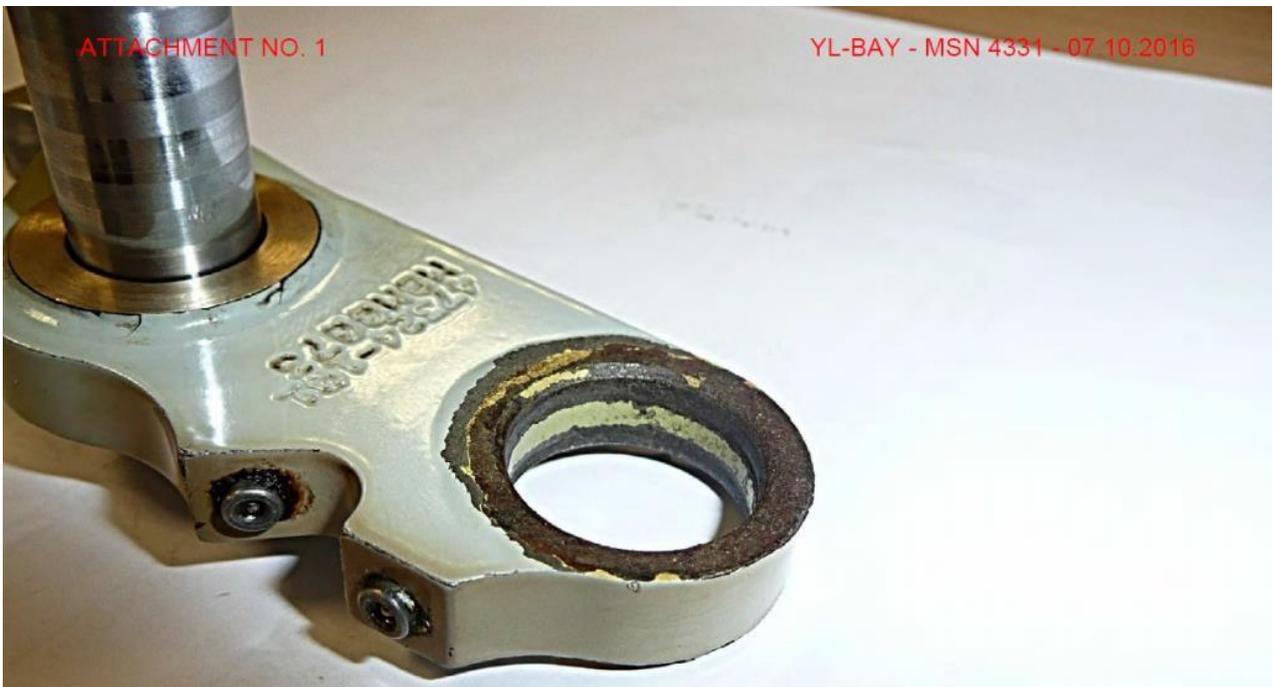
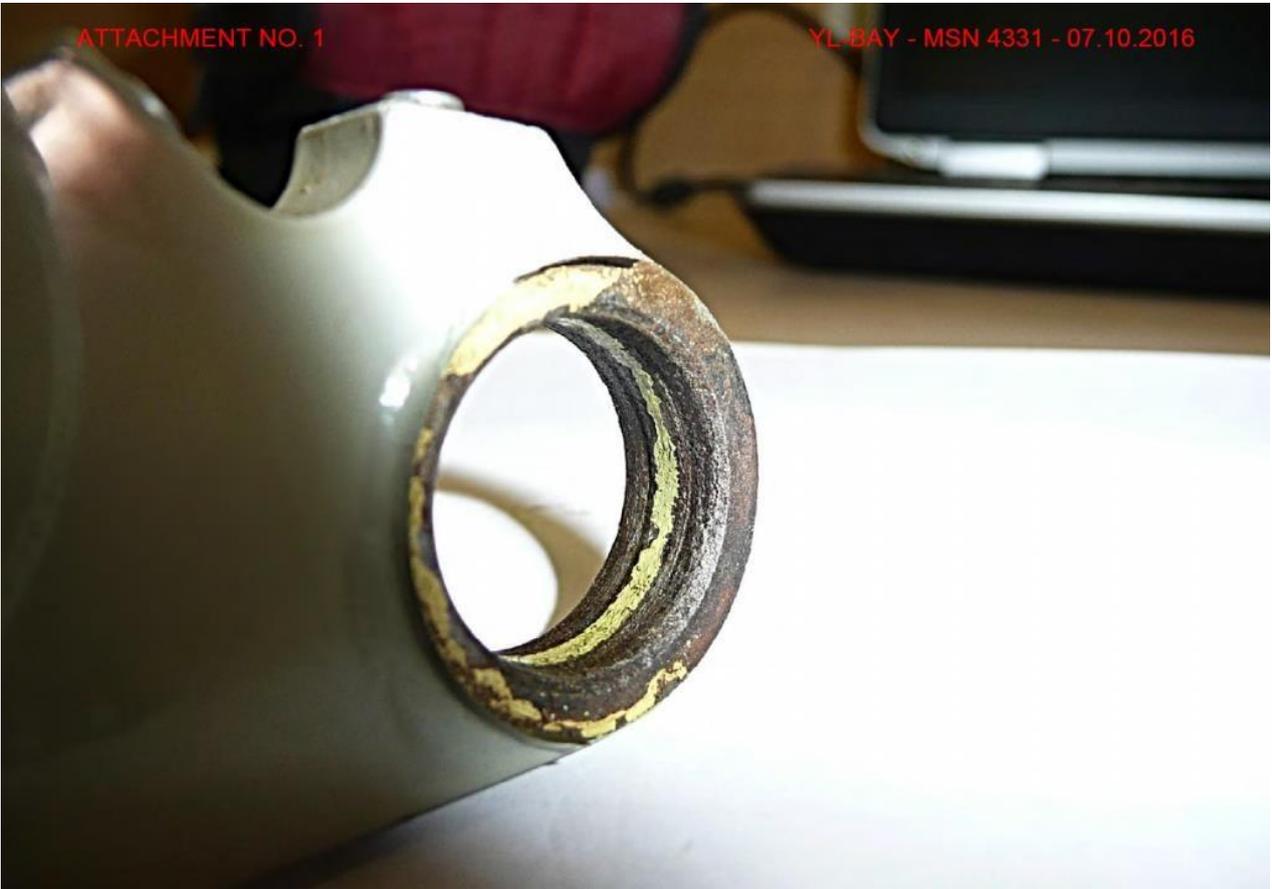
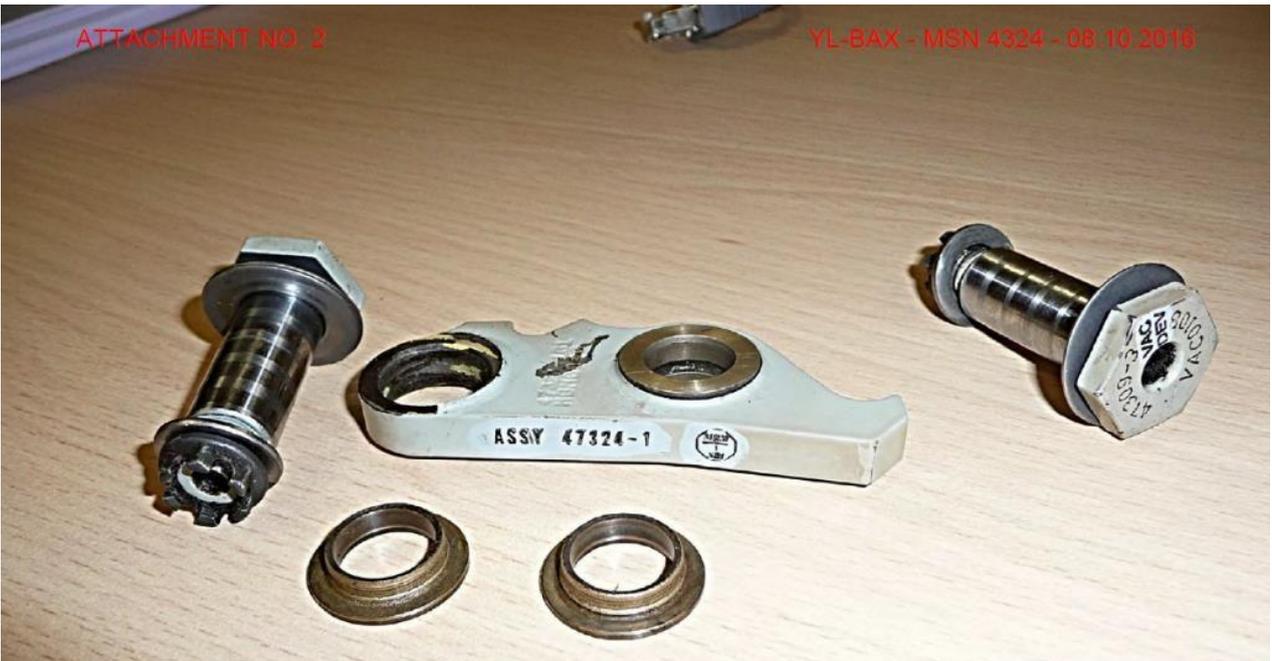
YL-BAY - MSN 4331 - 07.10.2016

Corrosion has been found on the affected lock links lower hole accompanied to the separation of bushings from the assembly. The corrosion is the result loss of sealant due to dislodged bushings (Photos of corrosion on links P/N: 47321-1 splitted by aircrafts according Table).

No	Aircraft reg.No	MS N	s/n of Lock Link P/N 47324-1	TSN (FH)	CSN (FC)	Inspection results
1.	YL-BAY	4331	MBM0073	16931:33	12376	Revealed corrosion of the Lock Link; Corrosion/loose bushings of NLG Drag Strut Lock Link was found
2.	YL-BAX	4324	MBM0040	16653:09	12338	
3.	YL-BAQ	4313	MBM0053	16014:39	12084	
4.	YL-BAJ	4309	MBM0011	16667:49	12098	
5.	YL-BAF	4293	MBM0035	17018:29	12703	
6.	YL-BAH	4296	MBM0029	17468:20	12925	
7.	YL-BAE	4289	MBM0021	17419:12	13302	
8.	YL-BBT	4438	MBM0197	11482:45	8131	
9.	YL-BBU	4439		10812	7745	No corrosion/loose bushings of NLG Drag Strut Lock Link was found
10.	YL-BBV	4444				
11.	YL-BBW	4448

Inspections on the following aircrafts were performed, affected parts have been replaced and respective aircrafts have been released to service.

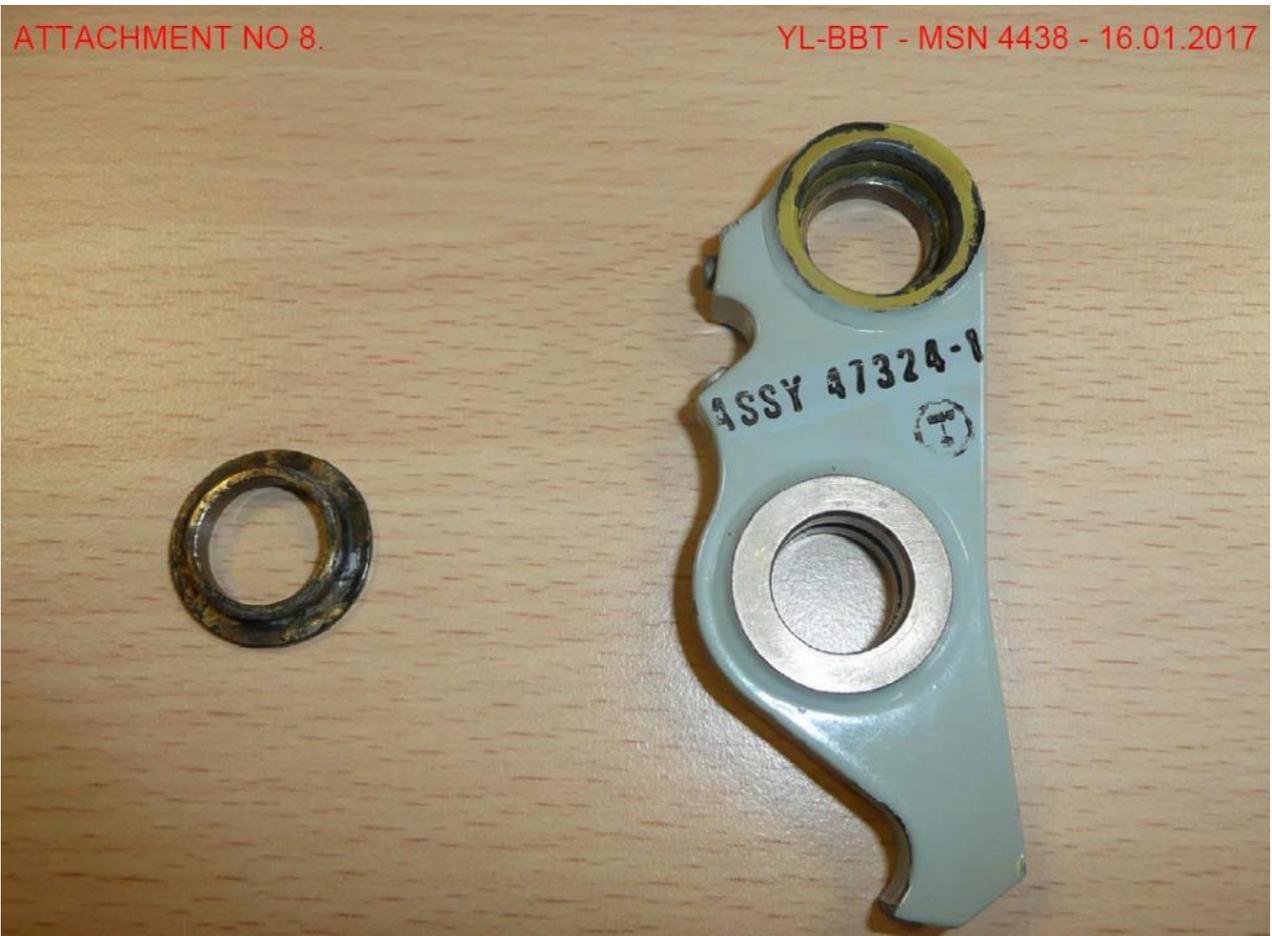
Picture 73

ATTACHMENT NO 8.

YL-BBT - MSN 4438 - 16.01.2017
