FINAL REPORT No. 4-02/4-16 (1-2018) on

THE SERIOUS INCIDENT of AIRCRAFT BOMBARDIER- DHC-8-402, REGISTRATION YL-BAI

ON SEPTEMBER 17, 2016 AT RIGA INTERNATIONAL AIRPORT

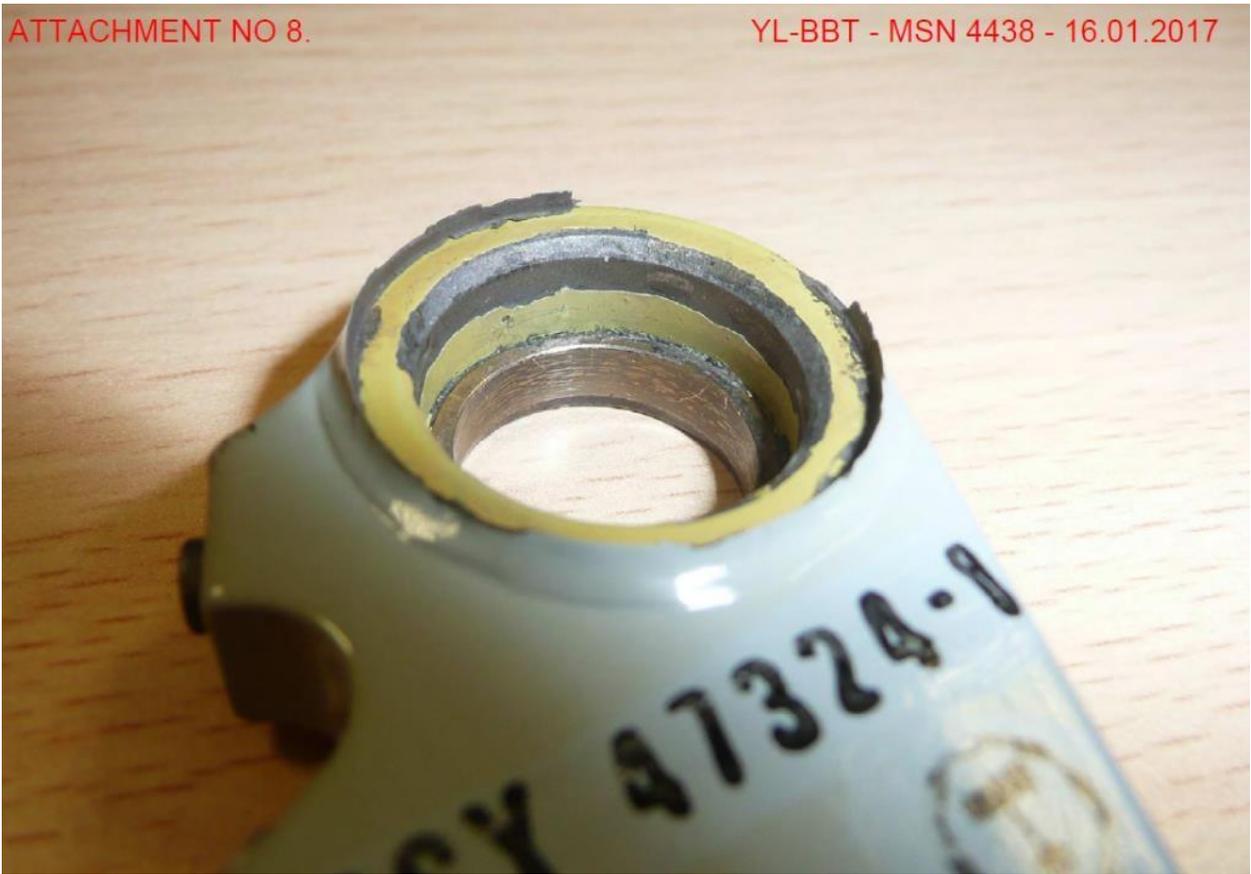
Picture 74

ATTACHMENT NO 8.

YL-BBT - MSN 4438 - 16.01.2017

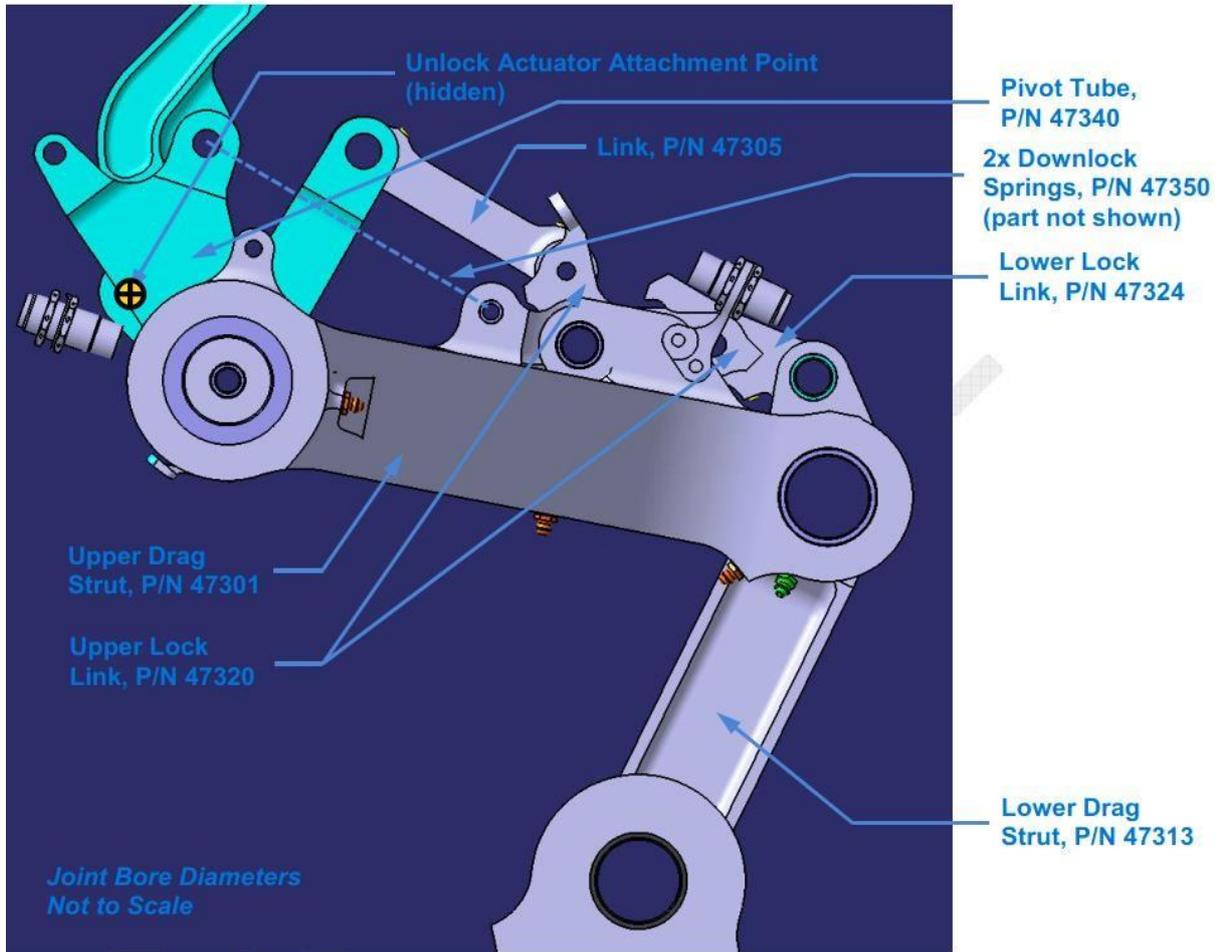
Picture 76 Q400 Nose Landing Gear Drag Strut Assembly

- The locking mechanism locks when the lock link angle γ , is more than 180° , which is possible at nose landing gear angles, α , of 0° (NLG fully extended/down) and 120° (NLG fully retracted/up). For a gear angle approaching 56° the angle between the upper and lower drag strut approaches a minimum value and the lock link angle approaches a local maximum of 162° ;

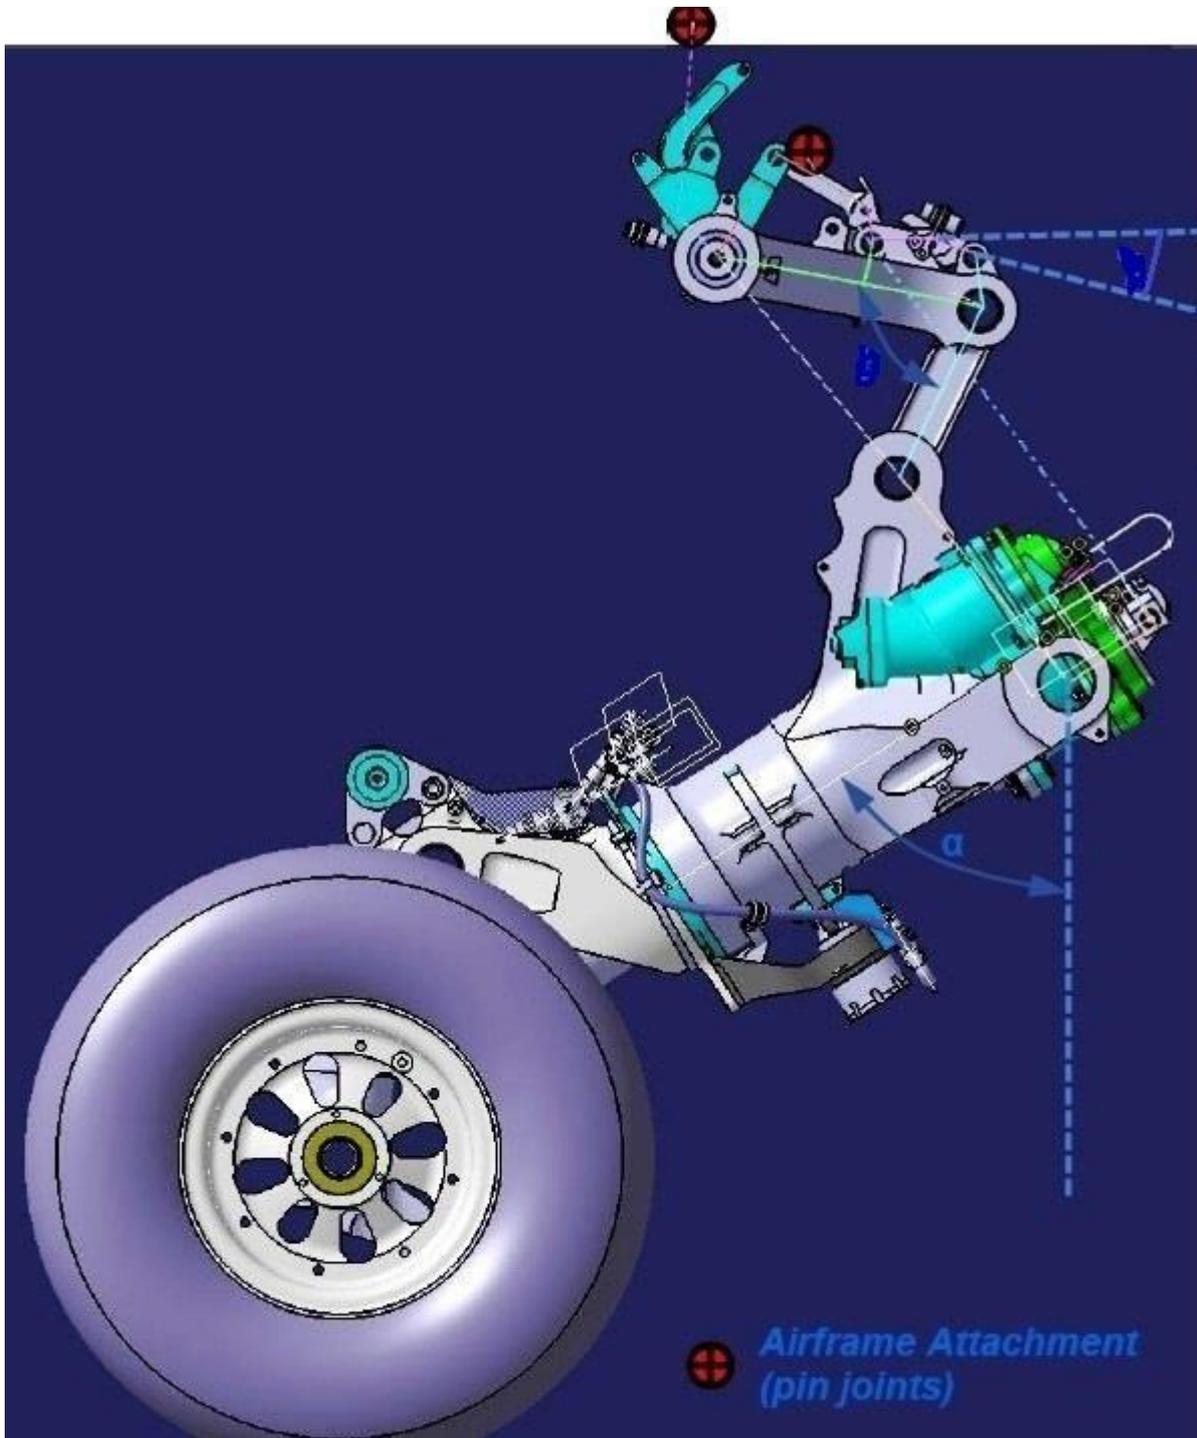
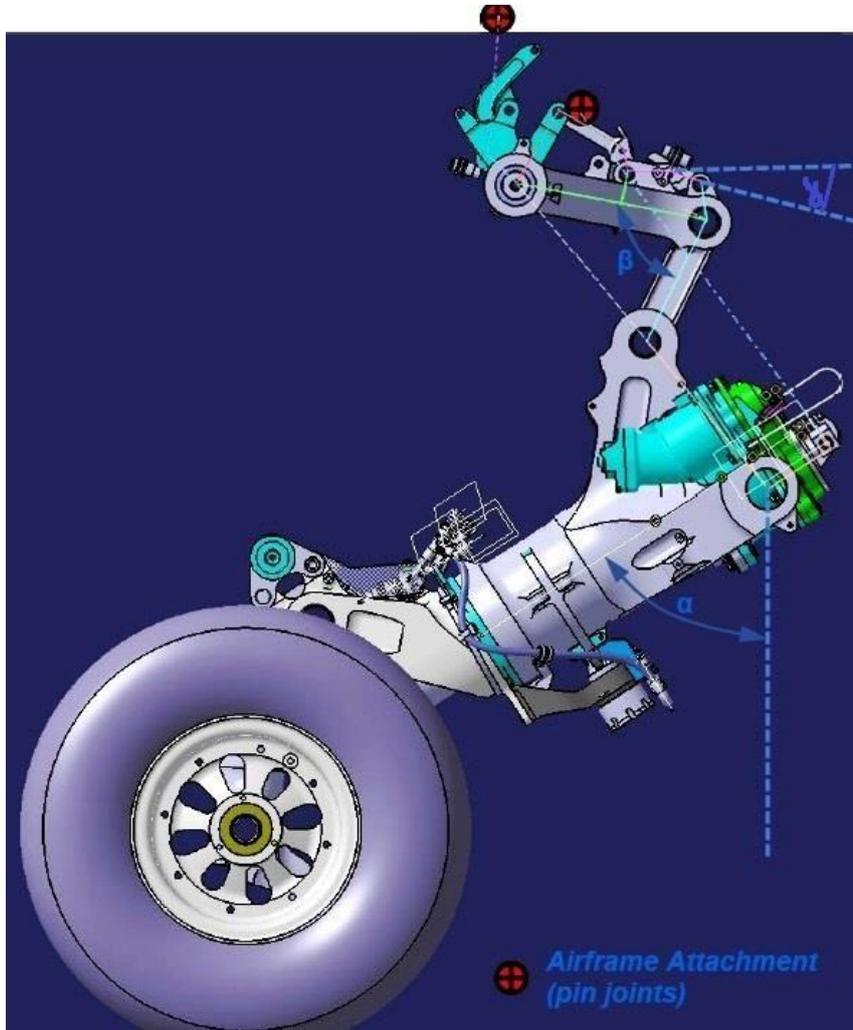
Picture 77 Relevant Angular Dimensions for Table 2 and Figure 5

α = Gear angle β =
 Drag strut angle
 γ = Lock link angle

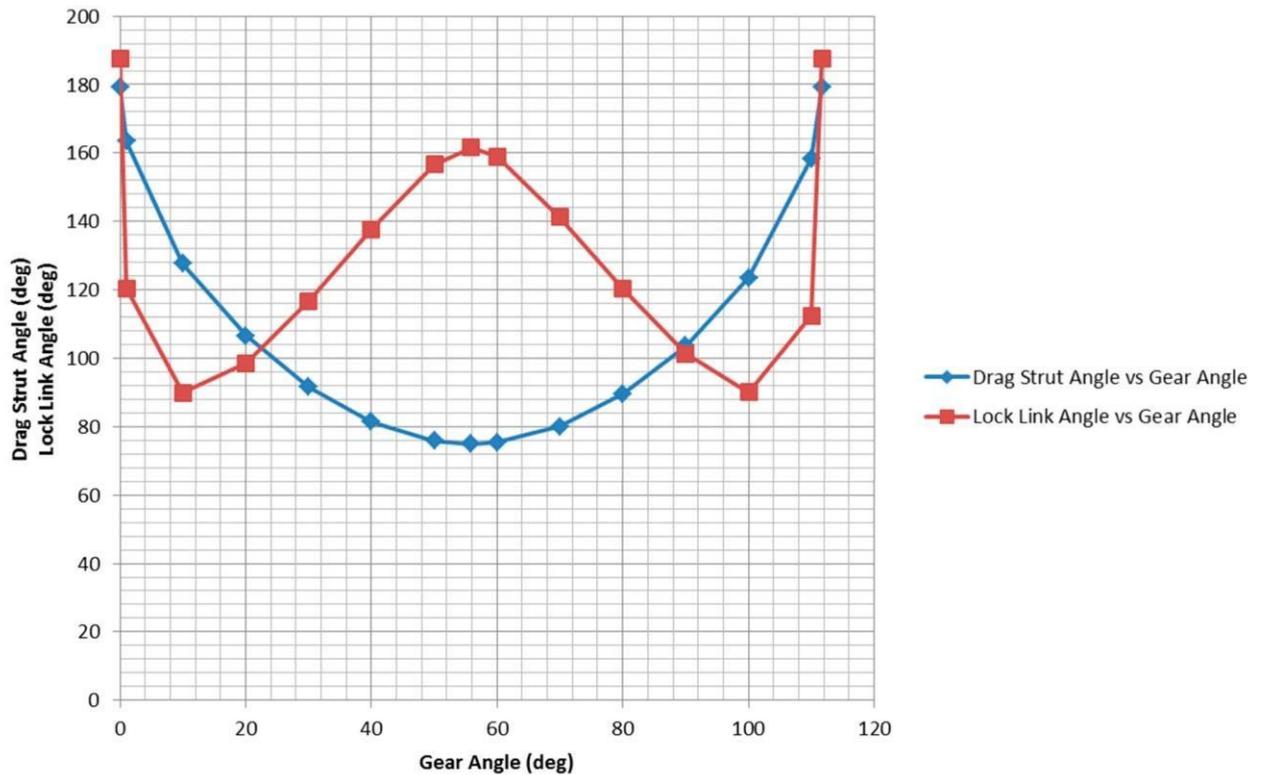
Picture 77 Drag Strut Angle and Lock Link Angle vs Gear Angle

- The exact lock link angle at the minimum drag strut angle depends on the clearances that are present in the turning points of the locking mechanism. From images just before touchdown of the aircraft it is concluded that the gear angle was approximately 60°. A possible scenario is that the locking mechanism locked when the drag strut angle was at the minimum value;

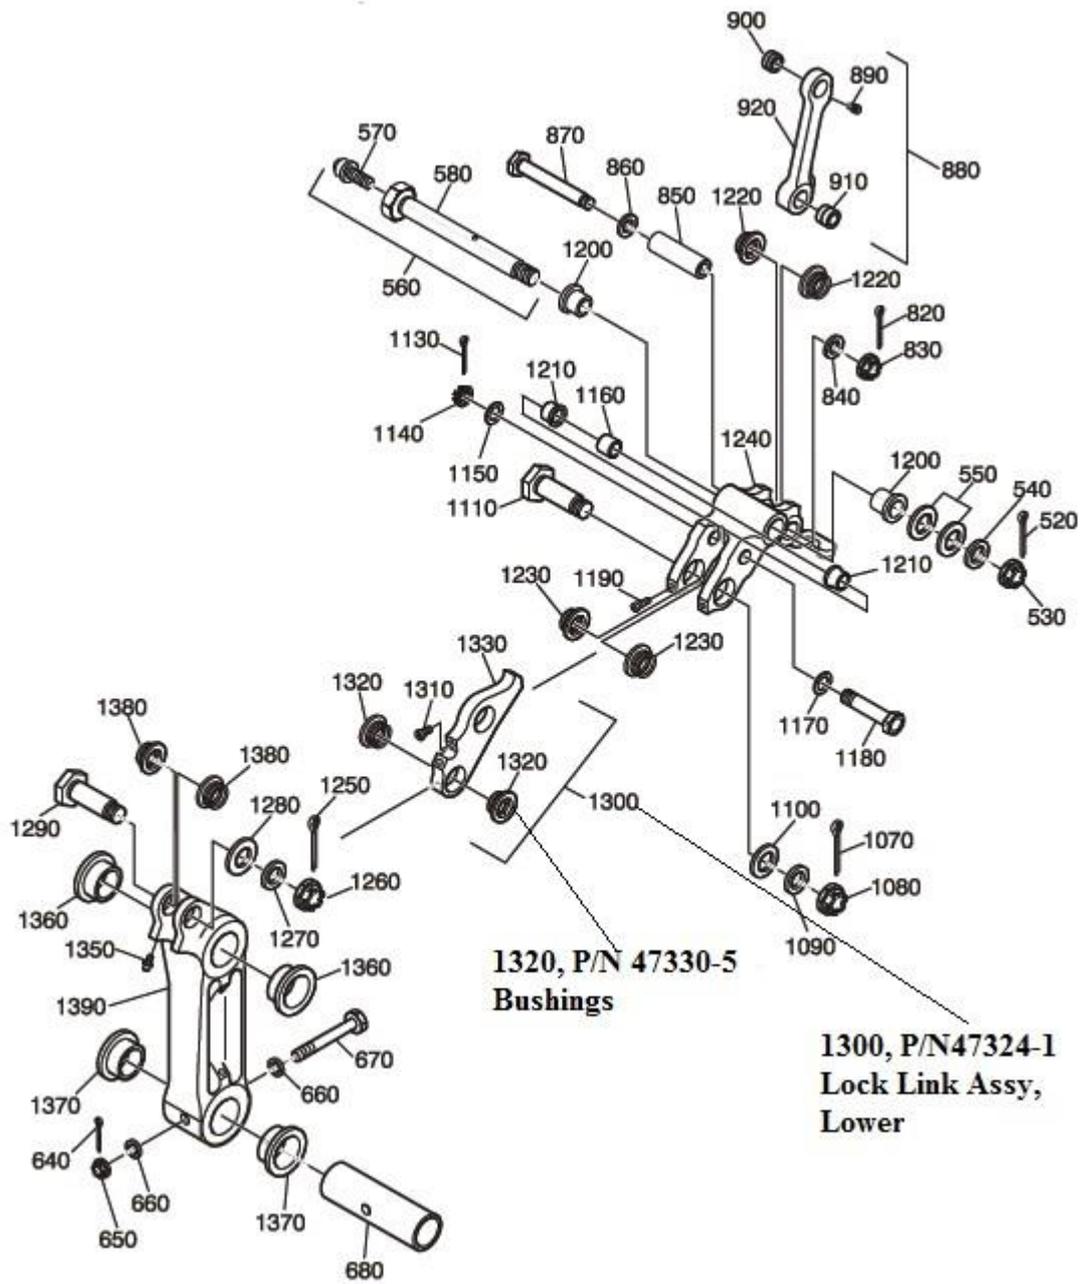
Picture 78 Drag Strut Assembly

This is evidence that rather bushings retention is a main problem and it is widespread while the corrosion damage might be endemic to certain geographical areas only.

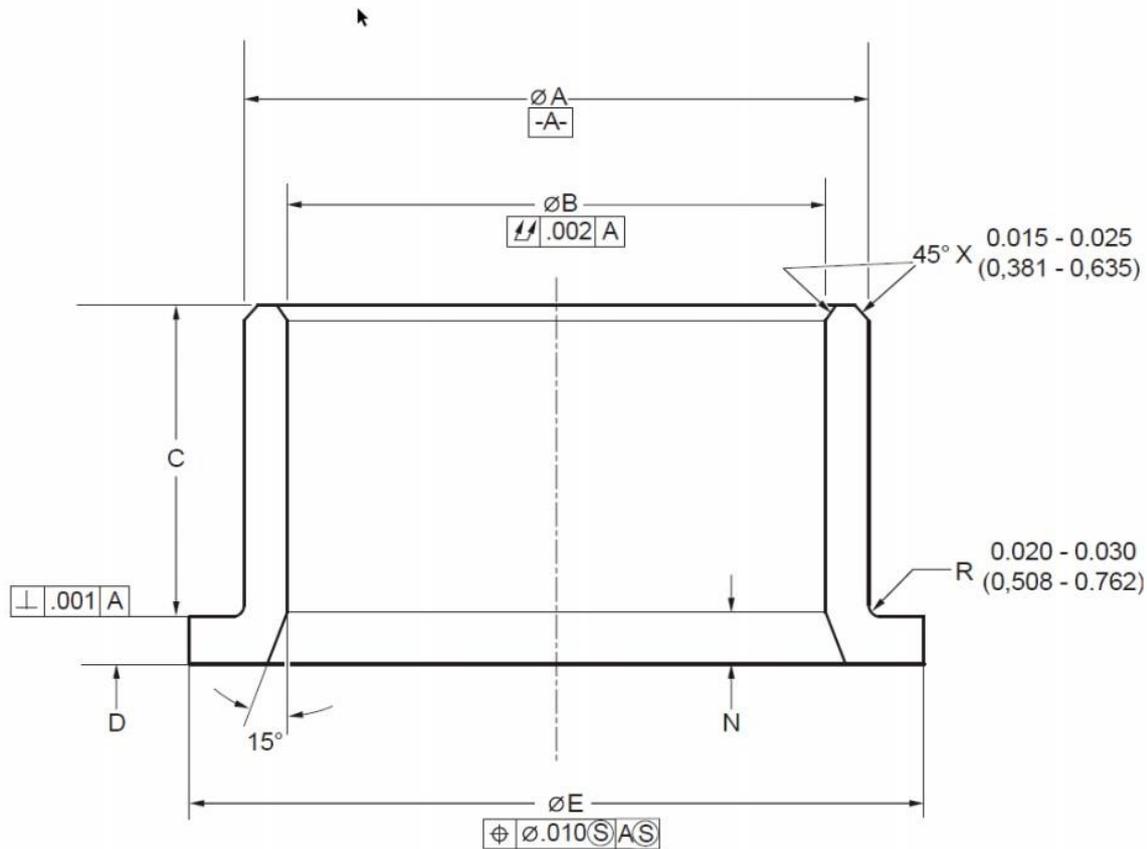
Picture 80

intense blue in color, so these should have left some discoloration on the LLL. None of this was found. The nature of pits on the OD of the bushings remains unknown.
