LATVIJAS REPUBLIKA  
**TRANSPORTA NELAIMES GADĪJUMU UN INCIDENTU  
IZMEKLĒŠANAS BIROJS**

REPUBLIC OF LATVIA  
**TRANSPORT ACCIDENT AND INCIDENT INVESTIGATION BUREAU**  
58 Brivibas Street, Riga, Latvia, LV-1011 Phone: +371-67288140 Mob. ph.: +371-26520082 Fax: +371-67283339  
E-mail: taiib@taiib.gov.lv www.taiib.gov.lv

**FINAL REPORT Nr.4-02/3-12(3-2013)**  
**OF THE AIRCRAFT SERIOUS INCIDENT**

**LOSS OF SEPARATION BETWEEN THE AEROFLOT AIRCRAFT A320,  
REGISTRATION VP-BZS, flight AFL2100 and AirBaltic AIRCRAFT Boeing 735,  
REGISTRATION YL-BBN, FLIGHT BTI60K, ON MAY 19, 2012**

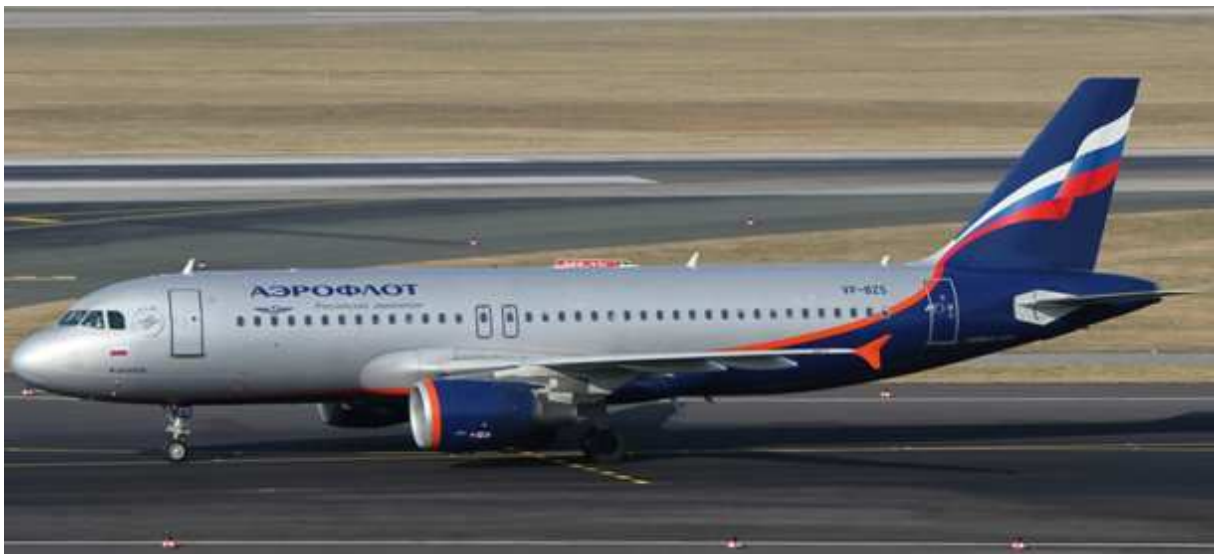
*Picture 1*

AIRBUS A320, operating by AEROFLOT, registration VP-BZS coming from Sheremetyevo International Airport – Moscow, Russia (UUEE) was on approach to RWY 18 Riga International airport (EVRA) crew declared that they are not stabilized and go around At the same time Boeing 735, operating by air Baltic, registration YL-BBN received take off clearance and performed take off and flew out by SID VALED 3E to Brussels Airport – Zaventem, Belgium (EBBR).

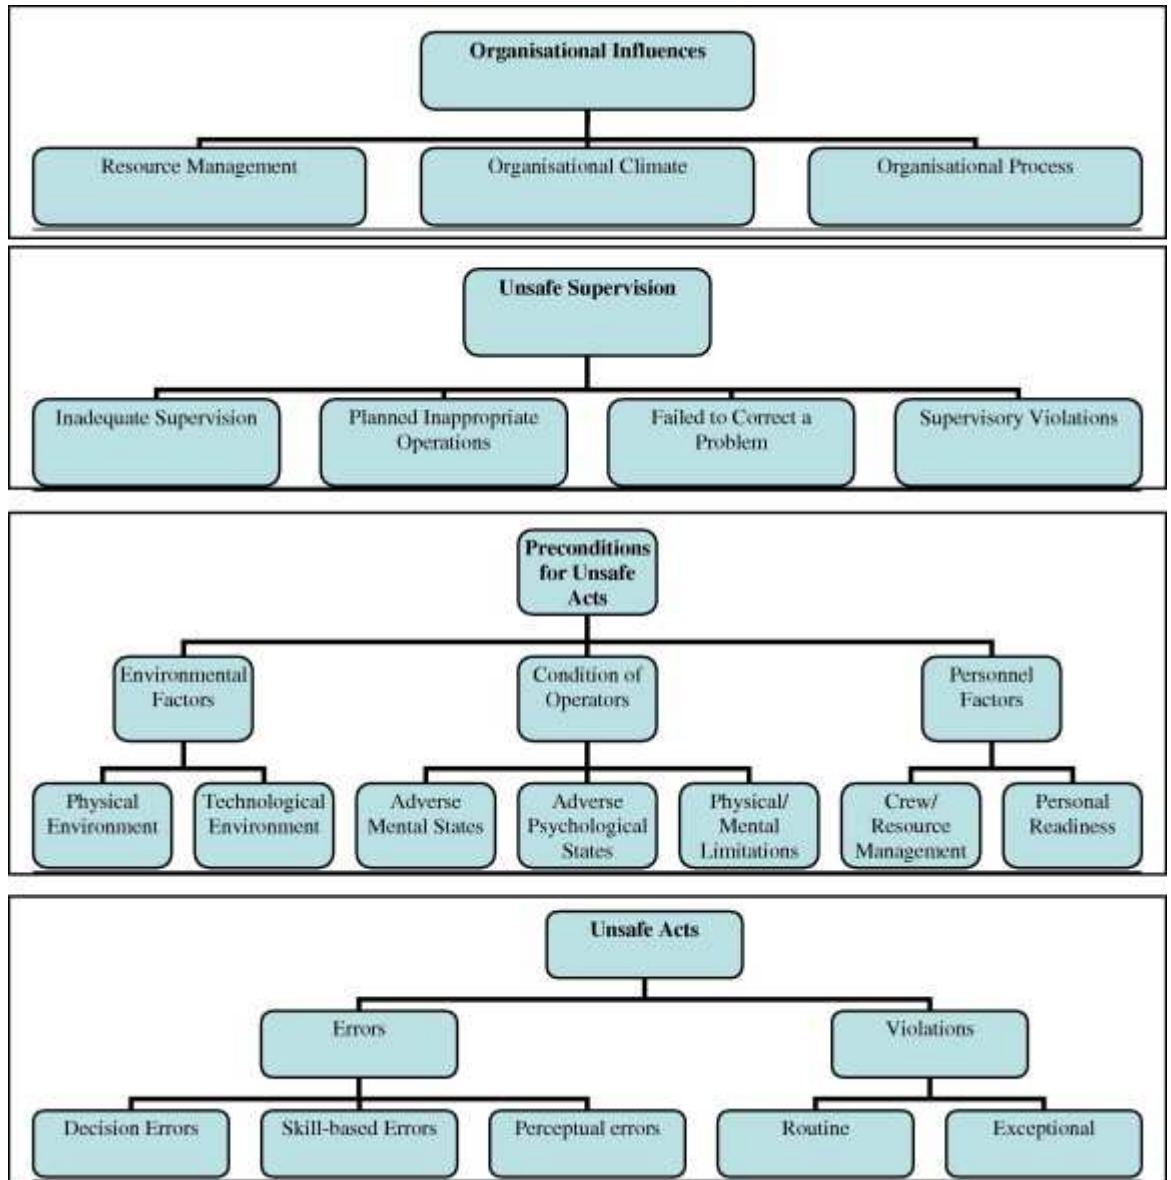
Picture 12 The HFACS framework

It is based on a sequential or chain-of-events theory of accident causation. The human contribution don't build on the person approach, that focuses on the errors and violations of individuals but is based on the system approach, that traces the causal factors back into the system as a whole. Such approach to providing investigation is not that Human Error is a cause of incident, but that Human Error is a symptom of trouble deeper inside a system. For analysis investigation has considered that the classification system has following four levels, each of which influences the next level:
